SECOND PERIODIC REVIEW REPORT FINAL

Murray Pacific 2 Facility Site ID#: 1211 Cleanup Site ID# 3075

2407 Port of Tacoma Road Tacoma, Washington 98421

July 2019

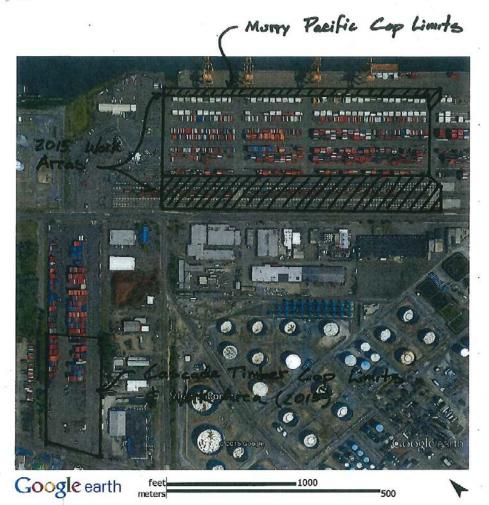
Since September 2011, a total of three rounds of cap inspections (February 2012, December 2014 and March 2017) have been conducted at the Site. As per these cap inspection reports recommendations and cap maintenance, the Port sealed or resealed approximately 8,712 feet of cracks, repaired, replaced, or removed 111 concrete wheel stops in the intermodal yard and adjacent to the pier on the drive aisle (Photo 1, Appendix 6.9).

Photo 1: Completed Cap Area Repairs in 2015

- . Crack and shiring seal overlay in the intermedal yard and adjacent to the pier on the drive aisle.
- · Also removed some concrete landing pads and reported the fabric liner in the asphalt section

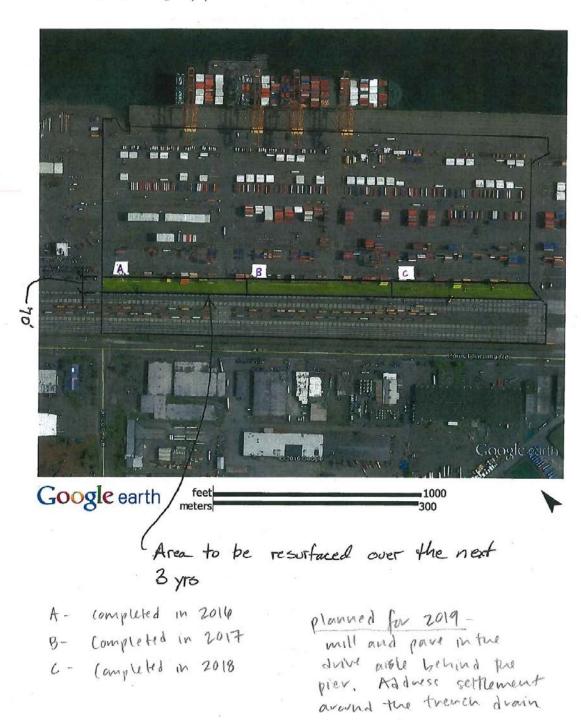
In addition, the Port resurfaced approximately 136,500 square-foot of the low permeability asphalt cap during 2016 through 2018 (Photo 2, Appendix 6.9). The cap section consisting of 4 inches of dense grade asphalt concrete (DGAC) within which a geotextile fabric was placed to improve the long-term performance of the cap. To provide suitable working surface for constructing the cap, a 4 to 12 inches of aggregate base was placed on the subgrade. The cap was installed on top of the aggregate base, and the pavement section was constructed above this cap layer. The pavement section in the container storage yard constructed consisted of 3.33 inches of Class B asphalt. Overlaid with an asphalt-impregnated fabric, then overlaid with two more lifts of Class E asphalt, for a total section thickness of 10 inches (Photo 3, Appendix 6.9). The Port has also scheduled to resurface the cap in the drive aisle behind the Pier and address settlement around the trench drain in 2019.

Photo 2: Completed Cap Area Repairs from 2016 through 2018

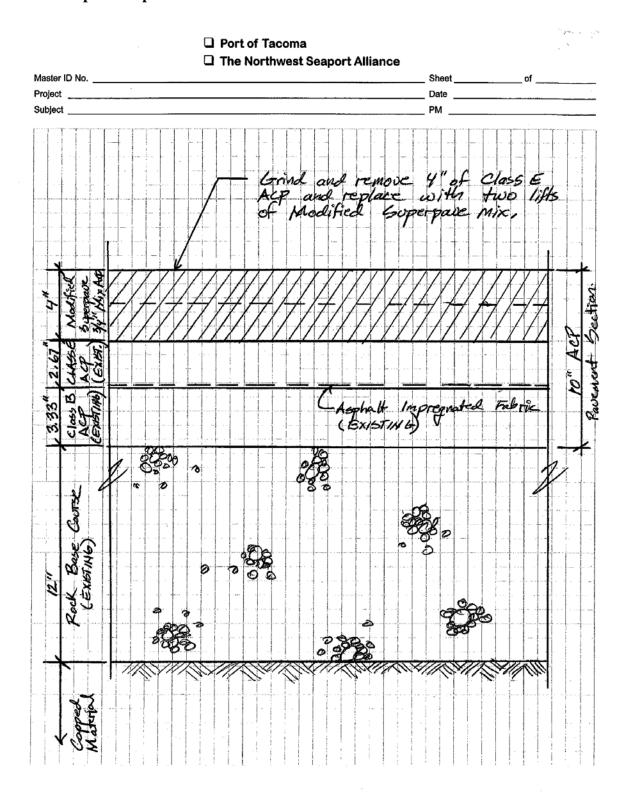
Photo 3: Asphalt Cap Pavement Section

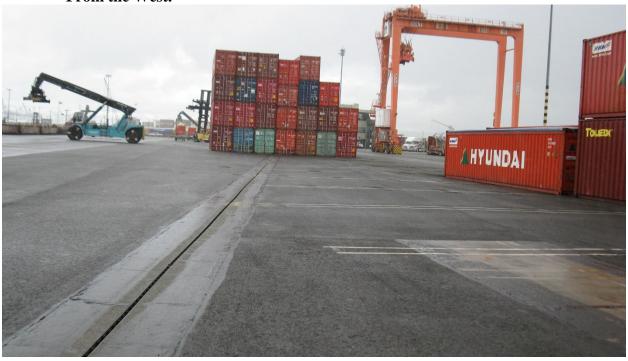
Photo 4: Part of the Cap Repaired Area from 2016 through 2018 and the Slot Drain – From the West.

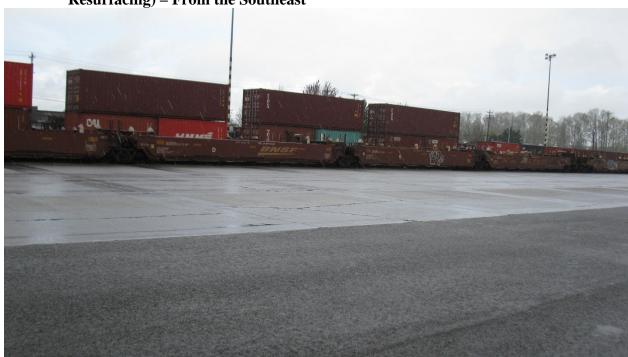
Photo 5: Container Storage Area, Asphalt/Concrete Cap and Repaired Cap Area (Asphalt Resurfacing) – From the Southeast

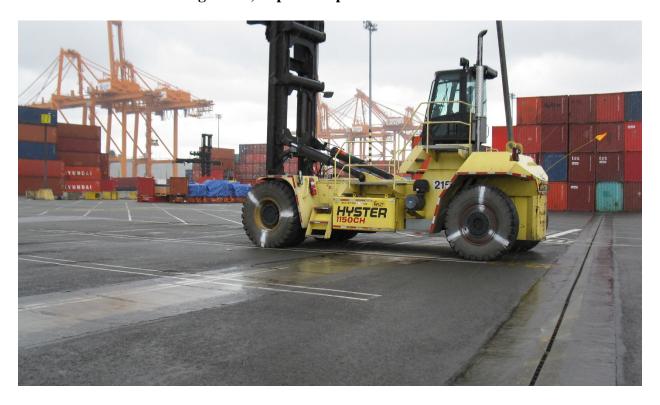
Photo 6: Container Storage Area, Asphalt Cap and Slot Drain – From the Northwest

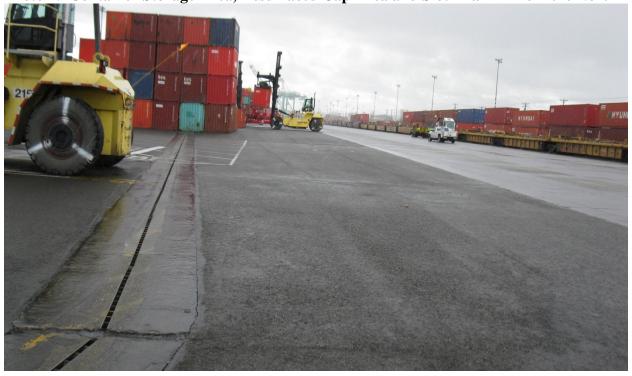
Photo 7: Container Storage Area, Resurfaced Cap Area and Slot Drain – From the North
