**FINAL INDEPENDENT REMEDIAL  
ACTION REPORT**

**ALGER FOOD MART  
BURLINGTON, WASHINGTON**

December 17, 1996

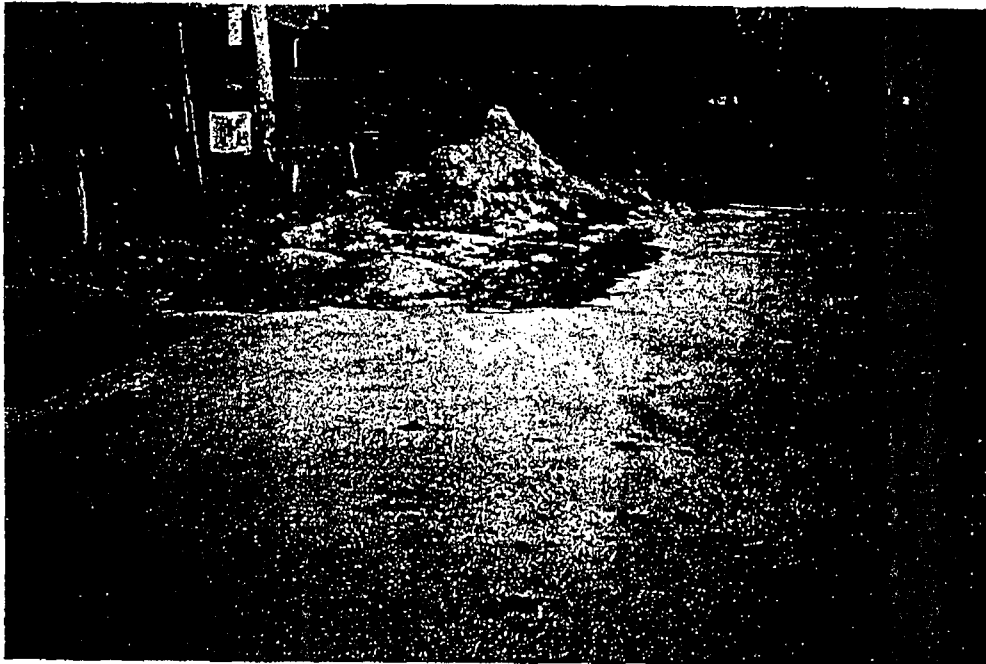
Figure 4. View of UST area on August 9, 1996. The pile of soil is from the removal of UST 1 and UST 2 which were located immediately in front of the soil stock pile. The two drums in the background are used for storing used cooking oil. The vent lines for UST 1 and UST 2 can be seen adjacent to the fence to the left of the power pole.
