PERIODIC REVIEW

**Weyerhaeuser Everett Mill E
Facility Site ID#: 12**

**515 East Marine View Drive,
Everett, Washington**

December 2009

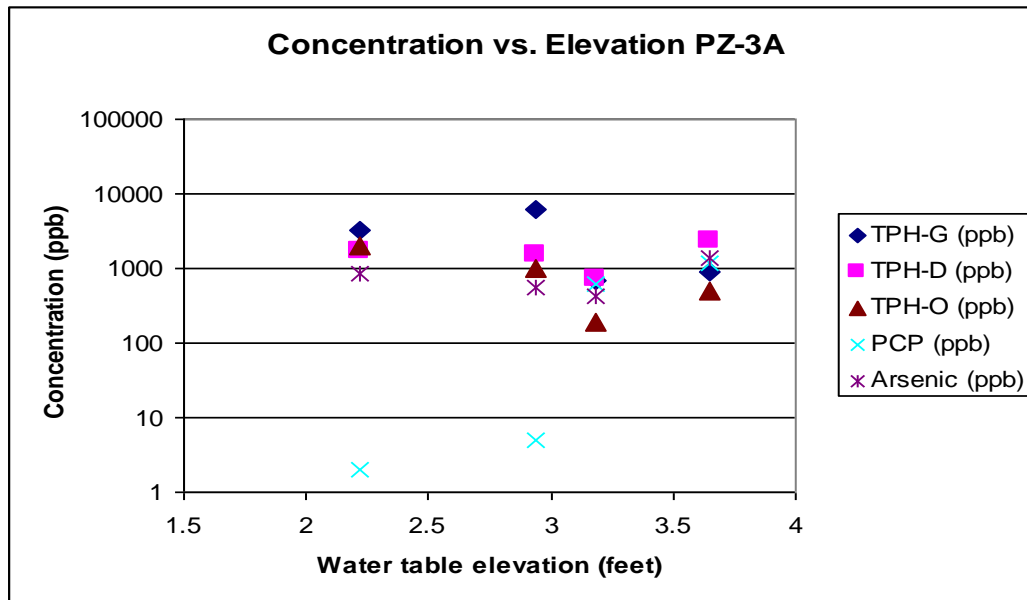
Figure 1 (from Ecology 2006)

Figures 1 – 3 below depict the water table and contaminant concentration trends in well PZ-3A. Figure 1 shows concentration vs. elevation. Figure 2 shows the change in concentration with time since barrier wall and cap installation, and Figure 3 shows elevation vs. time. Except for PCP, there does not appear to be large variations in contaminant concentration with water table elevation (Figure 1). Figure 2 shows that there was a significant reduction in PCP with time. However, the time series plot of the hydrocarbon contaminant concentrations seem to show increases but with a leveling off with time since the cap installation. This can imply a constant

petroleum hydrocarbon source term loading and thus vertical contaminant loading to the lower sand aquifer continues to occur. Although it has been characterized as below the cleanup standard, it is unknown if this is a standard which is protective of water quality and aquatic organism in the river receptor. Arsenic remains above cleanup levels. Finally, the water table beneath the cap still shows fluctuation, although as expected it is much lower than the water table in the upper sand outside of the wall. Note that the other piezometer information is not plotted in this graph, but the total results may be found in the monitoring reports. Parts per billion (ppb) are equivalent to ug/L.

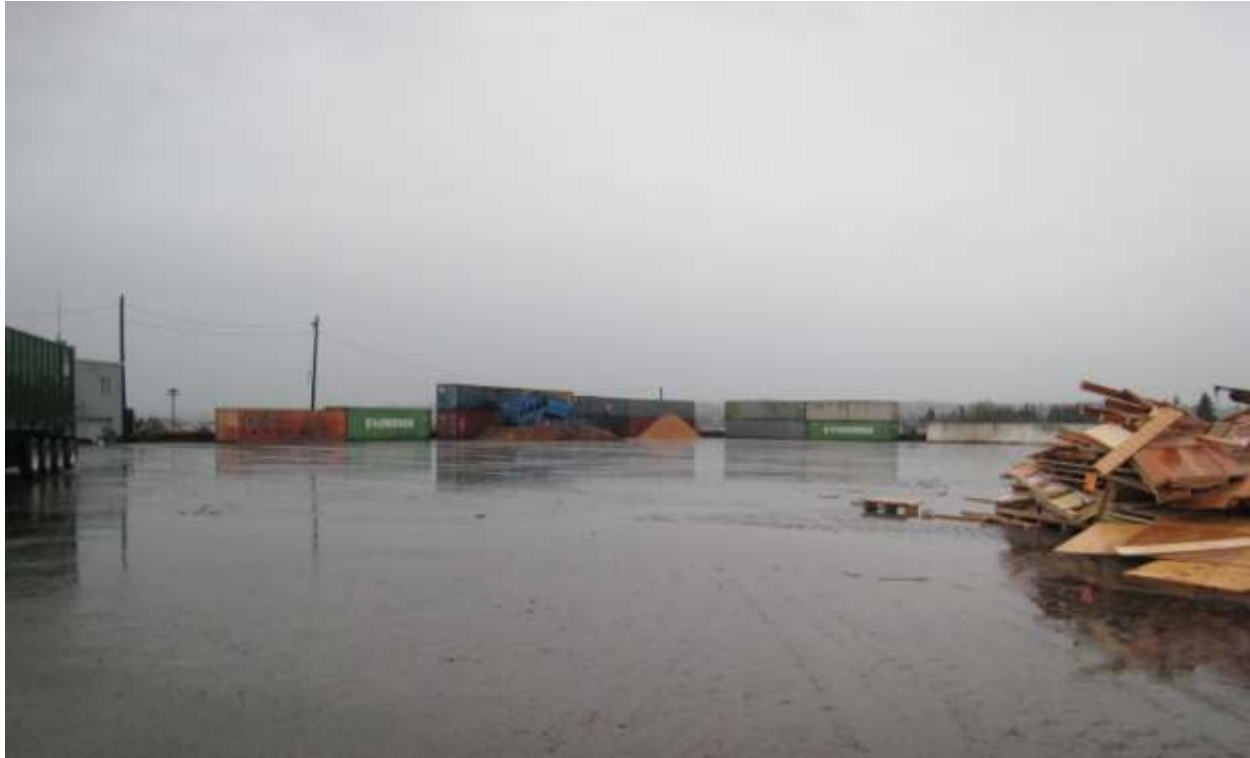
Based upon the site visit conducted on December 15, 2009, the asphalt cover part of the remedy at the Site continues to eliminate exposure to contaminated soils by ingestion and contact. The asphalt appears in satisfactory condition and no repair, maintenance, or contingency actions have been required. The Site is operating as a Pacific Topsoil facility. A photo log is available as Appendix 6.5.

Photo 1: Paved containment area - from the west

- 5) Cap monitoring and inspection should proceed as before. The PLPs have done a good job maintaining the integrity of the asphalt cap and fulfilling notification requirements of the institutional controls required in the Consent Decree.

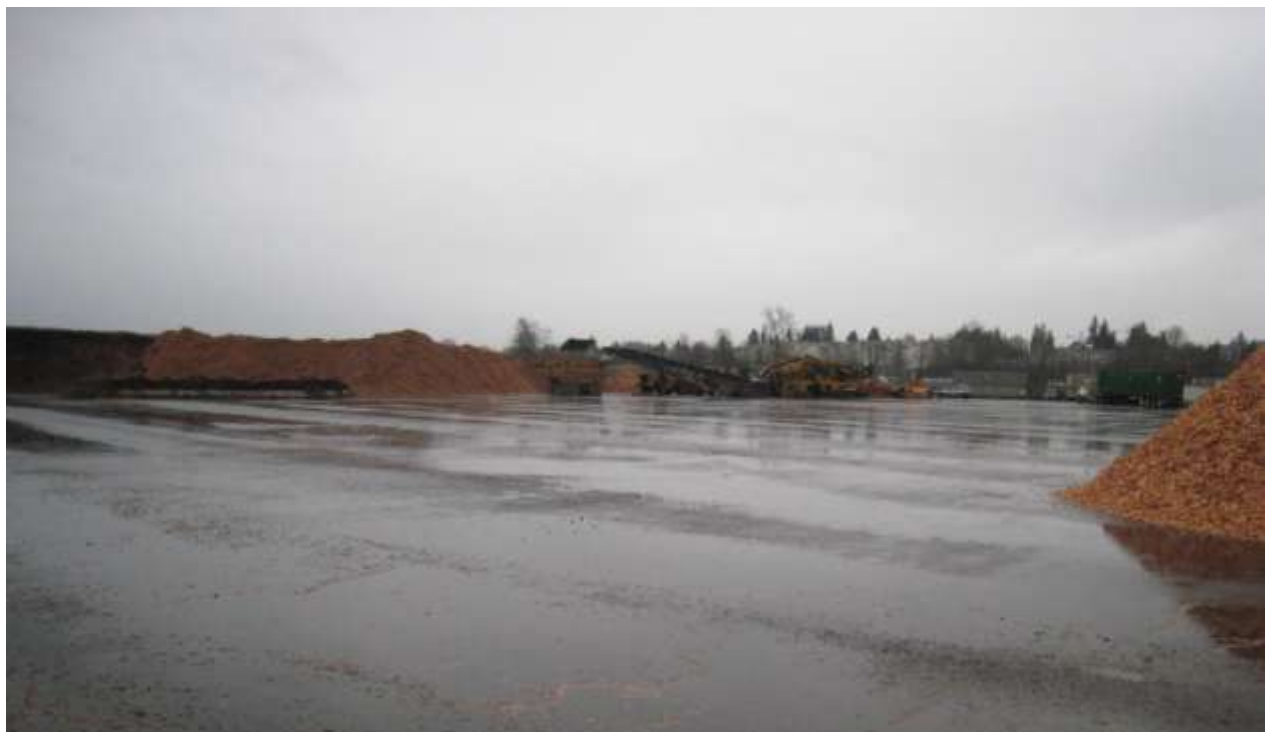
Photo 2: Paved containment area - from the east

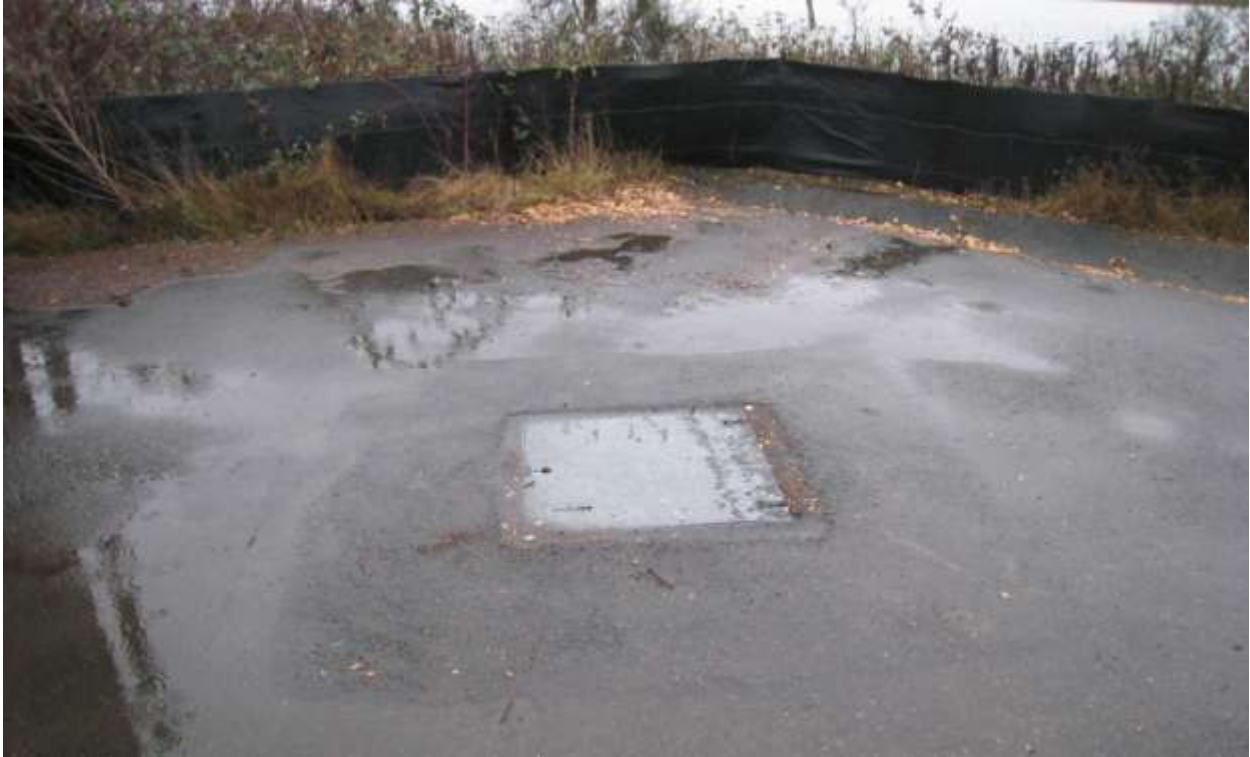
Photo 3: Monitoring location – northeast corner of containment area

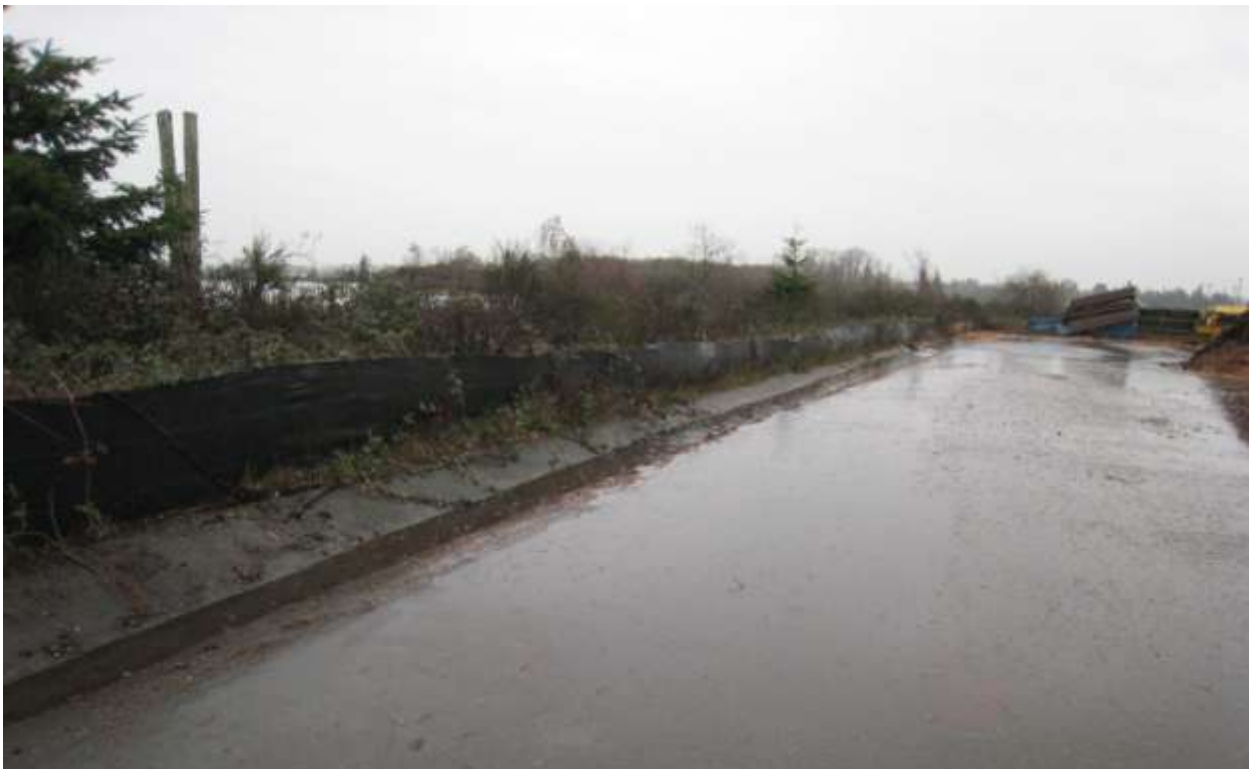
Photo 4: Surface water collection trench – east side of containment area
