**Dalton, Olmsted & Fuglevand, Inc.** *Environmental Consultants*

**MEMORANDUM**

**SUBJECT:** TECHNICAL MEMORANDUM  
INTERIM SITE CHARACTERIZATION REPORT  
MILL E SITE, EVERETT, WASHINGTON

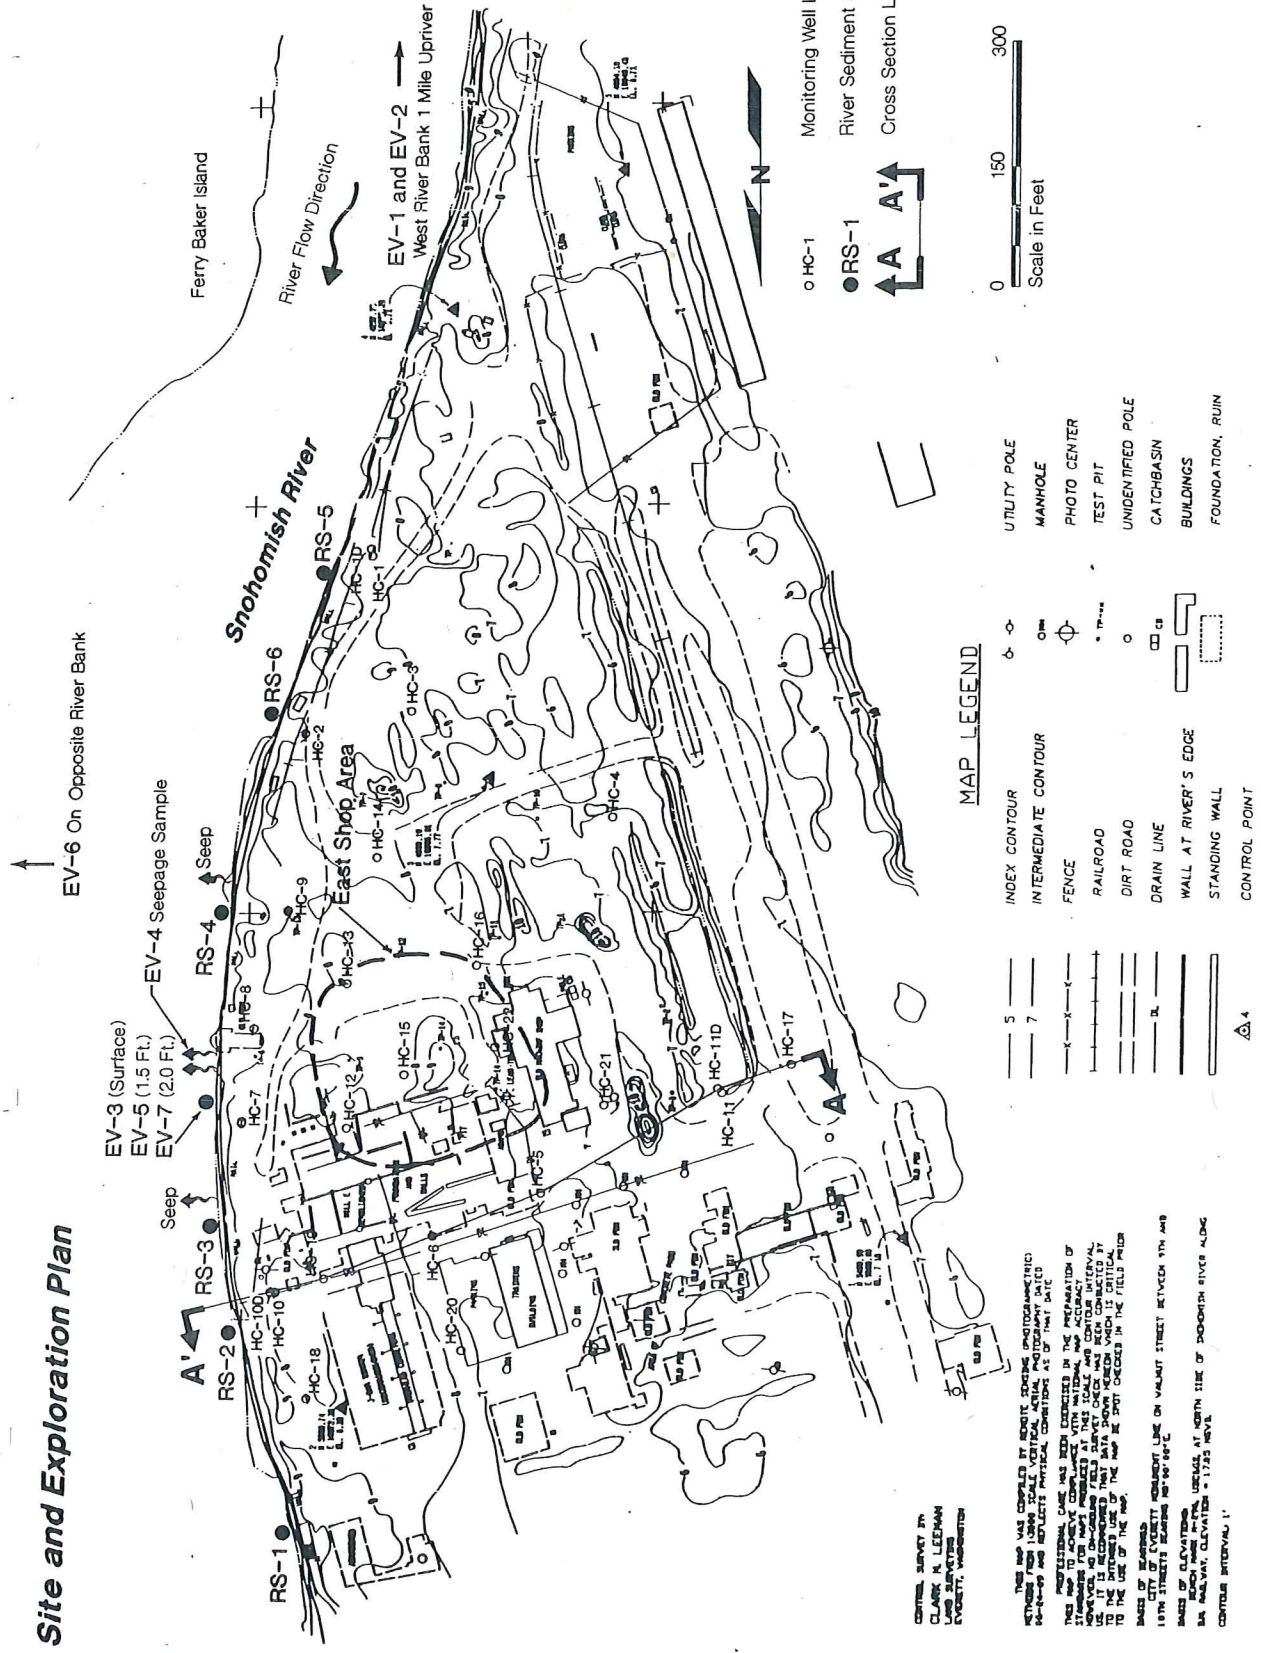
# Site and Exploration Plan

On May 23 and July 19, 1989, Weyerhaeuser collected two sets of low-tide river sediment samples from various locations adjacent to the site, and at locations across the river and on the west bank of the river, 1 mile upstream of the Mill E site. The sampling locations are shown on Figure 2.

Table 3 summarizes the sediment quality data that was collected as part of this work and compares this data with the LAETs and the HAETs. None of the concentrations exceed the HAETs but five chemicals, at one location (samples EV-3 and EV-5 - Figure 2), exceed the LAETs including acenaphthene, fluorene, 2-methylnaphthalene, naphthalene and dibenzofurans. Arsenic exceeds the LAET at one location (RS-6). Based on these data, possible sediment toxicity caused by site discharges is limited to small, localized areas, near seep EV-4 and sediment sampling location RS-6. Samples taken upstream and downstream of each of these locations (Figure 2) did not detect these compounds except at RS-4 where fluorene was detected at 1.7 ppm well below the LAET of 23 ppm. This finding is also supported by sediment data obtained from the main Snohomish River channel.

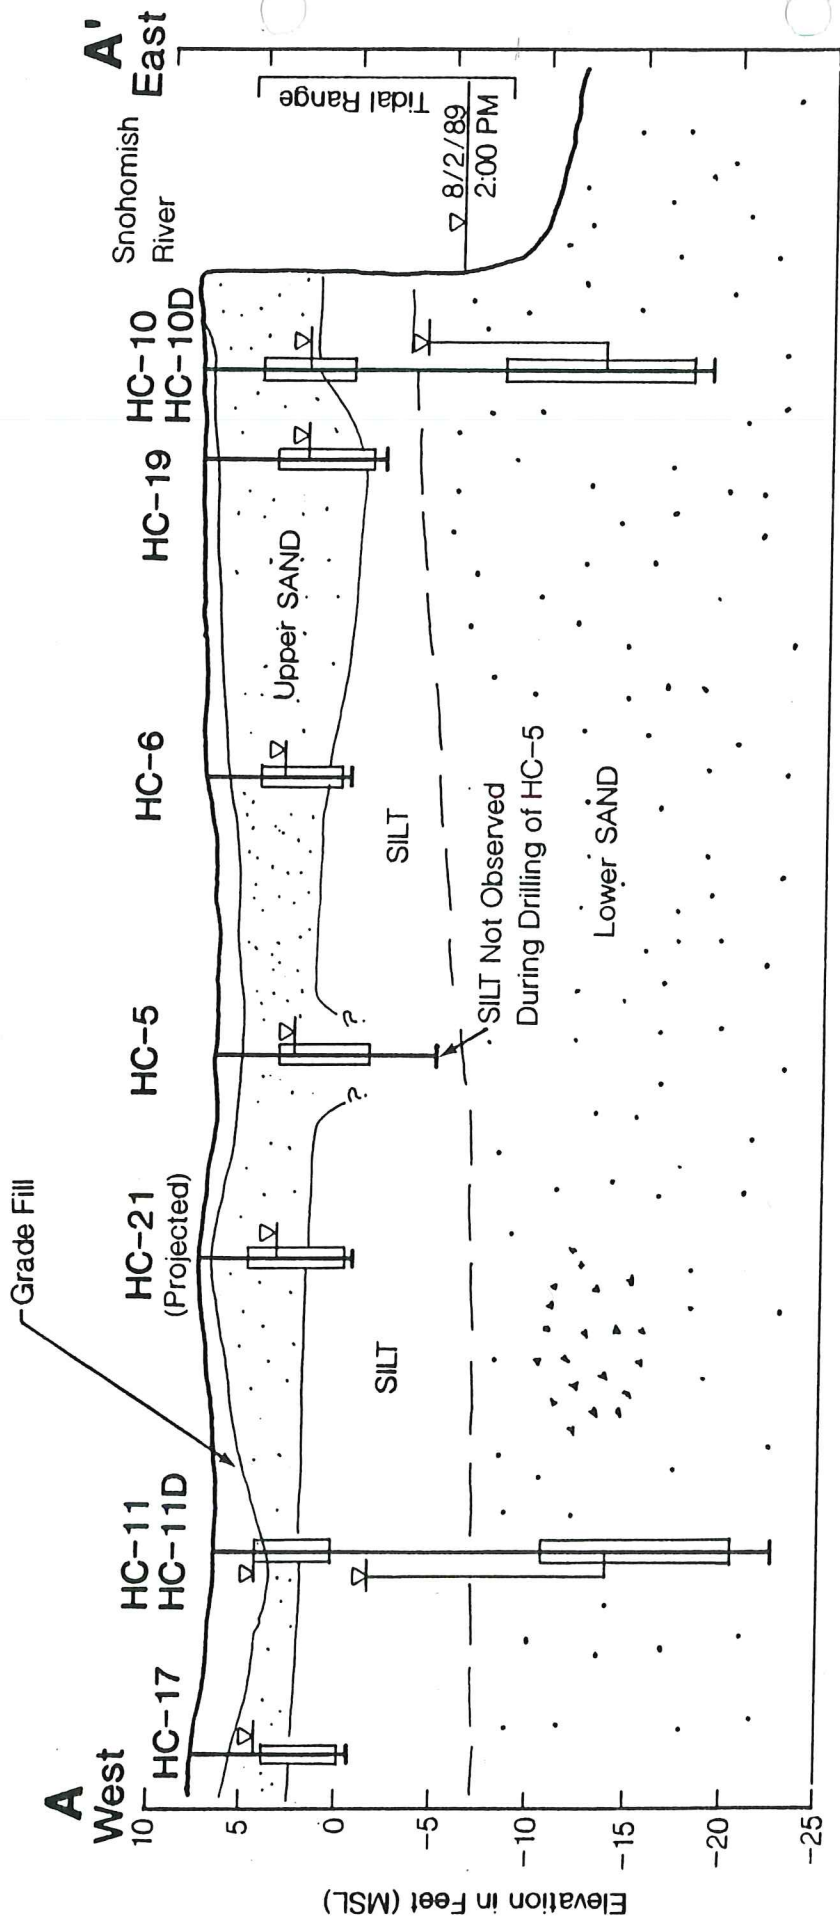
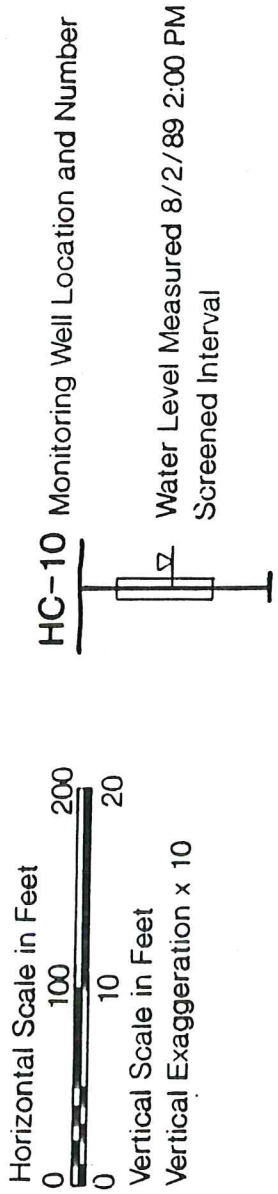
# Geologic Cross Section A-A'

The soils beneath the site are shown on Figure 3 and consist of three general soil units designated as:

The geologic borings and hydrologic data (groundwater contours in the Upper Sand unit) infer that a breach or "window" in the Silt Unit may be present in the vicinity of Well HC-5, northwest of the Old Machine Shop (Figures 3 and 4). This window may allow vertical flow between the upper and lower sand zones.

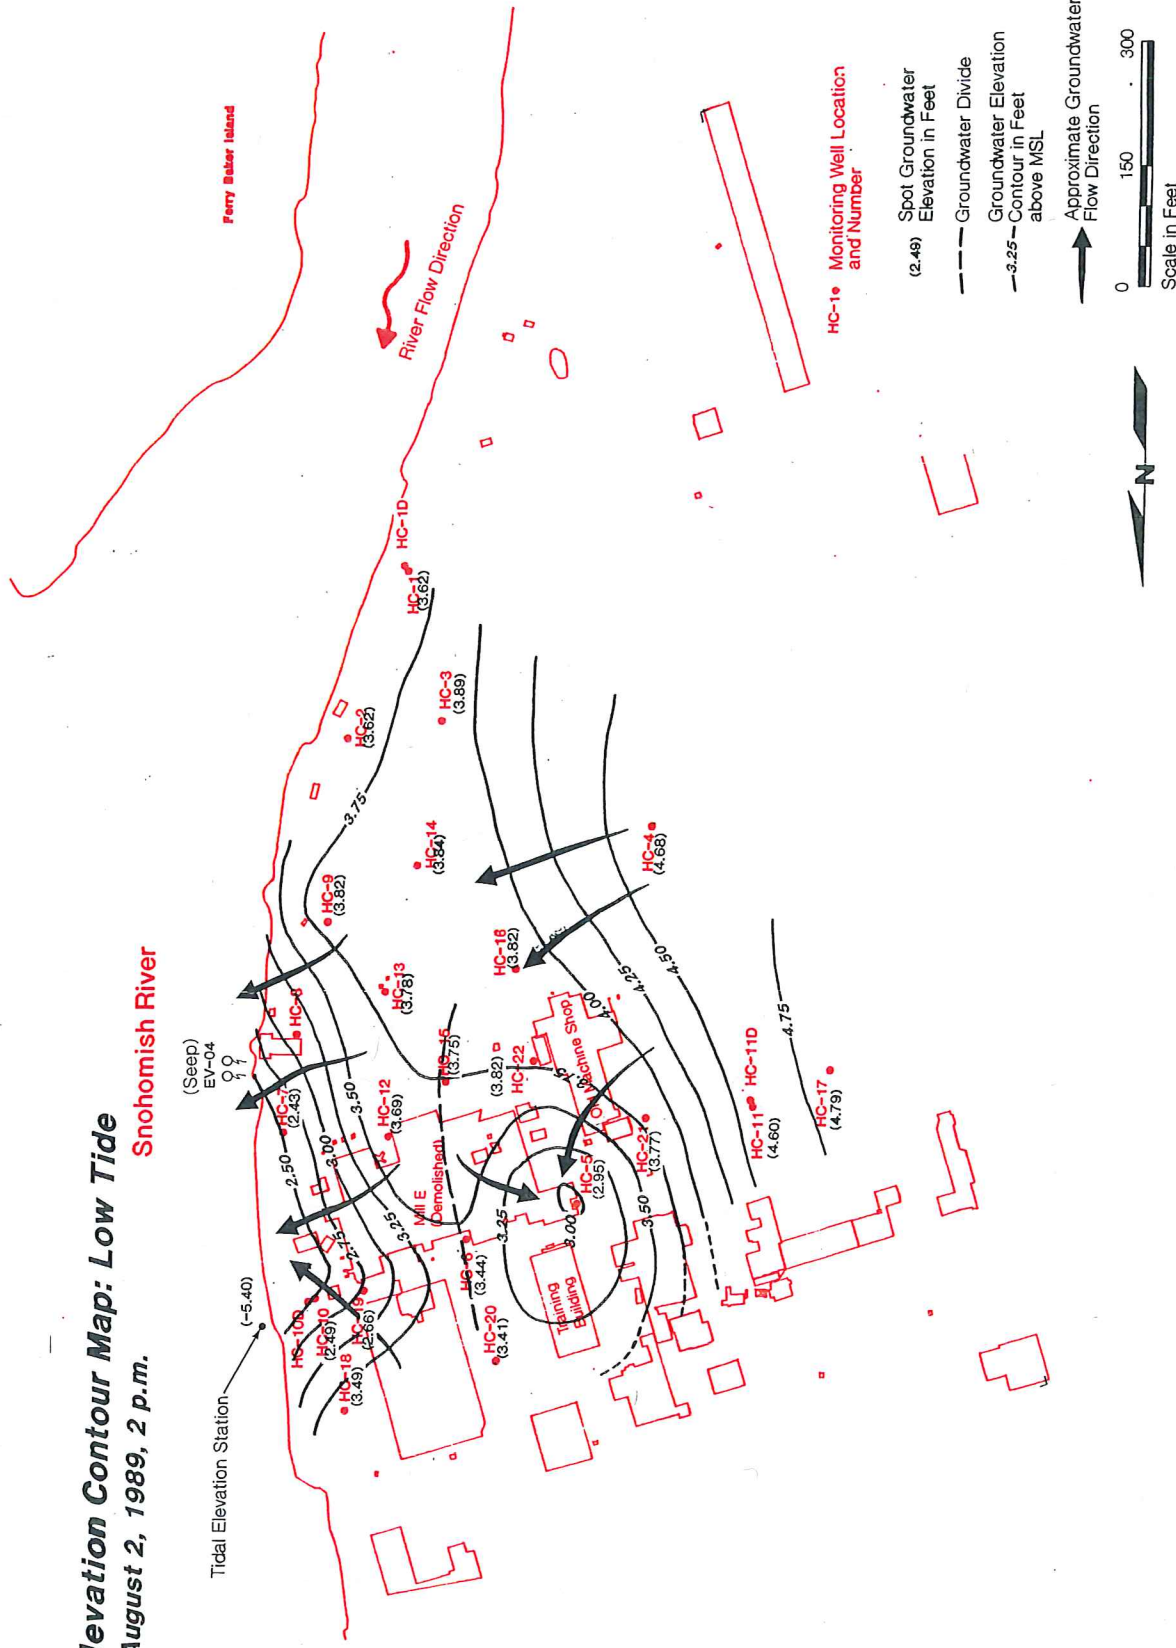
**Groundwater Elevation Contour Map: Low Tide**  
**Upper Sand Unit - August 2, 1989, 2 p.m.**

Water level responses during tidal monitoring in the Lower Sand indicate that this unit is hydraulically connected with the Snohomish River. Net groundwater flow is towards the river (Figure 4). A reversal of gradient occurs at the river margins for periods on the order of 6 to 8 hours depending on tidal range.

- o Groundwater discharge from the Upper Sand is towards the Snohomish River or into the underlying sand. A sample (EV-04) from a seep which discharges into the river, at a point downgradient of the East Shop area (Figure 4), contains detectable concentrations of BTEX (0.42 ppm) and PAH compounds (2.87 ppm). Benzene and total xylenes were detected in the seepage at 0.10 and 0.20 ppm respectively, while most of the PAH compounds consist of naphthalene which was detected at 2.3 ppm. Arsenic and several other metals were also detected in the seep water. Total arsenic was detected at a concentration of 0.115 ppm.

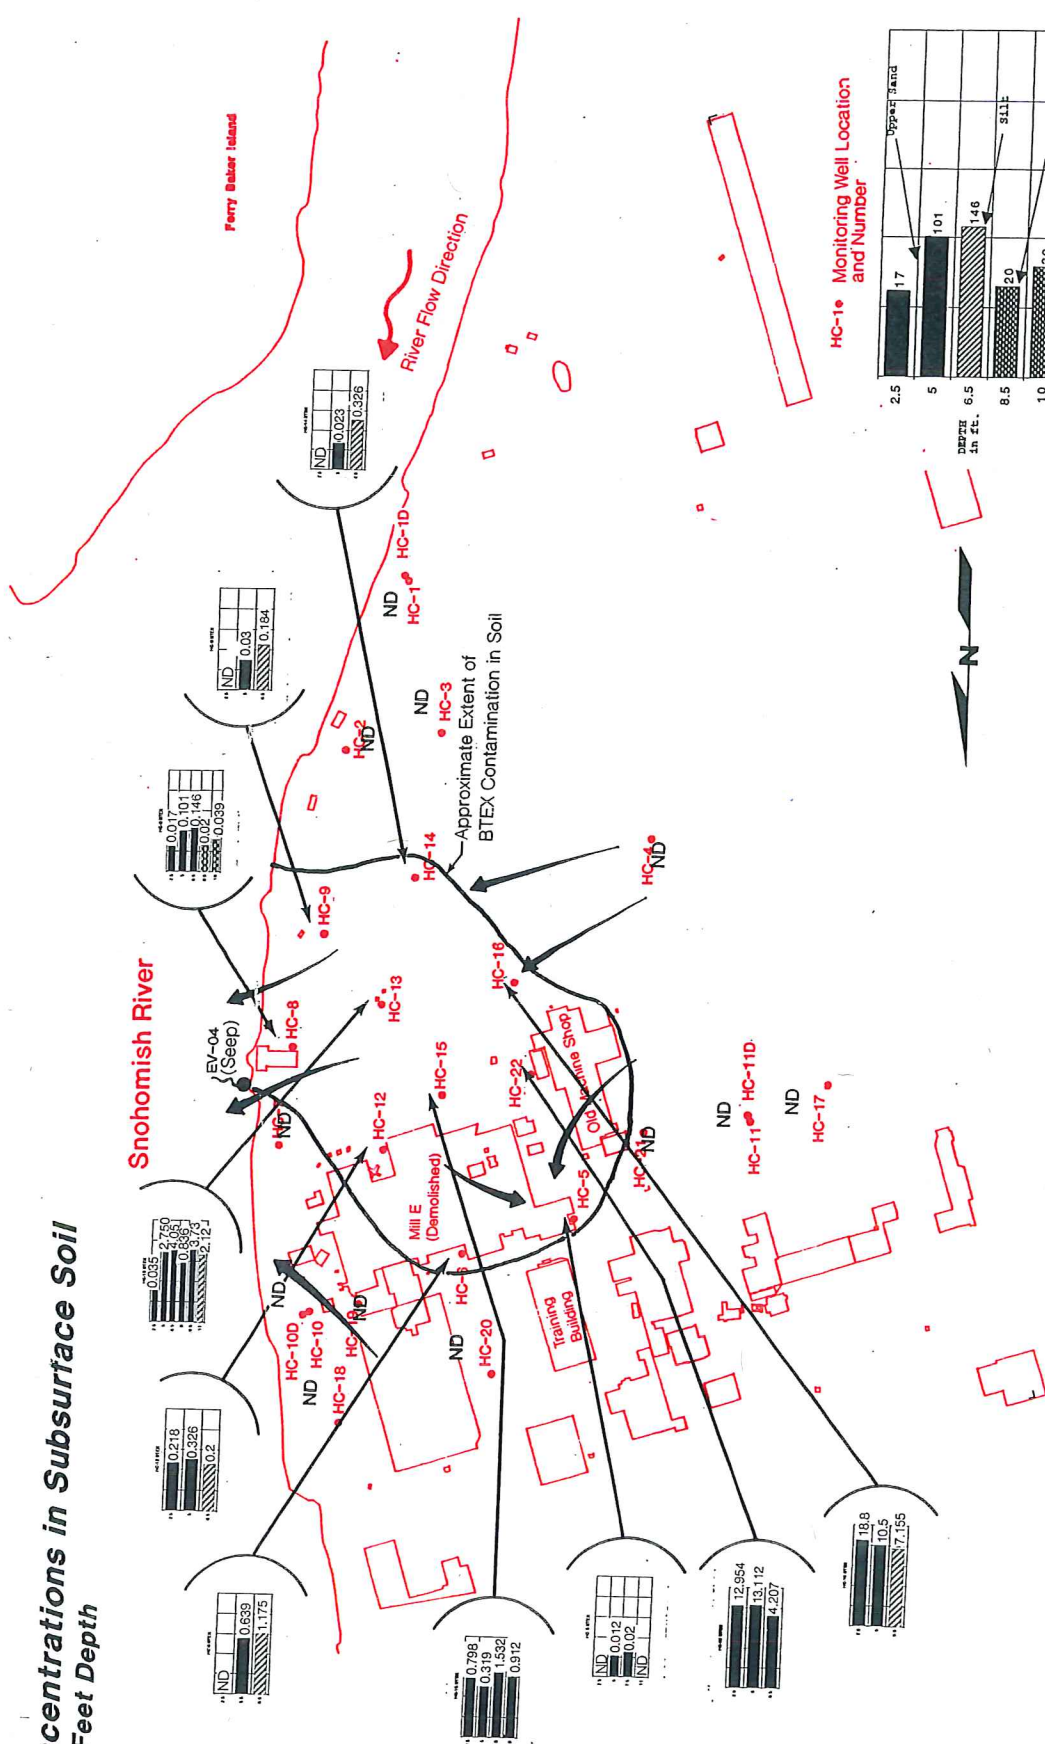
# BTEX Concentrations in Subsurface Soil 2.5 to 12.5 Feet Depth

- o No PCBs were detected above quantification limits;
- o Based on the data collected, the horizontal extent of organic compounds in soil has been delineated. The distribution and concentrations of BTEX compounds detected in the subsurface soils from 2.5 to 12.5 feet in depth are shown on Figure 5. The distribution and concentration of hydrocarbon compounds, indicative of the presence of petroleum products and creosote in soil, and pentachlorophenol (PCP) detections in subsurface soils from 2.5 to 12.5 in depth are shown on Figure 6. The types of petroleum products present are also shown and consist of diesel, gasoline, creosote and hydraulic oil range hydrocarbons. Mill E, which was a saw mill, is the likely source of the hydraulic oil hydrocarbons. The highest concentrations of BTEX compounds, pentachlorophenol, and PAH compounds were detected in the East Shop area in the general area shown on Figure 2;

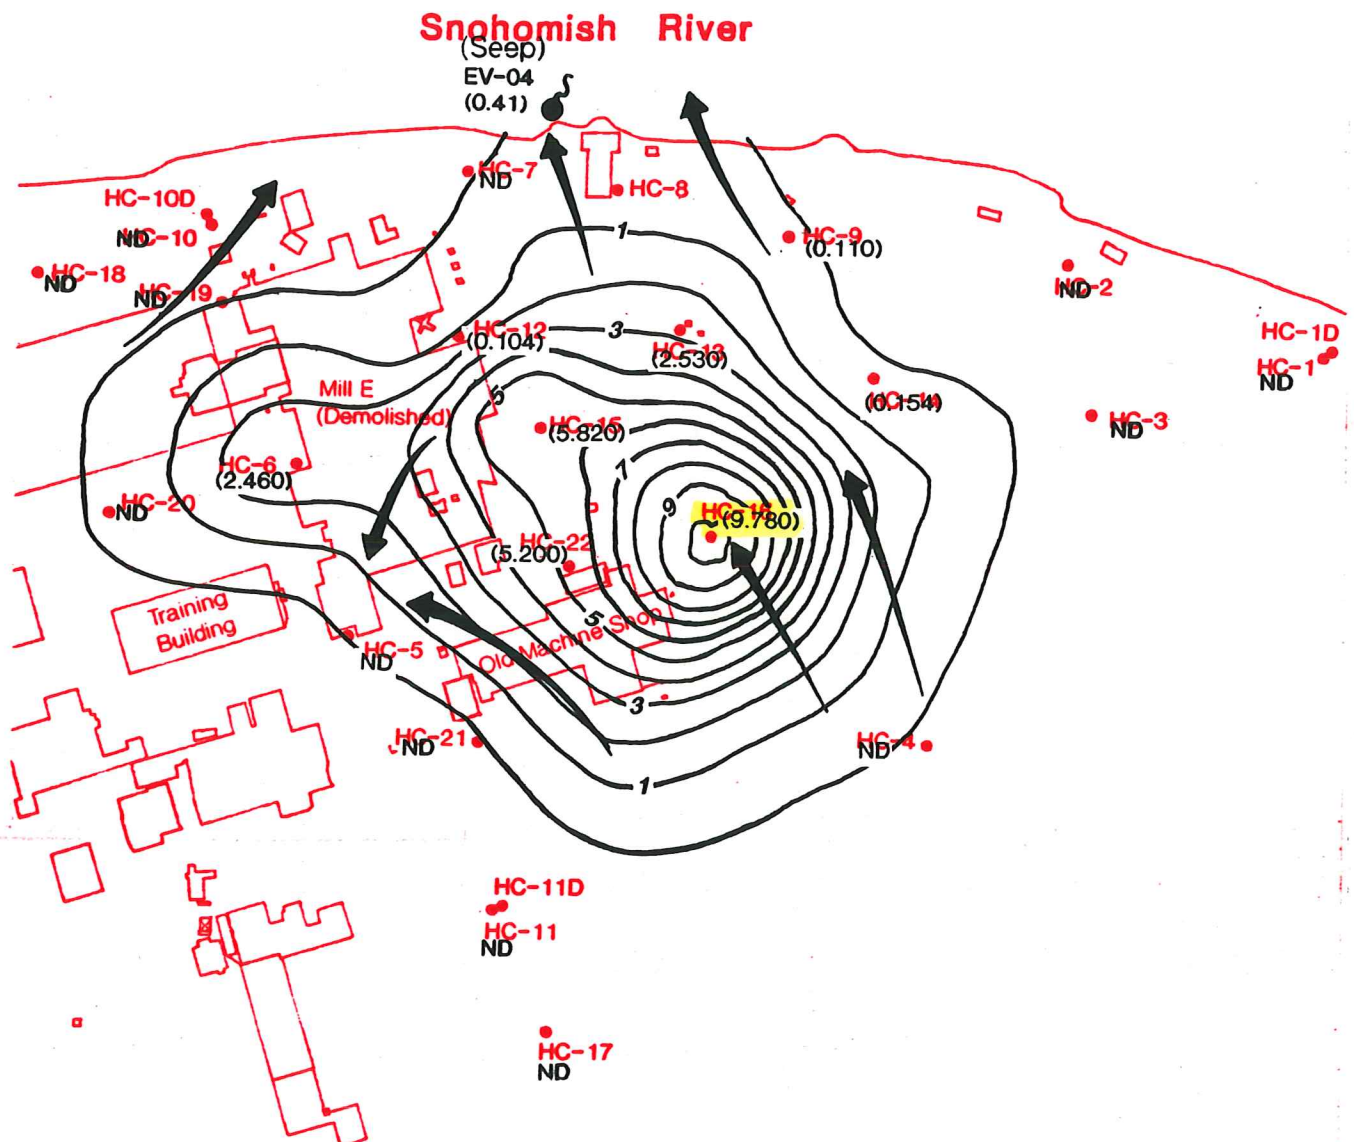
# BETX Concentrations in Groundwater Contour Map Upper SAND Unit

- o The highest concentrations of BTEX compounds were in well HC-16 which is located south of HC-13 (Figure 9). The primary source of these compounds were several underground fuel storage tanks which were removed in the fall of 1988.

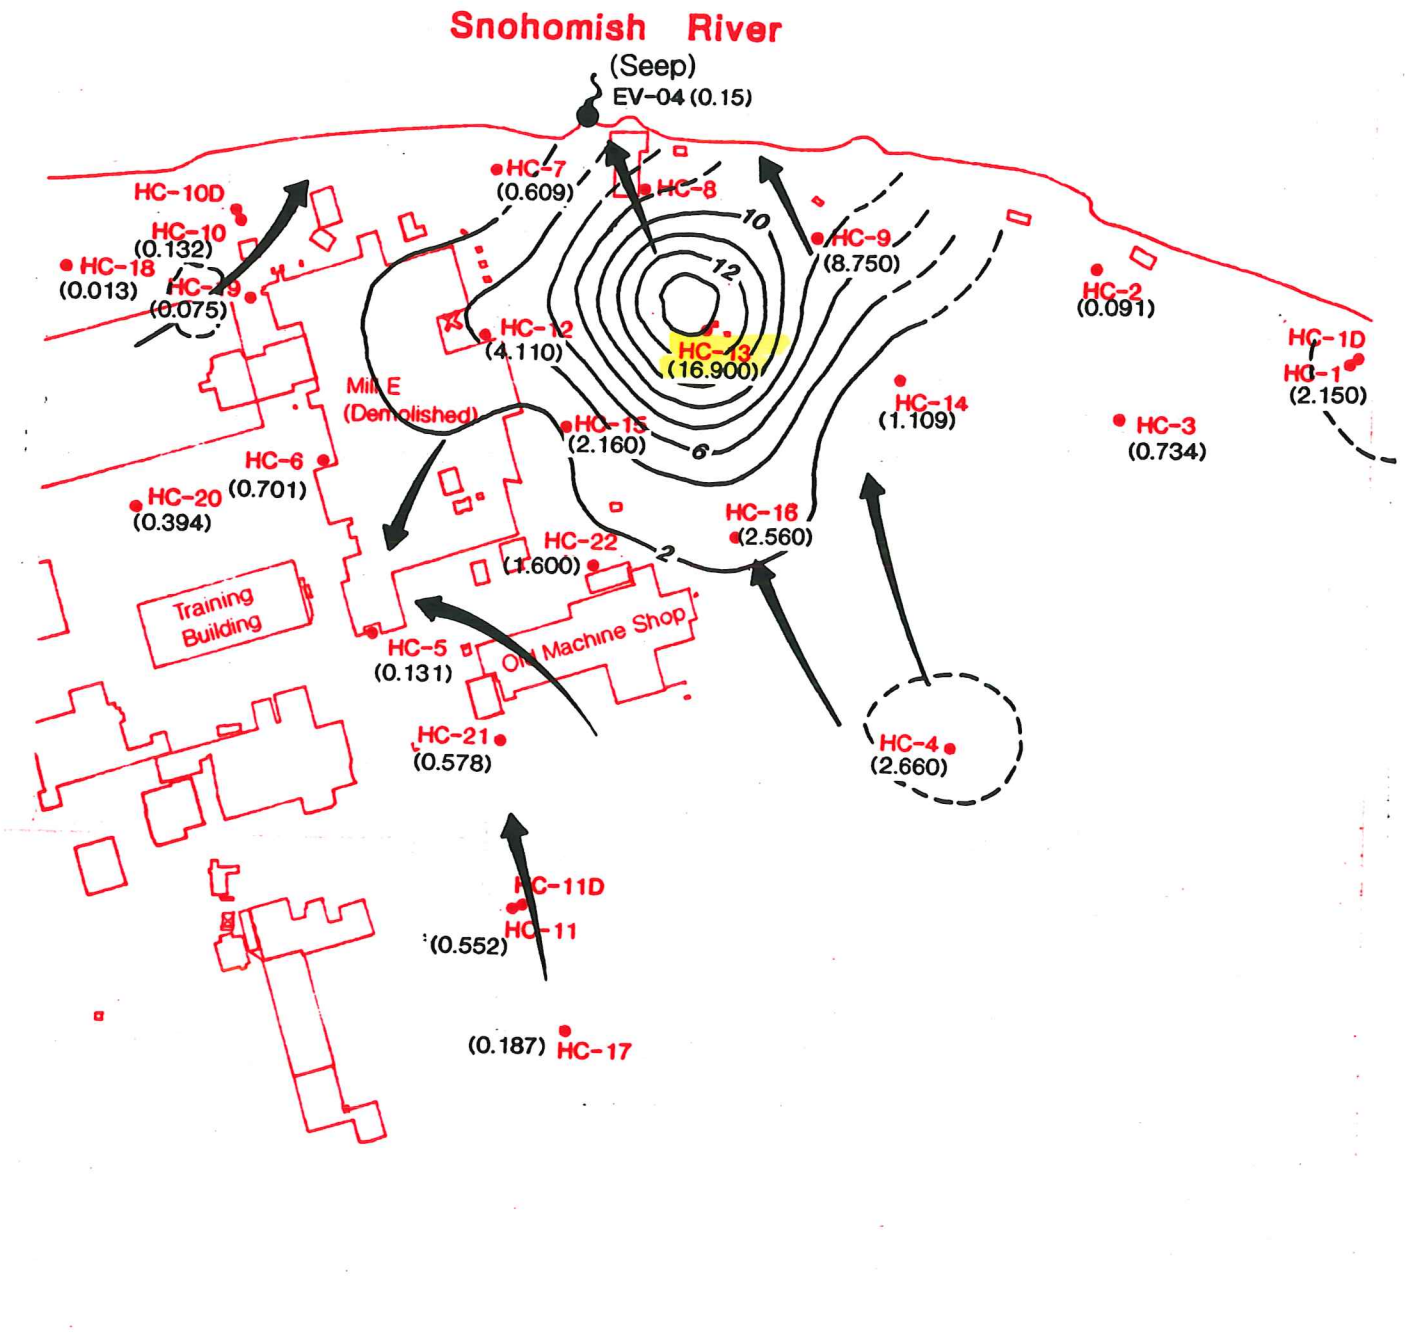
# Dissolved Arsenic Concentrations in Groundwater Contour Map

- o Relatively high arsenic concentrations were also detected in upgradient shallow wells as shown on Figure 7. Concentrations of more than 0.50 ppm were detected. The concentrations of arsenic in upgradient wells does not appear to be directly related to former wood treating operations. Additional sampling work is recommended to determine the source of this arsenic.

- Historical Review of Upgradient Activities. Historical activities that occurred upgradient from Mill E should be identified to assess the possible cause of relatively high arsenic concentrations in the upgradient Wells HC-11 and HC-17.

- Installation of Additional Upgradient Wells. Additional monitoring wells should be installed in the Upper Sand to assess arsenic groundwater concentrations upgradient of Mill E. The location of wells should be based on the results of the historical review.

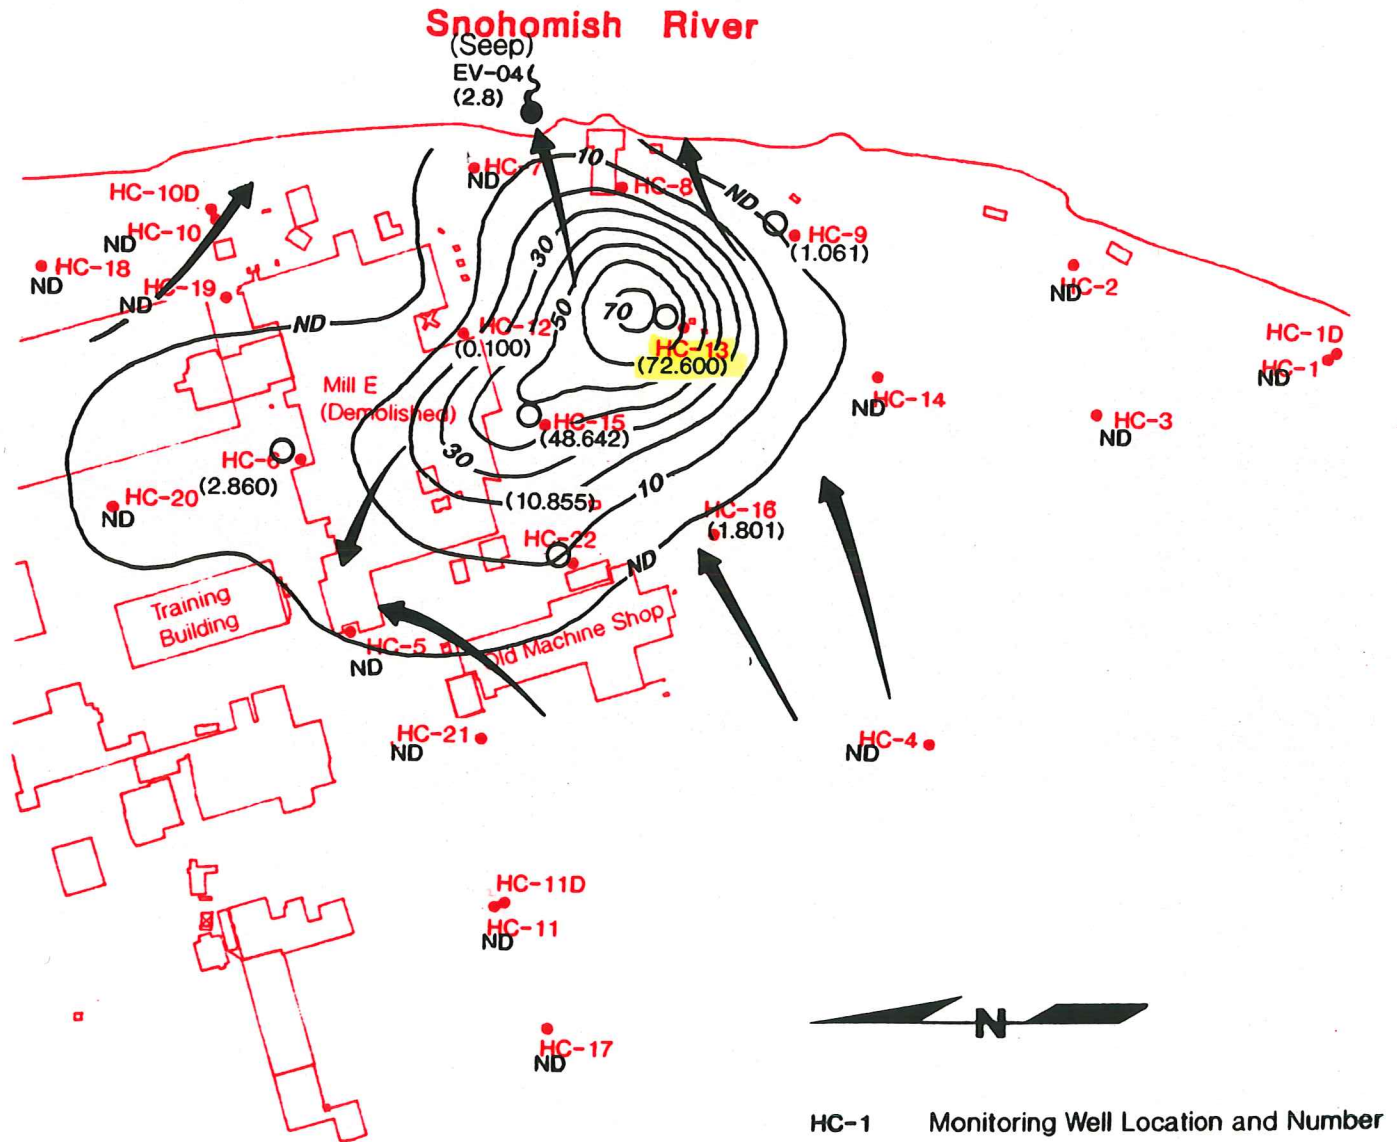
# PAH Concentration in Groundwater Contour Map Upper SAND Unit

- o The distribution of concentrations of metals and organic chemicals in upper sand groundwater is generally consistent with the site history and soil quality data. The highest concentrations of metals (e.g. arsenic) and wood treating compounds (as indicated by PAH concentrations) are in the East Shop Area generally centered on well HC-13 as shown on Figures 7 and 8. This is the area where aerial photographs showed soil staining and where the highest concentrations of wood treating soil contaminants were found in soil;
