SITE HAZARD ASSESSMENT

Worksheet 1: Summary Score Sheet

SITE NAME: Rainier Mall

Completed on 7/15/2019 for inclusion

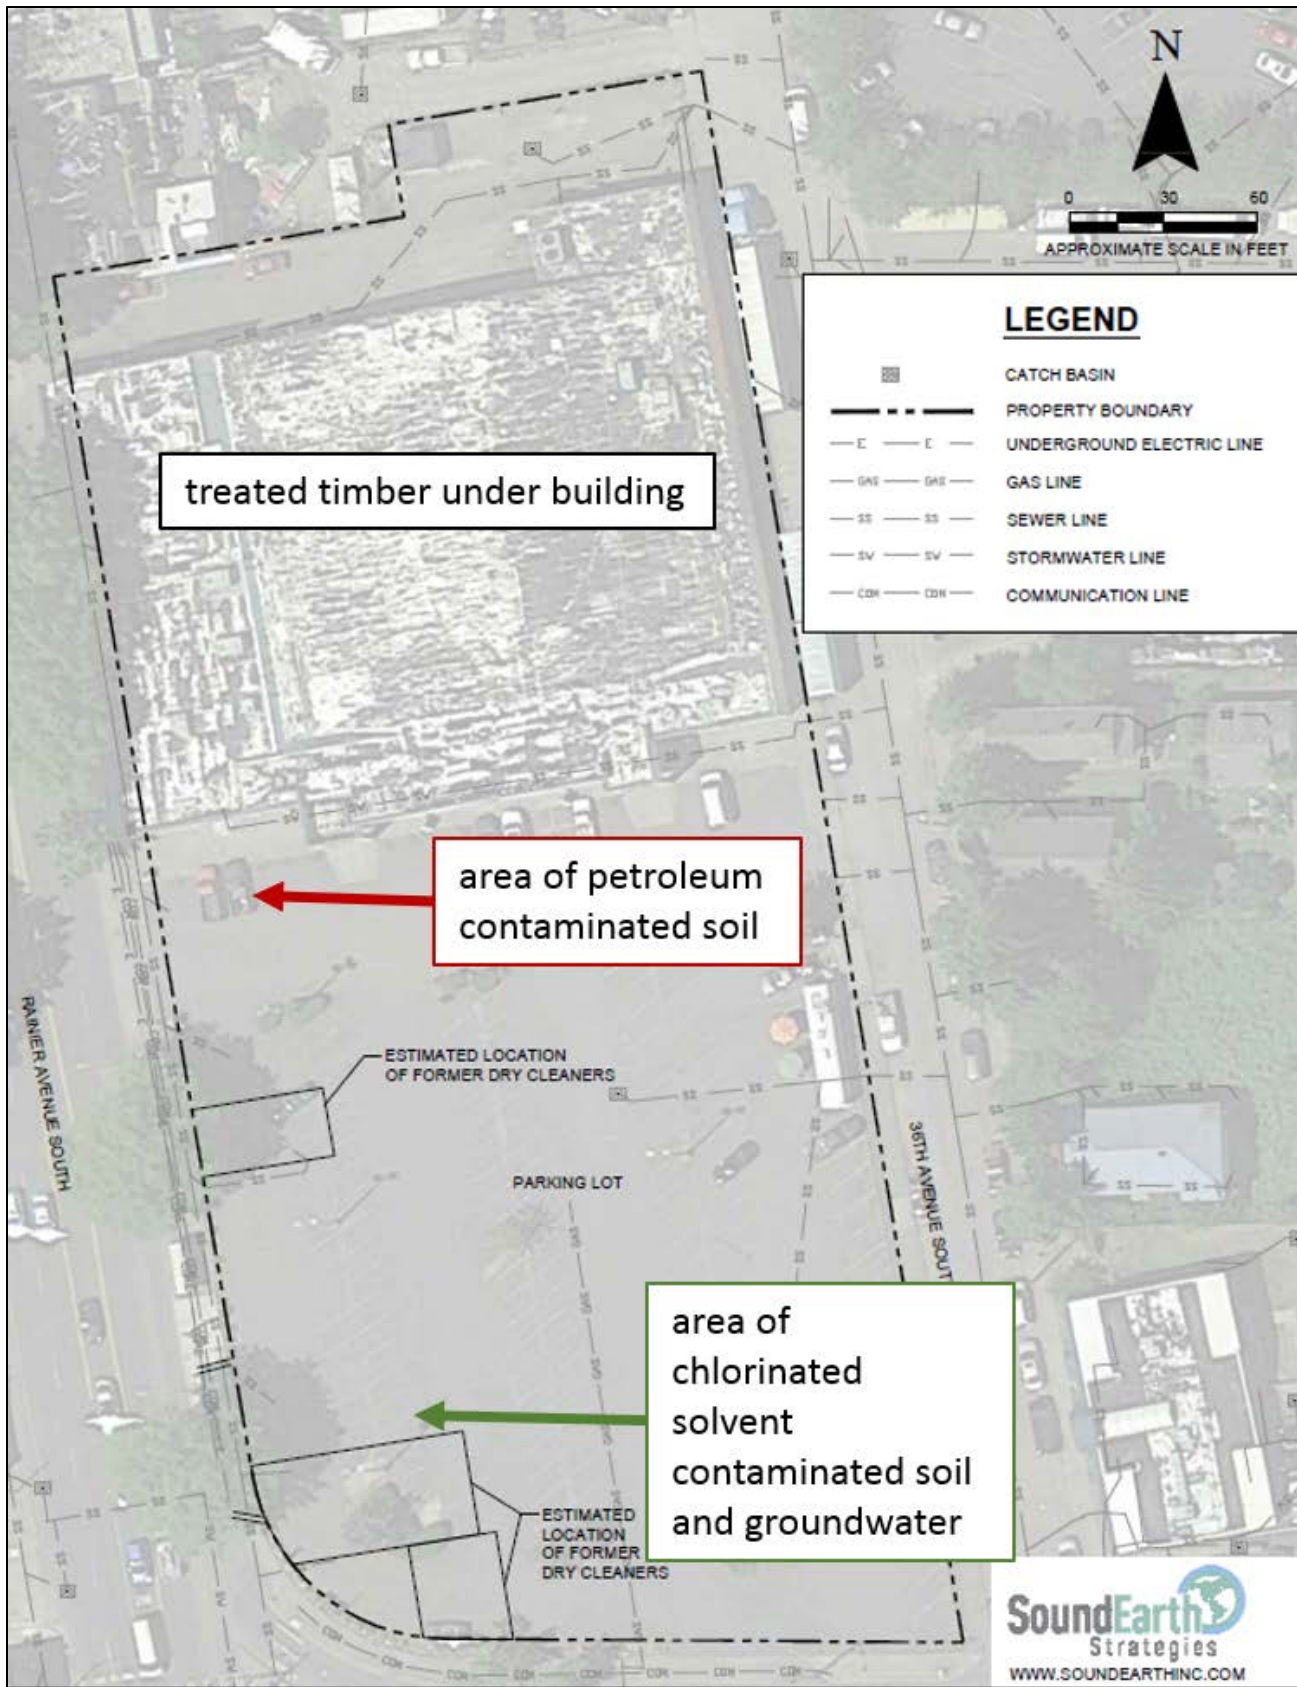
There are three distinct areas of confirmed or suspected contamination on the Site (Figure 2). From north to south, these are treated timber piles under the retail building currently on the Site; an area of petroleum contaminated soil on the northern half of the Site; and soil and groundwater contamination with chlorinated solvents in the area of the former dry cleaner buildings.

The retail building on Site is supported by up to 170 subsurface timber piles. It is likely that these timber piles were treated with creosote, which includes polycyclic aromatic hydrocarbons (PAHs) that can contaminate soil surrounding the piles. Soil sampling from outside the building footprint has not indicated contaminated soil, so current information suggests that any soil contamination is limited to the area adjacent to the piles.

Figure 2. General location of areas of contamination on Site. Base figure from Sound Earth Strategies (October 2018).

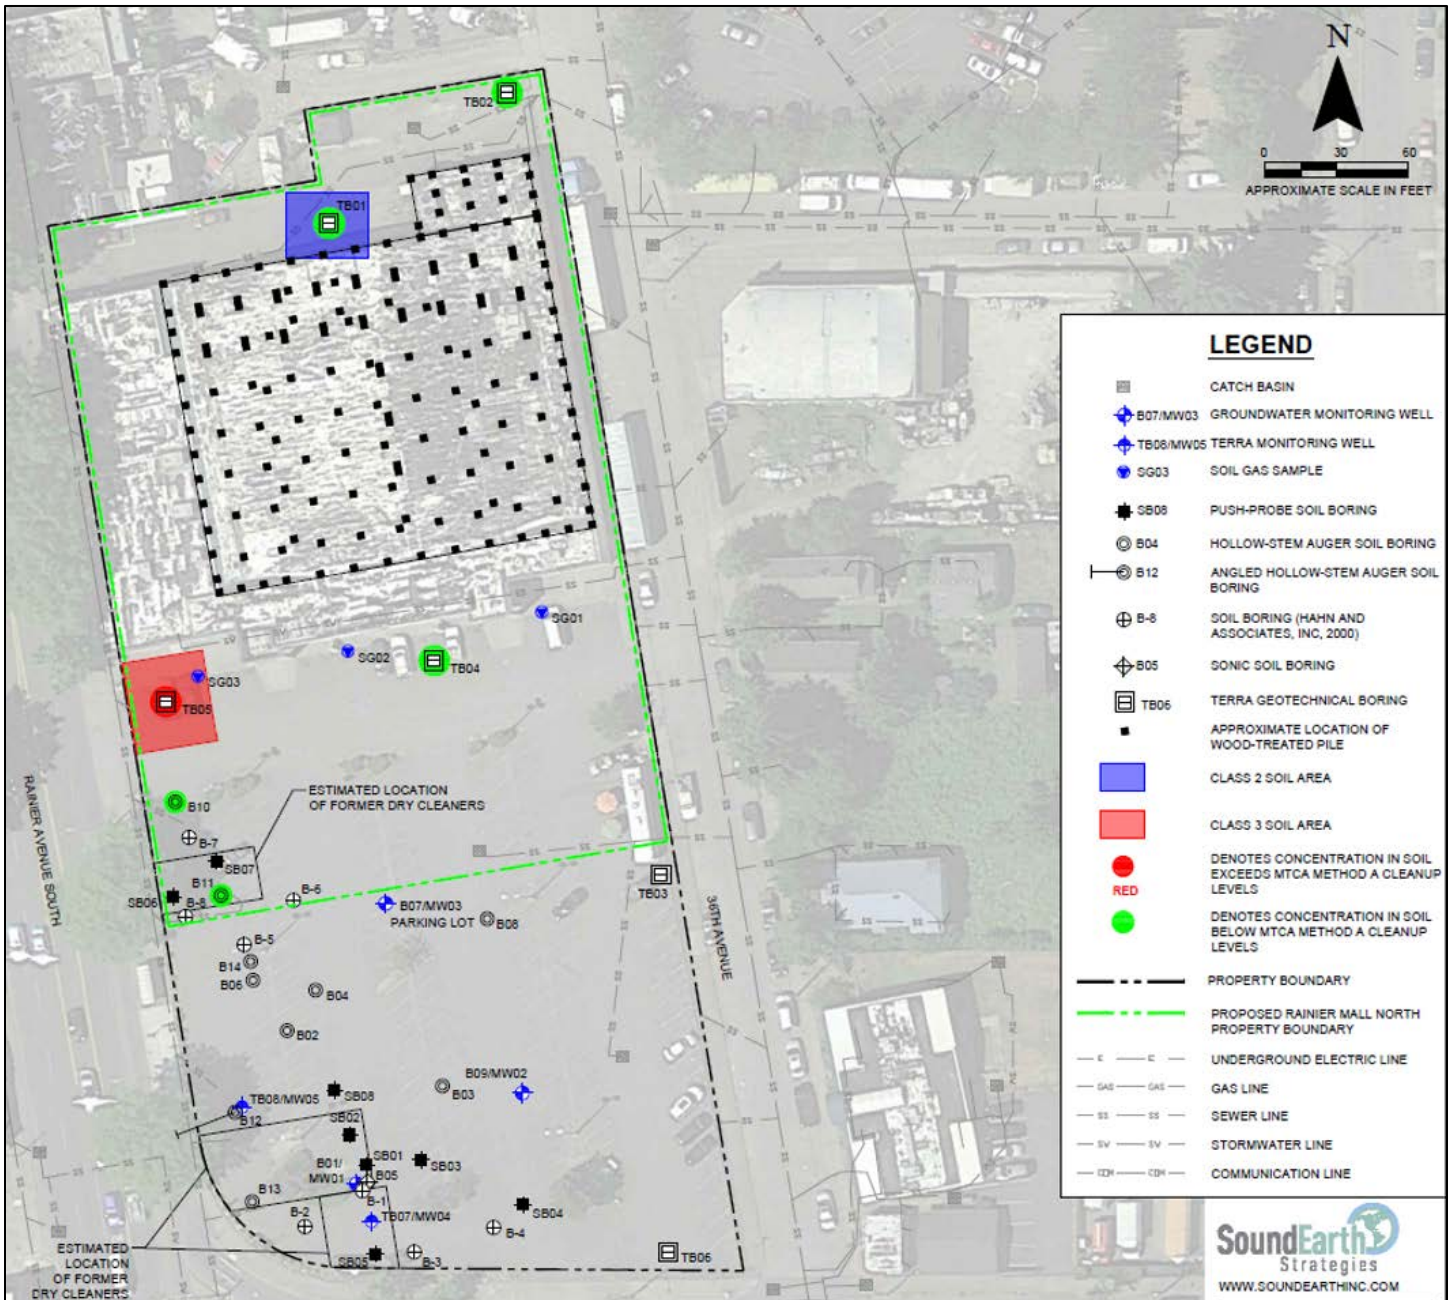
During sampling of the northern portion of the property conducted in 2017 by Sound Earth Strategies, discussed in more detail in the following section, oil range petroleum hydrocarbons (TPH-O) above MTCA Method A cleanup levels were discovered in soil collected 5 feet bgs in boring TB05. This boring was located near the southwest corner of the existing retail building (Figure 3). The lateral and vertical extent of petroleum contamination has not been fully delineated.

Figure 3. Sampling locations and areas of contamination during 2017 investigation of the northern part of the property. Soil indicated by the red area (Class 3 soil) is above cleanup levels. Figure from Sound Earth Strategies (March 2018 – north).

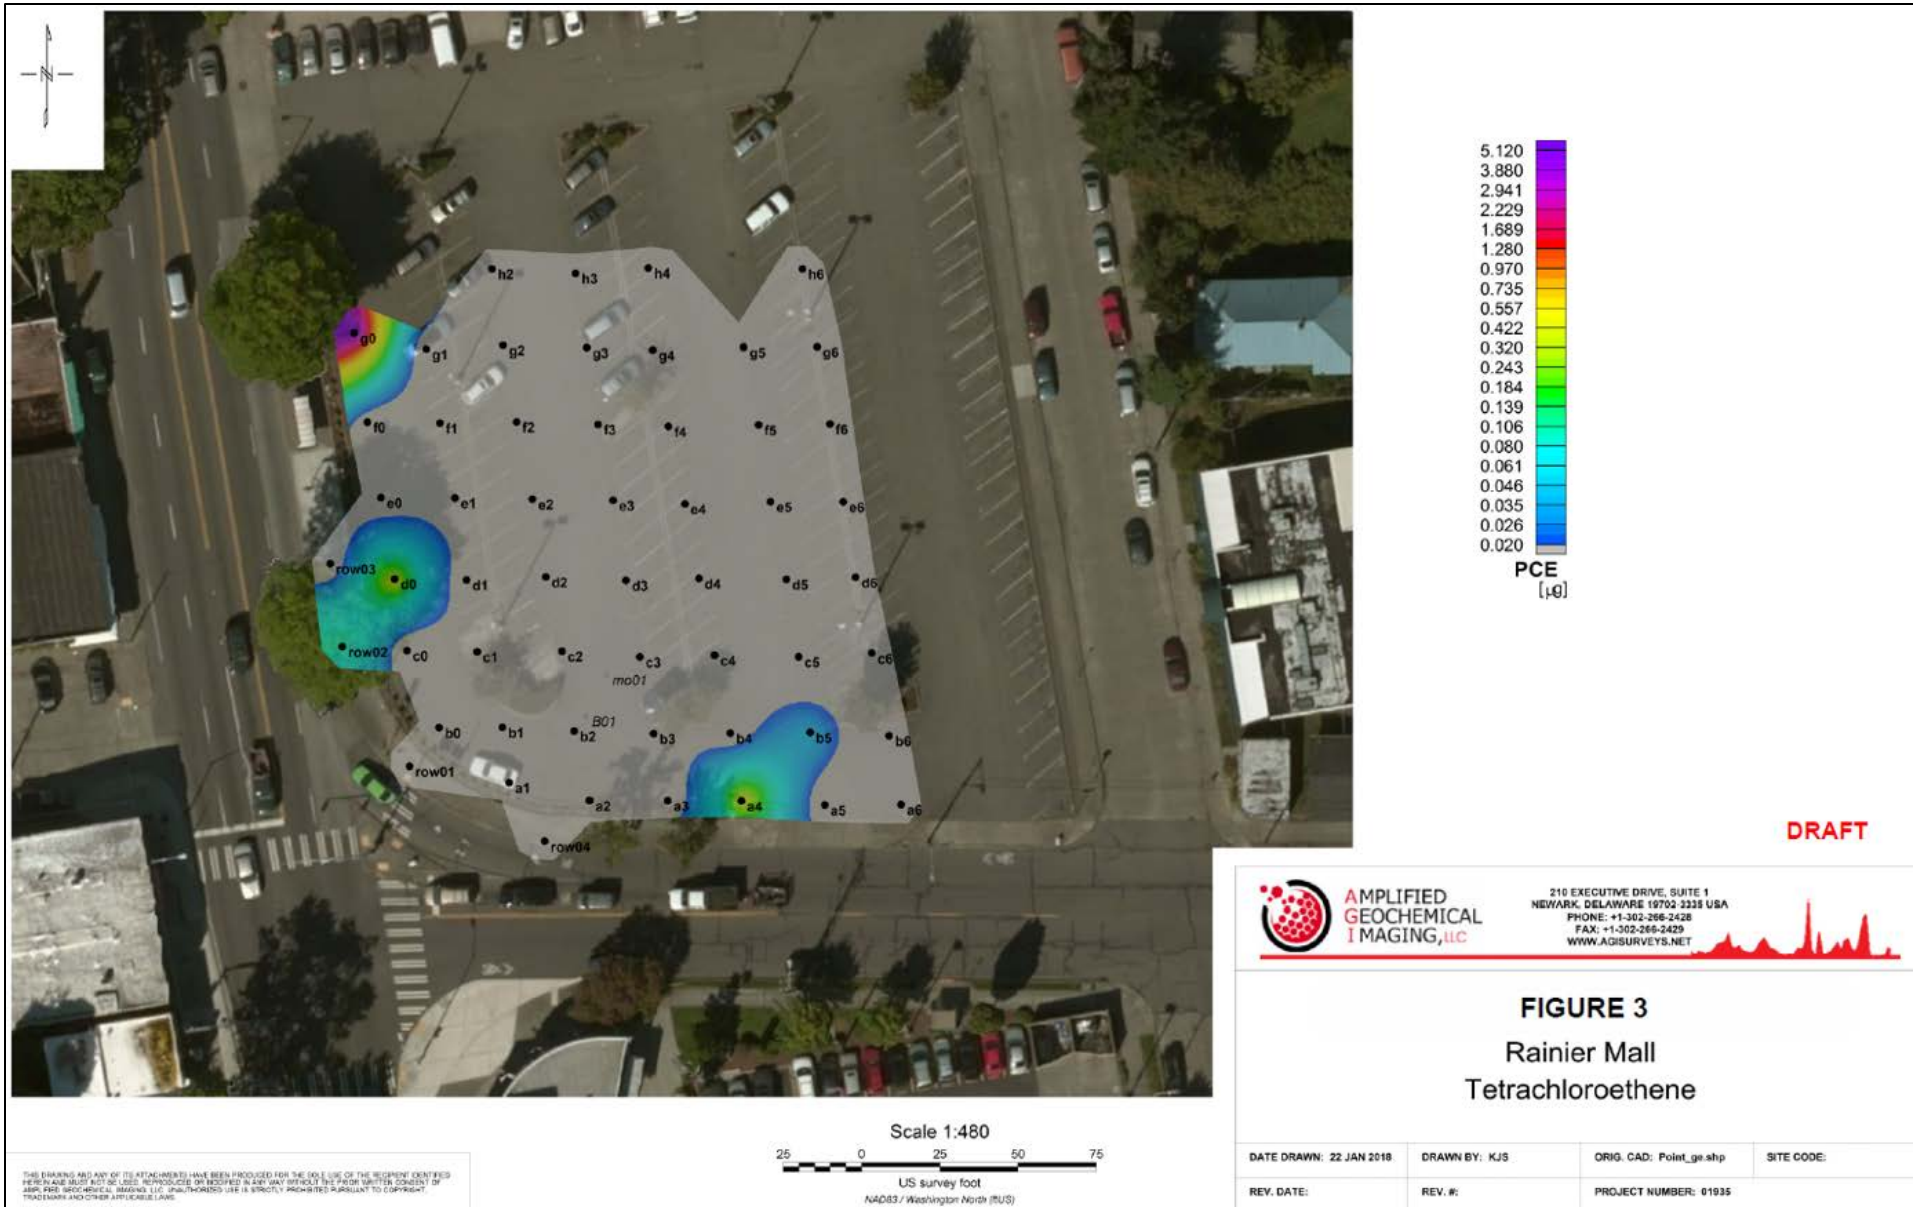
In the southern portion of the Site, investigations included soil gas sampling to evaluate conditions in shallow soil. Soil gas was sampled using passive samplers at 3 feet bgs; results for PCE are below in Figure 4. Sampling does not indicate widespread vapor contamination in shallow soil. Sampling included 15 soil borings (B06 through 09, B12 through 14, and TB01 through 08). Four of these borings were completed as monitoring wells (MW02 through 05). B12 was an angled boring completed under the sidewalk on Rainier Avenue South on the western edge of the property. These soil borings, in conjunction with previous borings, were used to delineate an approximate area of soil contamination, as shown below on Figure 5. Groundwater sampling was conducted for MW01 through 05 in January 2018. Depth to groundwater was between 5.5 and 13.5 feet bgs, and groundwater flow was to the south-southeast. Groundwater samples from MW01, 02, and 05 contained PCE, TCE, and/or vinyl chloride above cleanup levels.

Figure 4. Sampling locations and PCE results of soil gas sampling conducted on the southern portion of the property. Figure from Sound Earth Strategies (March 2018 – south).

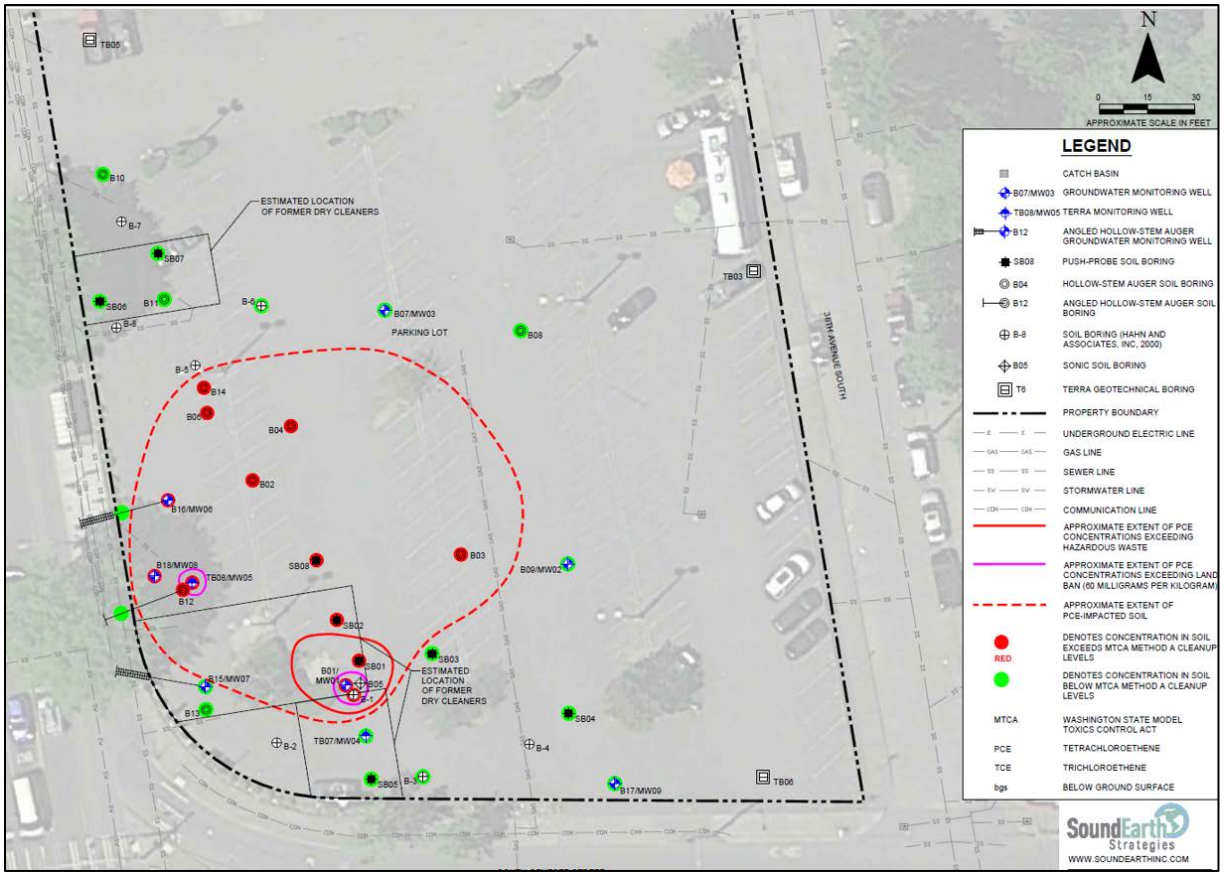
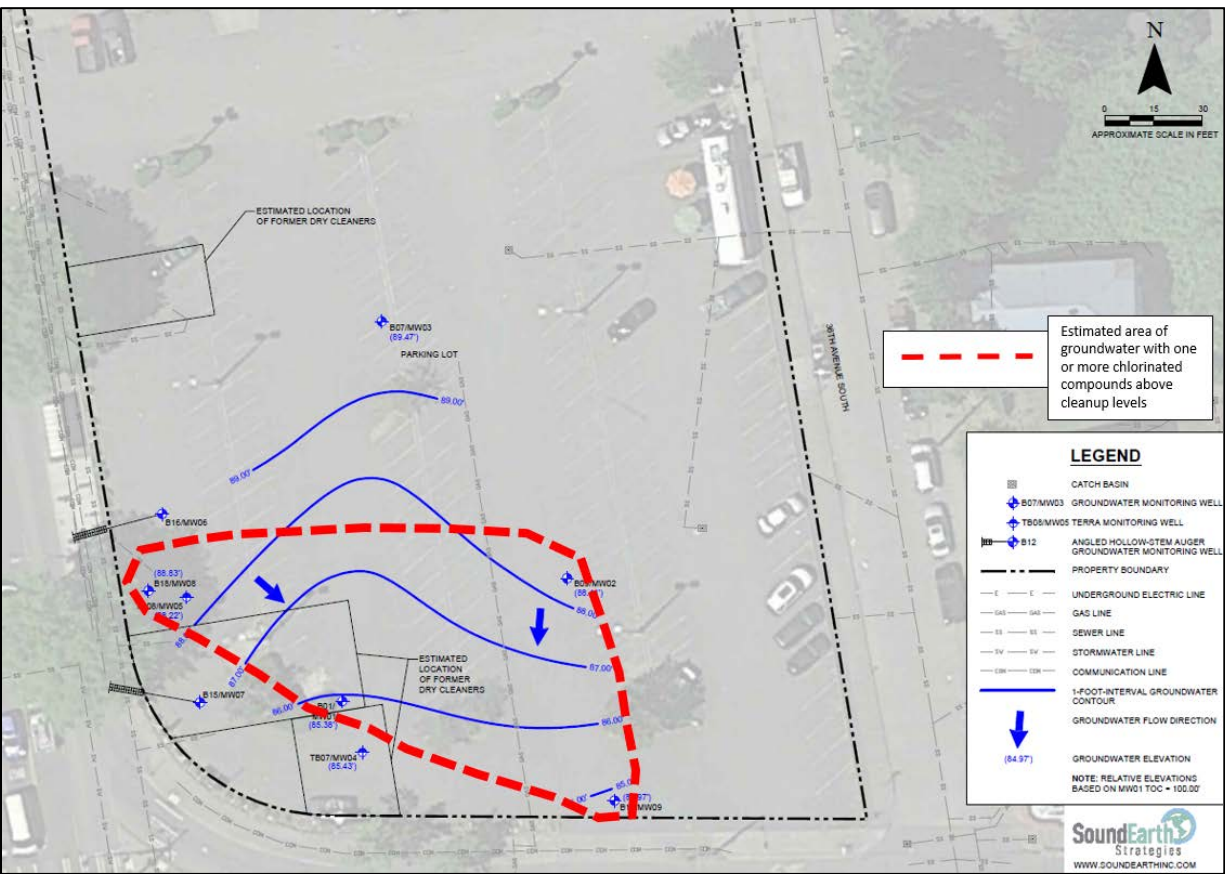
The final round of sampling conducted by Sound Earth Strategies in 2018 was done to assess conditions on the western and southern property boundaries. Four soil borings (B15 through 18) were installed near property boundaries and completed as monitoring wells (MW06 through 09). MW08 and 09 were vertical borings located on the western and southern edges of the property, respectively. MW06 and 07 were angled borings installed on the western property boundary to assess conditions under the adjacent Rainier Avenue South sidewalk. Groundwater from MW06 and 07 did not contain any chlorinated solvents above laboratory reporting limits, while groundwater from MW08 and 09 contained PCE, TCE, cis-1,2-dichloroethylene, and vinyl chloride above cleanup levels. Groundwater flow direction is shown in Figure 5.

The combined results from site characterization activities to date indicate an area of soil contaminated with chlorinated solvents that is contained within property boundaries (Figure 5), and an area of contaminated groundwater that has not been fully delineated. Based on sample results and groundwater flow, it is likely that the area of groundwater contamination extends off-property to the southeast, into the South Genesee Street right-of-way.

Figure 5. Area of soil (top) and groundwater (bottom) contaminated with chlorinated solvents. Base figures from Sound Earth Strategies (October 2018).

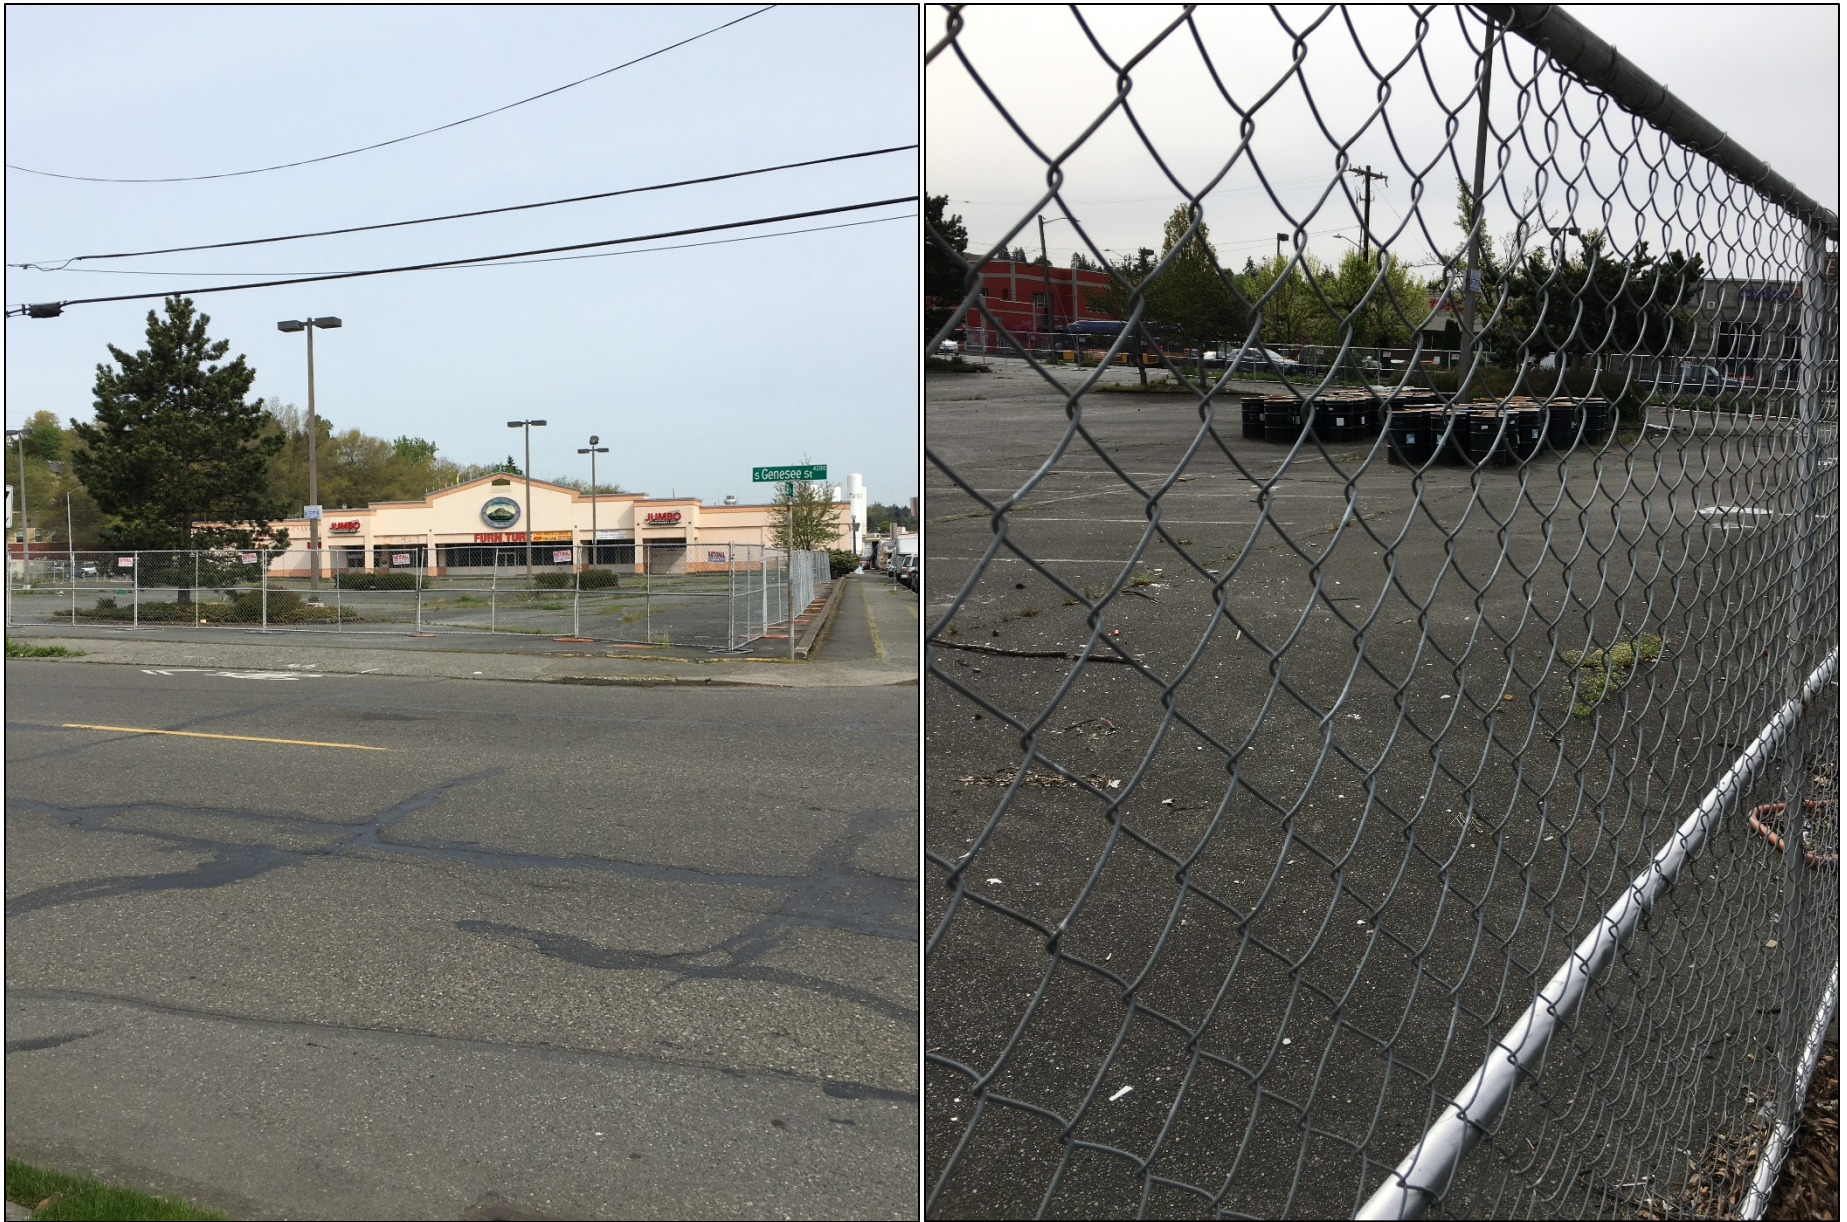
The Assessor visited the Site on April 25, 2019. Photos from the visit are in Figure 6. In general, the conditions observed were the same as those indicated in site reports. The existing retail building and parking lot were both empty. Fencing surrounded the property, preventing entry by vehicles or pedestrians. Barrels containing investigatively derived waste were observed in the parking lot in the southwest part of the property. Vehicles that appeared to be used as transient housing were observed east of the Site along 36th Avenue South, indicating a possible additional population that is not accounted for in scoring.

Figure 6. Photos from April 25, 2019 site visit. View of Site from the southeast corner, across South Genesee Street (left) and view of southwest corner of the property from sidewalk along Rainier Avenue South facing south (right).
