**A PHASE I
ENVIRONMENTAL SITE ASSESSMENT**

Rainier Mall
(Former Safeway Store No. 441)
4208 Rainier Avenue S
Seattle, Washington

May 23, 2000

Project No. 4936

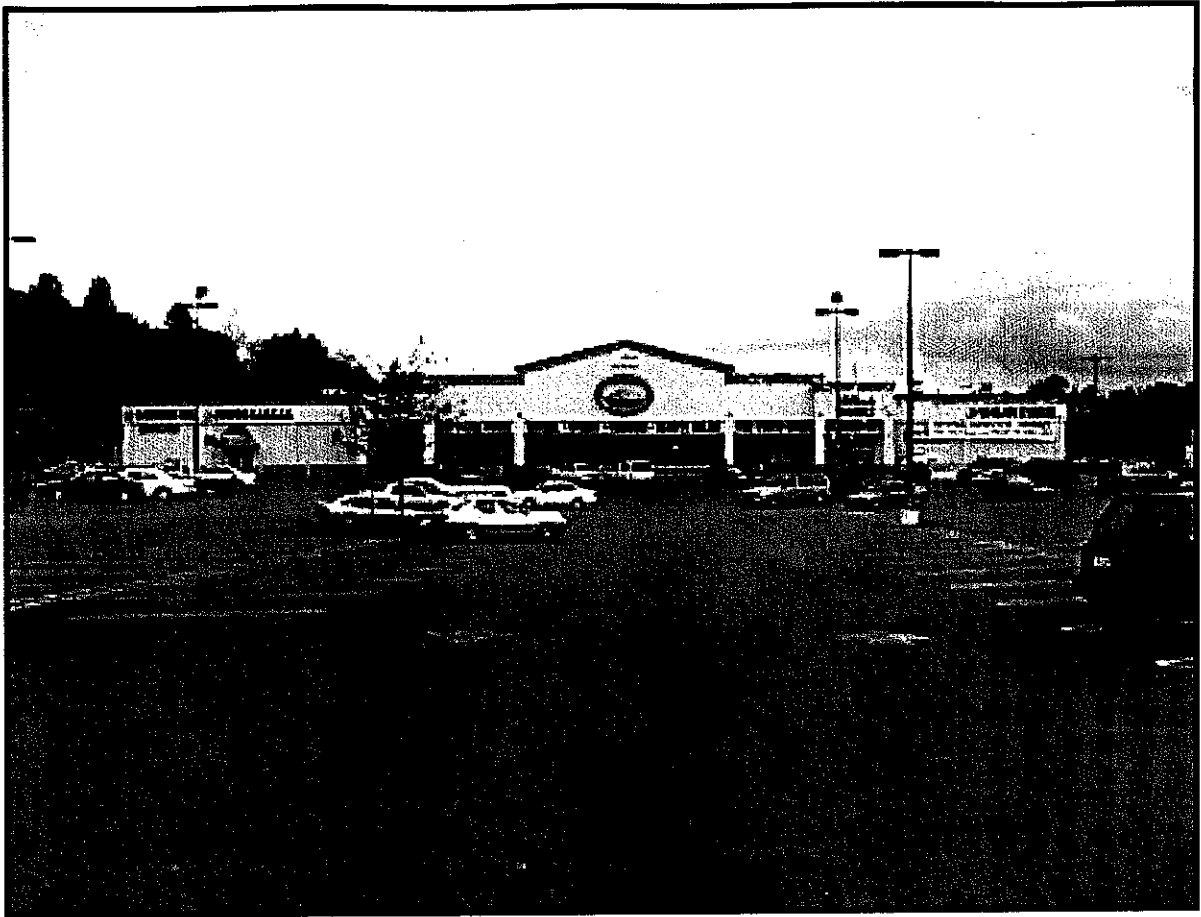
Photograph 1. View of the subject property facing north (May 10, 2000).

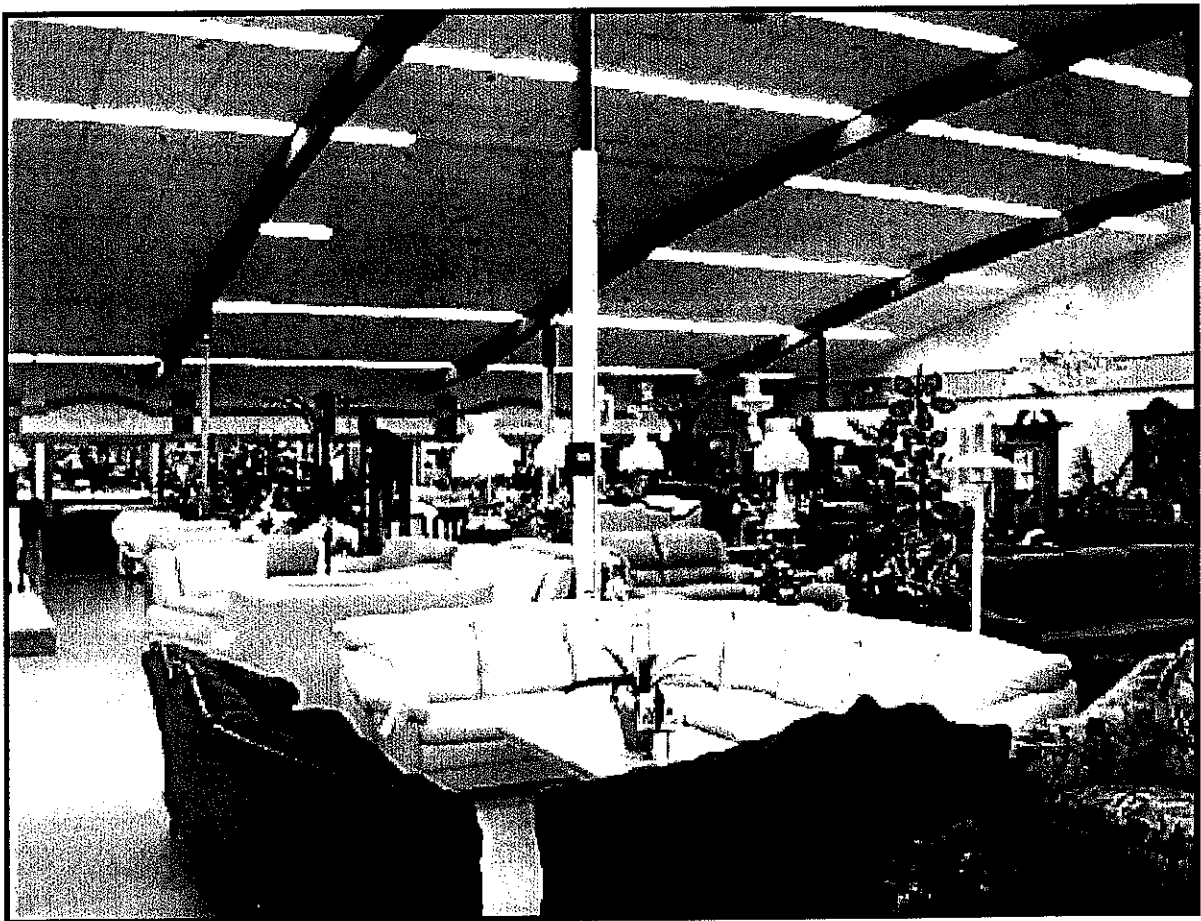
Photograph 2. View of the interior of the Rainier Mall (May 10, 2000).
