**Draft Engineering Design Report (EDR),  
Area B2 Storm Drain Repairs, and Areas C2  
and C3 Fencing/Signage**

Everett Smelter Site, Lowland Area  
Everett, Washington

**Washington State Department of Ecology**

June 29, 2018

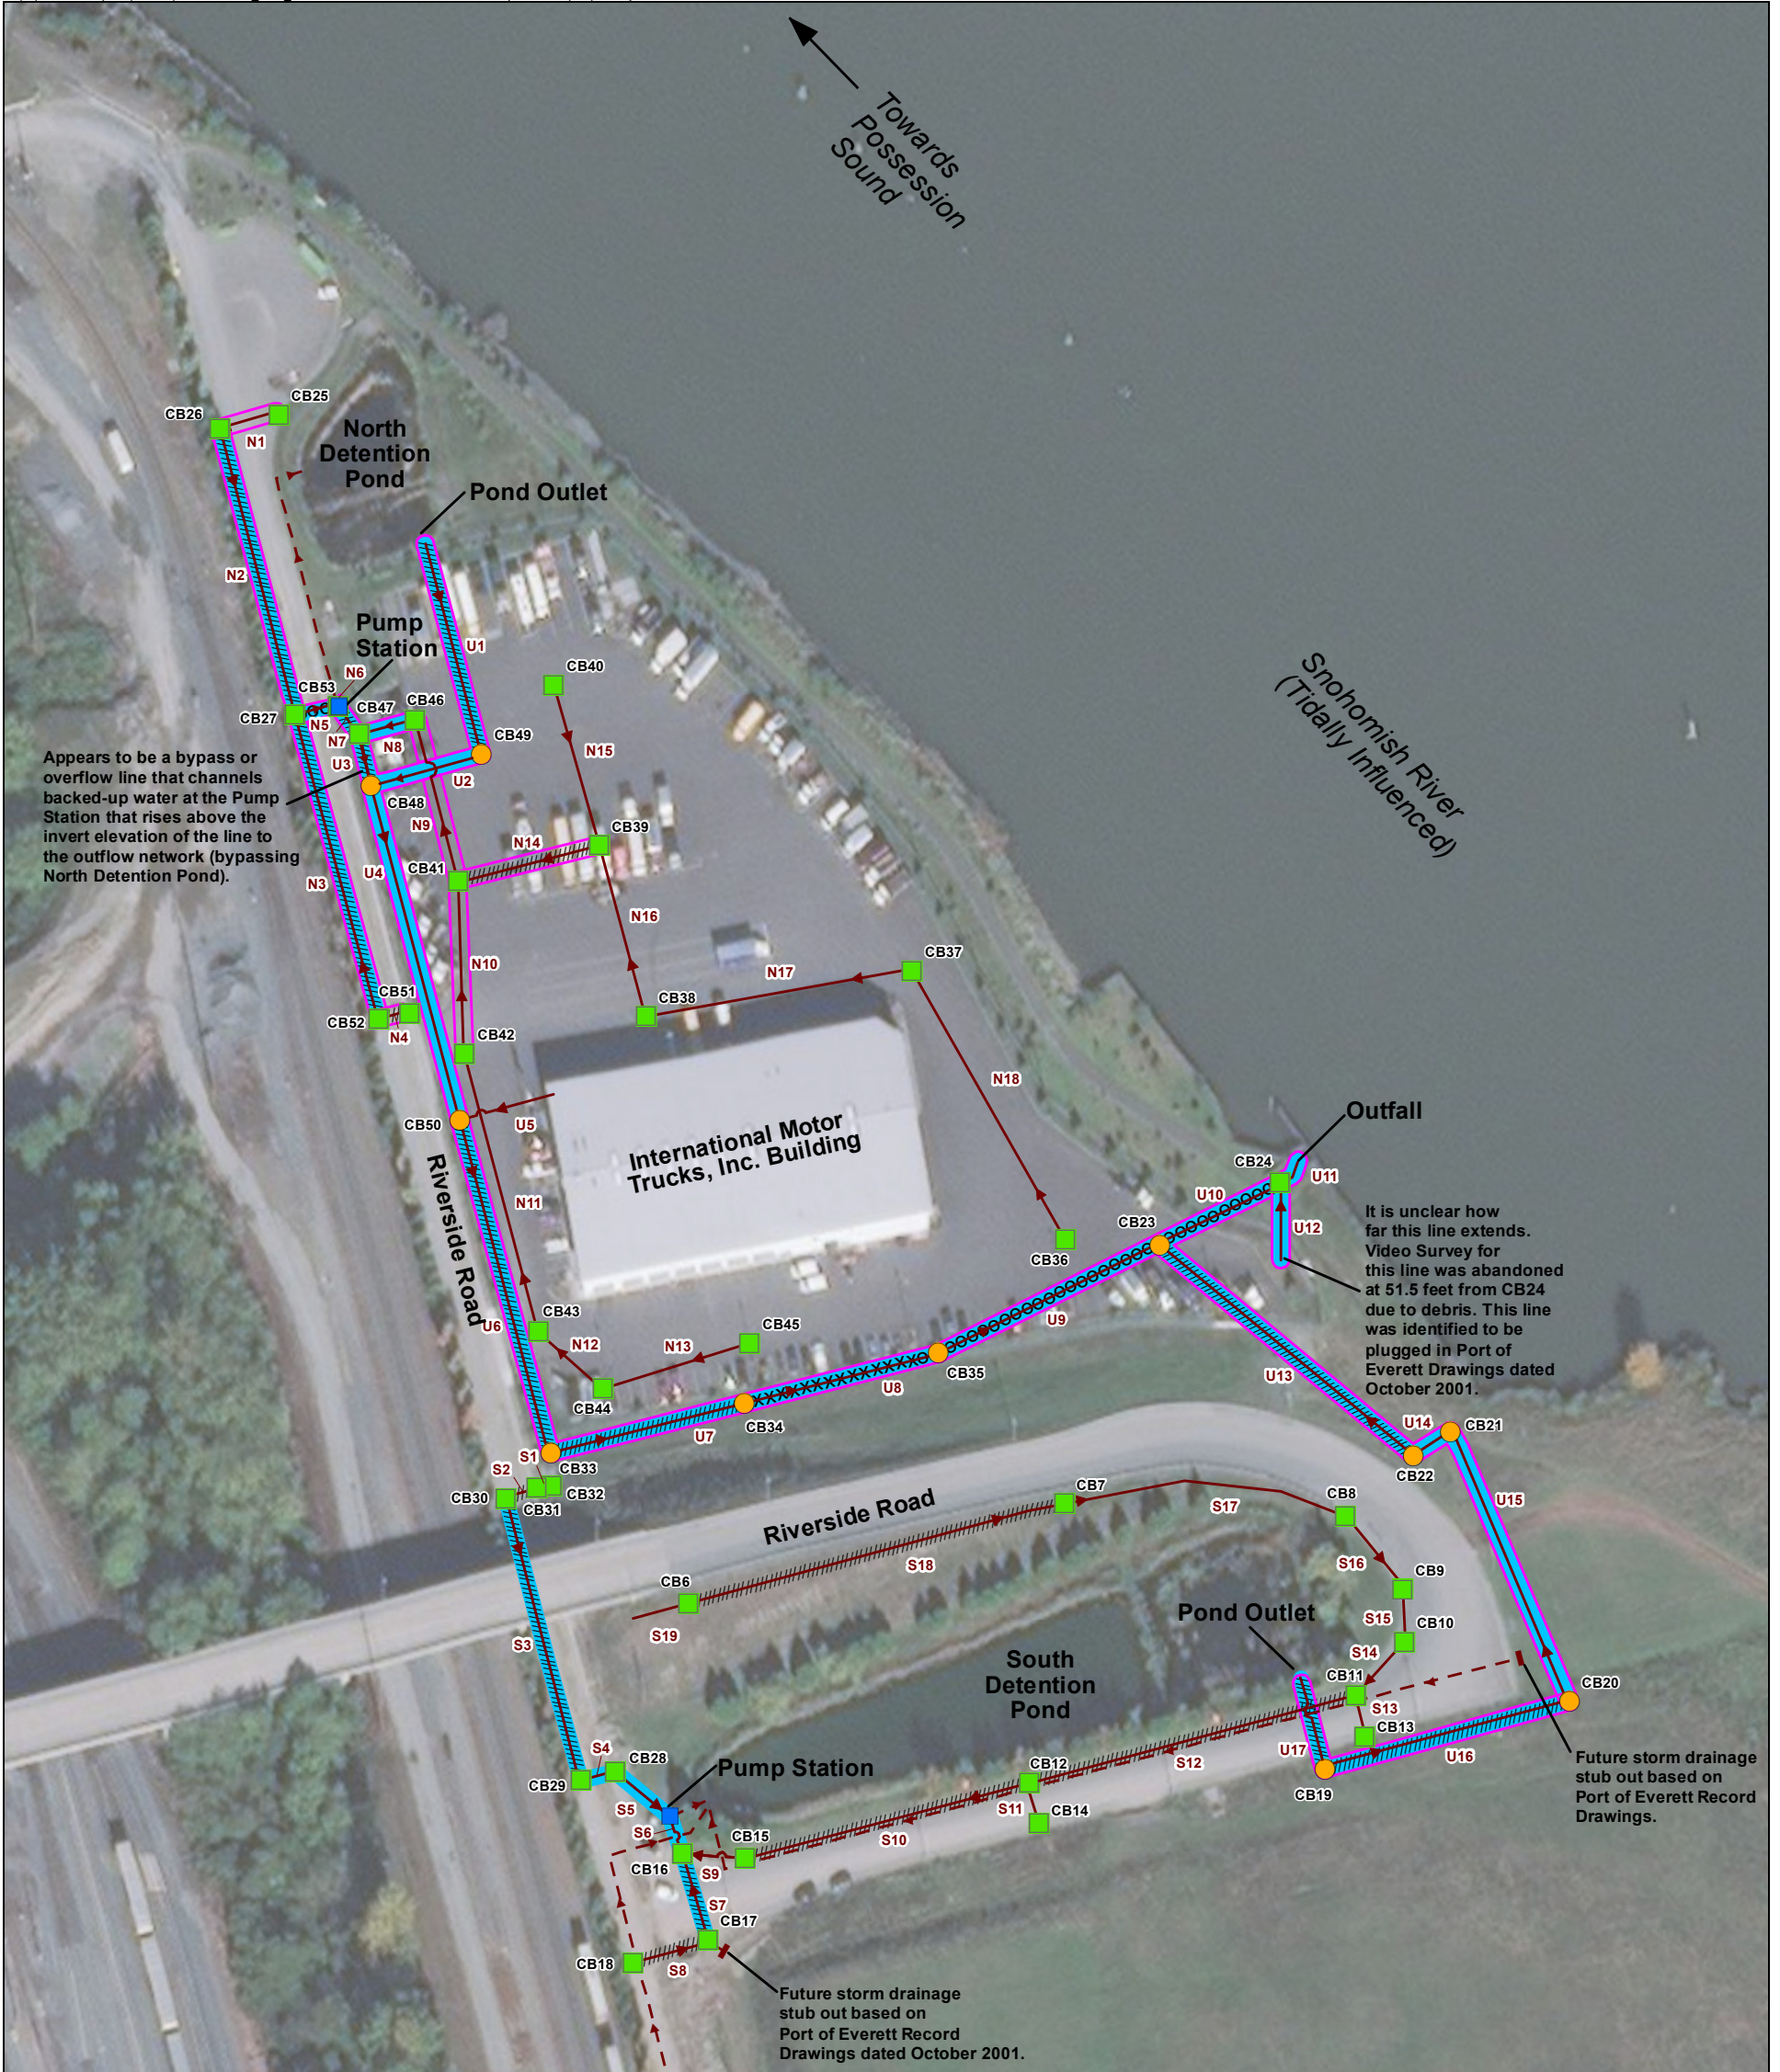
<b>Storm Drain Conditions</b>	
Everett Smelter - Lowland Area Remedial Action Area B2 Everett, Washington	
	Figure 5

The results of storm drain video survey are summarized in Table 2 and Figure 5. A detailed inspection report for each segment of the video survey prepared by Pro-Vac is presented in Appendix C. Pro-Vac's inspection report identifies the nature of defects or deposits (debris or sediment) if observed and distance at which defects/deposits were observed for each segment of the video survey. The following summarize the observations from the video survey:

- **Inflow network to the south detention pond:** Video survey attempts were made on all of the 19 storm drain segments located within the inflow network of the south detention pond. Of the 19 segments surveyed, videos for five segments were only partially completed and abandoned due to the presence of debris or broken pipes. These five segments include S10 through S12, S14 and S19. The video surveying activities identified a defect or defects in seven segments including S2, S3, S7, S8, S10, S12, and S18 and deposits in 13 segments including S3 through S5, S7, S8, S10 through S16 and S19. Four segments were observed to contain neither defects nor deposits including S1, S6, S9, and S17.

- **Inflow network to the north detention pond:** One segment, N5, located within the inflow network of the north detention pond could not be surveyed as it remained inundated with water during the time of the survey. Video survey attempts were made on the rest of the 17 storm drain segments located within the inflow network of the north detention pond. Of the 17 segments surveyed, video for one segment, N2, was partially completed and abandoned since the camera encountered debris and water causing poor or no visibility. The video surveying activities identified a defect or defects in five segments including N2 through N4, N7, and N14 and deposits in five segments including N1 through N4 and N10. Eleven segments were observed to contain neither defects nor deposits including N5, N6, N8, N9, N11 through N13, and N15 through N18.

The video surveying activities identified a defect or defects in seven segments including U1, U3, U6, U7, U13, U16 and U17 and deposits in four segments including U7, U8, U10 and U12. Six segments were observed to contain neither defects nor deposits including U2, U4, U5, U11, U14 and U15.

Table 3 summarizes storm drain repairs that will be completed for each segment. CIPP lining will be installed in all storm drain segments located below the seasonal high groundwater table (identified on Figure 5 and Table 3) to eliminate infiltration of contaminated groundwater. Additionally, for segments located below seasonal high groundwater table, point repairs will be completed (prior to installing CIPP) for defects that cannot be addressed using CIPP. For storm drain segments located above seasonal high groundwater table, either CIPP and/or point repairs will be completed depending on type and location of defect, and length of the segment. For example, if the segment is located across the street and the defect can be addressed using CIPP, then CIPP will be preferred since, unlike point repair, it does not require excavation and thus causing less disruption to the street. If the segment length is long such that point repair will be more economical then installing CIPP then point repair will be preferred. Table 3 identifies storm drain segments above seasonal high groundwater table that will be repaired. No storm drain repairs are proposed for segments that are located above seasonal high groundwater table and have no defects.

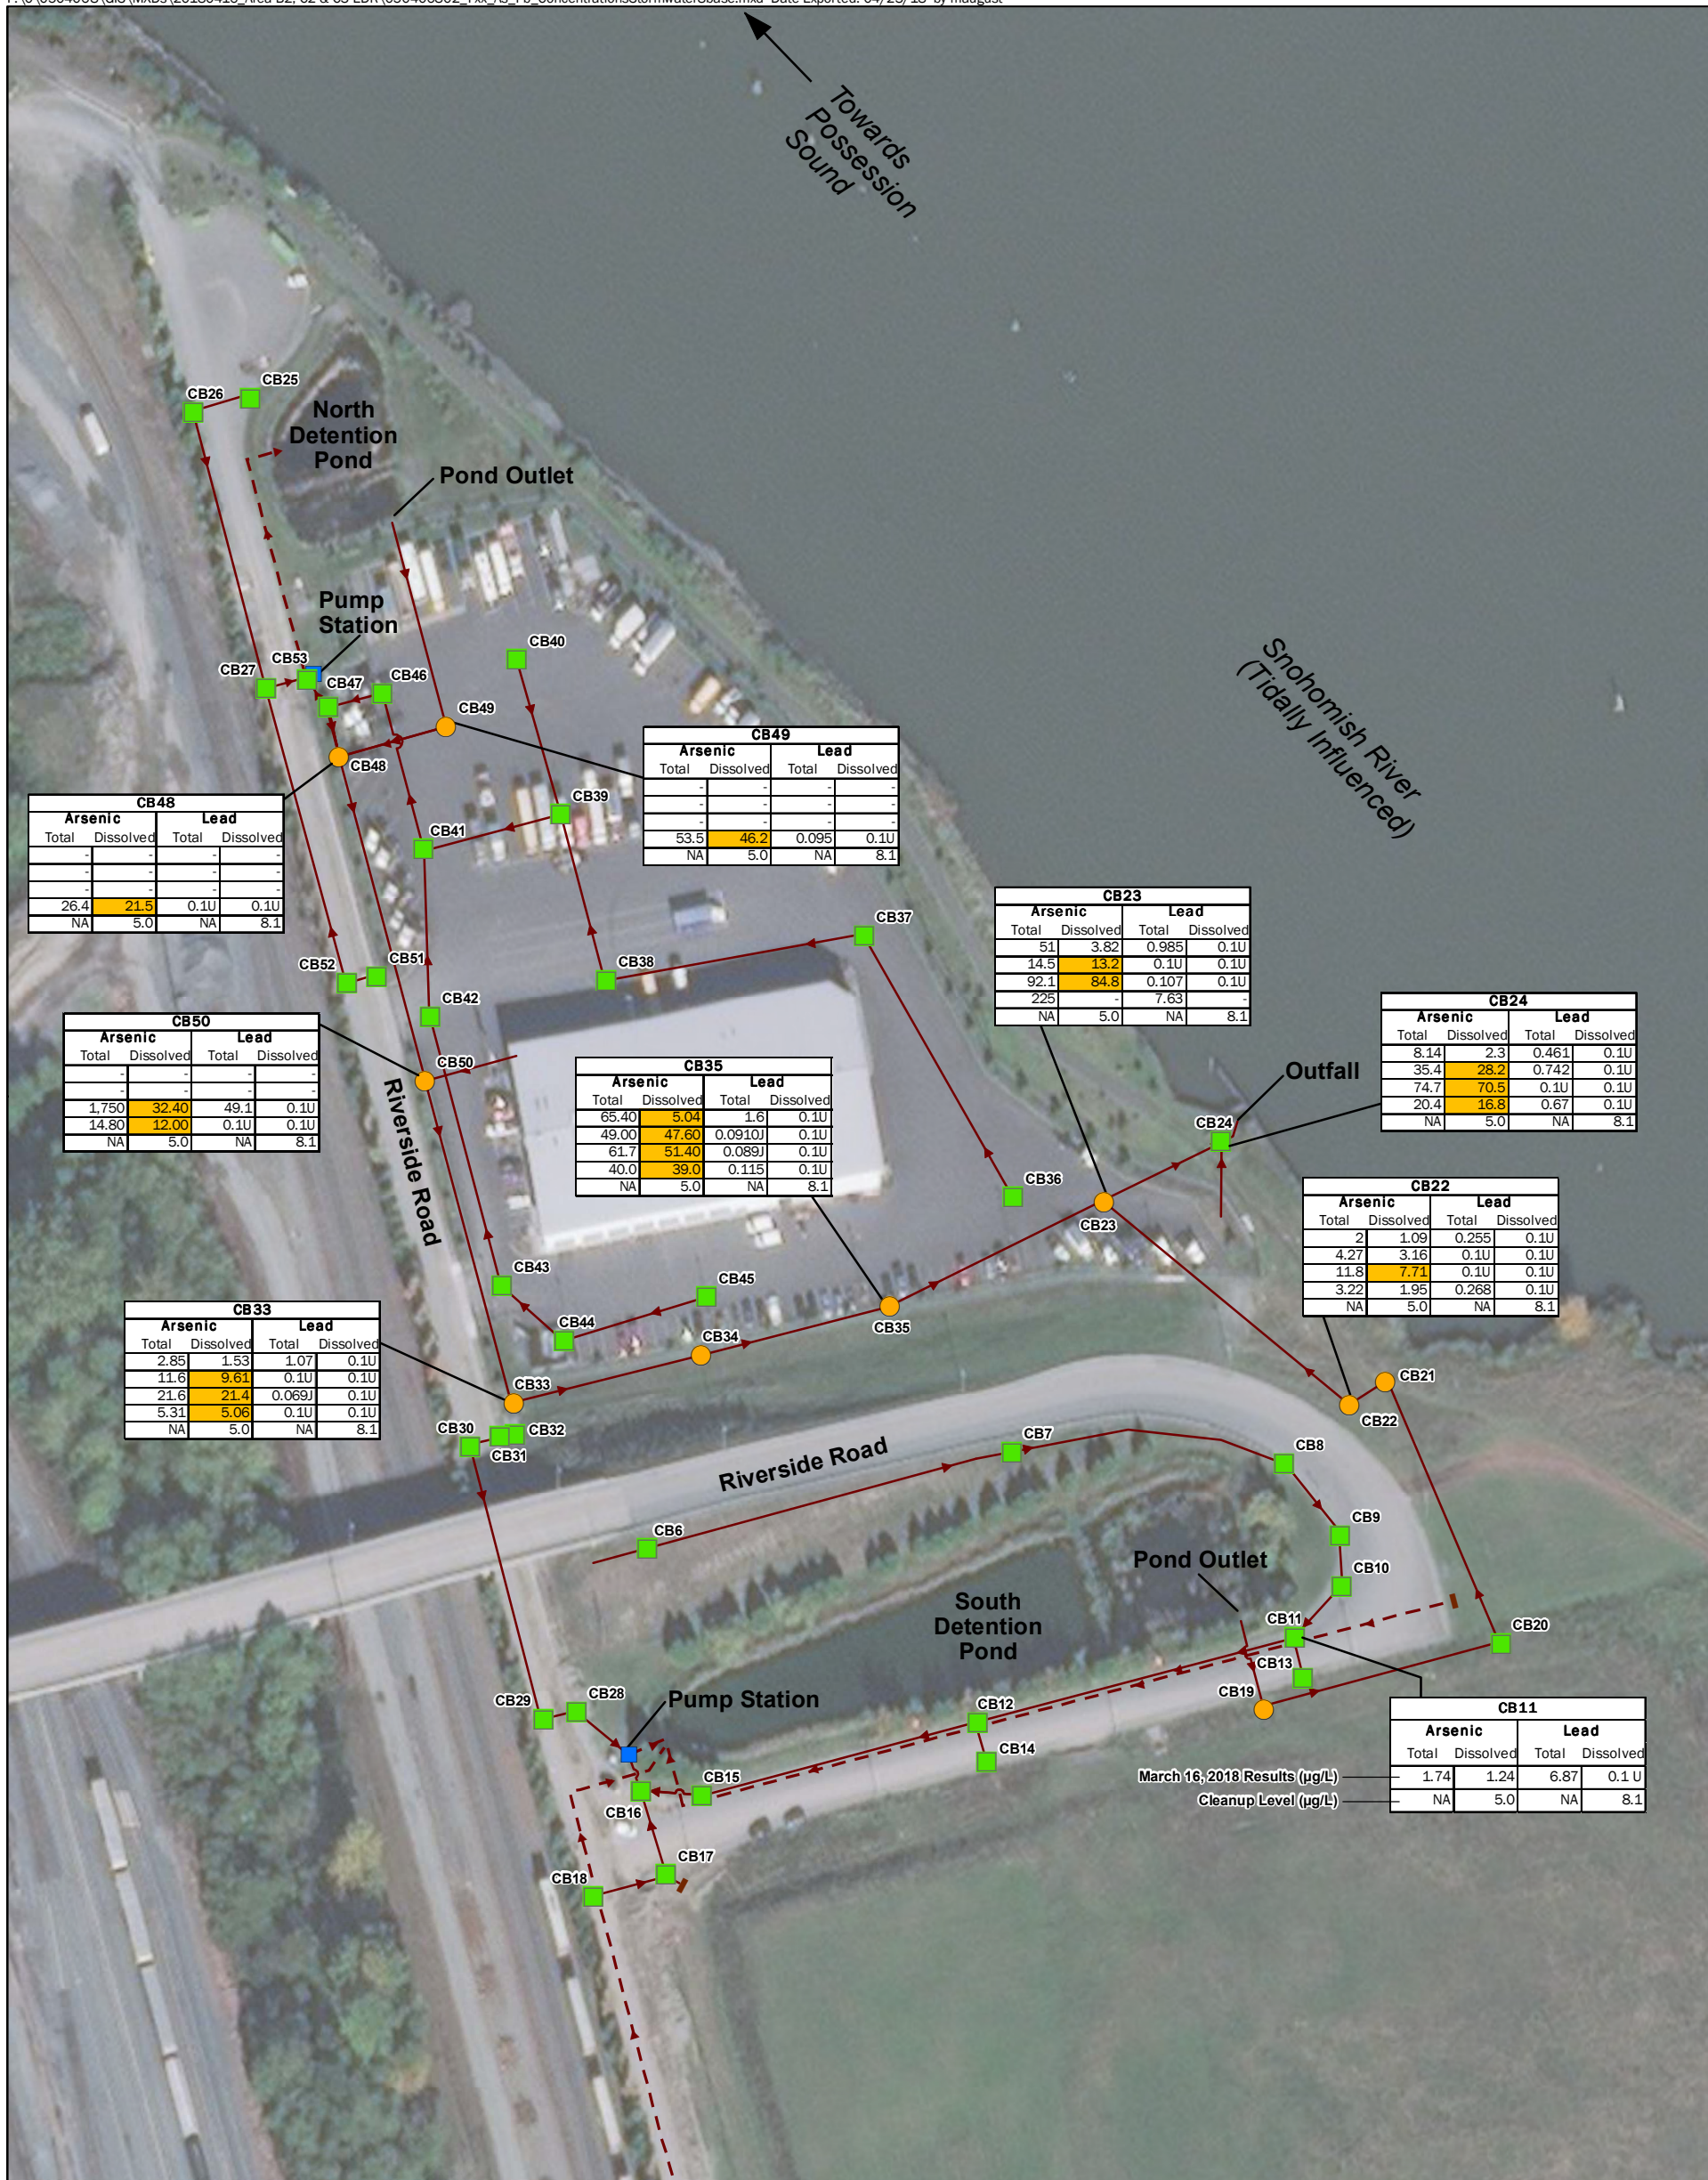
<b>Summary of Water Contamination in Storm Drain System at Area B2</b>
Everett Smelter - Lowland Area Remedial Action Area B2 Everett, Washington
<b>GEOENGINEERS</b> <b>Figure 6</b>

In March 2018, a sample was collected from CB11 located within the inflow network to south detention pond as a result of an observation made during a site visit. The site visit was made to confirm that no groundwater was infiltrating into the storm drain segments that are expected to be above groundwater table. Section 2.4.2.2 and Figure 5 identify storm drain segments that are expected to be above seasonal high groundwater table. Water was not observed in storm drain segments that are expected to be above groundwater table with the exception of segments S14 located between CB9 and CB10 and S15 located between CB10 and CB11. Debris and standing water was observed within CB9 and CB10, and a trickle of water was observed flowing into CB11. It appeared that there was a blockage in segment S14 which was causing a backup of water in CB10 and up till CB9. A water sample was collected from CB11, the downgradient most catch basin from segments S14 and S15 to characterize the backed-up water. The water sample was analyzed for total and dissolved arsenic and lead. The results for both arsenic and lead were below the cleanup level. The results are summarized on Figure 6. The laboratory analytical report is presented in Appendix D.

The results of samples collected from the eight catch basins/manholes located within the outflow network indicate that contaminated groundwater and/or soil is infiltrating into the storm drain segments in Area B2. The results of samples collected from CB24, the catch basin immediately upgradient of the outfall, indicates that water with arsenic concentrations greater than the cleanup level is being discharged from the outfall into the Snohomish River.
