LEVEL 1 ENVIRONMENTAL SITE ASSESSMENT

Subject Property:
2119 Mildred St. West
Tacoma, Washington

May 7, 1999

Creative Environmental Technologies, Inc.

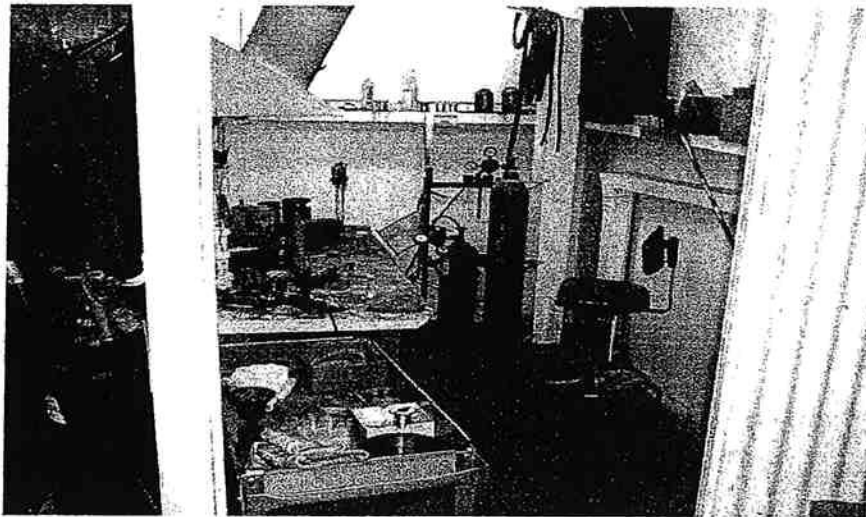
Welding and Soldering Room

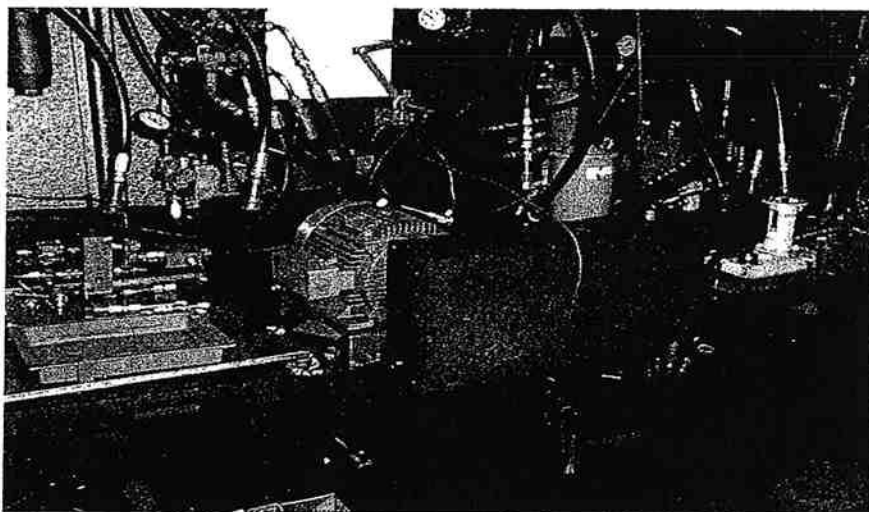
Hydraulic Systems Test Bench

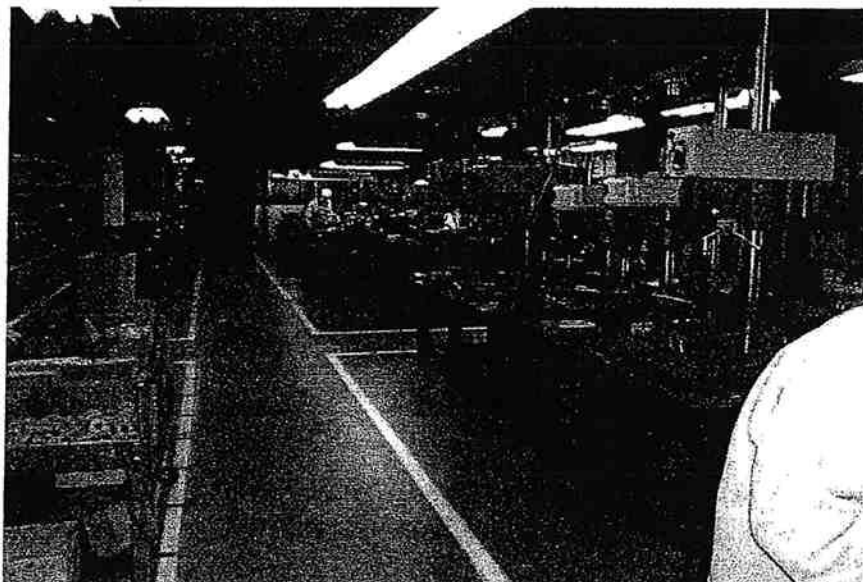
Machine Shop

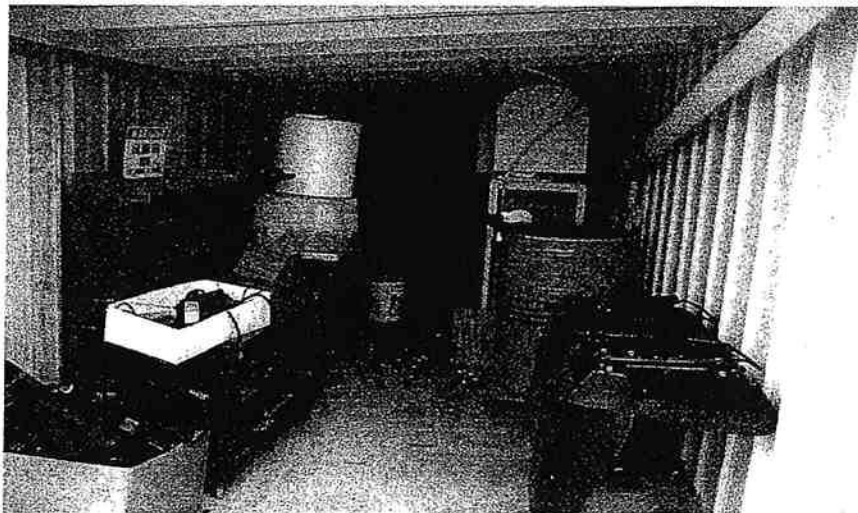
Empty drums that once contained petroleum products were observed at several locations. These locations are comprised of the lean-to shed on the east side of the property and the area between the paint storage shed and the cardboard storage shed. A drum leaking what appeared to be lubricating oil was observed in the lean-to shed. CETI recommends these materials be removed from the property and disposed of properly.

Fluid Storage Lean -To

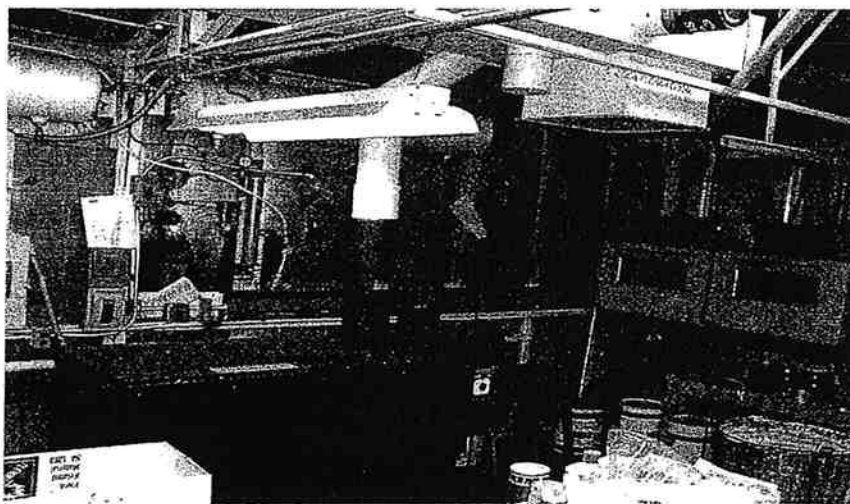
A hydraulic test facility, hydraulic doors, an air compression system, a solvent recovery system, and a kerosene solvent recycling system were all observed to be operating properly. CETI recommends that this equipment be monitored carefully should it remain on the property, to insure against leakage of any contaminants.

Evaporator and Recovery System

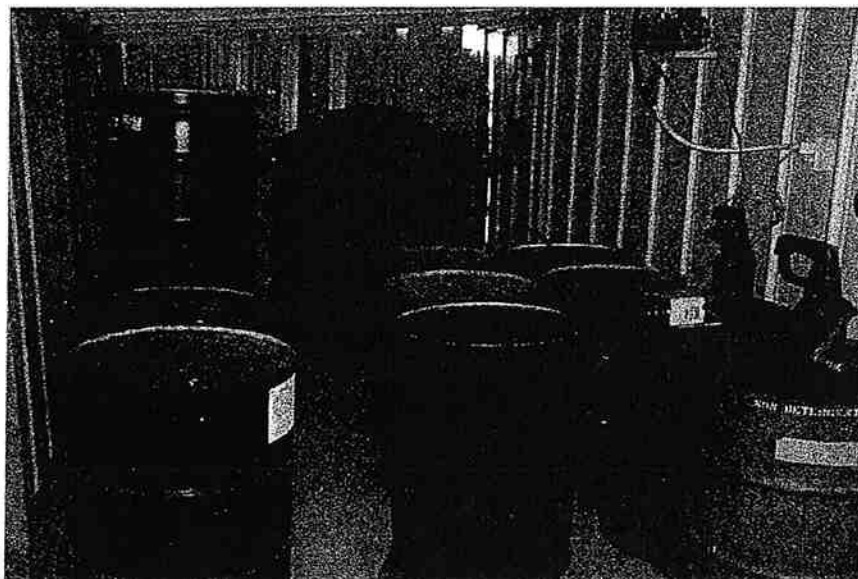
CETI was informed that residue which accumulates in the evaporator and stored in 55-Gallon drums still resides on the property. CETI recommends that this residue be disposed of properly.

Evaporator Recovery Tank and Drum Storage in Lean-To

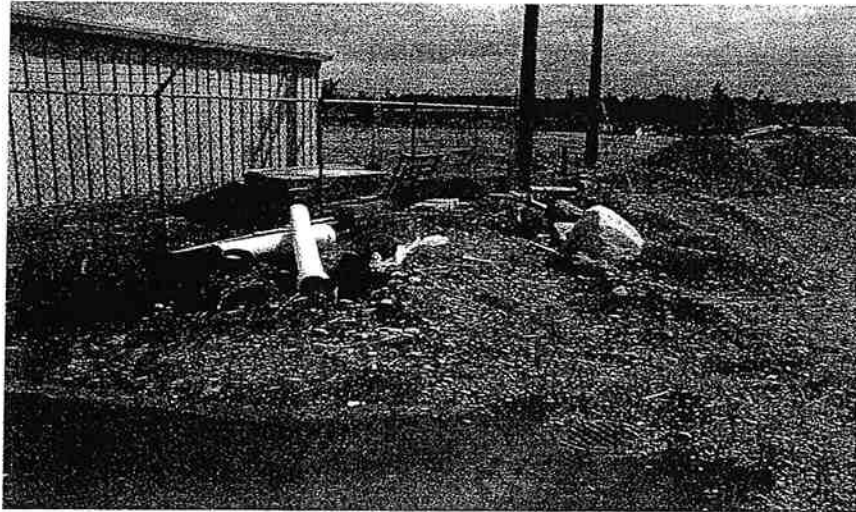
Storm Drain on South End of Building Site of Removed USTs

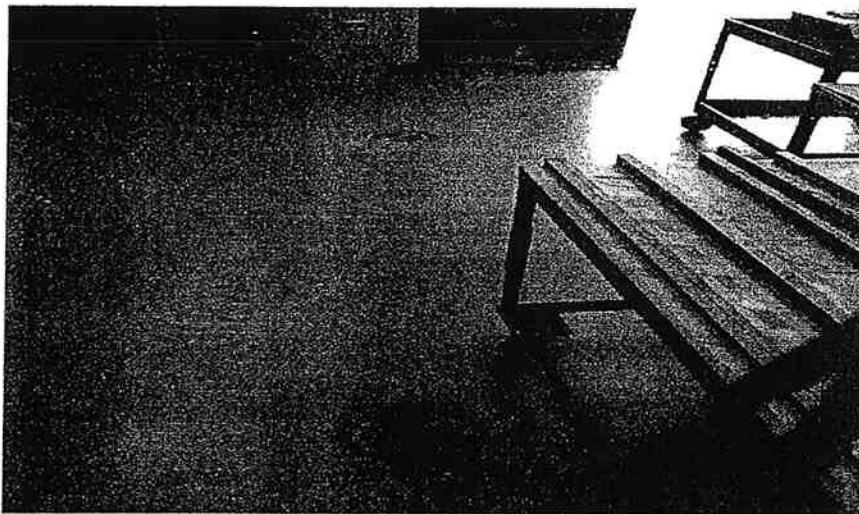
Drains in Floor of Paint Shop which Lead to Recovery Tank

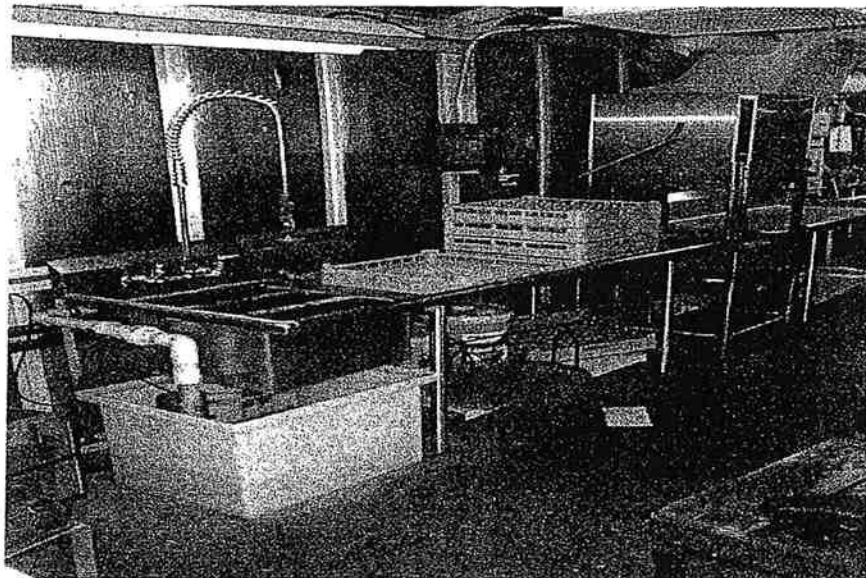
Parts Washing Facility

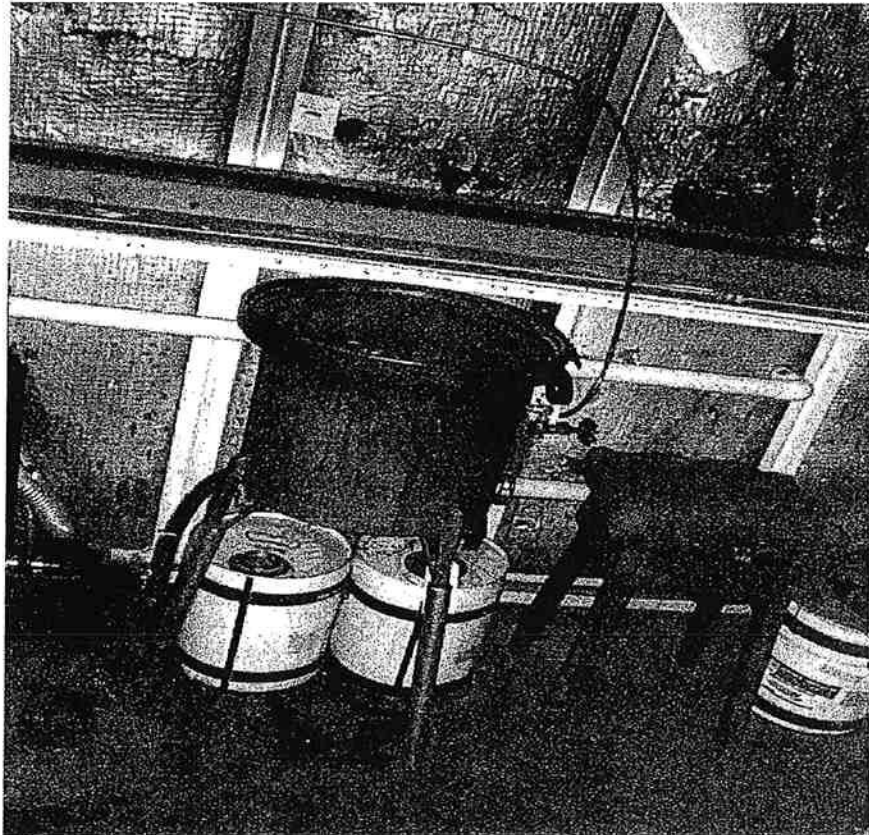
Varnish Dip Facility
