February 27, 2019

University of Washington  
Capitol Projects Office  
Facilities Service Annex 2  
Box 352205  
Seattle, Washington 98195-2205

Subject: Potential Upgradient Sources Along Tacoma Avenue South  
University of Washington - Tacoma  
Tacoma, Washington  
File No. 0183-109-02

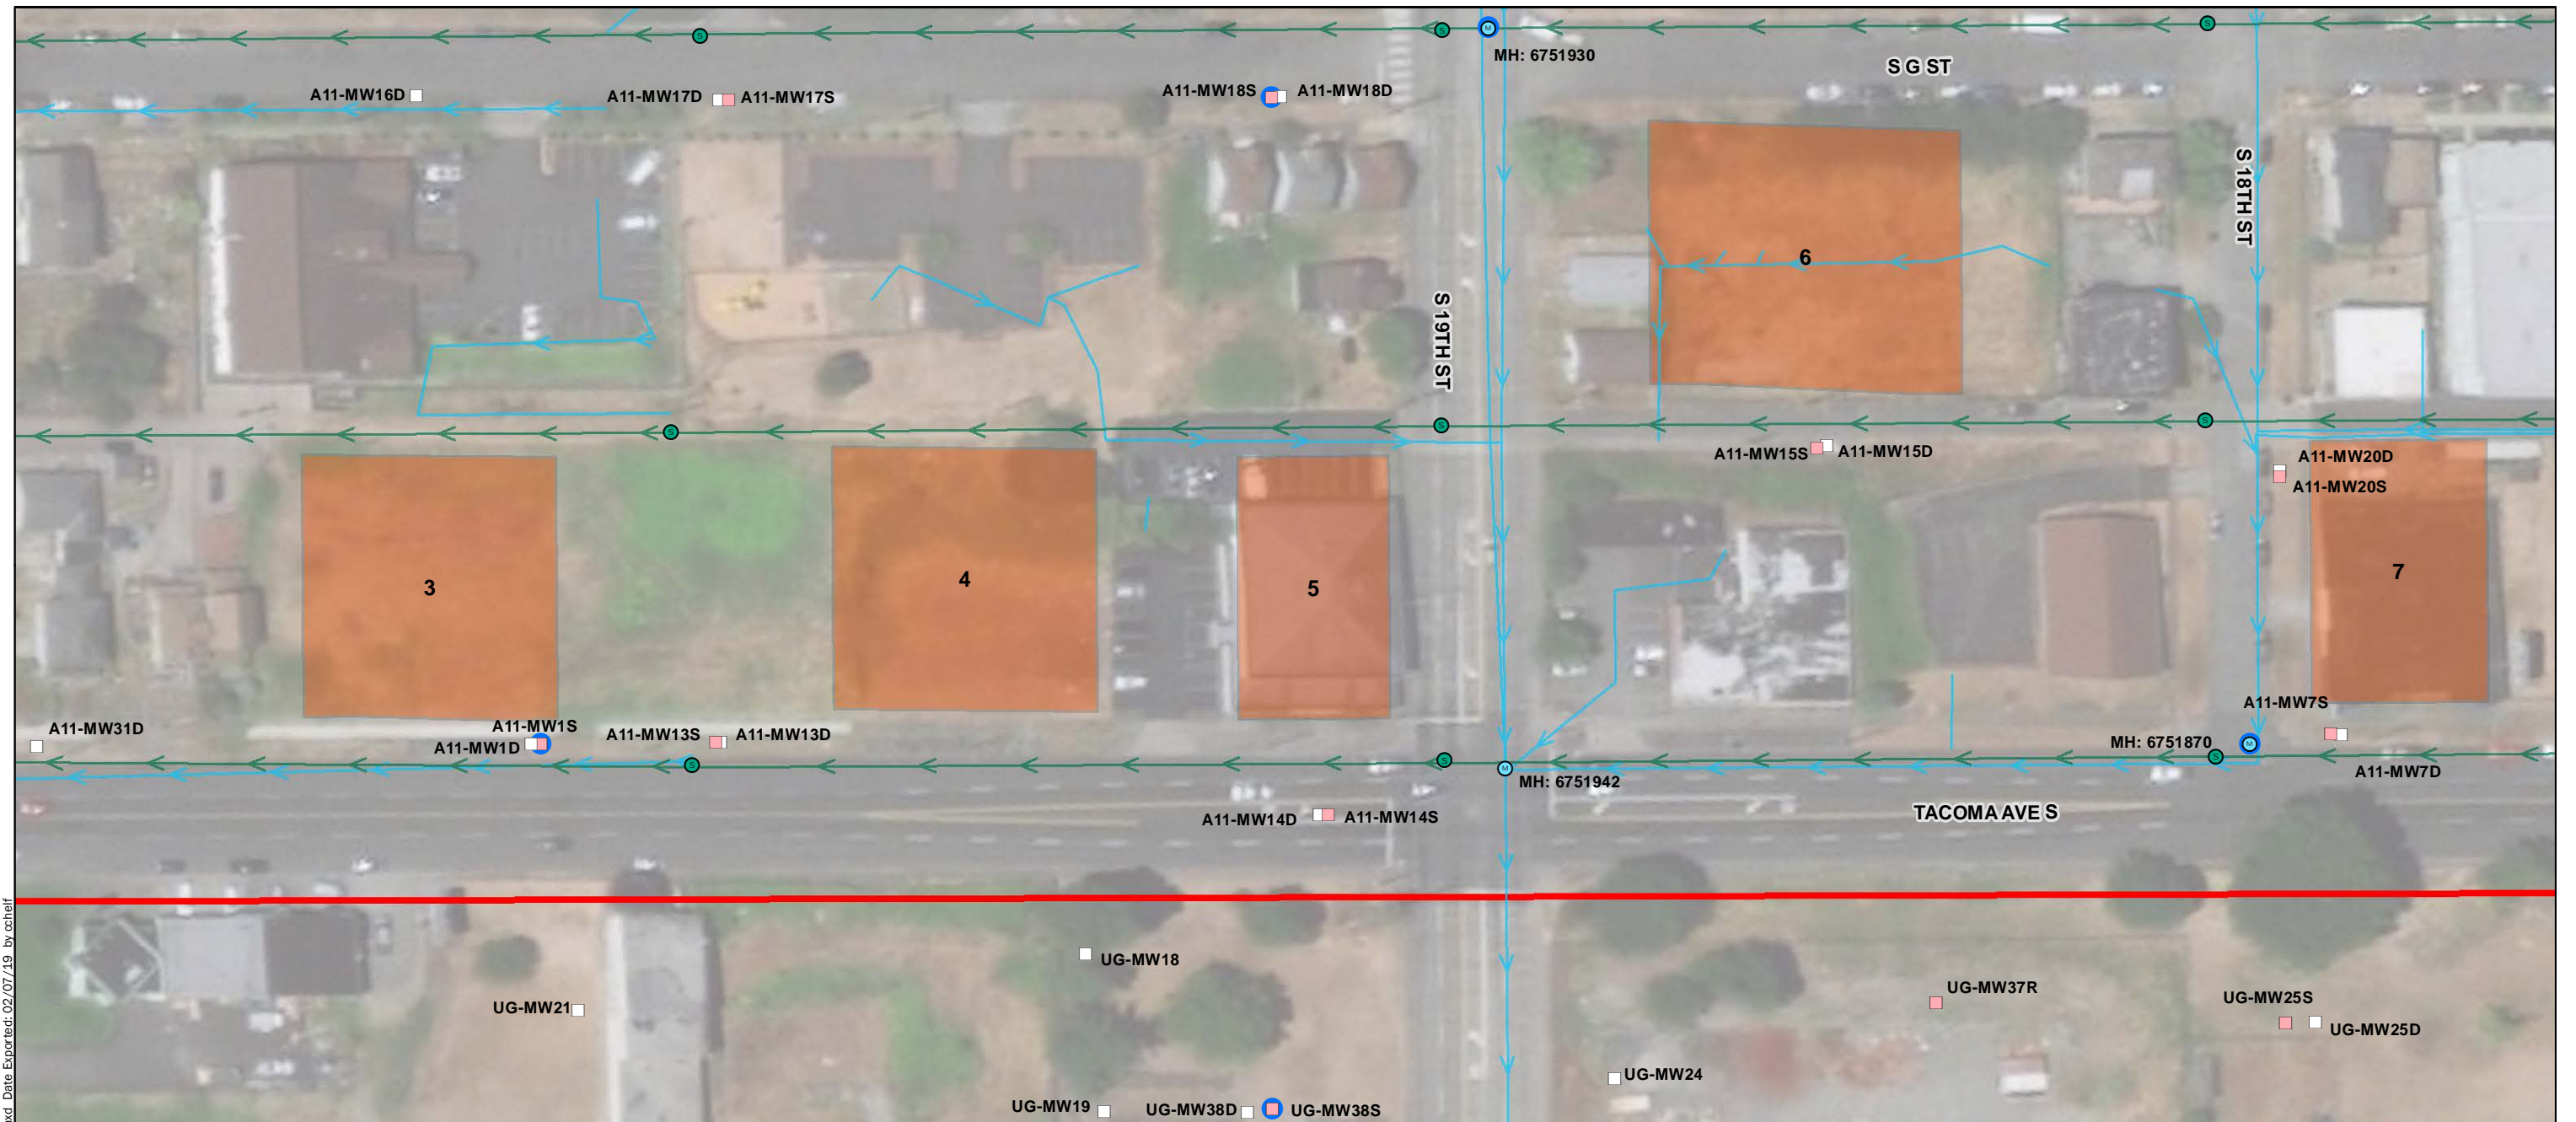
**Figure 2**

- A metal photoengraving facility operated on the property from 1956 to 1988. Numerous sinks and floor drains were included in the building design based on a review of permit records. The engraving facility operations included use of 1,1,1-TCA and TCE products during their operations and discharging of neutralized acid to the sanitary sewer in at least 1988 based on a review of Ecology records. It appears 1,1,1-TCA and TCE may have spilled during normal operations and/or was discharged to the sanitary sewer through the sinks or floor drains in the past.
- The sanitary sewer utility trends from north to south along Tacoma Avenue. Two manholes are present between Potential Source #7 and South 19<sup>th</sup> Street as shown on Figure 2.

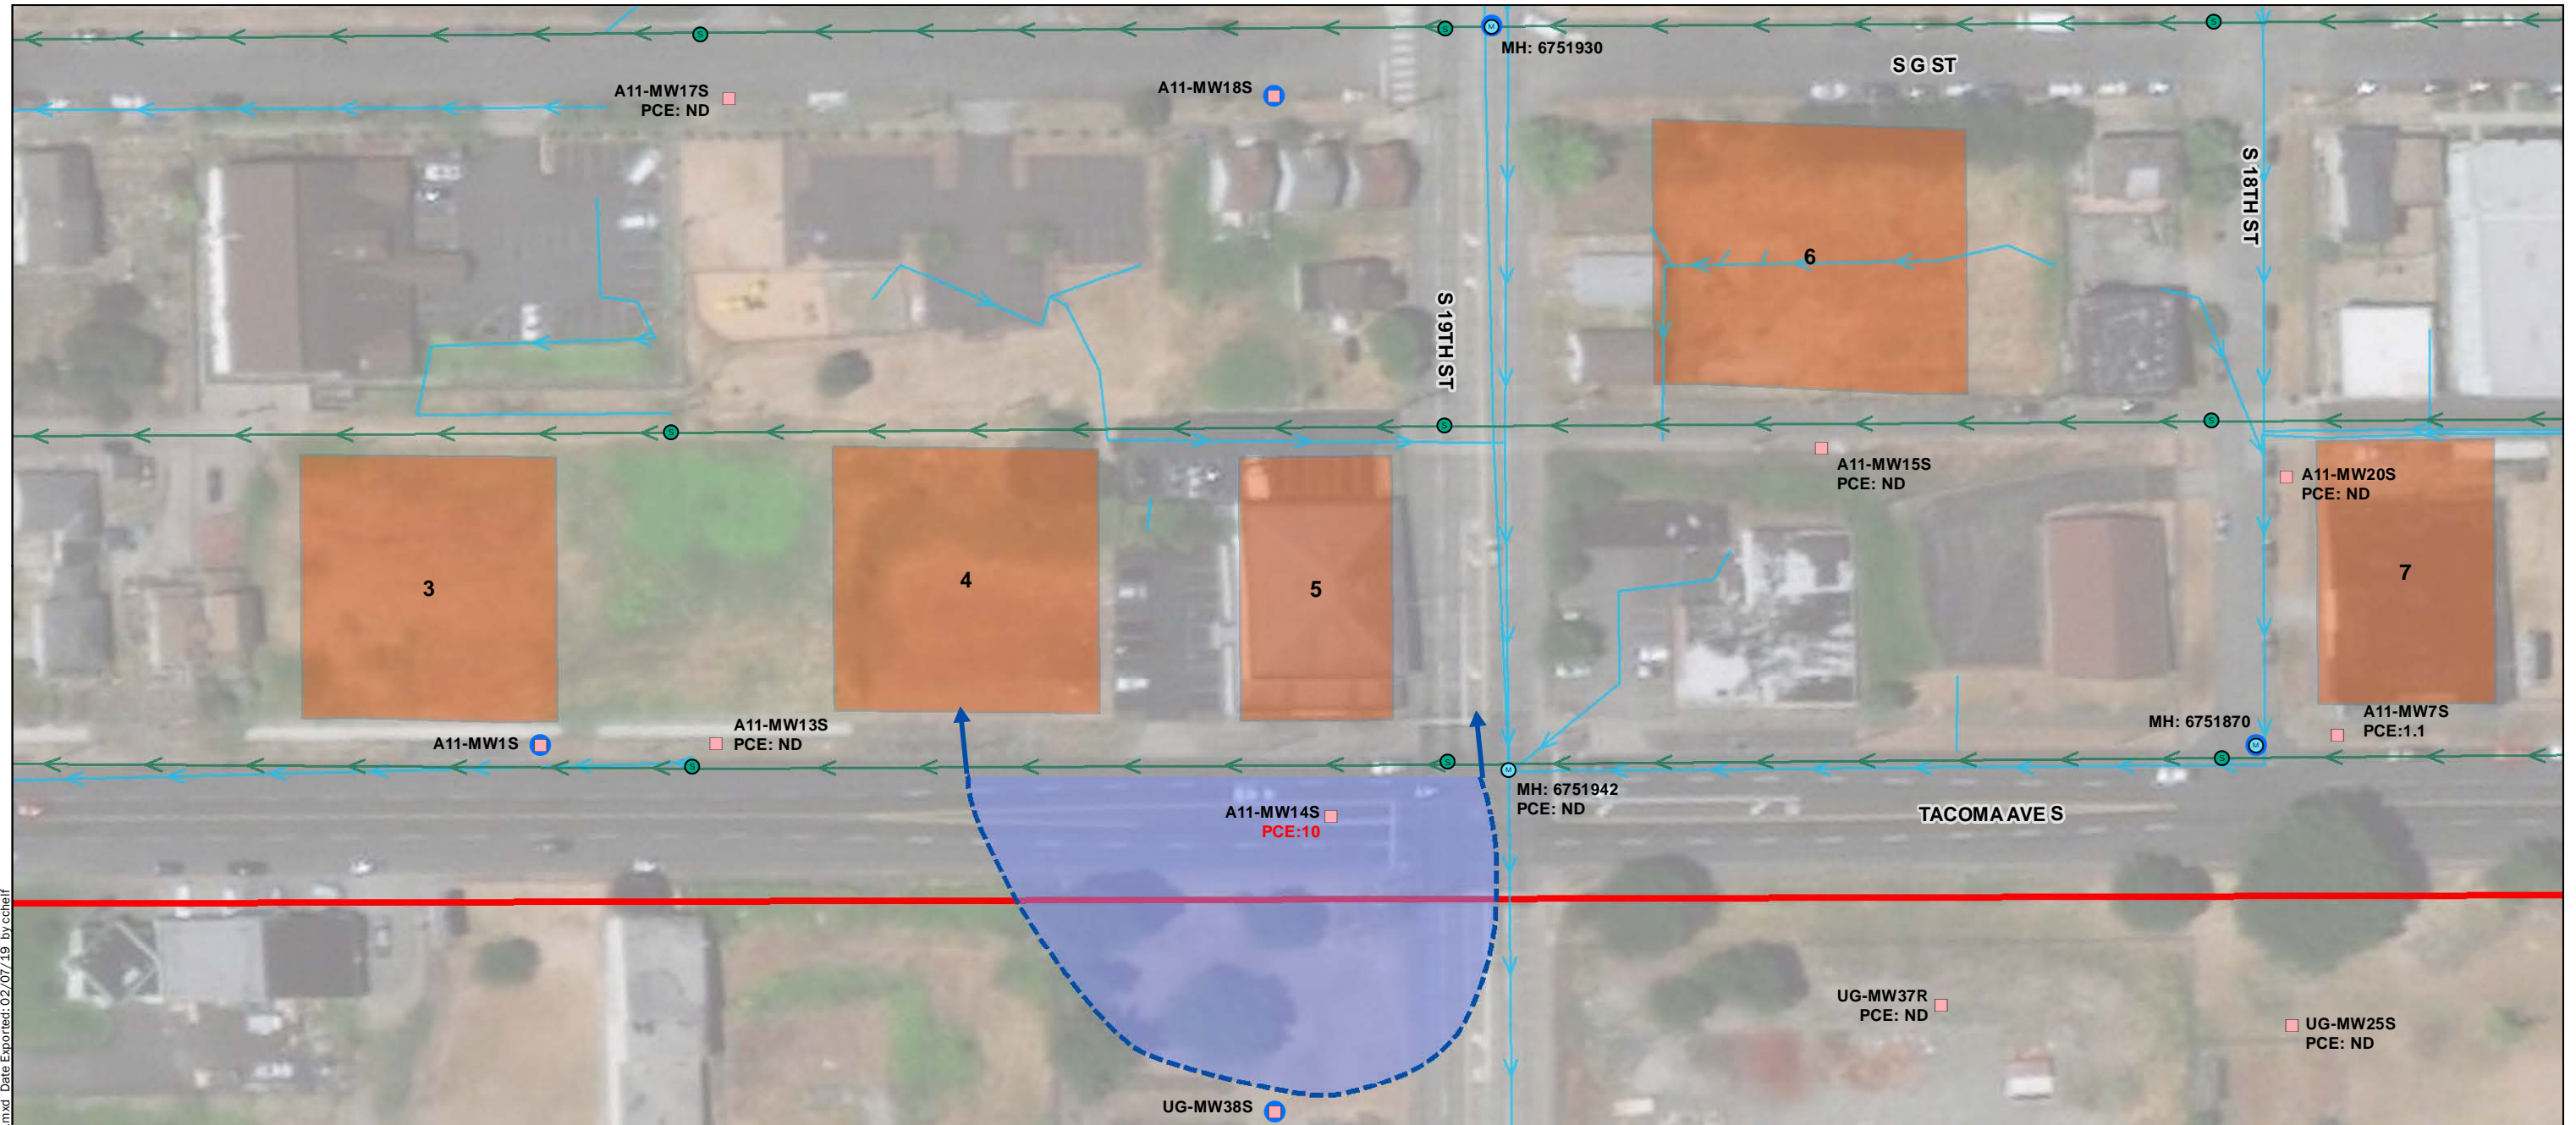
<b>Shallow Aquifer - PCE</b>	
Potential Upgradient Sources Along Tacoma Avenue South University of Washington - Tacoma Tacoma, Washington	
	<b>Figure 3</b>

- PCE groundwater plumes were identified within the shallow and deep aquifers in the area of South 19<sup>th</sup> Street (generally in the same location). The lateral extent of these plumes to the west (upgradient) appears to be limited to the South G Street boundary.

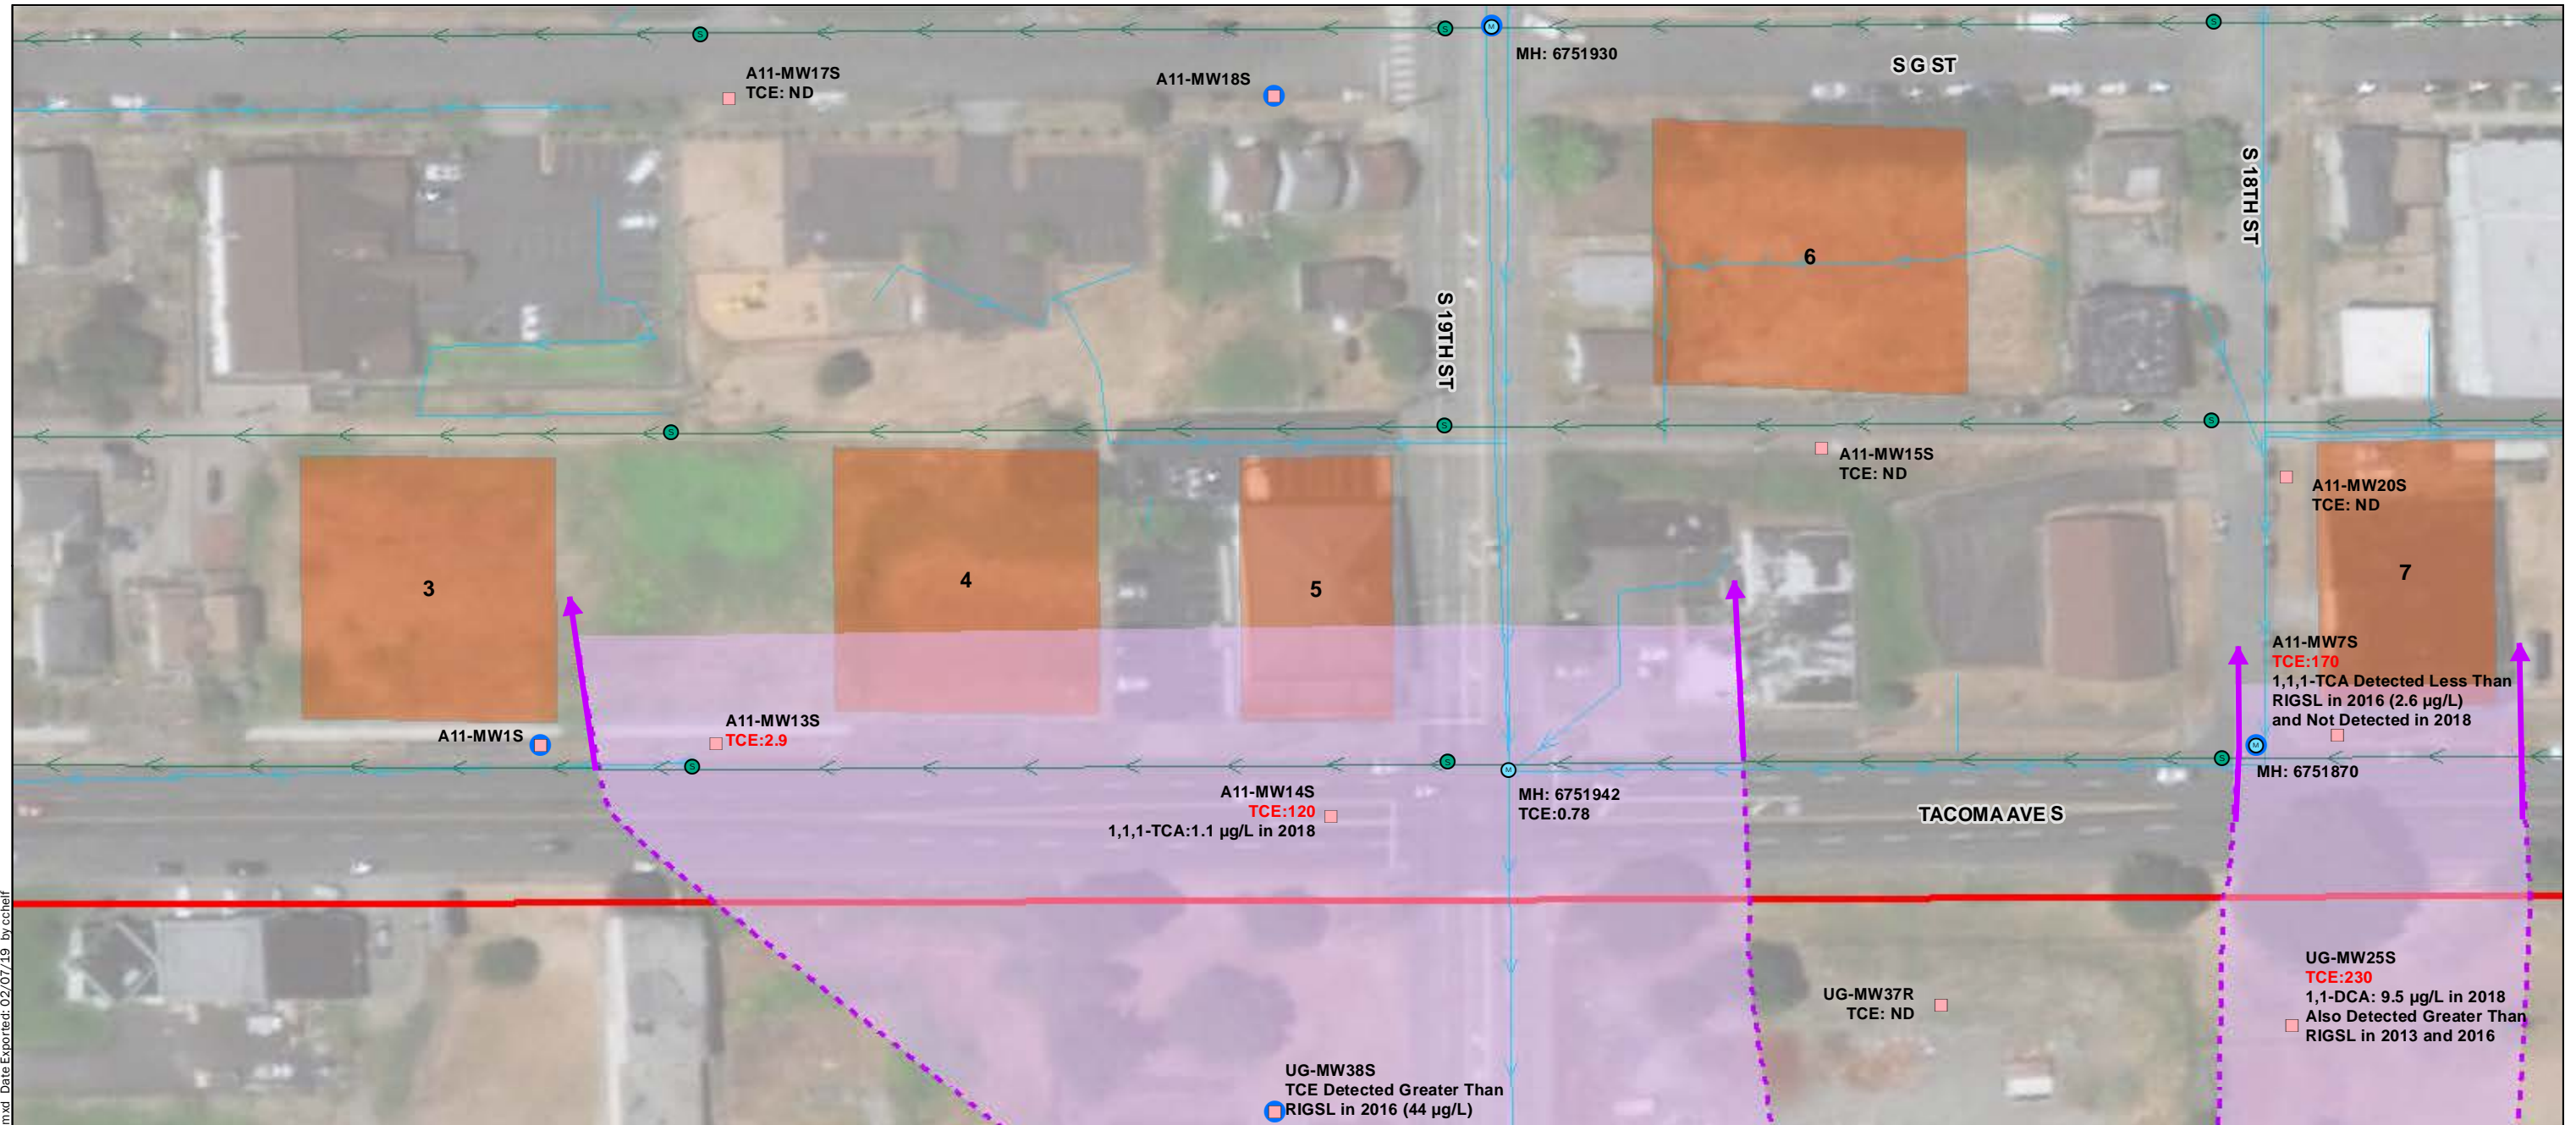
<b>Shallow Aquifer - TCE</b>	
Potential Upgradient Sources Along Tacoma Avenue South University of Washington – Tacoma Tacoma, Washington	
	<b>Figure 5</b>

- TCE groundwater plumes were identified within the shallow and deep aquifers between South 19<sup>th</sup> Street and South 21<sup>st</sup> Street (generally in the same location). The lateral extent of these plumes to the west (upgradient) appears to be limited to the South G Street boundary.

- A TCE and 1,1-DCA plume groundwater plume is located within the shallow aquifer near South 18<sup>th</sup> Street. The lateral extent of this plume to the west (upgradient) appears to be limited to the Court F boundary.

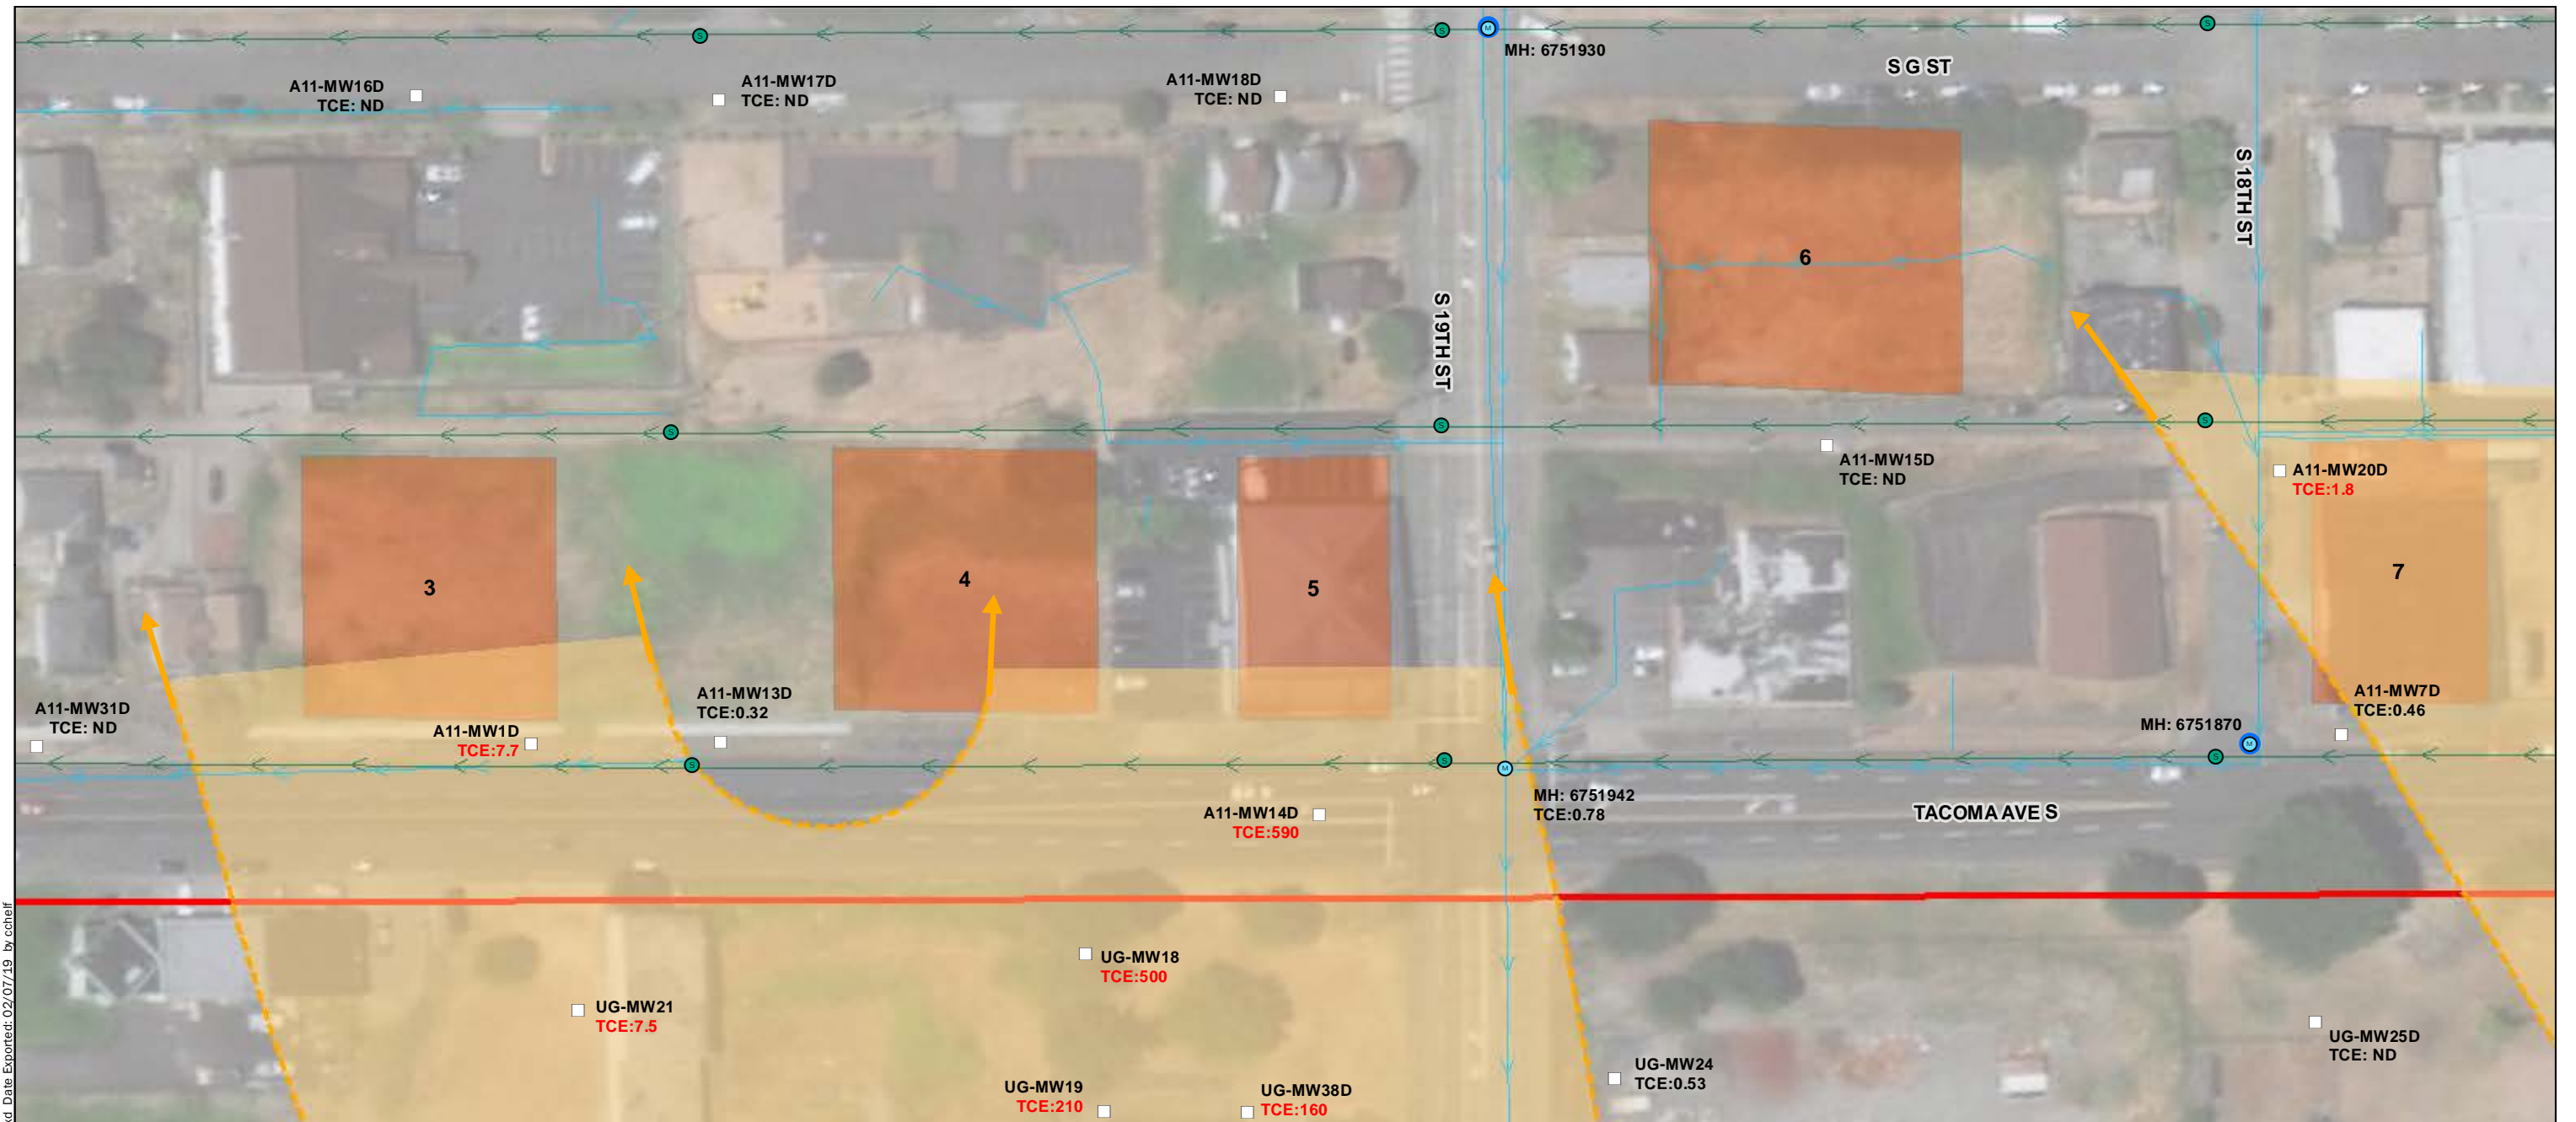
<b>Deep Aquifer - TCE</b>	
Potential Upgradient Sources Along Tacoma Avenue South University of Washington - Tacoma Tacoma, Washington	
	<b>Figure 6</b>

- A TCE plume was identified within the deep aquifer between South 17<sup>th</sup> Street and South 18<sup>th</sup> Street. The lateral extent of this plume to the west (upgradient) is currently unknown.

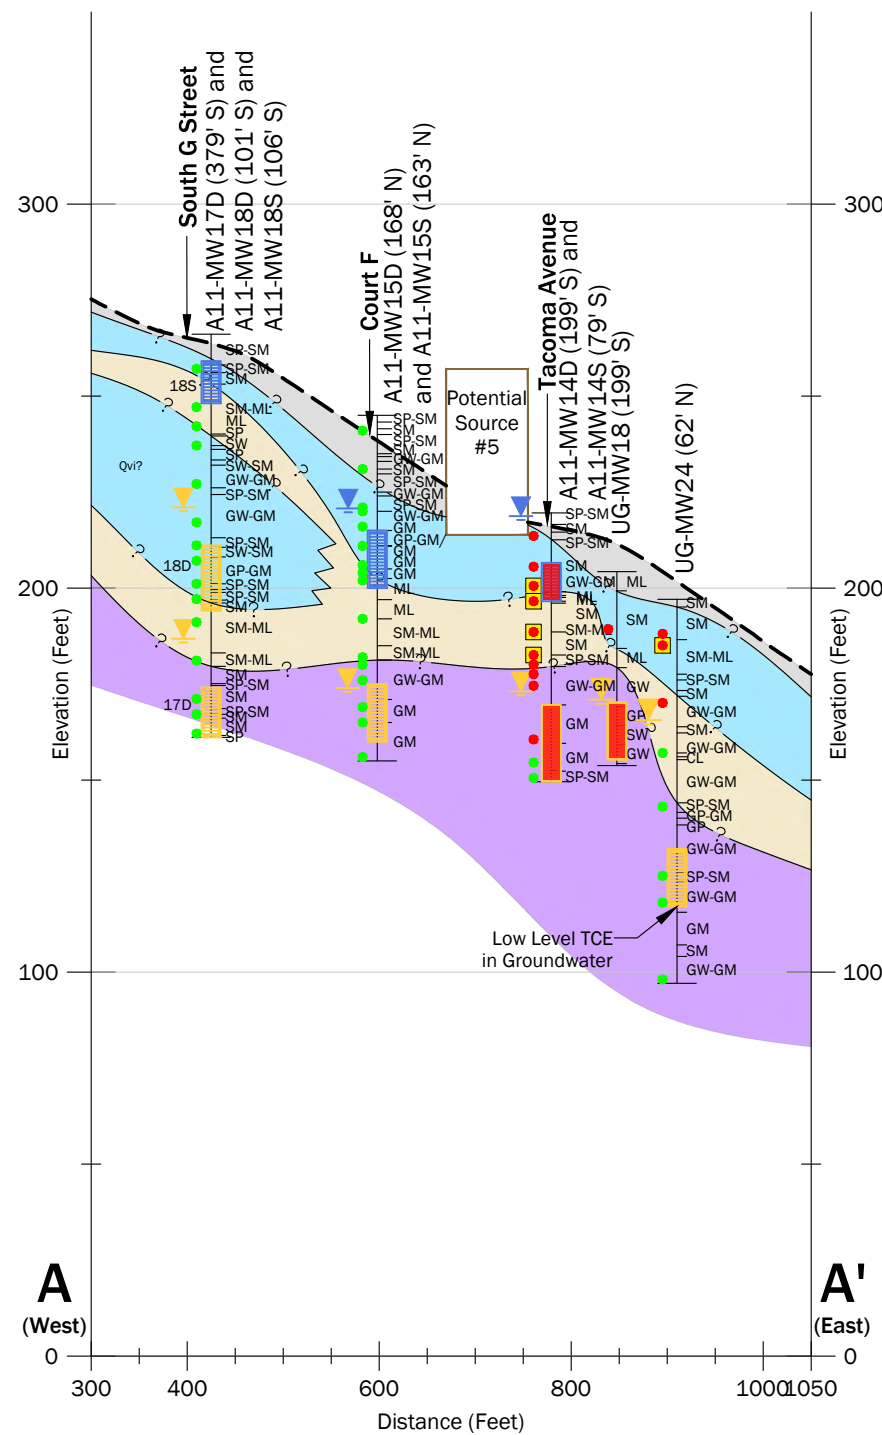
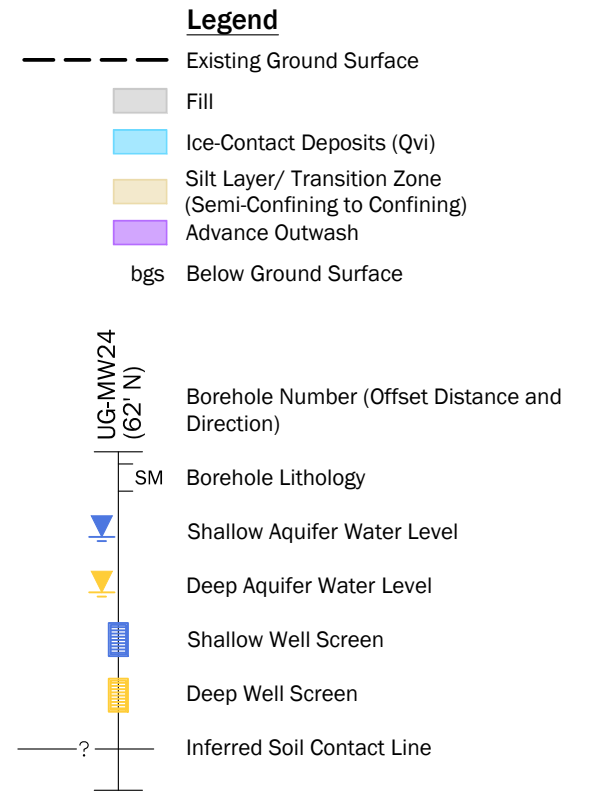
**Figure 7**

█ Red well screen indicates TCE was detected at a concentration greater than the RIGSL in 2018
