## SITE HAZARD ASSESSMENT

### Worksheet 1: Summary Score Sheet

**SITE NAME: Northwest Plating**

Cleanup Site ID: 1361

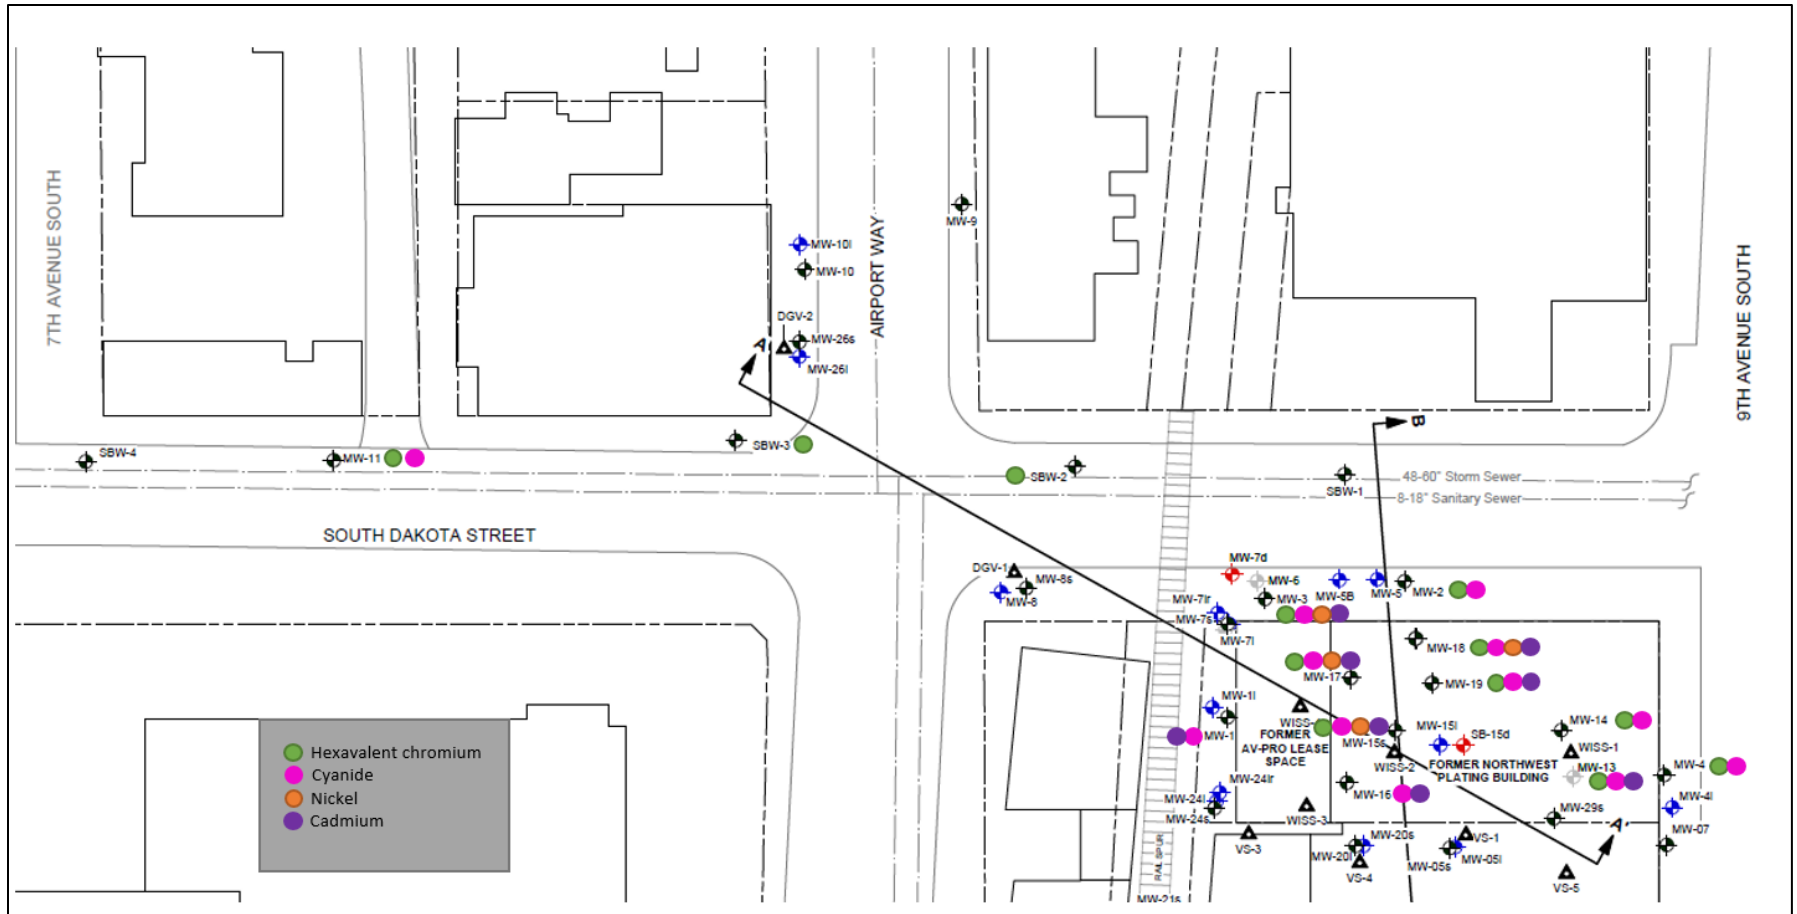
Groundwater and vapor contamination have moved off the Property (see Figures 3, 4, and 6), and the Site is currently defined to include the source parcel, the south-adjacent Perine property (parcel 7886101280), the west adjacent A Better Roofing property (parcel 7886101315), and the South Dakota Street right-of-way. Based on proximity to the defined edges of the groundwater plume prior to beginning interim remedial actions in 2016, 6 additional parcels (listed below; also see Figure 2) may also be impacted by contaminated groundwater and/or vapors.

**Figure 3.** Areas of groundwater contaminated with metals above cleanup levels, in any samples collected prior to the 2016 Remedial Investigation report. While chromium has continued to be monitored regularly in groundwater samples and concentrations of hexavalent chromium have been decreasing, other metals have not been consistently included in analyses since the Remedial Investigation report. Base figure from 2016 EPI Remedial Investigation Report.

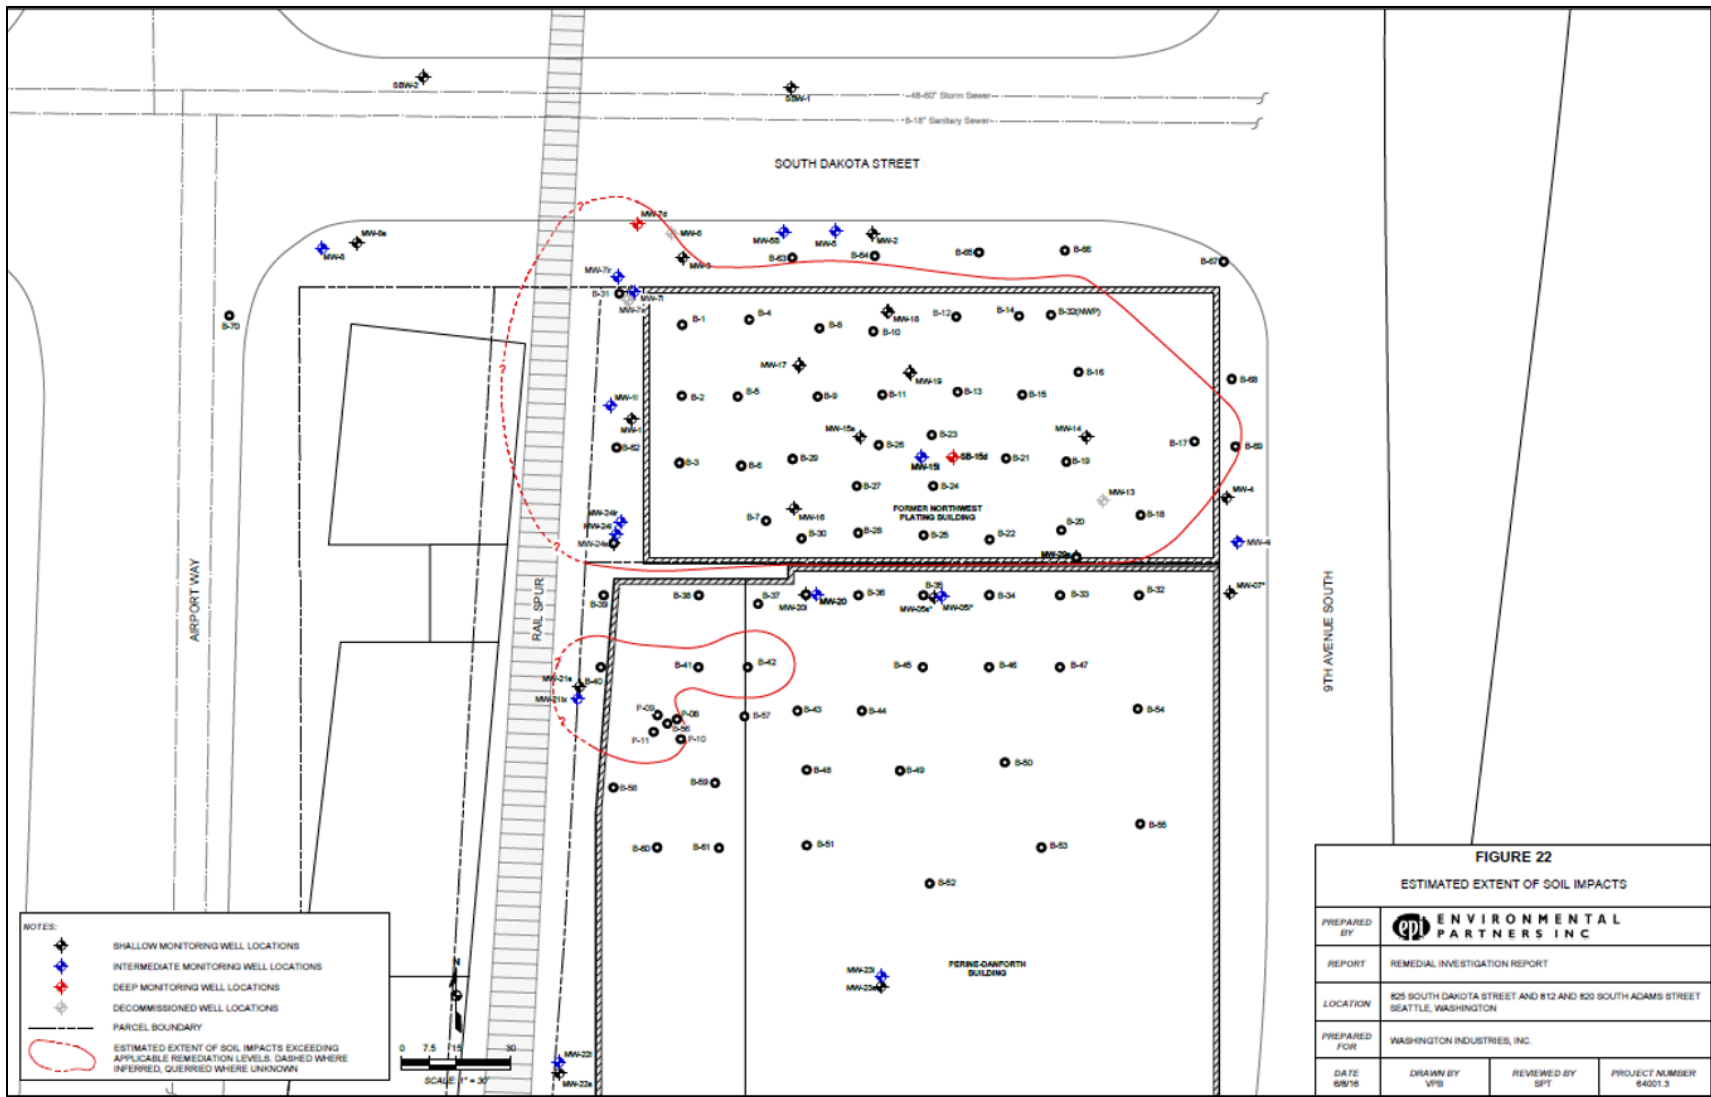
of VOC contamination (see figures), primarily TCE. For soil, the area of contamination with the highest concentrations was located in the south-central portion of the Property. This area has been the target of an interim remedial action, described in more detail below. A plume of contaminated groundwater was defined beginning on the Property near the highly contaminated soil area, extending northwest in the direction of groundwater flow, and then extending to the west along South Dakota Street.

Figure 4. Area of chlorinated solvent contaminated soil at the time of the Remedial Investigation report (2016).

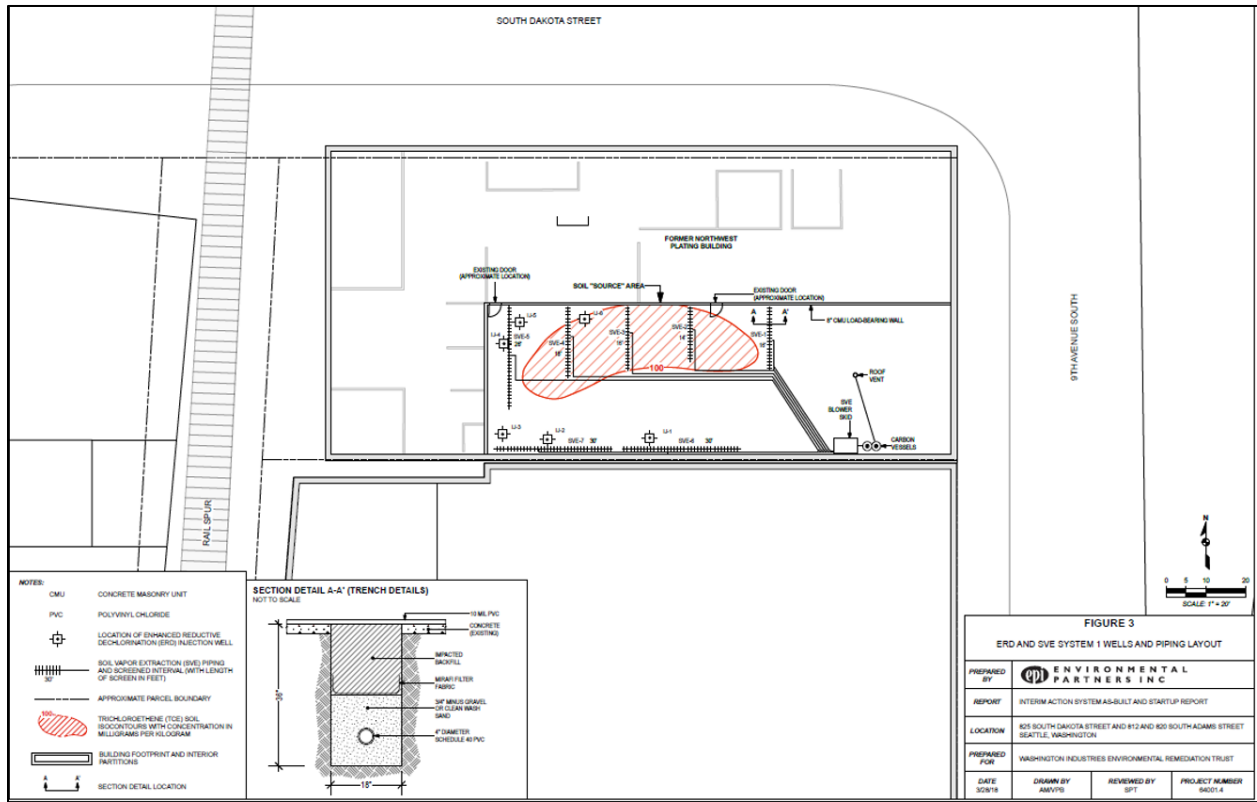
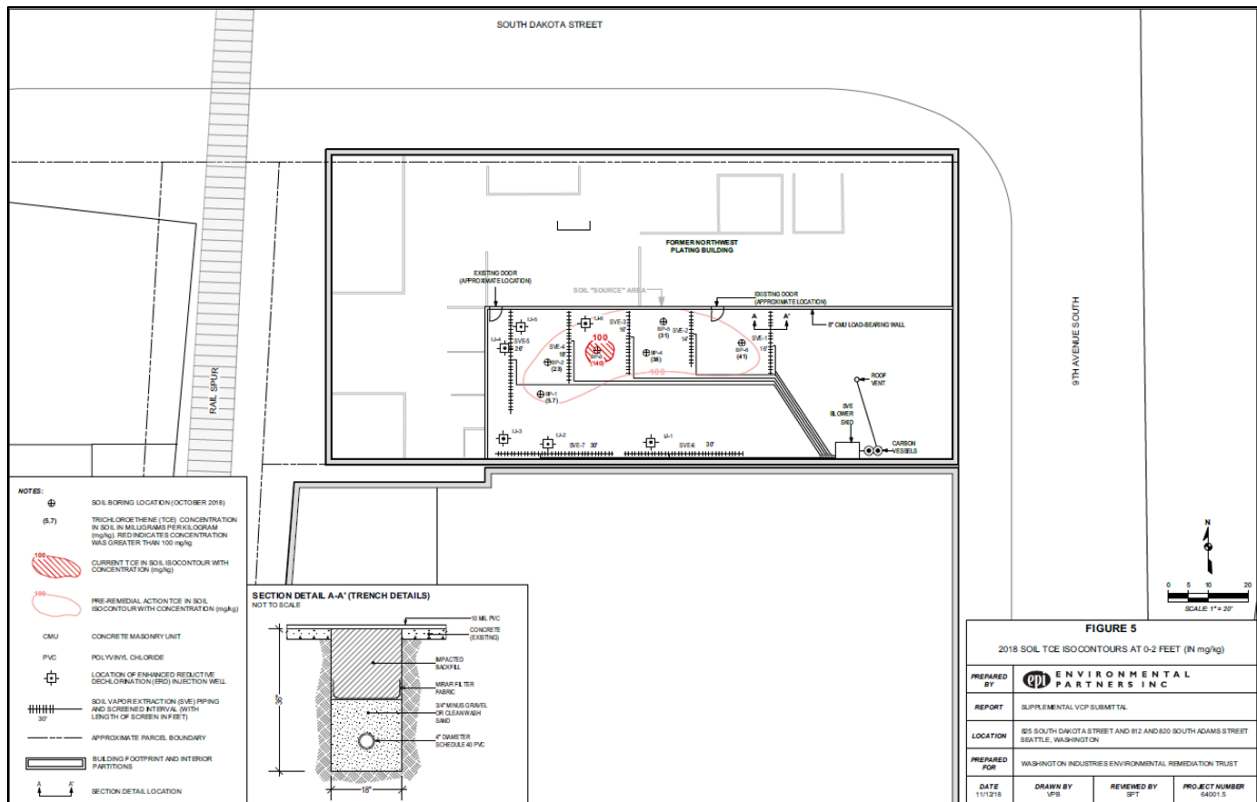
The interim remedial action has been successful in decreasing VOC concentrations in soil and groundwater near the "source" zone (see Figures 5 and 6). Interim actions have also decreased hexavalent chromium concentrations in groundwater. Groundwater monitoring occurs in a subset of monitoring wells every 3 months. The SVE system is currently in operation, and effluent is sampled monthly for VOCs. Effluent concentrations are used to confirm that emissions do not need to be permitted by the Puget Sound Clean Air Agency and to determine contaminant mass removal rate. The SVE system removed an estimated 167 pounds of VOCs between May 2017 and February 2019.

**Figure 5.** Area of highest soil concentration of chlorinated solvents ("source" zone) before beginning interim remedial actions (top) and in October 2018 (bottom), after the SVE system had been in use for approximately 16 months.

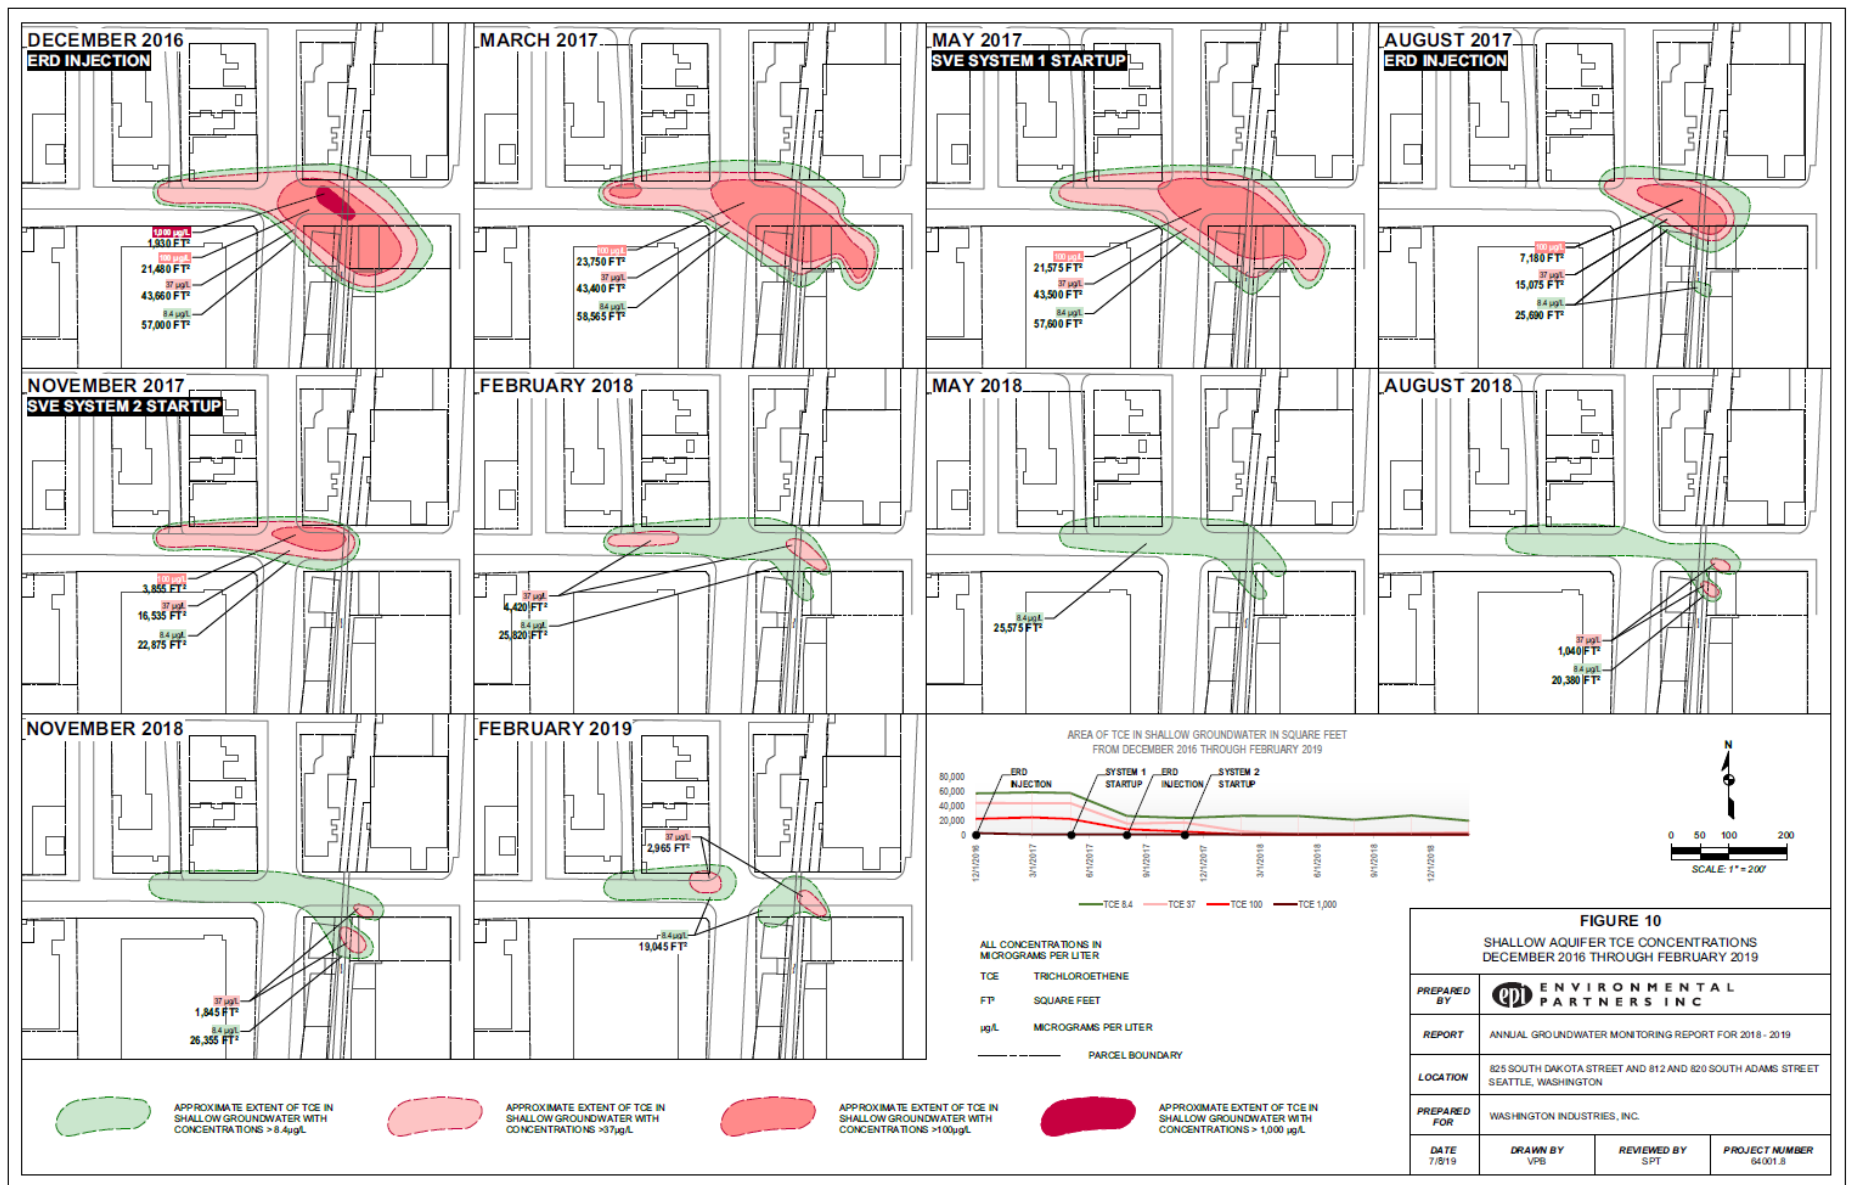
**Figure 6.** Area of groundwater contamination with chlorinated solvents prior to beginning of interim remedial actions (December 2016) and as determined from results of quarterly monitoring events since that time.

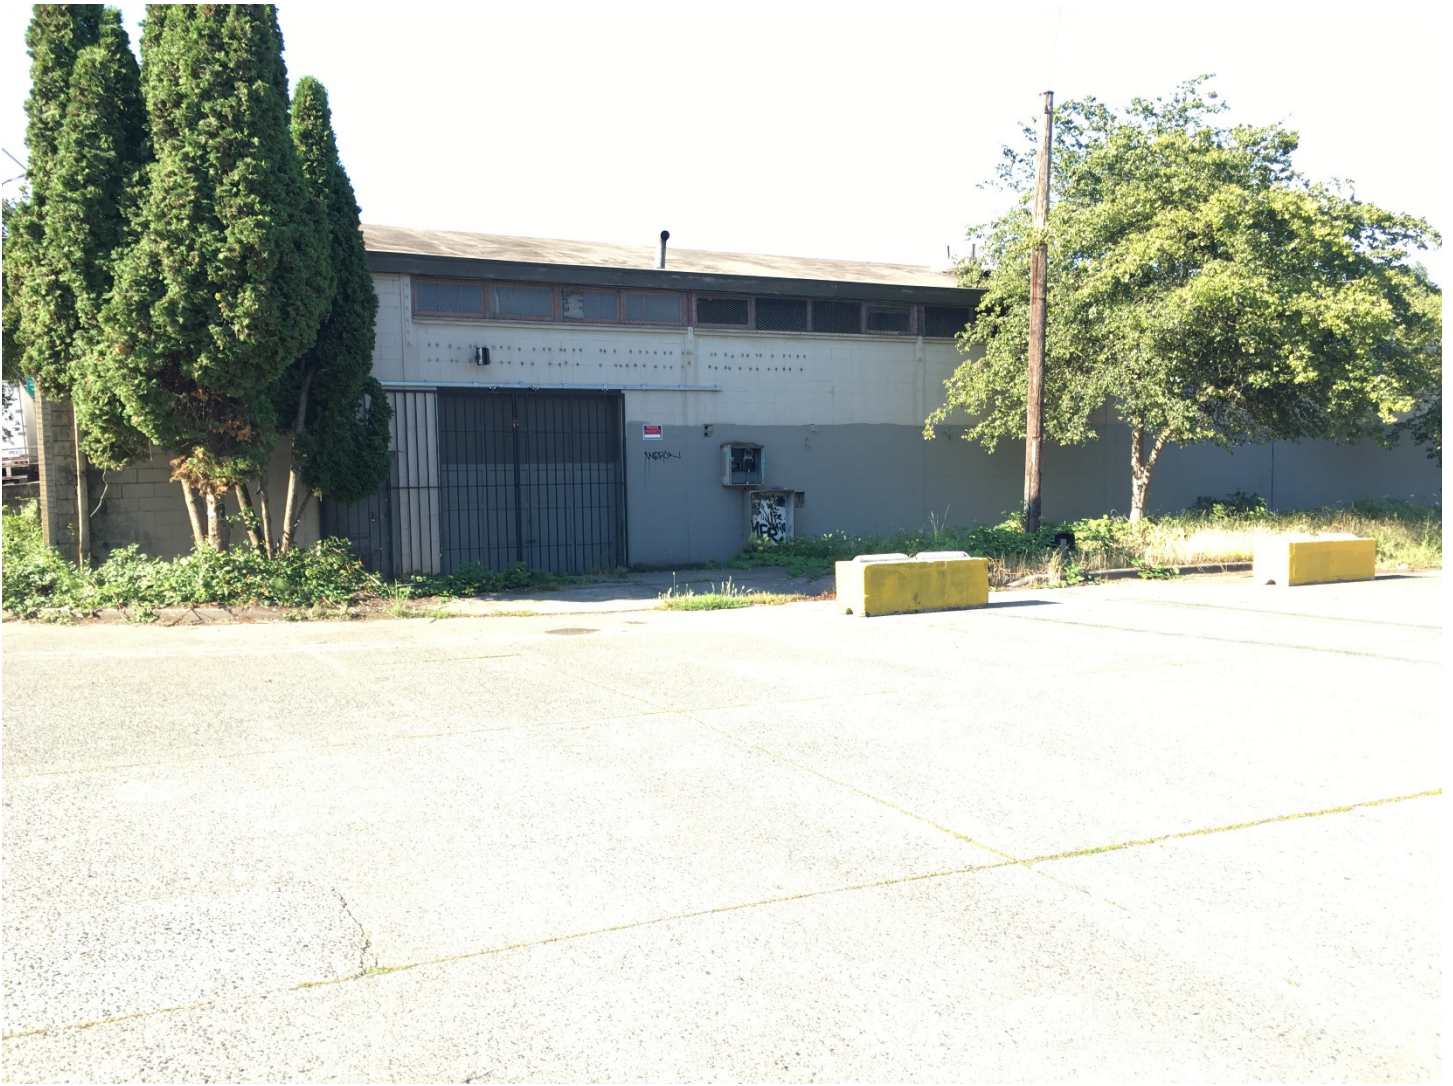
The assessor visited the Site on July 29, 2019. Conditions observed were consistent with those described in site reports.

**Figure 7.** Photo taken during 7/29/19 site visit. East end of the north side of the former Northwest Plating building.
