**APPENDIX E**  
**Hazardous Building Material Survey**

## Regulated Building Materials Survey

### Port of Anacortes Quiet Cove Site

**Date Prepared: 04/24/2019**

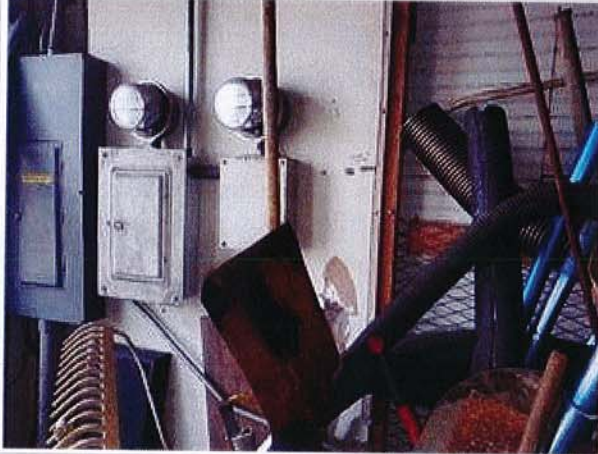
Sample			
<b>Project Name</b>	Port of Anacortes Quite Cove Site		
<b>Sample Type</b>	Physical Sample	<b>AHERA Category</b>	Miscellaneous
<b>Sample Number</b>	1	<b>Homogenous Material Number</b>	1
<b>Material Description</b>	Sheetrock (GWB)		
<b>Sample Location</b>	Garage 1, area 1, east wall.		
<b>Quantity</b>	32	<b>Unit of Measure</b>	Square Feet
<b>Asbestos Type/%</b>	<b>None Detected (Both Layers)</b>		
<b>Sample Photo</b>

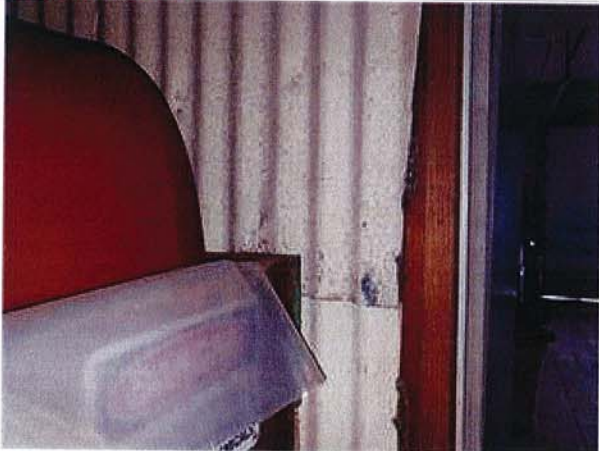
Sample			
<b>Project Name</b>	Port of Anacortes Quite Cove Site		
<b>Sample Type</b>	Physical Sample	<b>AHERA Category</b>	Surfacing
<b>Sample Number</b>	2	<b>Homogenous Material Number</b>	2
<b>Material Description</b>	Coatings On corrugated tin.		
<b>Sample Location</b>	Garage 1, area 2, North wall.		
<b>Quantity</b>	350	<b>Unit of Measure</b>	Square Feet
<b>Asbestos Type/%</b>	<b>Tremolite &lt;1%</b>		
<b>Sample Photo</b>

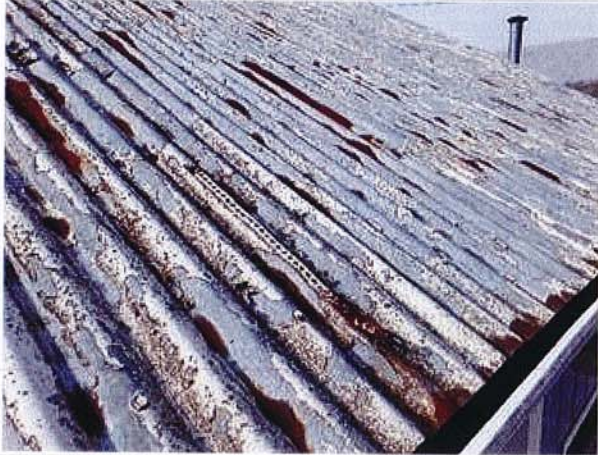
Sample			
<b>Project Name</b>	Port of Anacortes Quite Cove Site		
<b>Sample Type</b>	Physical Sample	<b>AHERA Category</b>	Surfacing
<b>Sample Number</b>	3	<b>Homogenous Material Number</b>	3
<b>Material Description</b>	Coatings On corrugated tin roof.		
<b>Sample Location</b>	Garage 1 roof.		
<b>Quantity</b>	1180	<b>Unit of Measure</b>	Square Feet
<b>Asbestos Type/%</b>	None Detected.		
<b>Sample Photo</b>

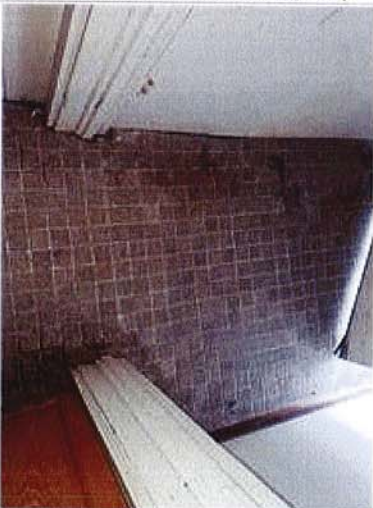
Sample			
<b>Project Name</b>	Port of Anacortes Quite Cove Site		
<b>Sample Type</b>	Physical Sample	<b>AHERA Category</b>	Miscellaneous
<b>Sample Number</b>	4	<b>Homogenous Material Number</b>	4
<b>Material Description</b>	Flooring sheet vinyl		
<b>Sample Location</b>	Garage 1, bathroom floor.		
<b>Quantity</b>	36	<b>Unit of Measure</b>	Square Feet
<b>Asbestos Type/%</b>	None Detected (Both Layers)		
<b>Sample Photo</b>

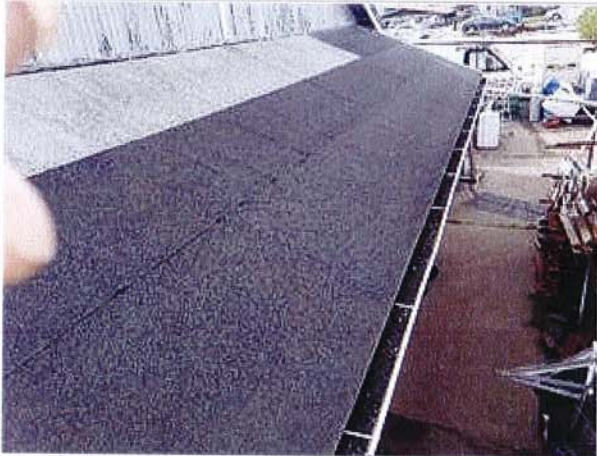
Sample			
<b>Project Name</b>	Port of Anacortes Quite Cove Site		
<b>Sample Type</b>	Physical Sample	<b>AHERA Category</b>	Miscellaneous
<b>Sample Number</b>	5	<b>Homogenous Material Number</b>	5
<b>Material Description</b>	Waterproofing felt		
<b>Sample Location</b>	Garage 1, at shed roof.		
<b>Quantity</b>	300	<b>Unit of Measure</b>	Square Feet
<b>Asbestos Type/%</b>	None Detected.		
<b>Sample Photo</b>

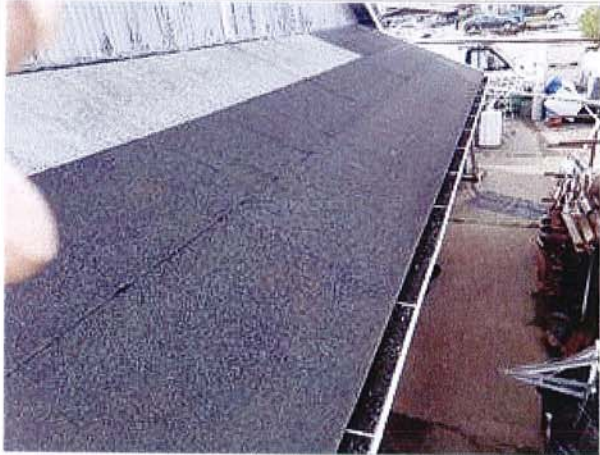
Sample			
<b>Project Name</b>	Port of Anacortes Quite Cove Site		
<b>Sample Type</b>	Physical Sample	<b>AHERA Category</b>	Miscellaneous
<b>Sample Number</b>	6	<b>Homogenous Material Number</b>	6
<b>Material Description</b>	rolled roofing		
<b>Sample Location</b>	Garage 1, at shed roof.		
<b>Quantity</b>	300	<b>Unit of Measure</b>	Square Feet
<b>Asbestos Type/%</b>	None Detected.		
<b>Sample Photo</b>

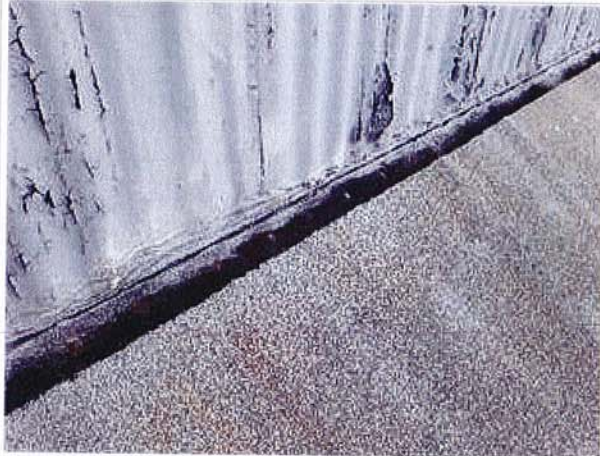
Sample			
<b>Project Name</b>	Port of Anacortes Quite Cove Site		
<b>Sample Type</b>	Physical Sample	<b>AHERA Category</b>	Miscellaneous
<b>Sample Number</b>	7	<b>Homogenous Material Number</b>	7
<b>Material Description</b>	Putty / caulk		
<b>Sample Location</b>	Garage 1, at shed roof to corrugated wall penetration.		
<b>Quantity</b>	30	<b>Unit of Measure</b>	Lineal Feet
<b>Asbestos Type/%</b>	<b>Chrysotile 7-10%</b>		
<b>Sample Photo</b>

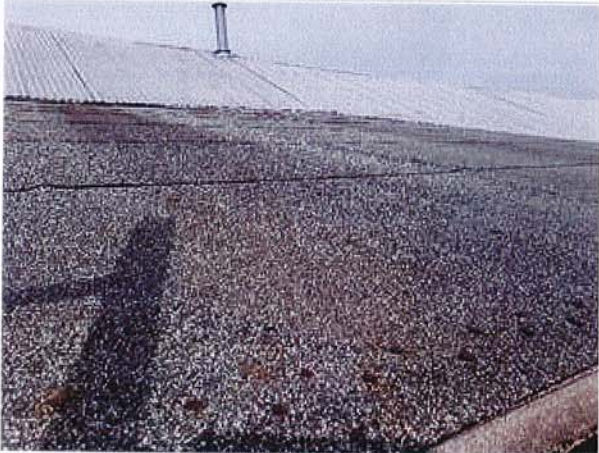
Sample			
<b>Project Name</b>	Port of Anacortes Quite Cove Site		
<b>Sample Type</b>	Physical Sample	<b>AHERA Category</b>	Miscellaneous
<b>Sample Number</b>	8	<b>Homogenous Material Number</b>	8
<b>Material Description</b>	rolled roofing		
<b>Sample Location</b>	Garage 2 roof.		
<b>Quantity</b>	370	<b>Unit of Measure</b>	Square Feet
<b>Asbestos Type/%</b>	<b>None Detected (Both Layers)</b>		
<b>Sample Photo</b>

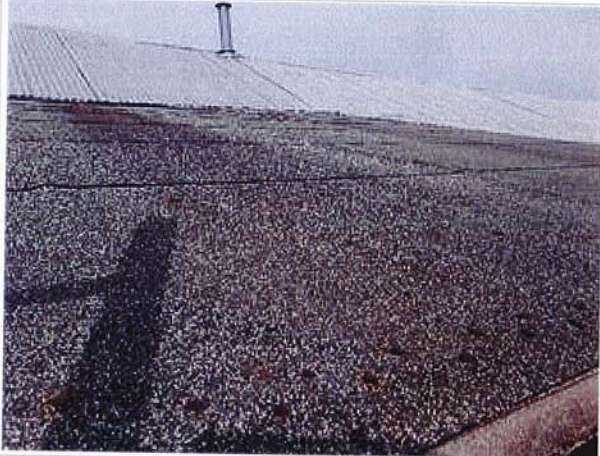
Sample			
<b>Project Name</b>	Port of Anacortes Quite Cove Site		
<b>Sample Type</b>	Physical Sample	<b>AHERA Category</b>	Miscellaneous
<b>Sample Number</b>	9	<b>Homogenous Material Number</b>	9
<b>Material Description</b>	Waterproofing felt		
<b>Sample Location</b>	Garage 2 roof.		
<b>Quantity</b>	370	<b>Unit of Measure</b>	Square Feet
<b>Asbestos Type/%</b>	<b>None Detected.</b>		
<b>Sample Photo</b>

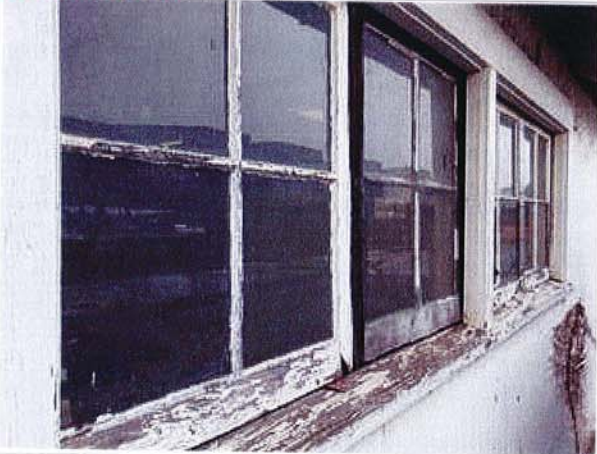
Sample			
<b>Project Name</b>	Port of Anacortes Quite Cove Site		
<b>Sample Type</b>	Physical Sample	<b>AHERA Category</b>	Miscellaneous
<b>Sample Number</b>	10	<b>Homogenous Material Number</b>	10
<b>Material Description</b>	Window Putty		
<b>Sample Location</b>	Garage 2 west exterior.		
<b>Quantity</b>	8 windows at 2ft x 2ft	<b>Unit of Measure</b>	Each
<b>Asbestos Type/%</b>	<b>Tremolite &lt;1%</b>		
<b>Sample Photo</b>

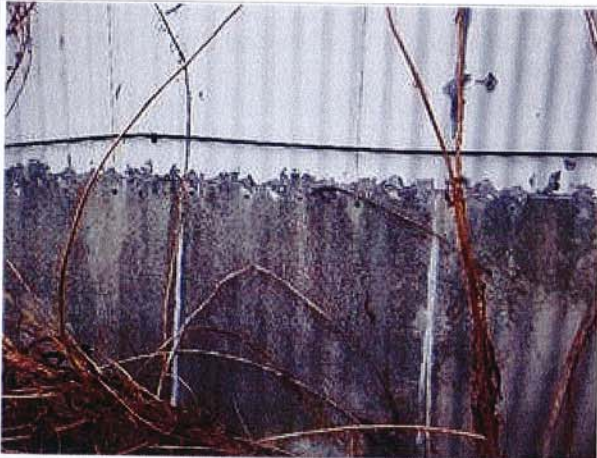
Sample			
<b>Project Name</b>	Port of Anacortes Quite Cove Site		
<b>Sample Type</b>	Physical Sample	<b>AHERA Category</b>	Miscellaneous
<b>Sample Number</b>	11	<b>Homogenous Material Number</b>	11
<b>Material Description</b>	Putty / caulk		
<b>Sample Location</b>	Garage 2, at west exterior, at corrugated tin to fiberglass seam, of wall.		
<b>Quantity</b>	50	<b>Unit of Measure</b>	Lineal Feet
<b>Asbestos Type/%</b>	<b>None Detected.</b>		
<b>Sample Photo</b>

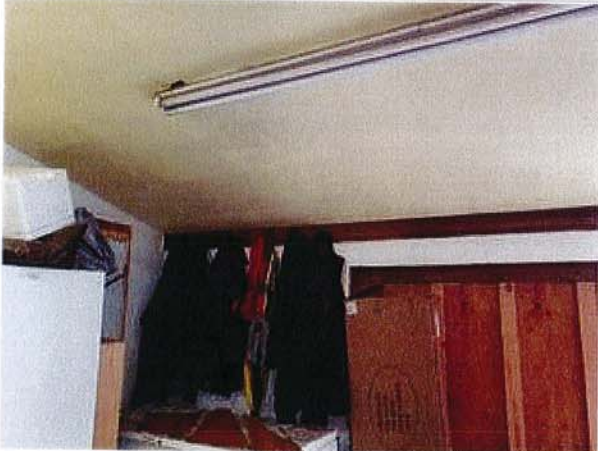
Sample			
<b>Project Name</b>	Port of Anacortes Quite Cove Site		
<b>Sample Type</b>	Physical Sample	<b>AHERA Category</b>	Surfacing
<b>Sample Number</b>	12	<b>Homogenous Material Number</b>	12
<b>Material Description</b>	Texture on GWB		
<b>Sample Location</b>	Garage 2, coat storage area, ceiling.		
<b>Quantity</b>	190	<b>Unit of Measure</b>	Square Feet
<b>Asbestos Type/%</b>	<b>None Detected (Both Layers)</b>		
<b>Sample Photo</b>

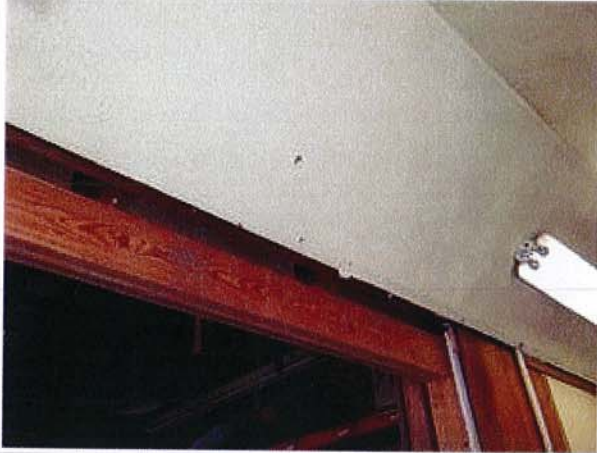
Sample			
<b>Project Name</b>	Port of Anacortes Quite Cove Site		
<b>Sample Type</b>	Physical Sample	<b>AHERA Category</b>	Surfacing
<b>Sample Number</b>	13	<b>Homogenous Material Number</b>	12
<b>Material Description</b>	Texture on GWB		
<b>Sample Location</b>	Garage 2, at coat storage area, ceiling.		
<b>Quantity</b>	See sample 12 for total quantity.	<b>Unit of Measure</b>	Square Feet
<b>Asbestos Type/%</b>	<b>None Detected (Both Layers)</b>		
<b>Sample Photo</b>

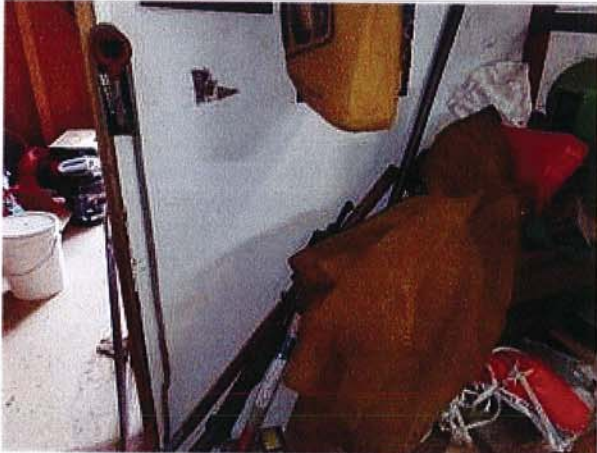
Sample			
<b>Project Name</b>	Port of Anacortes Quite Cove Site		
<b>Sample Type</b>	Physical Sample	<b>AHERA Category</b>	Miscellaneous
<b>Sample Number</b>	14	<b>Homogenous Material Number</b>	13
<b>Material Description</b>	Gypsum Wall Board/Tape/Joint Compound		
<b>Sample Location</b>	Garage 2, east wall.		
<b>Quantity</b>	400	<b>Unit of Measure</b>	
<b>Asbestos Type/%</b>	<b>None Detected (All Layers)</b>		
<b>Sample Photo</b>

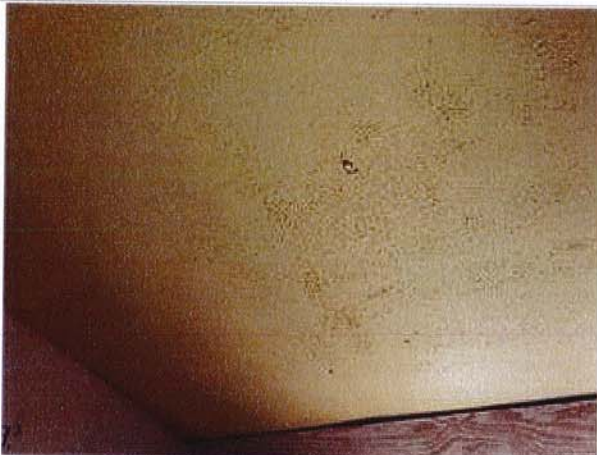
Sample			
<b>Project Name</b>	Port of Anacortes Quite Cove Site		
<b>Sample Type</b>	Physical Sample	<b>AHERA Category</b>	Surfacing
<b>Sample Number</b>	15	<b>Homogenous Material Number</b>	14
<b>Material Description</b>	Texture on GWB		
<b>Sample Location</b>	Office 1 ceiling.		
<b>Quantity</b>	250	<b>Unit of Measure</b>	Square Feet
<b>Asbestos Type/%</b>	<b>None Detected (Both Layers)</b>		
<b>Sample Photo</b>

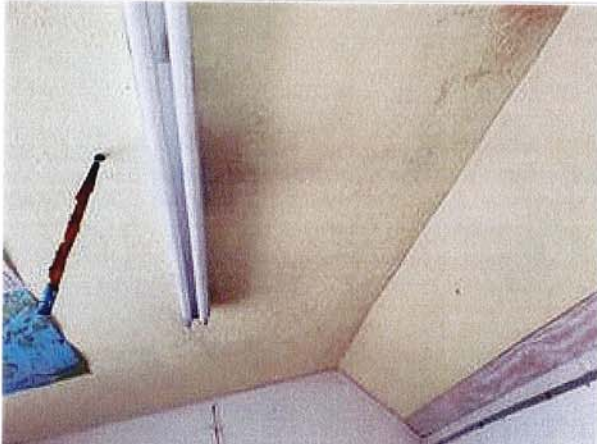
Sample			
<b>Project Name</b>	Port of Anacortes Quite Cove Site		
<b>Sample Type</b>	Physical Sample	<b>AHERA Category</b>	Surfacing
<b>Sample Number</b>	16	<b>Homogenous Material Number</b>	14
<b>Material Description</b>	Texture on GWB		
<b>Sample Location</b>	Office 1, ceiling.		
<b>Quantity</b>	See sample 15 for total quantity.	<b>Unit of Measure</b>	Square Feet
<b>Asbestos Type/%</b>	<b>None Detected (All Layers)</b>		
<b>Sample Photo</b>

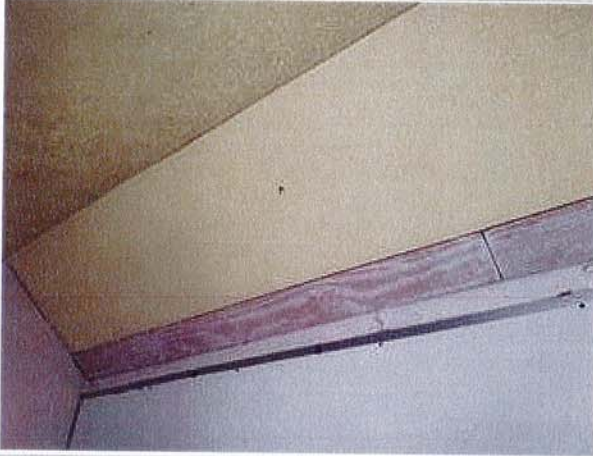
Sample			
<b>Project Name</b>	Port of Anacortes Quite Cove Site		
<b>Sample Type</b>	Physical Sample	<b>AHERA Category</b>	Surfacing
<b>Sample Number</b>	17	<b>Homogenous Material Number</b>	14
<b>Material Description</b>	Texture on GWB		
<b>Sample Location</b>	Office 1, ceiling.		
<b>Quantity</b>	See sample 15 for total quantity.	<b>Unit of Measure</b>	Square Feet
<b>Asbestos Type/%</b>	<b>None Detected (Both Layers)</b>		
<b>Sample Photo</b>

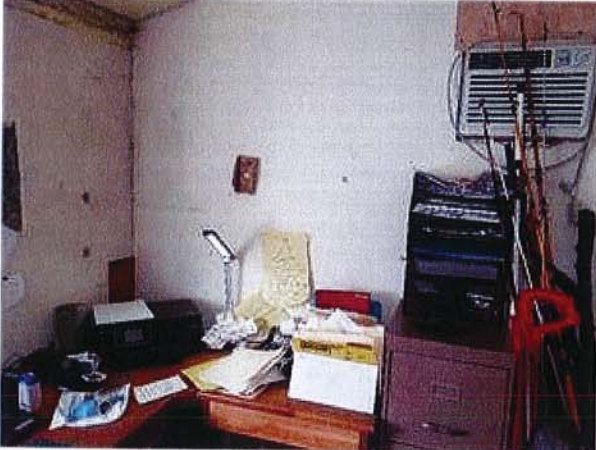
Sample			
<b>Project Name</b>	Port of Anacortes Quite Cove Site		
<b>Sample Type</b>	Physical Sample	<b>AHERA Category</b>	Miscellaneous
<b>Sample Number</b>	18	<b>Homogenous Material Number</b>	15
<b>Material Description</b>	Sheetrock (GWB)		
<b>Sample Location</b>	Office 1, south wall.		
<b>Quantity</b>	400	<b>Unit of Measure</b>	Square Feet
<b>Asbestos Type/%</b>	<b>None Detected.</b>		
<b>Sample Photo</b>

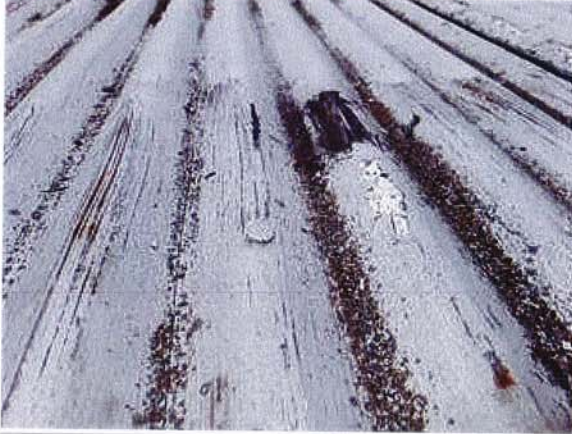
Sample			
<b>Project Name</b>	Port of Anacortes Quite Cove Site		
<b>Sample Type</b>	Physical Sample	<b>AHERA Category</b>	Surfacing
<b>Sample Number</b>	19	<b>Homogenous Material Number</b>	16
<b>Material Description</b>	Coatings silver on black.		
<b>Sample Location</b>	On roof corrugated tin of office 1 entry.		
<b>Quantity</b>	7000	<b>Unit of Measure</b>	Square Feet
<b>Asbestos Type/%</b>	<b>Layer 1 (Silver coating): None Detected.</b> <b>Layer 2 (Black mastic): Chrysotile 10-15%</b>		
<b>Sample Photo</b>

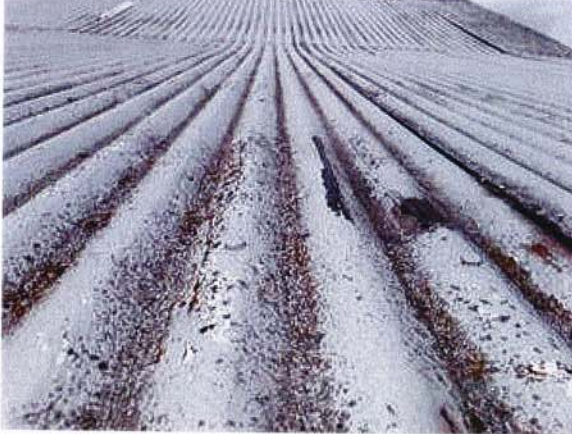
Sample			
<b>Project Name</b>	Port of Anacortes Quite Cove Site		
<b>Sample Type</b>	Physical Sample	<b>AHERA Category</b>	Surfacing
<b>Sample Number</b>	20	<b>Homogenous Material Number</b>	16
<b>Material Description</b>	Coatings silver on black.		
<b>Sample Location</b>	At front door entry of office 2 roof corrugated tin.		
<b>Quantity</b>	See sample 19 for total quantity.	<b>Unit of Measure</b>	Square Feet
<b>Asbestos Type/%</b>	<b>Layer 1 (Silver coating): None Detected.</b> <b>Layer 2 (Black mastic): Chrysotile 3-5%</b>		
<b>Sample Photo</b>

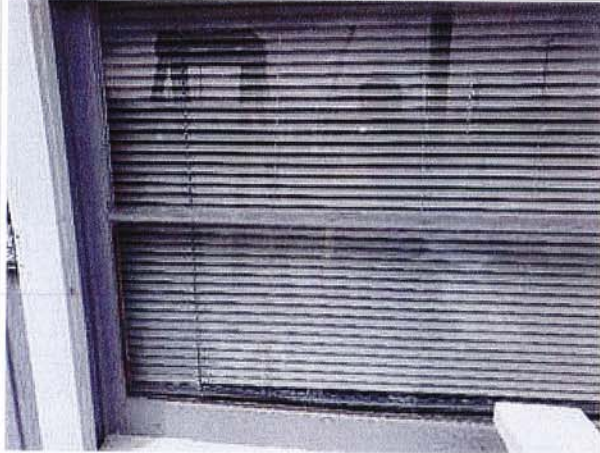
Sample			
<b>Project Name</b>	Port of Anacortes Quite Cove Site		
<b>Sample Type</b>	Physical Sample	<b>AHERA Category</b>	Miscellaneous
<b>Sample Number</b>	21	<b>Homogenous Material Number</b>	17
<b>Material Description</b>	Window Putty		
<b>Sample Location</b>	Office 2, to the right of front entry.		
<b>Quantity</b>	One window at 4' by 5'	<b>Unit of Measure</b>	Each
<b>Asbestos Type/%</b>	<b>Layer 1 (Putty): Tremolite &lt;1%</b> <b>Layer 2 (Substrate): None Detected.</b>		
<b>Sample Photo</b>

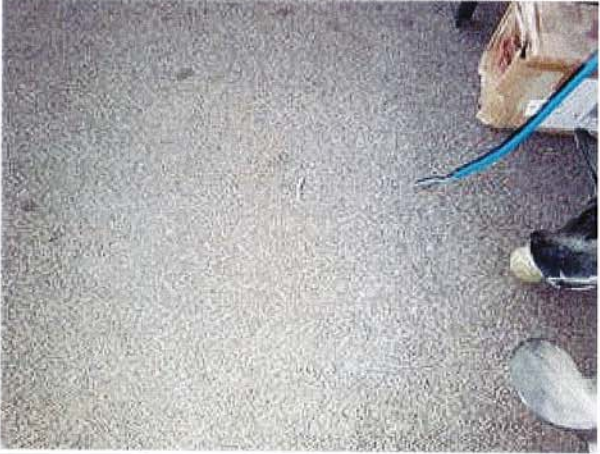
Sample			
<b>Project Name</b>	Port of Anacortes Quite Cove Site		
<b>Sample Type</b>	Physical Sample	<b>AHERA Category</b>	Miscellaneous
<b>Sample Number</b>	22	<b>Homogenous Material Number</b>	18
<b>Material Description</b>	Carpet Mastic		
<b>Sample Location</b>	Office 2 floor.		
<b>Quantity</b>	285	<b>Unit of Measure</b>	Square Feet
<b>Asbestos Type/%</b>	<b>None Detected.</b>		
<b>Sample Photo</b>

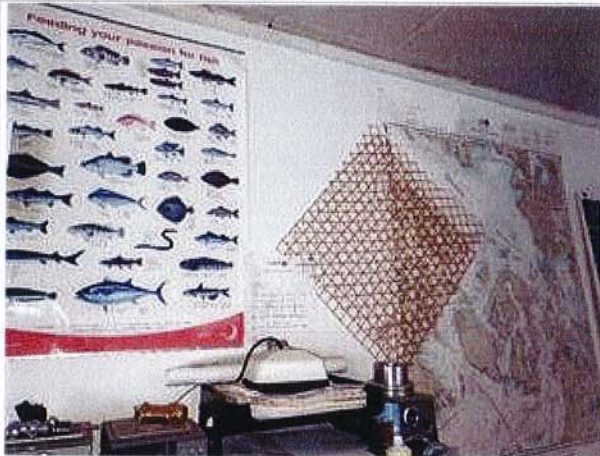
Sample			
<b>Project Name</b>	Port of Anacortes Quite Cove Site		
<b>Sample Type</b>	Physical Sample	<b>AHERA Category</b>	Miscellaneous
<b>Sample Number</b>	23	<b>Homogenous Material Number</b>	19
<b>Material Description</b>	Sheetrock (GWB)		
<b>Sample Location</b>	Office 2, south wall.		
<b>Quantity</b>	480	<b>Unit of Measure</b>	Square Feet
<b>Asbestos Type/%</b>	None Detected.		
<b>Sample Photo</b>

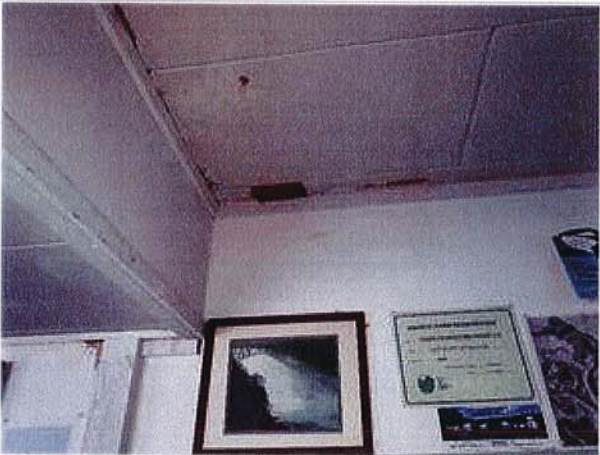
Sample			
<b>Project Name</b>	Port of Anacortes Quite Cove Site		
<b>Sample Type</b>	Physical Sample	<b>AHERA Category</b>	Miscellaneous
<b>Sample Number</b>	24	<b>Homogenous Material Number</b>	20
<b>Material Description</b>	Ceiling tile, 31 inch by 16 inch .		
<b>Sample Location</b>	Office 2 ceiling.		
<b>Quantity</b>	285	<b>Unit of Measure</b>	Square Feet
<b>Asbestos Type/%</b>	None Detected.		
<b>Sample Photo</b>

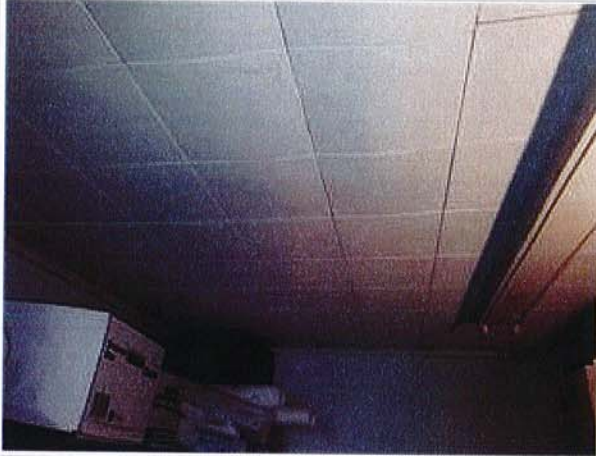
Sample			
<b>Project Name</b>	Port of Anacortes Quite Cove Site		
<b>Sample Type</b>	Physical Sample	<b>AHERA Category</b>	Miscellaneous
<b>Sample Number</b>	25	<b>Homogenous Material Number</b>	21
<b>Material Description</b>	Ceiling tile 12" x 12"		
<b>Sample Location</b>	Office 2 ,storage Room ceiling.		
<b>Quantity</b>	160	<b>Unit of Measure</b>	Square Feet
<b>Asbestos Type/%</b>	None Detected.		
<b>Sample Photo</b>

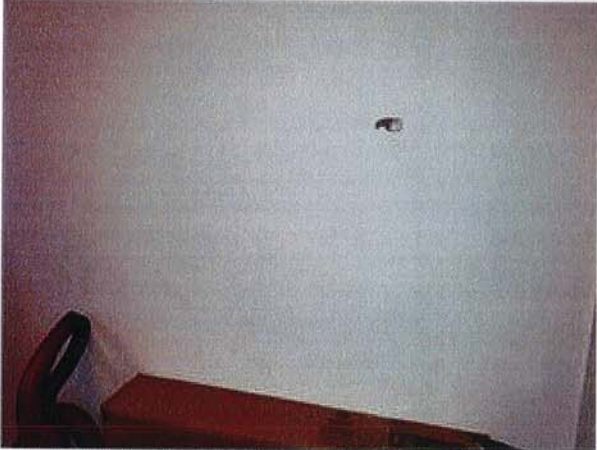
Sample			
<b>Project Name</b>	Port of Anacortes Quite Cove Site		
<b>Sample Type</b>	Physical Sample	<b>AHERA Category</b>	Miscellaneous
<b>Sample Number</b>	26	<b>Homogenous Material Number</b>	22
<b>Material Description</b>	Sheetrock (GWB)		
<b>Sample Location</b>	Office 2 storage area East wall.		
<b>Quantity</b>	300	<b>Unit of Measure</b>	Square Feet
<b>Asbestos Type/%</b>	None Detected.		
<b>Sample Photo</b>

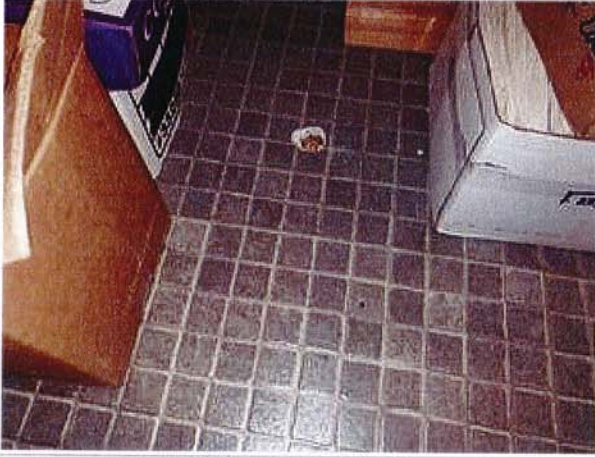
Sample			
<b>Project Name</b>	Port of Anacortes Quite Cove Site		
<b>Sample Type</b>	Physical Sample	<b>AHERA Category</b>	Miscellaneous
<b>Sample Number</b>	27	<b>Homogenous Material Number</b>	23
<b>Material Description</b>	Flooring sheet vinyl, 2 inseparable layers.		
<b>Sample Location</b>	Office 2 storage Room floor.		
<b>Quantity</b>	160	<b>Unit of Measure</b>	Square Feet
<b>Asbestos Type/%</b>	Layers 1-4: None Detected. <b>Layer 5 (White backing): Chrysotile 35-40%</b> Layers 6-7: None Detected.		
<b>Sample Photo</b>

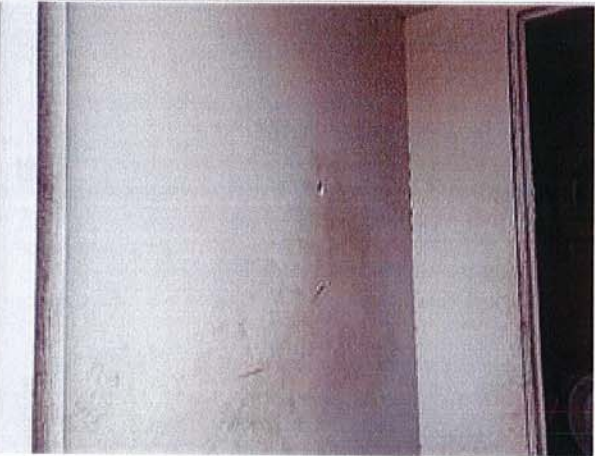
Sample			
<b>Project Name</b>	Port of Anacortes Quite Cove Site		
<b>Sample Type</b>	Physical Sample	<b>AHERA Category</b>	Miscellaneous
<b>Sample Number</b>	28	<b>Homogenous Material Number</b>	24
<b>Material Description</b>	Sheetrock (GWB)		
<b>Sample Location</b>	Garage 1, bathroom, north wall.		
<b>Quantity</b>	120	<b>Unit of Measure</b>	Square Feet
<b>Asbestos Type/%</b>	<b>None Detected.</b>		
<b>Sample Photo</b>

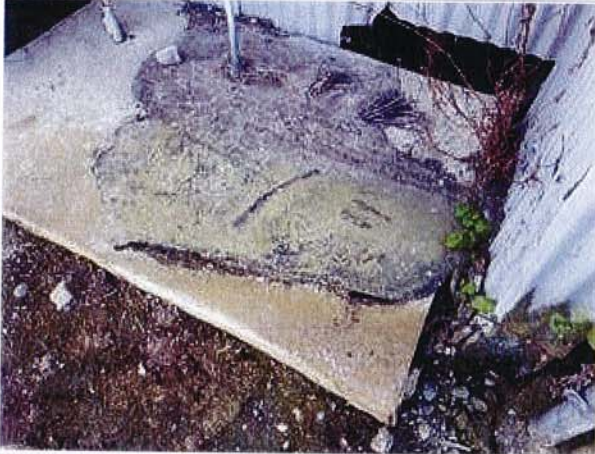
Sample			
<b>Project Name</b>	Port of Anacortes Quite Cove Site		
<b>Sample Type</b>	Physical Sample	<b>AHERA Category</b>	Miscellaneous
<b>Sample Number</b>	29	<b>Homogenous Material Number</b>	25
<b>Material Description</b>	Roofing tar		
<b>Sample Location</b>	At the North West corner of office 2, on cement slab.		
<b>Quantity</b>	16	<b>Unit of Measure</b>	Square Feet
<b>Asbestos Type/%</b>	<b>Chrysotile 1-3%</b>		
<b>Sample Photo</b>

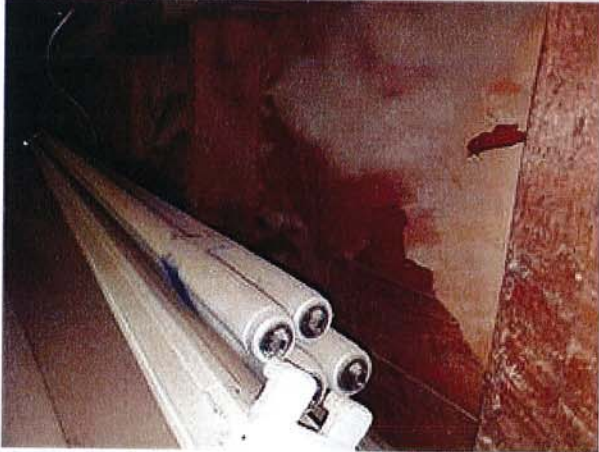
Sample			
<b>Project Name</b>	Port of Anacortes Quite Cove Site		
<b>Sample Type</b>	Physical Sample	<b>AHERA Category</b>	Miscellaneous
<b>Sample Number</b>	30	<b>Homogenous Material Number</b>	26
<b>Material Description</b>	Vapor Barrier brown brittle.		
<b>Sample Location</b>	Around the top of the outside of the ceiling of office 2.		
<b>Quantity</b>	200	<b>Unit of Measure</b>	Square Feet
<b>Asbestos Type/%</b>	<b>None Detected.</b>		
<b>Sample Photo</b>
