Subject: Second Quarter 2019 Progress Report, Southwest Harbor Project Remediation Areas 1, 2, 3, and 5 Ecology Facility/Site Numbers 2384, 2385, 2127, and 2383

Semiannual Inspection of T-5 Ecology-Lead Sites

2019 Mid-Year Inspection

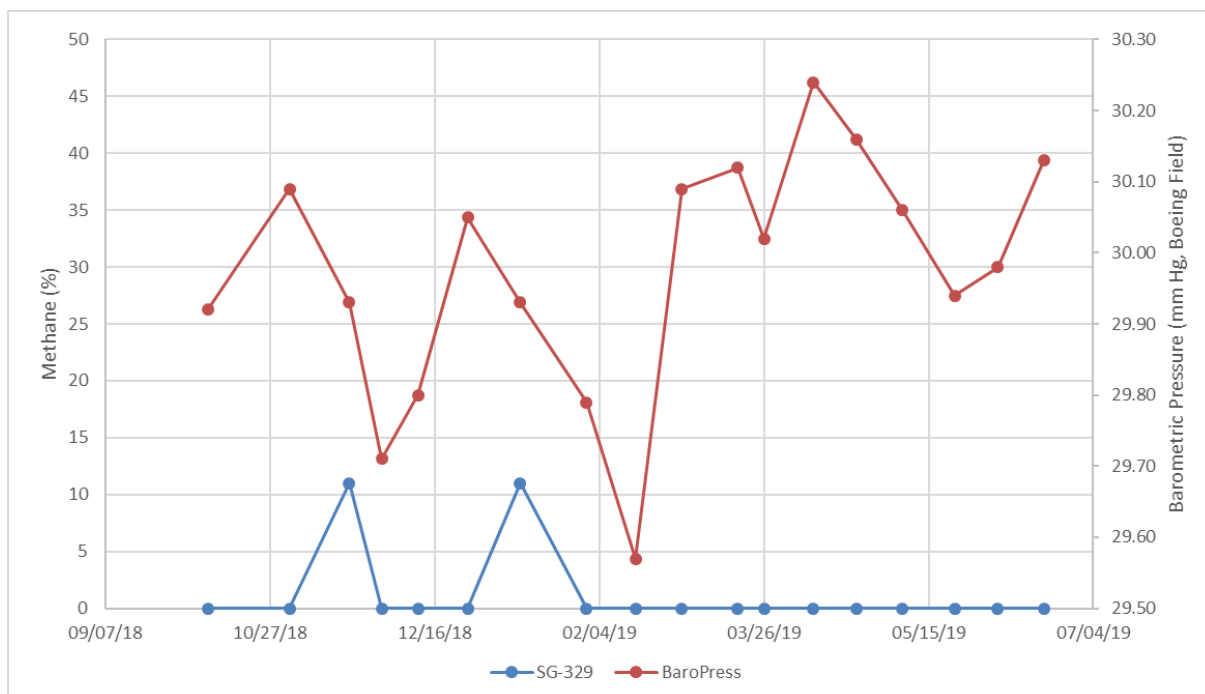
In order to evaluate a potential relationship between barometric pressure and methane detections in soil gas, we compared time-series methane concentrations in SG-329 and barometric pressure records from Boeing Field. Inspection of the graphs (see below) indicates that the two detections did not occur during periods of particularly low (or high) barometric pressure and does not indicate any clear relationship.

We believe that the two methane detections in SG-329 may have been the result a carryover effect from monitoring SG-329 shortly after monitoring high-methane-level sampling ports within the gas collection system. We have modified our field sampling protocol so as to monitor the off-site soil vapor probes first before monitoring the high-level ports in the gas collection system and to make sure the instrument is adequately flushed and zeroed before each location.

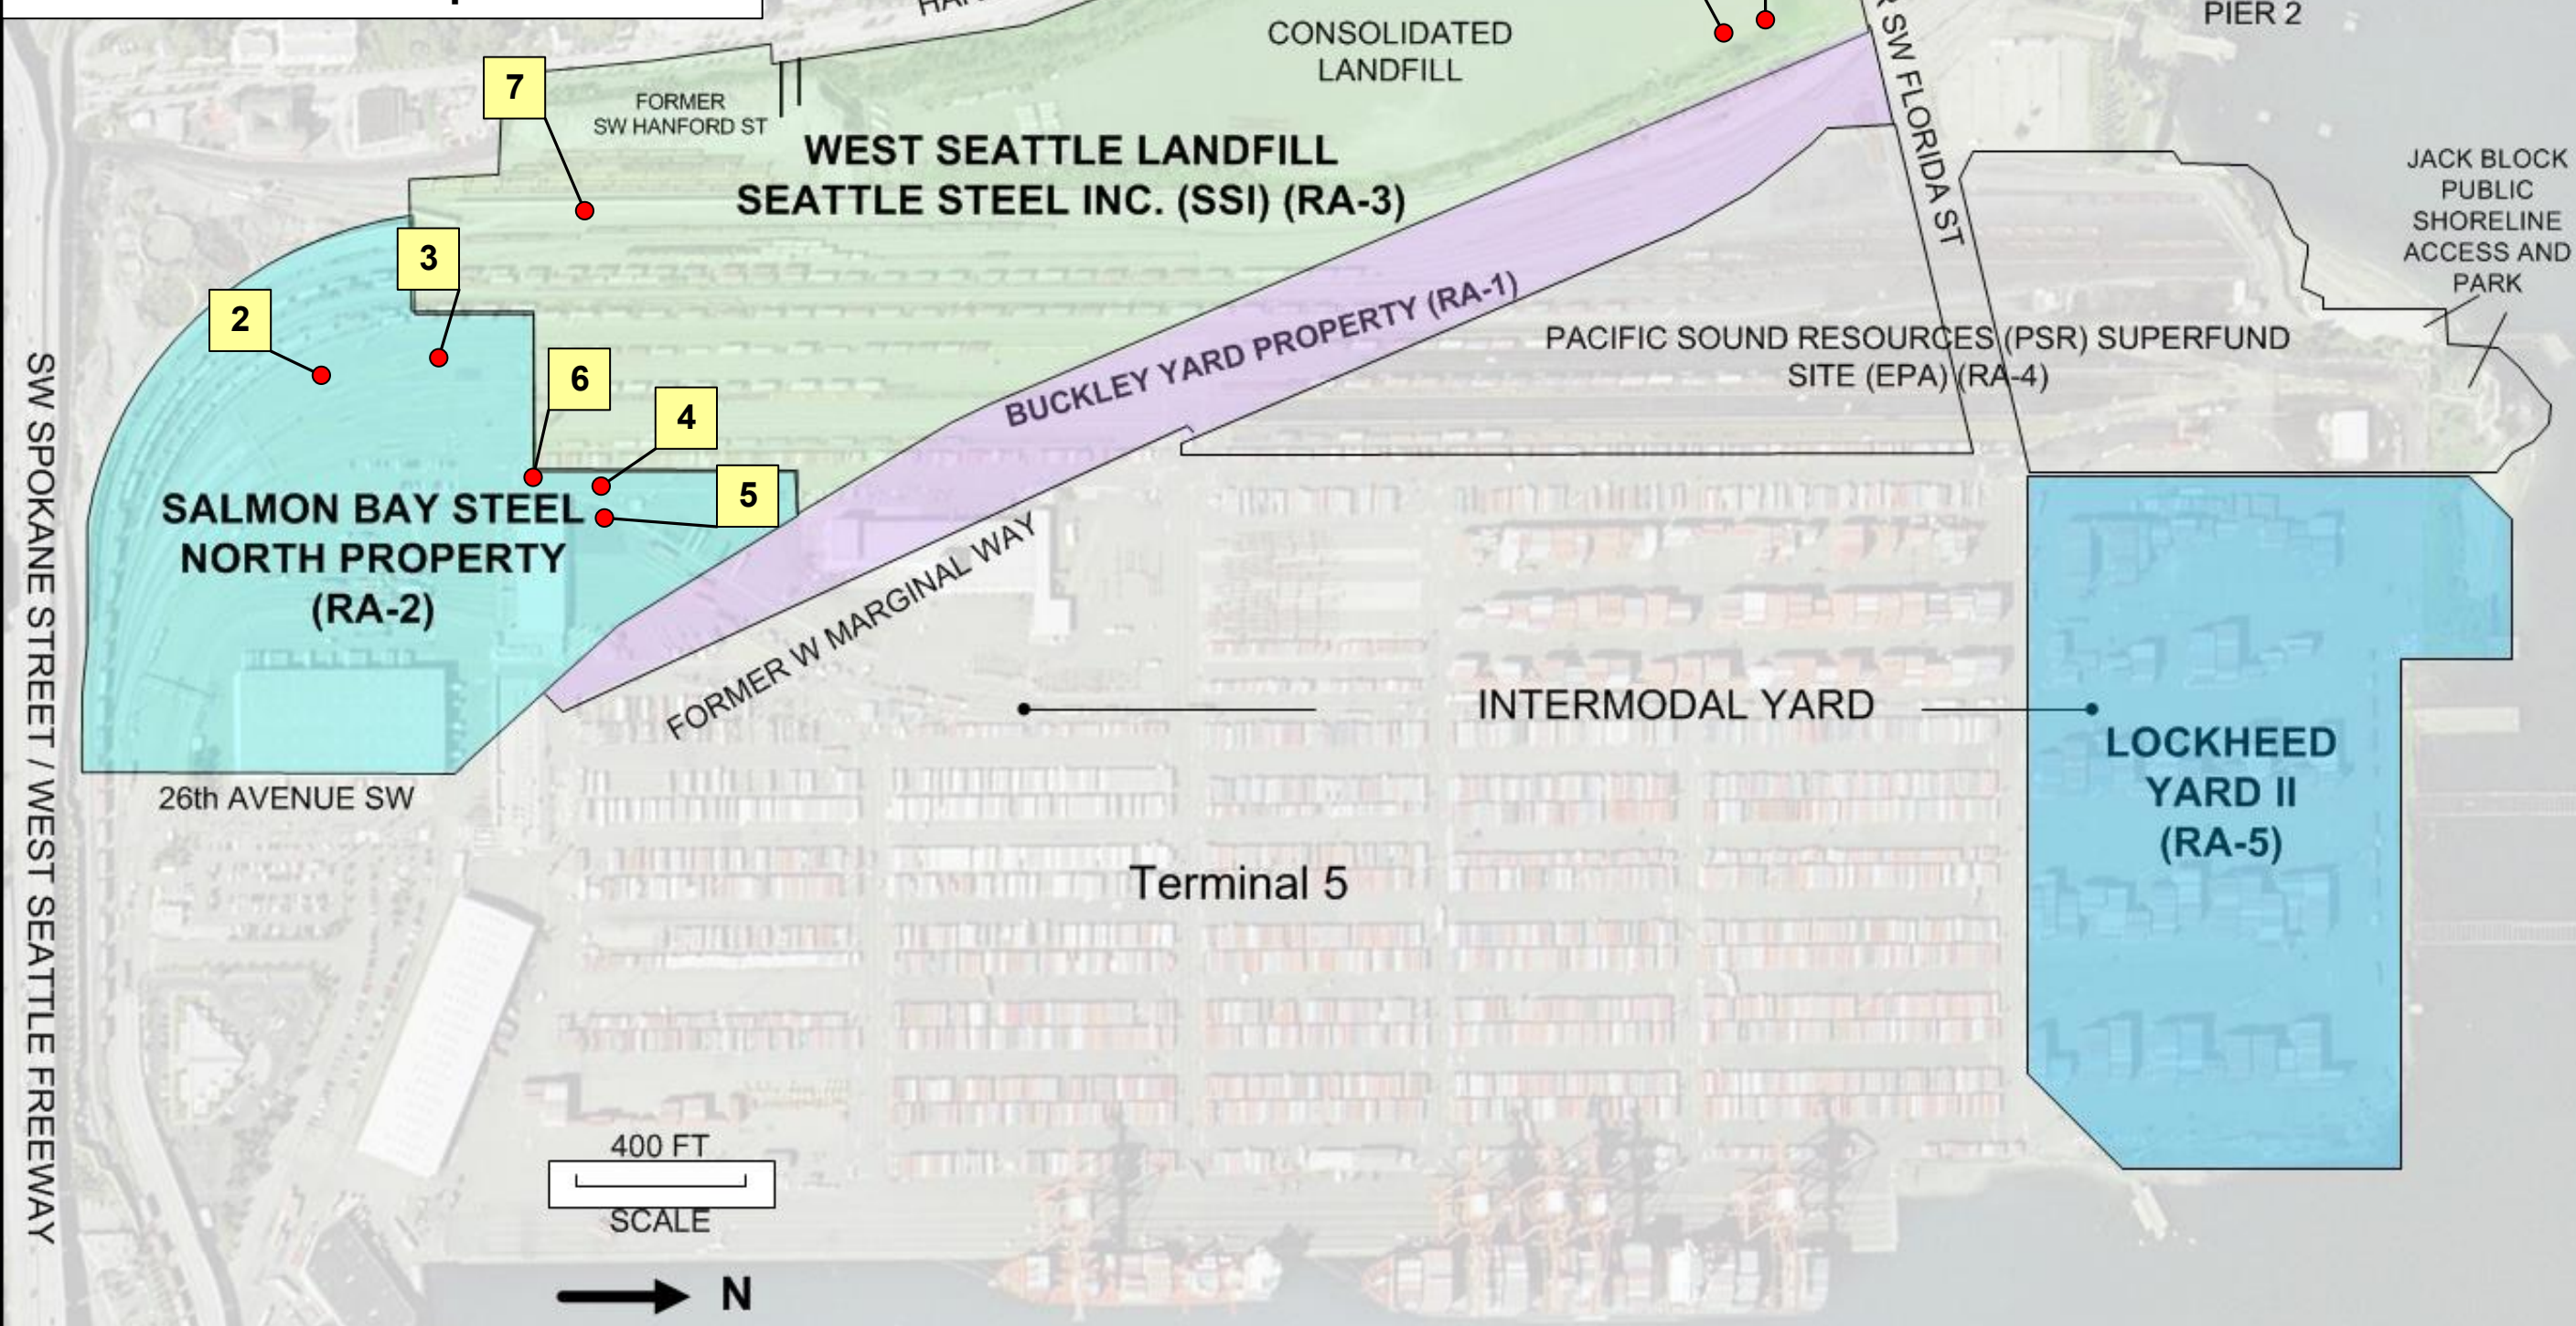
Terminal 5 Ecology-lead remediation areas –
Locations of observations noted in report

Notes: 1. Hole in fence on west side of consolidated landfill
2. Vegetation growth near south rail gate
3. Vegetation growth near south rail gate

4. Pavement mounding with cracks wider than ¼ in.
5. Pavement mounding with cracks wider than ¼ in.
6. Pavement deterioration

7. Potholes in BNSF access road
8. Area cleared of vegetation and covered with loose soil
9. Area of cleared vegetation covered with loose soil

Condition Noted	Map (Attachment 1) reference	Recommendation
Vegetation growth near terminal entrance, RA-2	2, 3	Remove vegetation from these location and from throughout RA-2 during maintenance. Check during future inspections.
Elongated pavement mounding with cracks wider than ¼ in., RA-2	4	Evaluate and repair prior to new tenant occupancy. Clean and seal cracks. Check during future inspections.
Pavement mounding with cracks wider than ¼ in., RA-2	5	Evaluate and repair prior to new tenant occupancy. Clean and seal cracks. Check during future inspections.
Pavement deterioration at interface of lifts at different grades	6	Monitor during future inspections.
Potholes in BNSF access road	7	Monitor. Request BNSF to repair as needed.
Area of cleared vegetation covered with loose soil, east slope of consolidated landfill, RA-3	8, 9	Monitor.

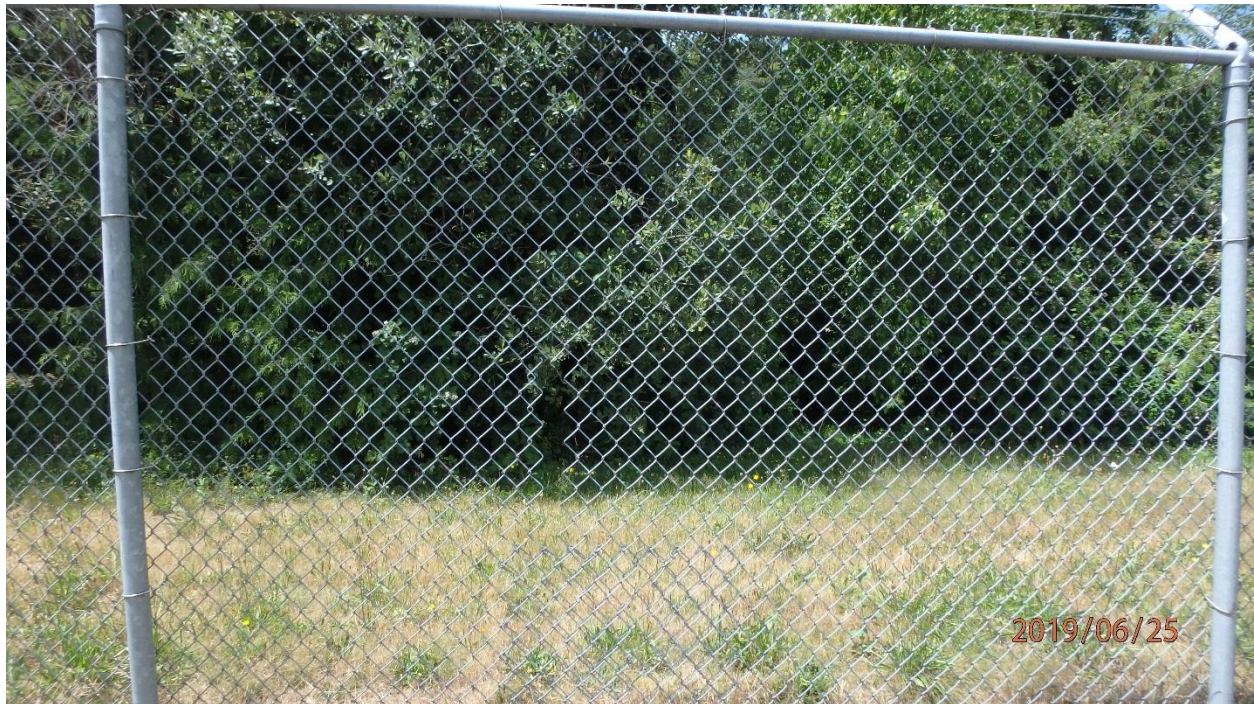
The chain-link security fencing surrounding the consolidated landfill was examined. Most of the vegetation along the fence on the west and south sides of the landfill has been removed, aiding in this inspection. One new hole was observed in the fencing on the west side of the landfill area and should be repaired (Attachment 1: map note 1; Attachment 2; photo 1).

Photo 1. Hole in fence, west side of consolidated landfill: RA-3 (map note 1)

The hole in the fence on the west side of the consolidated landfill should be repaired. The two localized areas of pavement mounding and cracking located in RA-2 should be addressed as described in Section 2.

Condition Noted	Map (Attachment 1) reference	Recommendation
Hole in fence on west side of consolidated landfill	1	Patch hole.

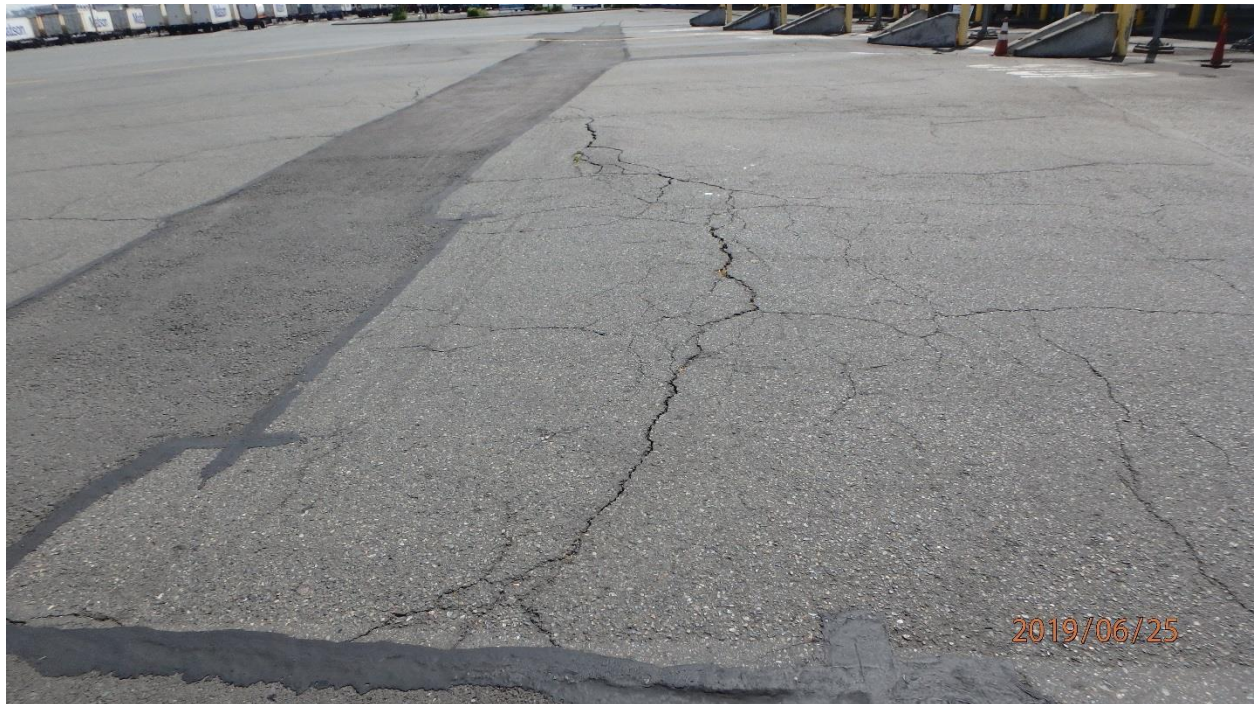
1. Map note 4 (RA-2): The impacted area is approximately 25 × 6 ft (photo 2). The cracks are approximately as wide as 1 in. and as deep as 5 in. (photo 3).
2. Map note 5 (RA-2): This area includes cracking over an area of approximately 15 × 5 ft and mounding over an area of approximately 5 × 5 ft (photo 4). The cracks are as wide as approximately 2 in. (photo 5).

These conditions are localized and do not compromise the overall cap performance. However, these mounding areas are in traffic areas and should be addressed. Near-term (i.e., temporary) sealing of the cracks should also be done to prevent further deterioration in these two locations. The cause of the mounding in the five areas (possibly buried piles or old foundations) should be determined and, if possible, removed.

Photo 2. Elongated mound in pavement with cracks as wide as 1 in.: RA-2 (map note 4)

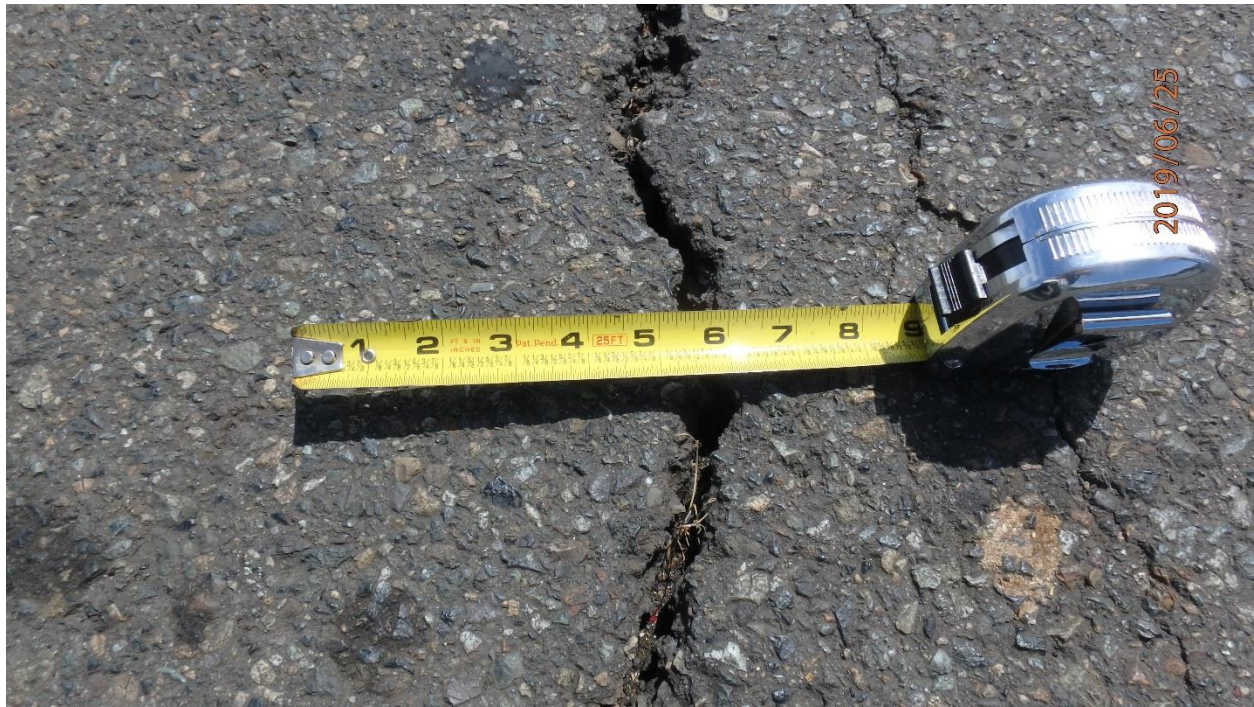
Photo 3. Close up of elongated mound in pavement with cracks as wide as 1 in.: RA-2 (map note 4)

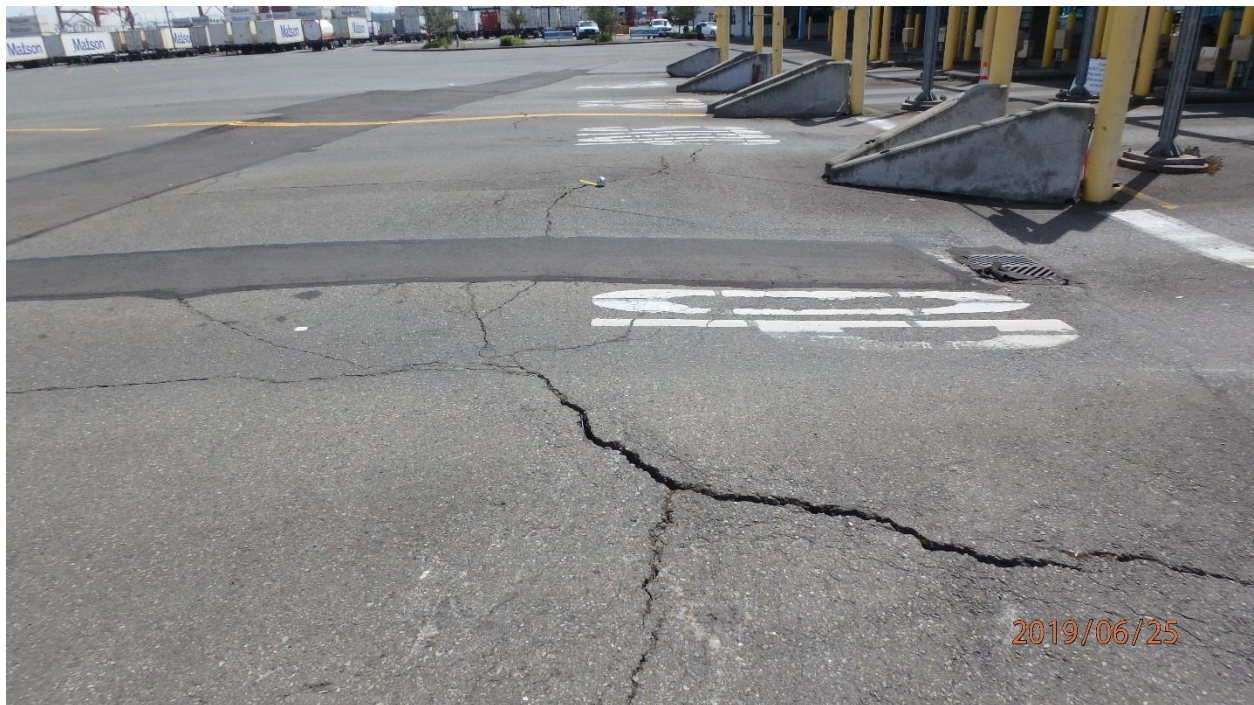
Photo 4. Mound in pavement with cracks as wide as 2 in.: RA-2 (map note 5)

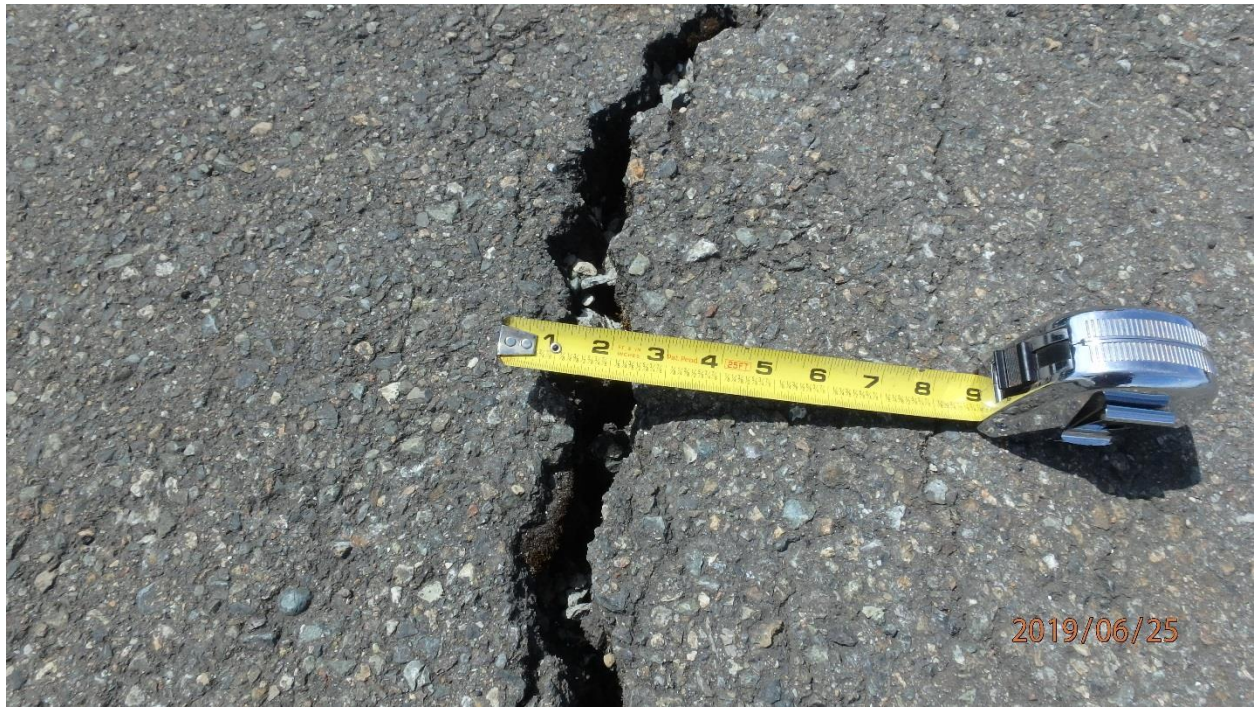
Photo 5. Close-up of mound in pavement with cracks as wide as 2 in.: RA-2 (map note 5)

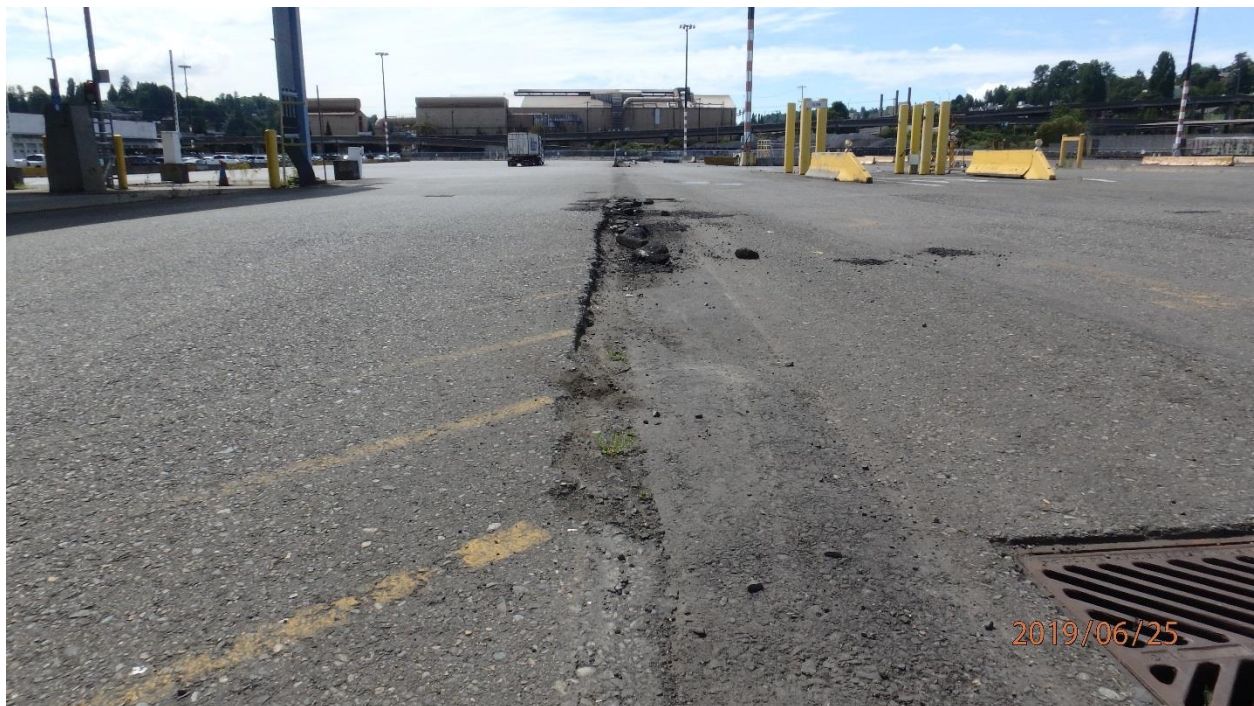
Deterioration was observed at an area of pavement just west of the truck weight scales in RA-2 (map note 6). It appears that Ecology blocks were removed from the area, exposing a

difference in grade between two areas of pavement (photo 6). Underlying material is not exposed; this area should be monitored during future inspections to check for further deterioration or any exposure of underlying material.

Photo 6. Pavement deterioration: RA-2 (map note 6)

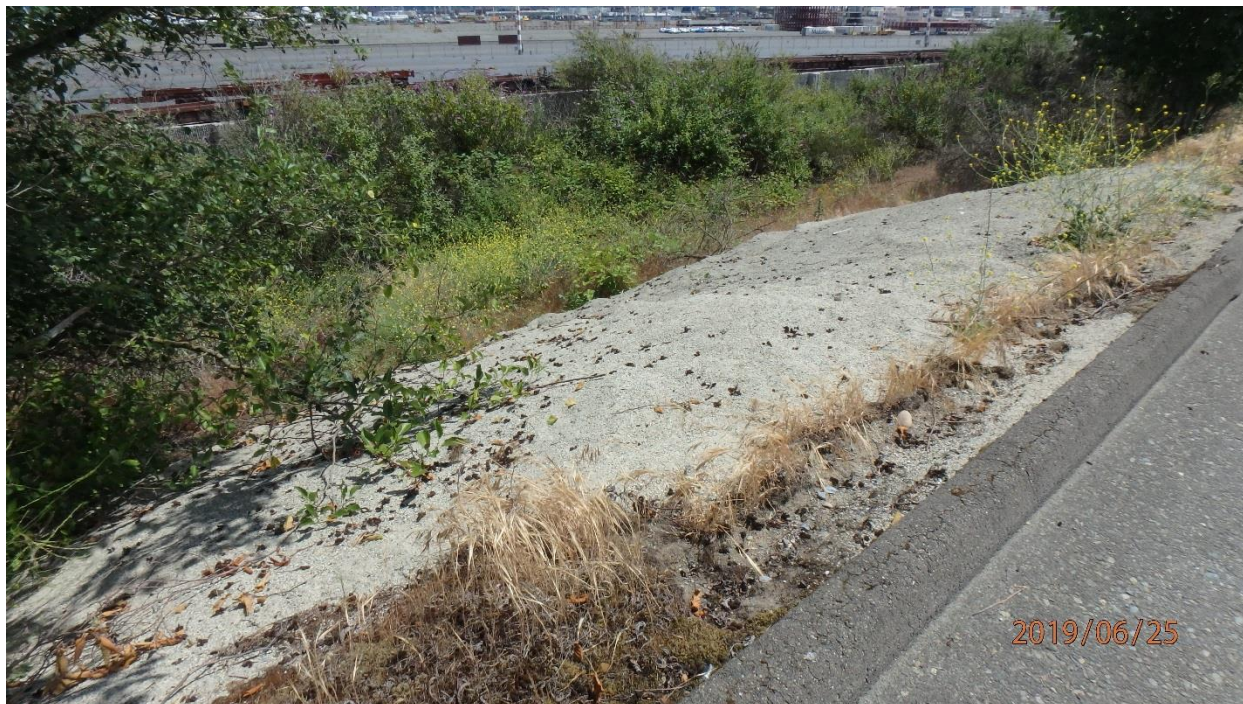
There were no signs of erosion or exposure of the underlying consolidated landfill liner during this inspection. During the 2018 end-of-year inspection, three locations were observed on the eastern side of the landfill from which vegetation had been completely cleared and loose dirt/sand had been placed (2018 end-of-year inspection report, Attachment 1: map notes 17, 18, and 19). Vegetation has re-established in one of these areas. The other two areas remain void of vegetation (map notes 8 and 9). A representative photo of these two areas is included in Attachment 2 (photo 7). These areas have the potential to erode; they should be inspected during future inspections (if not more often). There was no visual evidence that the underlying liner was exposed.

Photo 7. Representative photo of two areas on east landfill slope, cleared of vegetation and covered with loose sandy soil: RA-3 (map notes 8 and 9)
