PERIODIC REVIEW

Former GE-Dawson Facility

**220 South Dawson Street
Seattle, WA 98108**

**WAD 009278706
Facility Site ID #2522
Cleanup Site ID #2446**

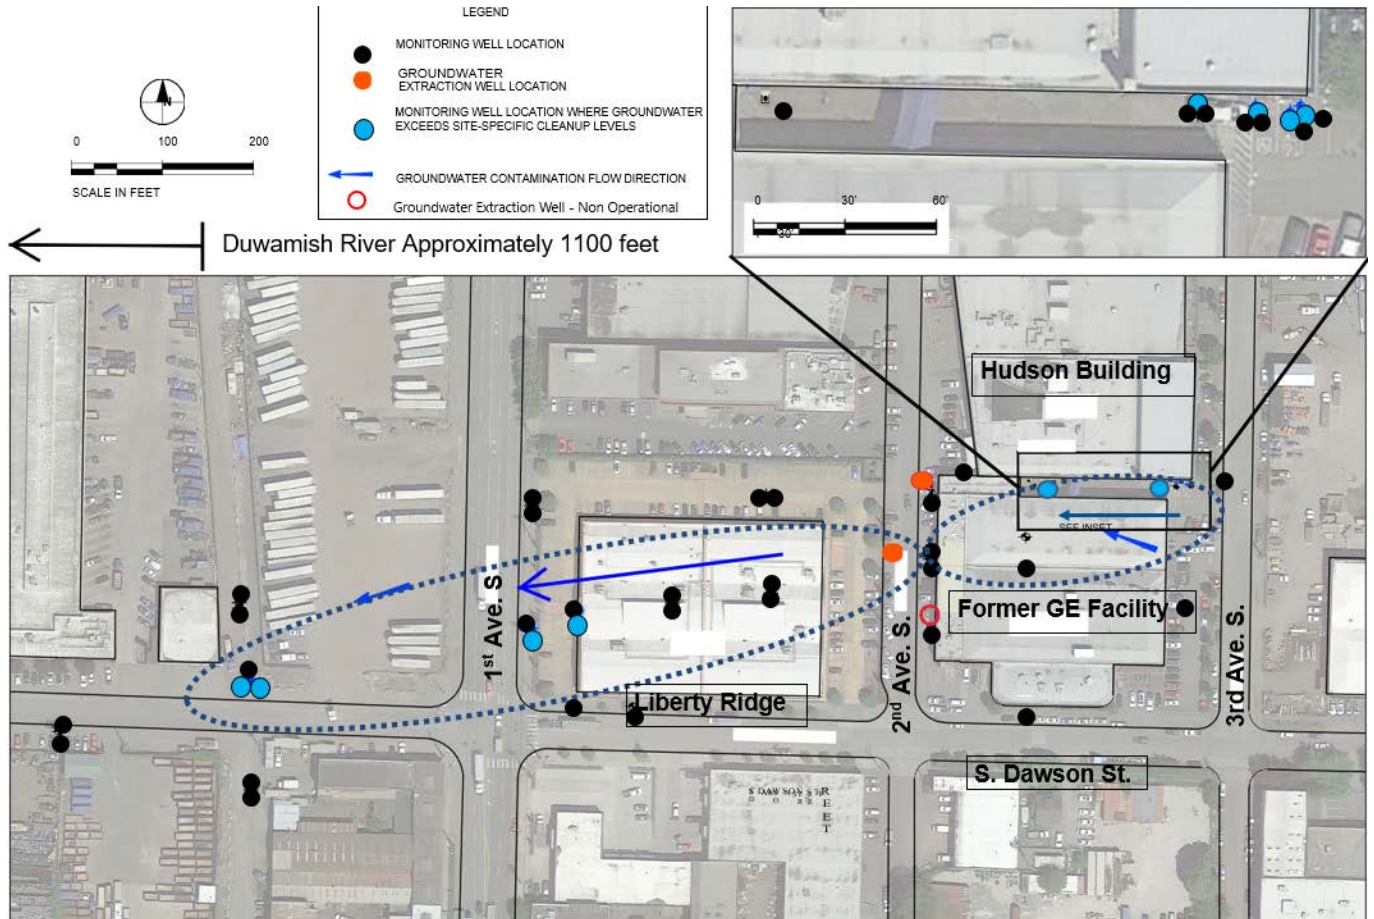
6.3 Groundwater TCE Plume Figure

Interpreted Trichloroethene (TCE) Groundwater Plume as measured at Site monitoring wells. Slightly Diving TCE Groundwater Plume - Shallow TCE groundwater contamination on the 220 S. Dawson Street property and Deeper Zone TCE Groundwater Contamination Off Property.

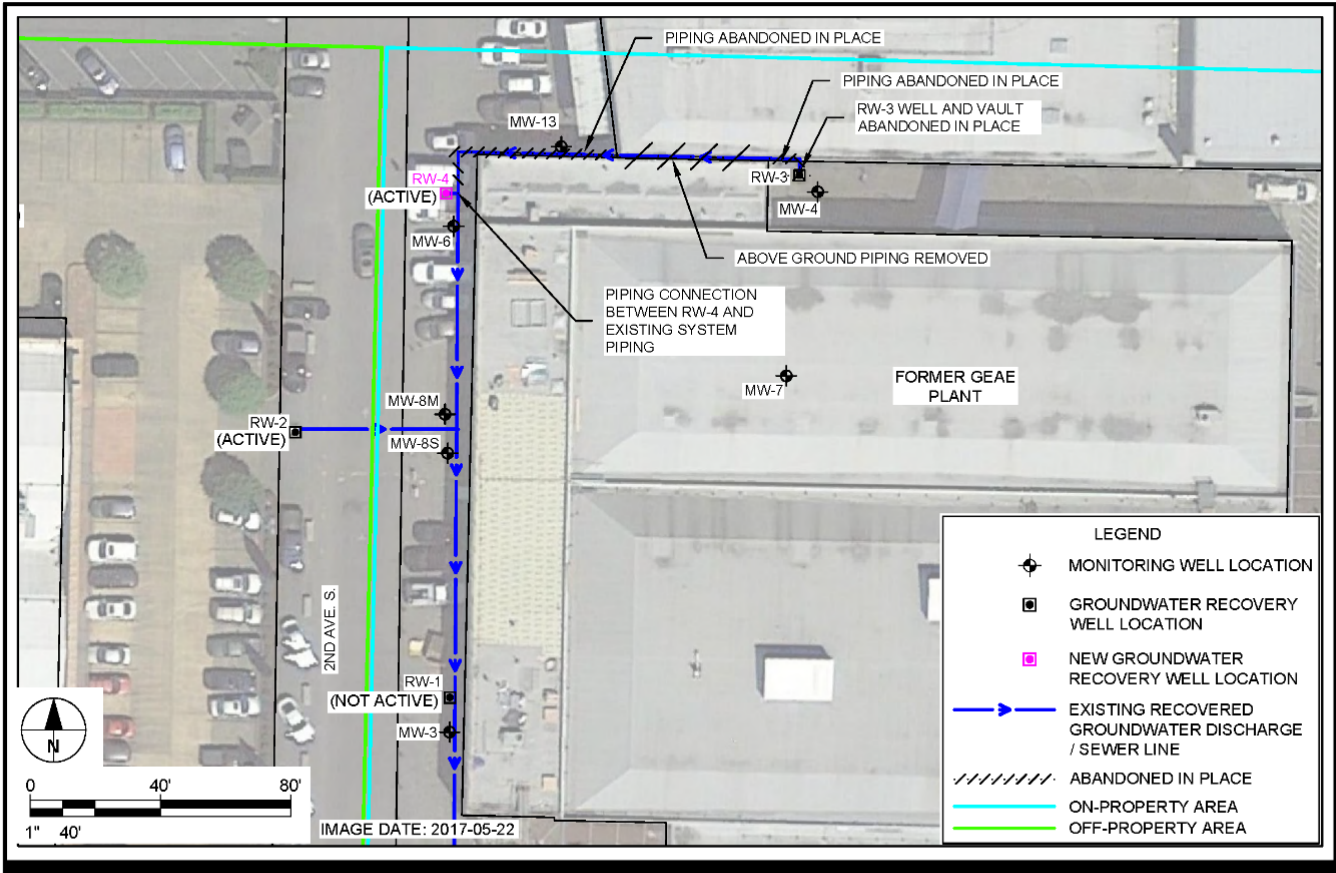
Figure A: Groundwater Extraction Well Locations

- The groundwater extraction system on 2nd Avenue S. continues to operate, with the exception for unanticipated pump failures and short durations of time when pump cleaning and maintenance is required. Extraction well RW-3 was abandoned and replaced by a new extraction well RW-4 during summer of 2018. The continuous operation of these groundwater extraction wells reduces the amount of contaminated groundwater from migrating to off-properties.

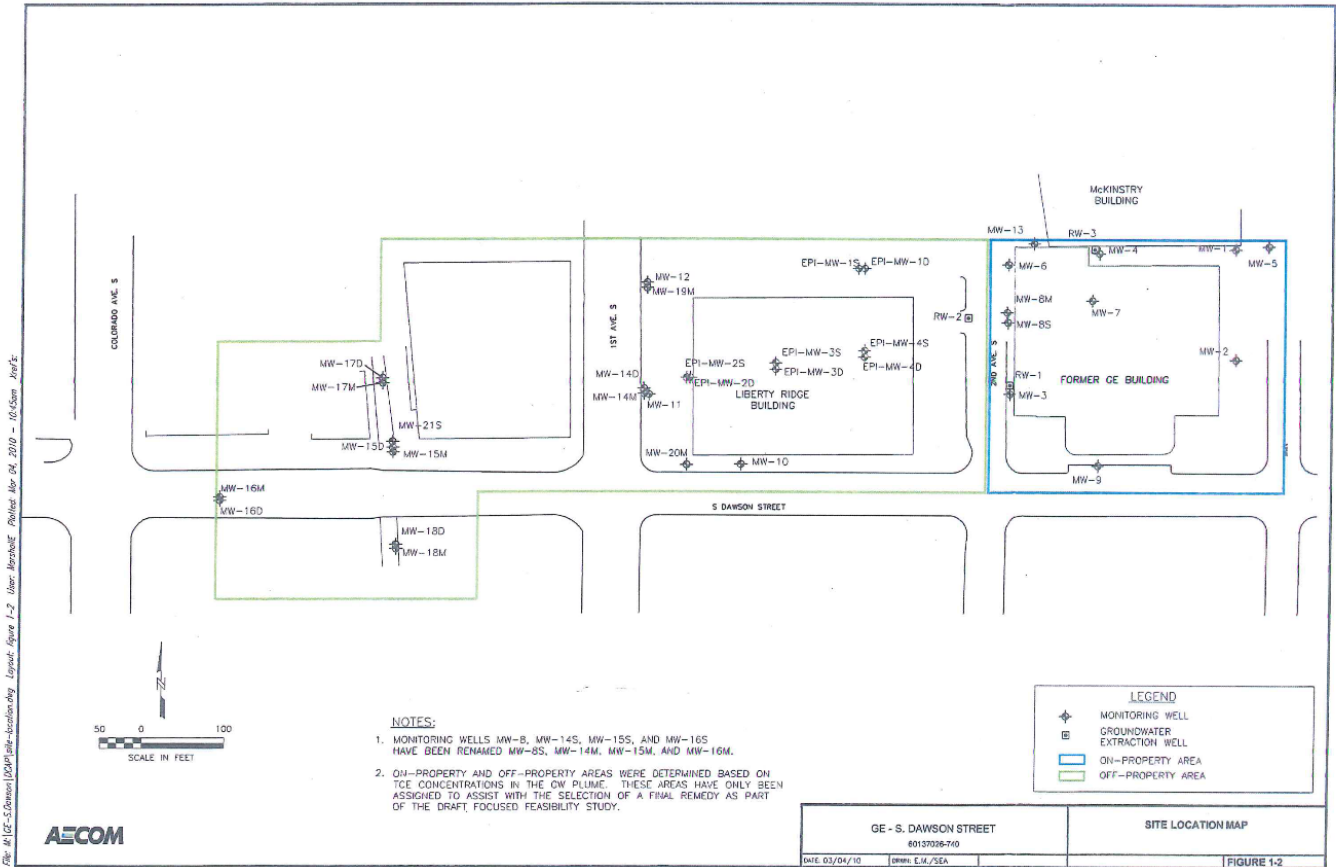
Figure B: Groundwater Monitoring Network

The monitoring well network is shown on Figure B and includes the following wells. Wells were initially installed in 1992 and 1994 as part of an independent action (no Ecology oversight). Subsequently, additional groundwater wells were installed under the 2002 Ecology-GE Agreed Order.
