STATE OF WASHINGTON
DEPARTMENT OF ECOLOGY

November 22, 2019

Re: Opinion pursuant to WAC 173-340-515(5) on Remedial Action for the following Hazardous Waste Site:

- **Site Name:** Kelly Moore Paint Company
- **Site Address:** 5410 Airport Way South, Seattle, WA 98108
- **Facility/Site No.:** 2163
- **Cleanup Site ID:** 5064
- **VCP Project No.:** NW2305

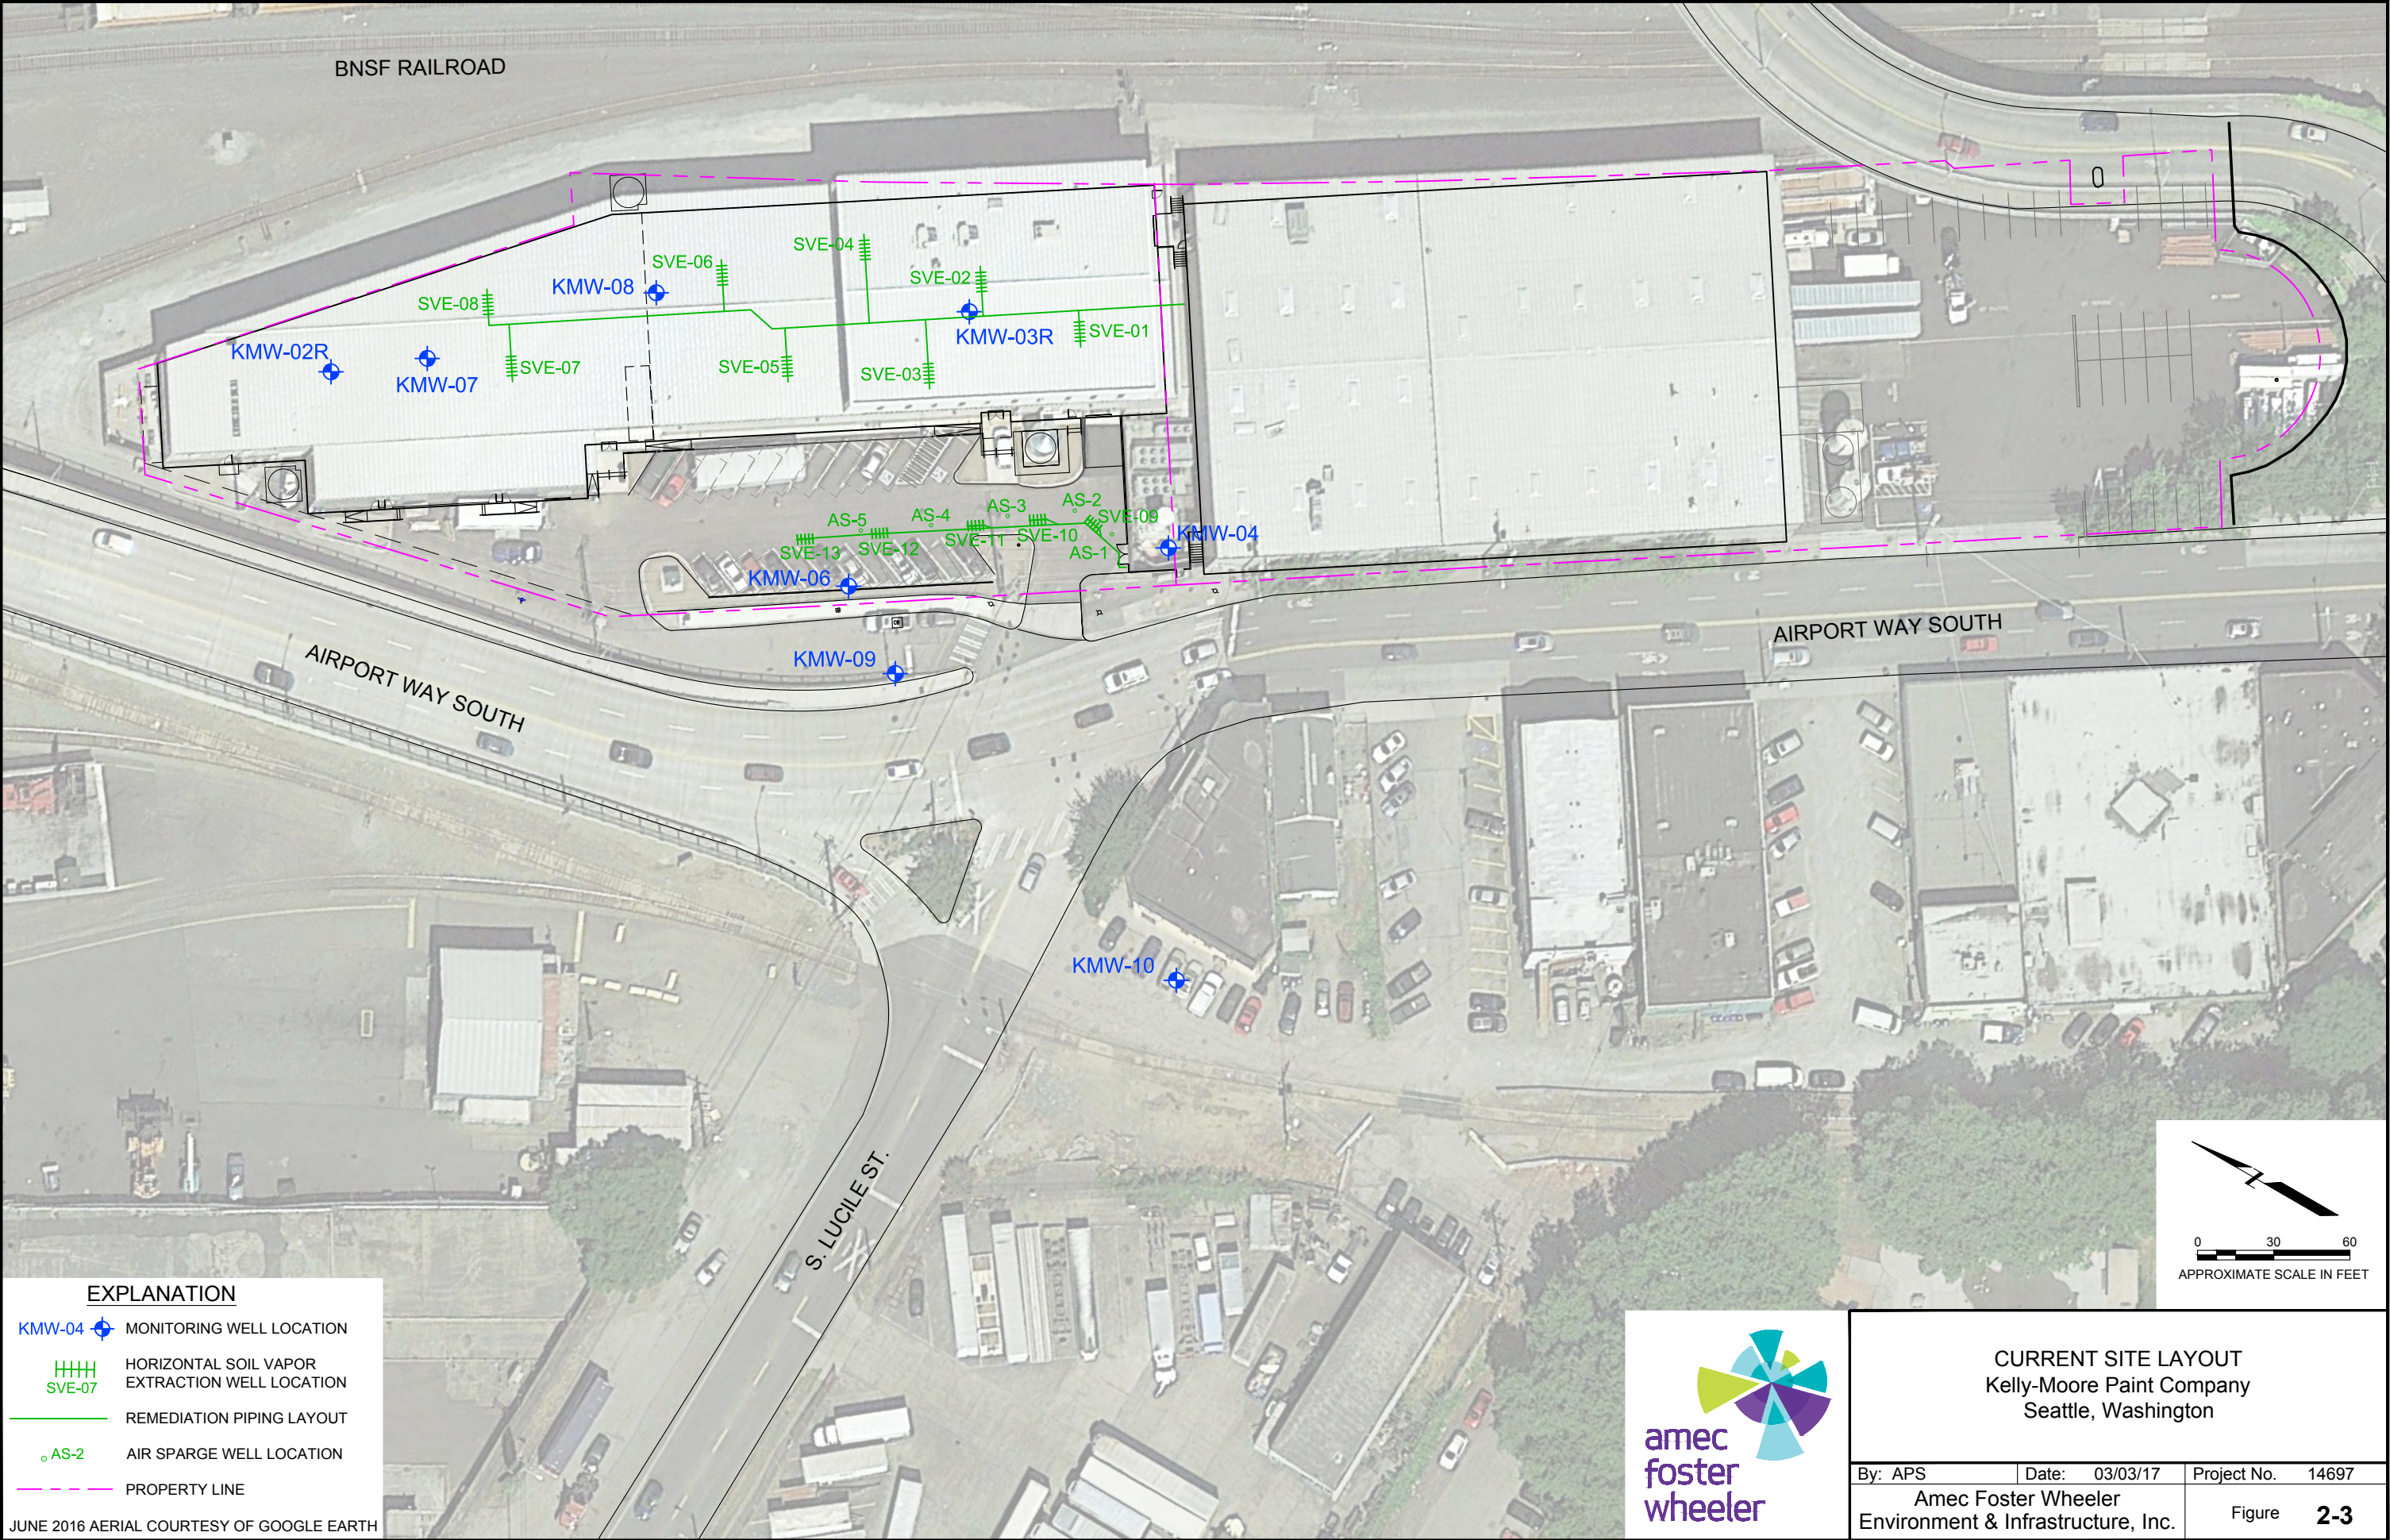
Enclosure A: Figure 2

The current Property layout is depicted on **Figure 2**. Both parcels are currently owned by Encore Elysian LLC. A large warehouse building has been present on the southern portion of the Property since 1997. A new warehouse building was built on the northern portion of the Property in 2015. Elysian Brewing Company (a beer manufacturer) currently occupies both warehouse buildings and uses them for beer brewing and manufacturing.

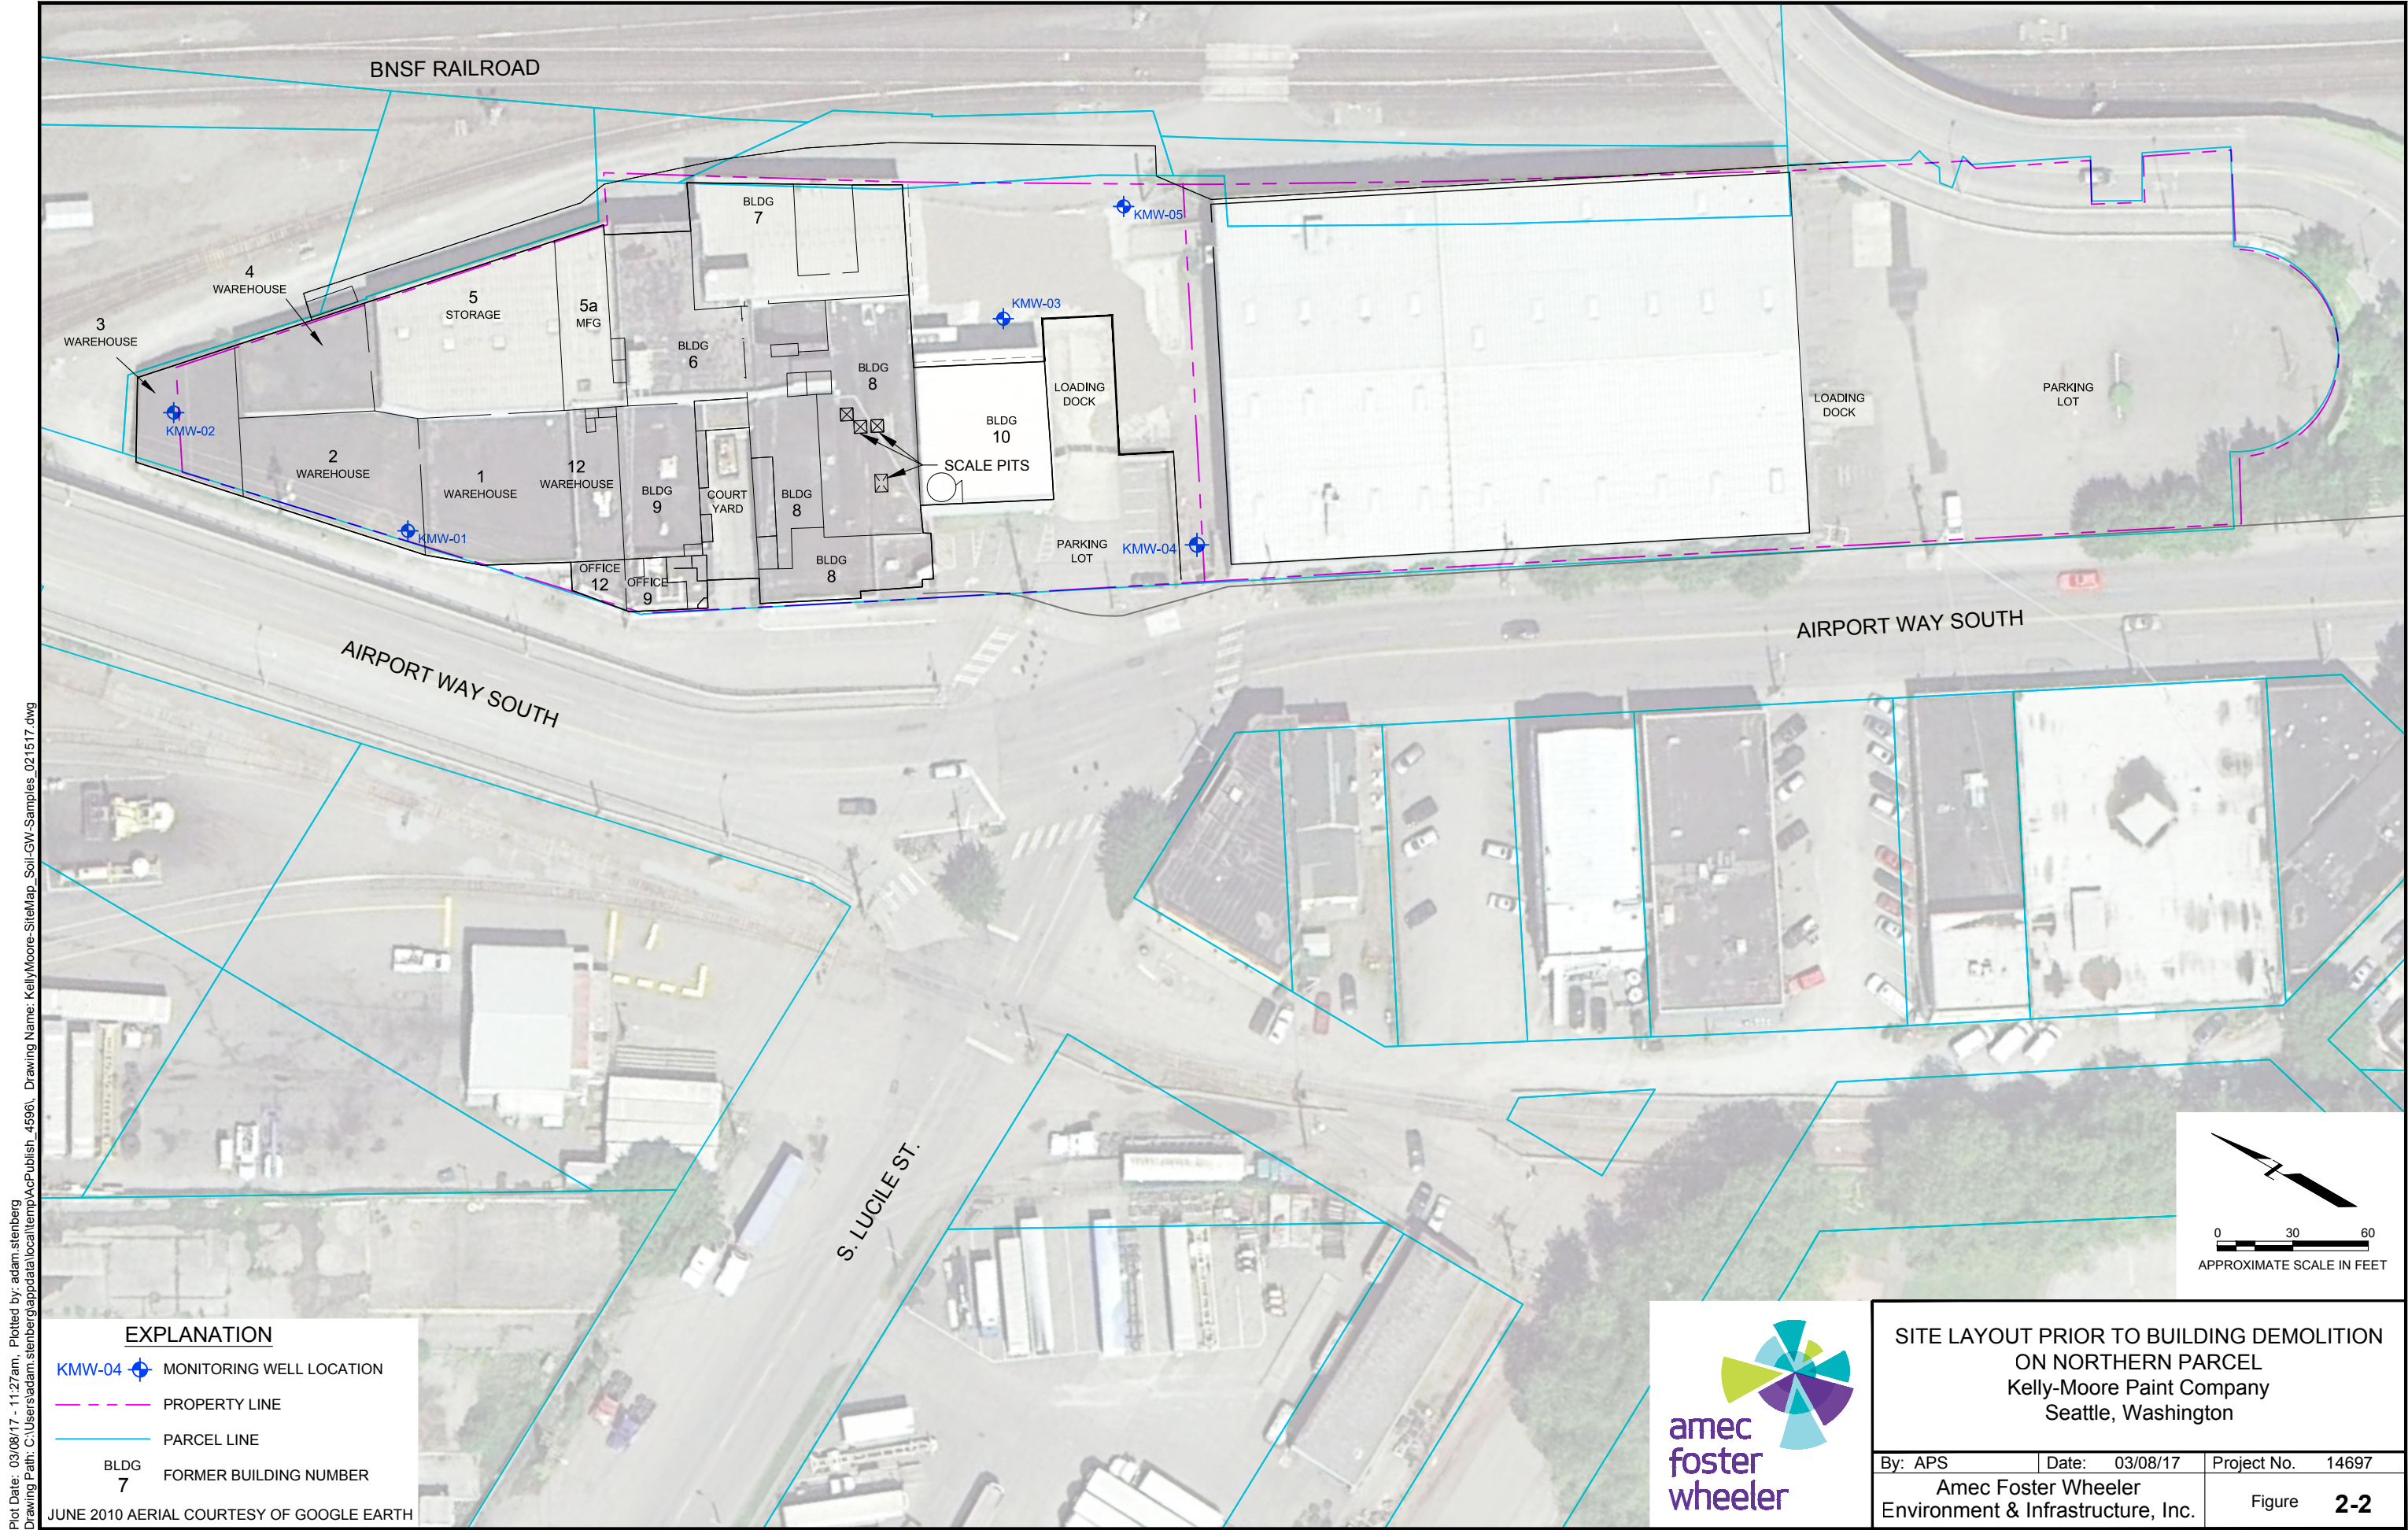
Enclosure A: Figure 3

longer using the Property and was leasing the buildings to various commercial tenants. Kelly Moore sold the southern portion of the Property in 2011 and the northern portion in 2014. The former Property layout during Kelly Moore's operation is depicted on **Figure 3**.

A large warehouse building has been present on the southern portion of the Property since 1997, which is still present on the Property and used for beer manufacturing. A large conglomeration of buildings of various ages had been present on the northern portion of the Property in some form between the 1920s and 2015. Usage of the former buildings on the northern portion of the Property prior to the cessation of manufacturing in 2008 are listed as following (**Figure 3**):

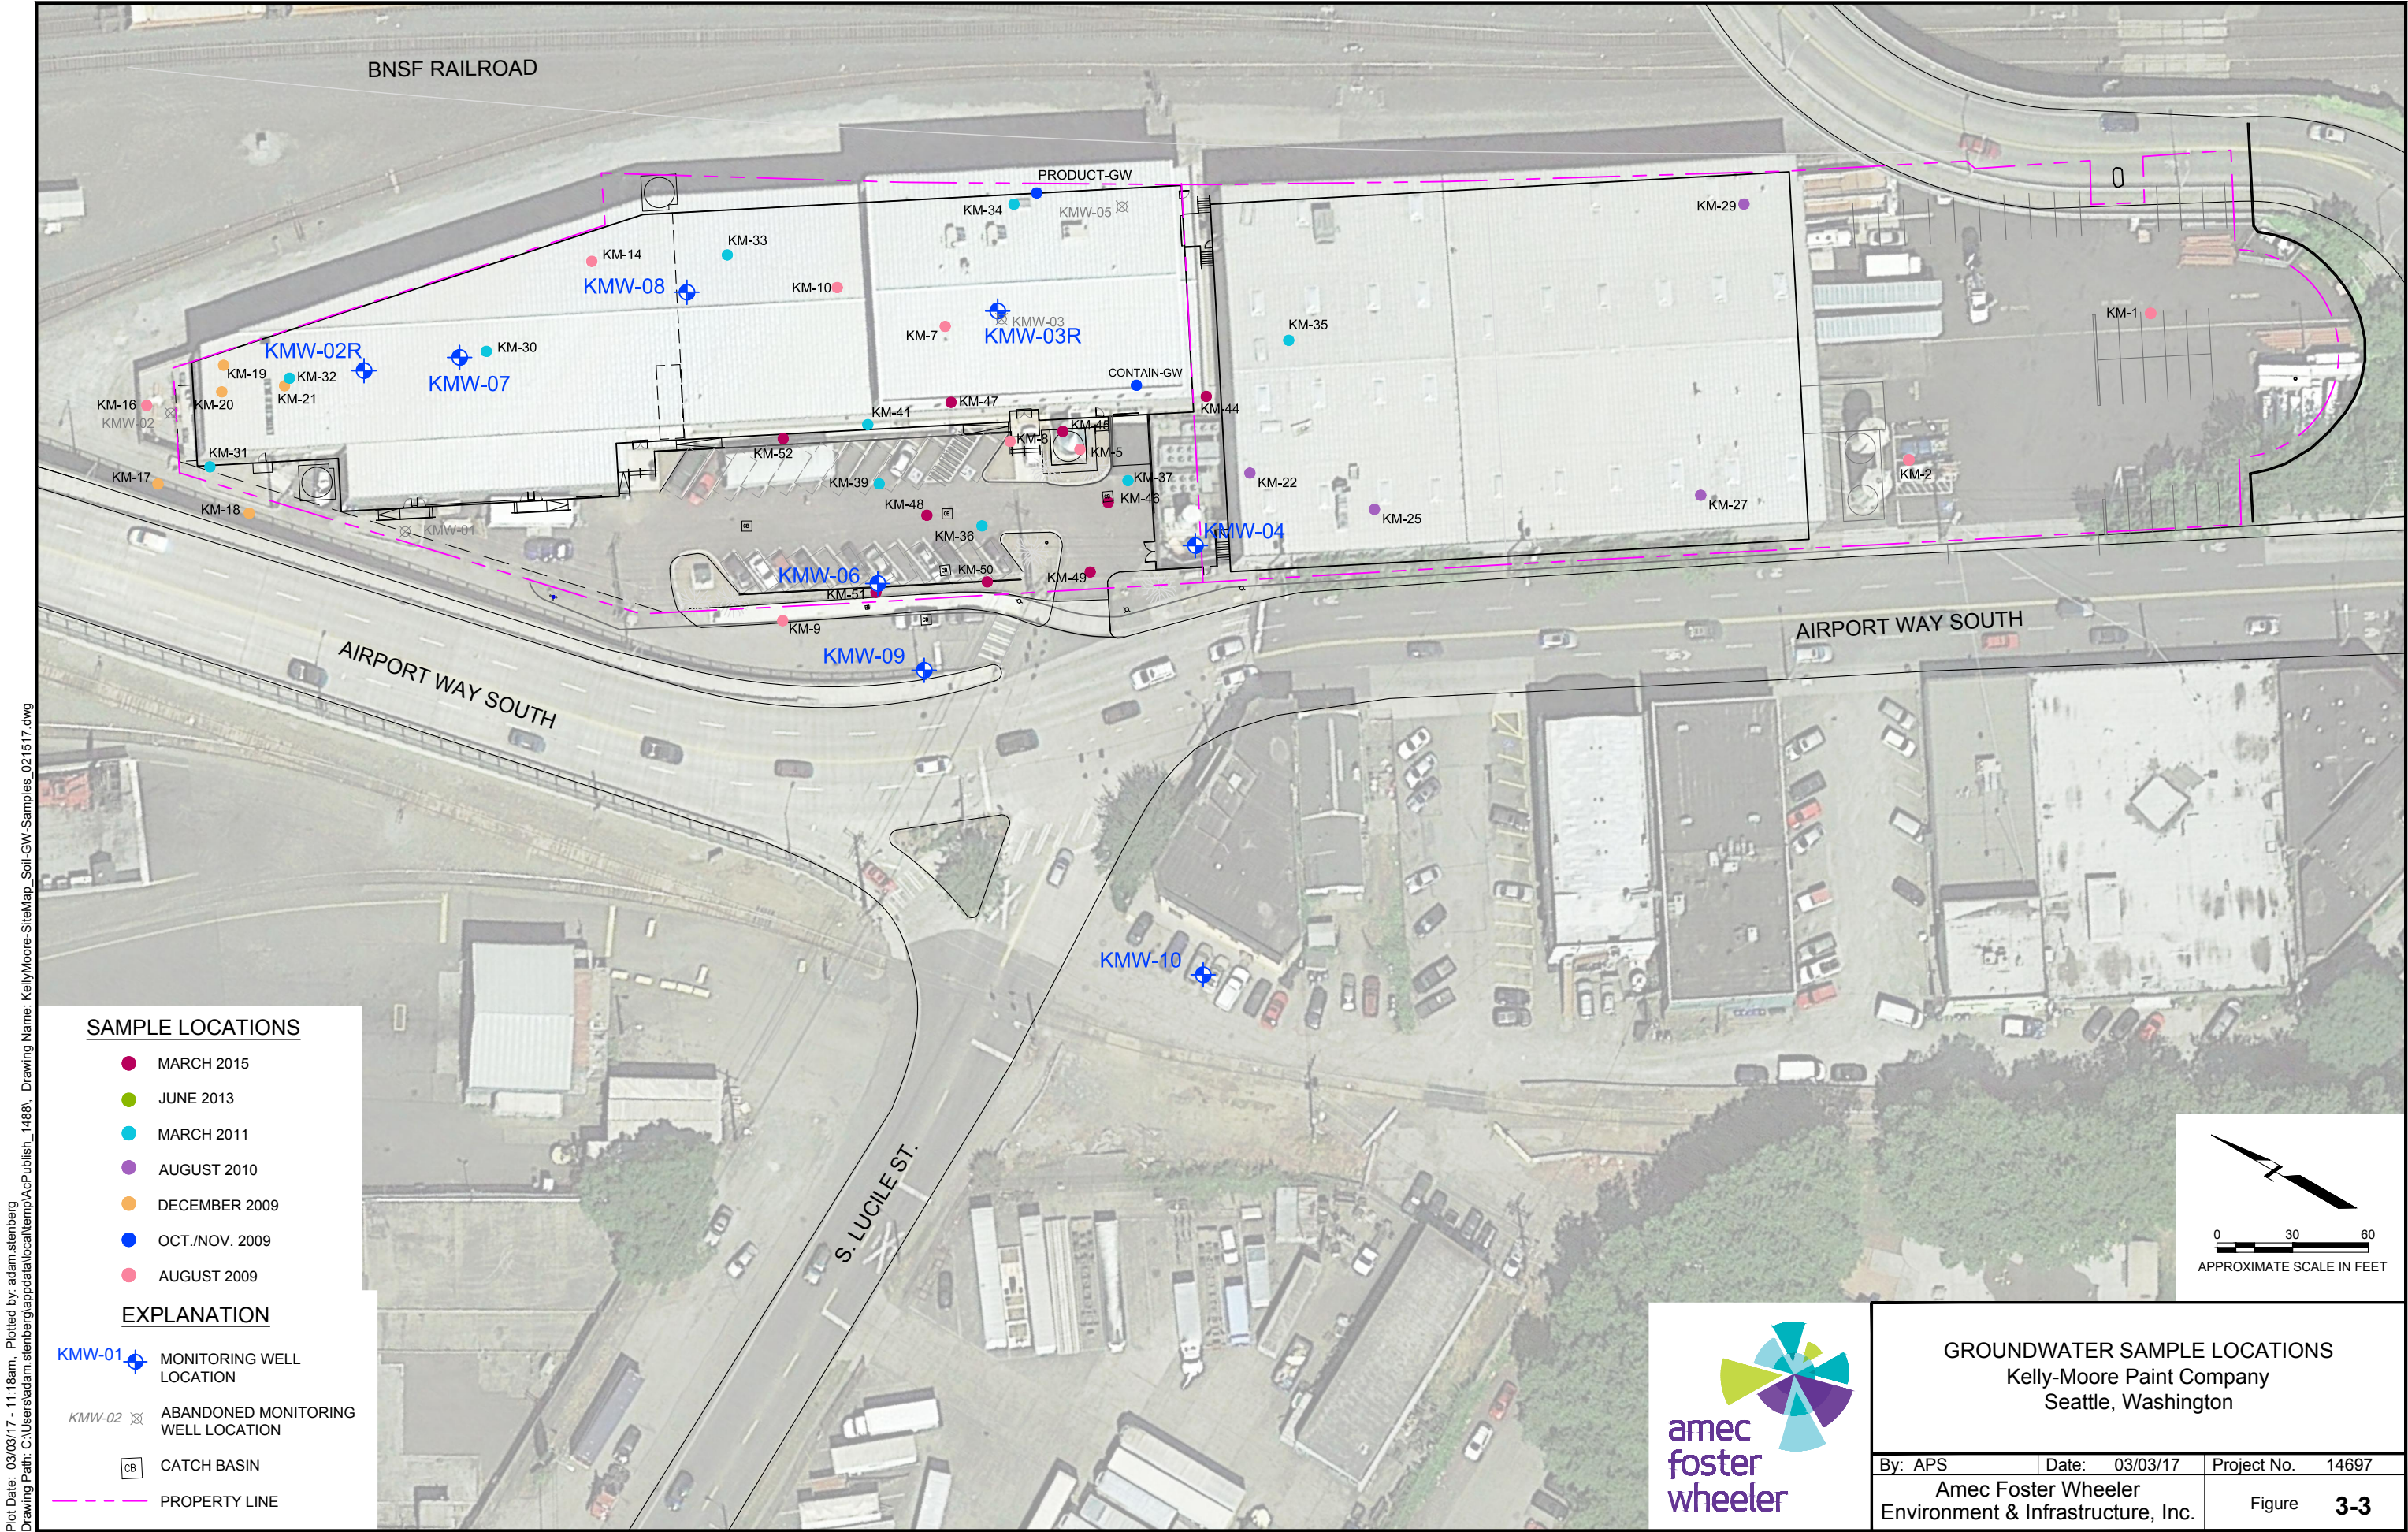
Enclosure A: Figure 7

Release and Extent of Soil and Ground Water Contamination: Multiple environmental investigations and interim remedial actions have been completed at the Site. The bullets below summarize the major investigations and interim remedial activities known to Ecology. The soil excavation and sampling locations in 1997 are depicted on **Figure 4**. The soil excavation and sampling locations after 1997 are depicted on **Figure 5** (northern portion) and **Figure 6** (southern portion). The ground water sampling locations are depicted on **Figure 7**.
