# 2008 Skykomish Remediation – As-Built Completion Report

## Former Maintenance and Fueling Facility

AECOM, Inc.  
August 2009  
**Document No.: 01140-222-0500**

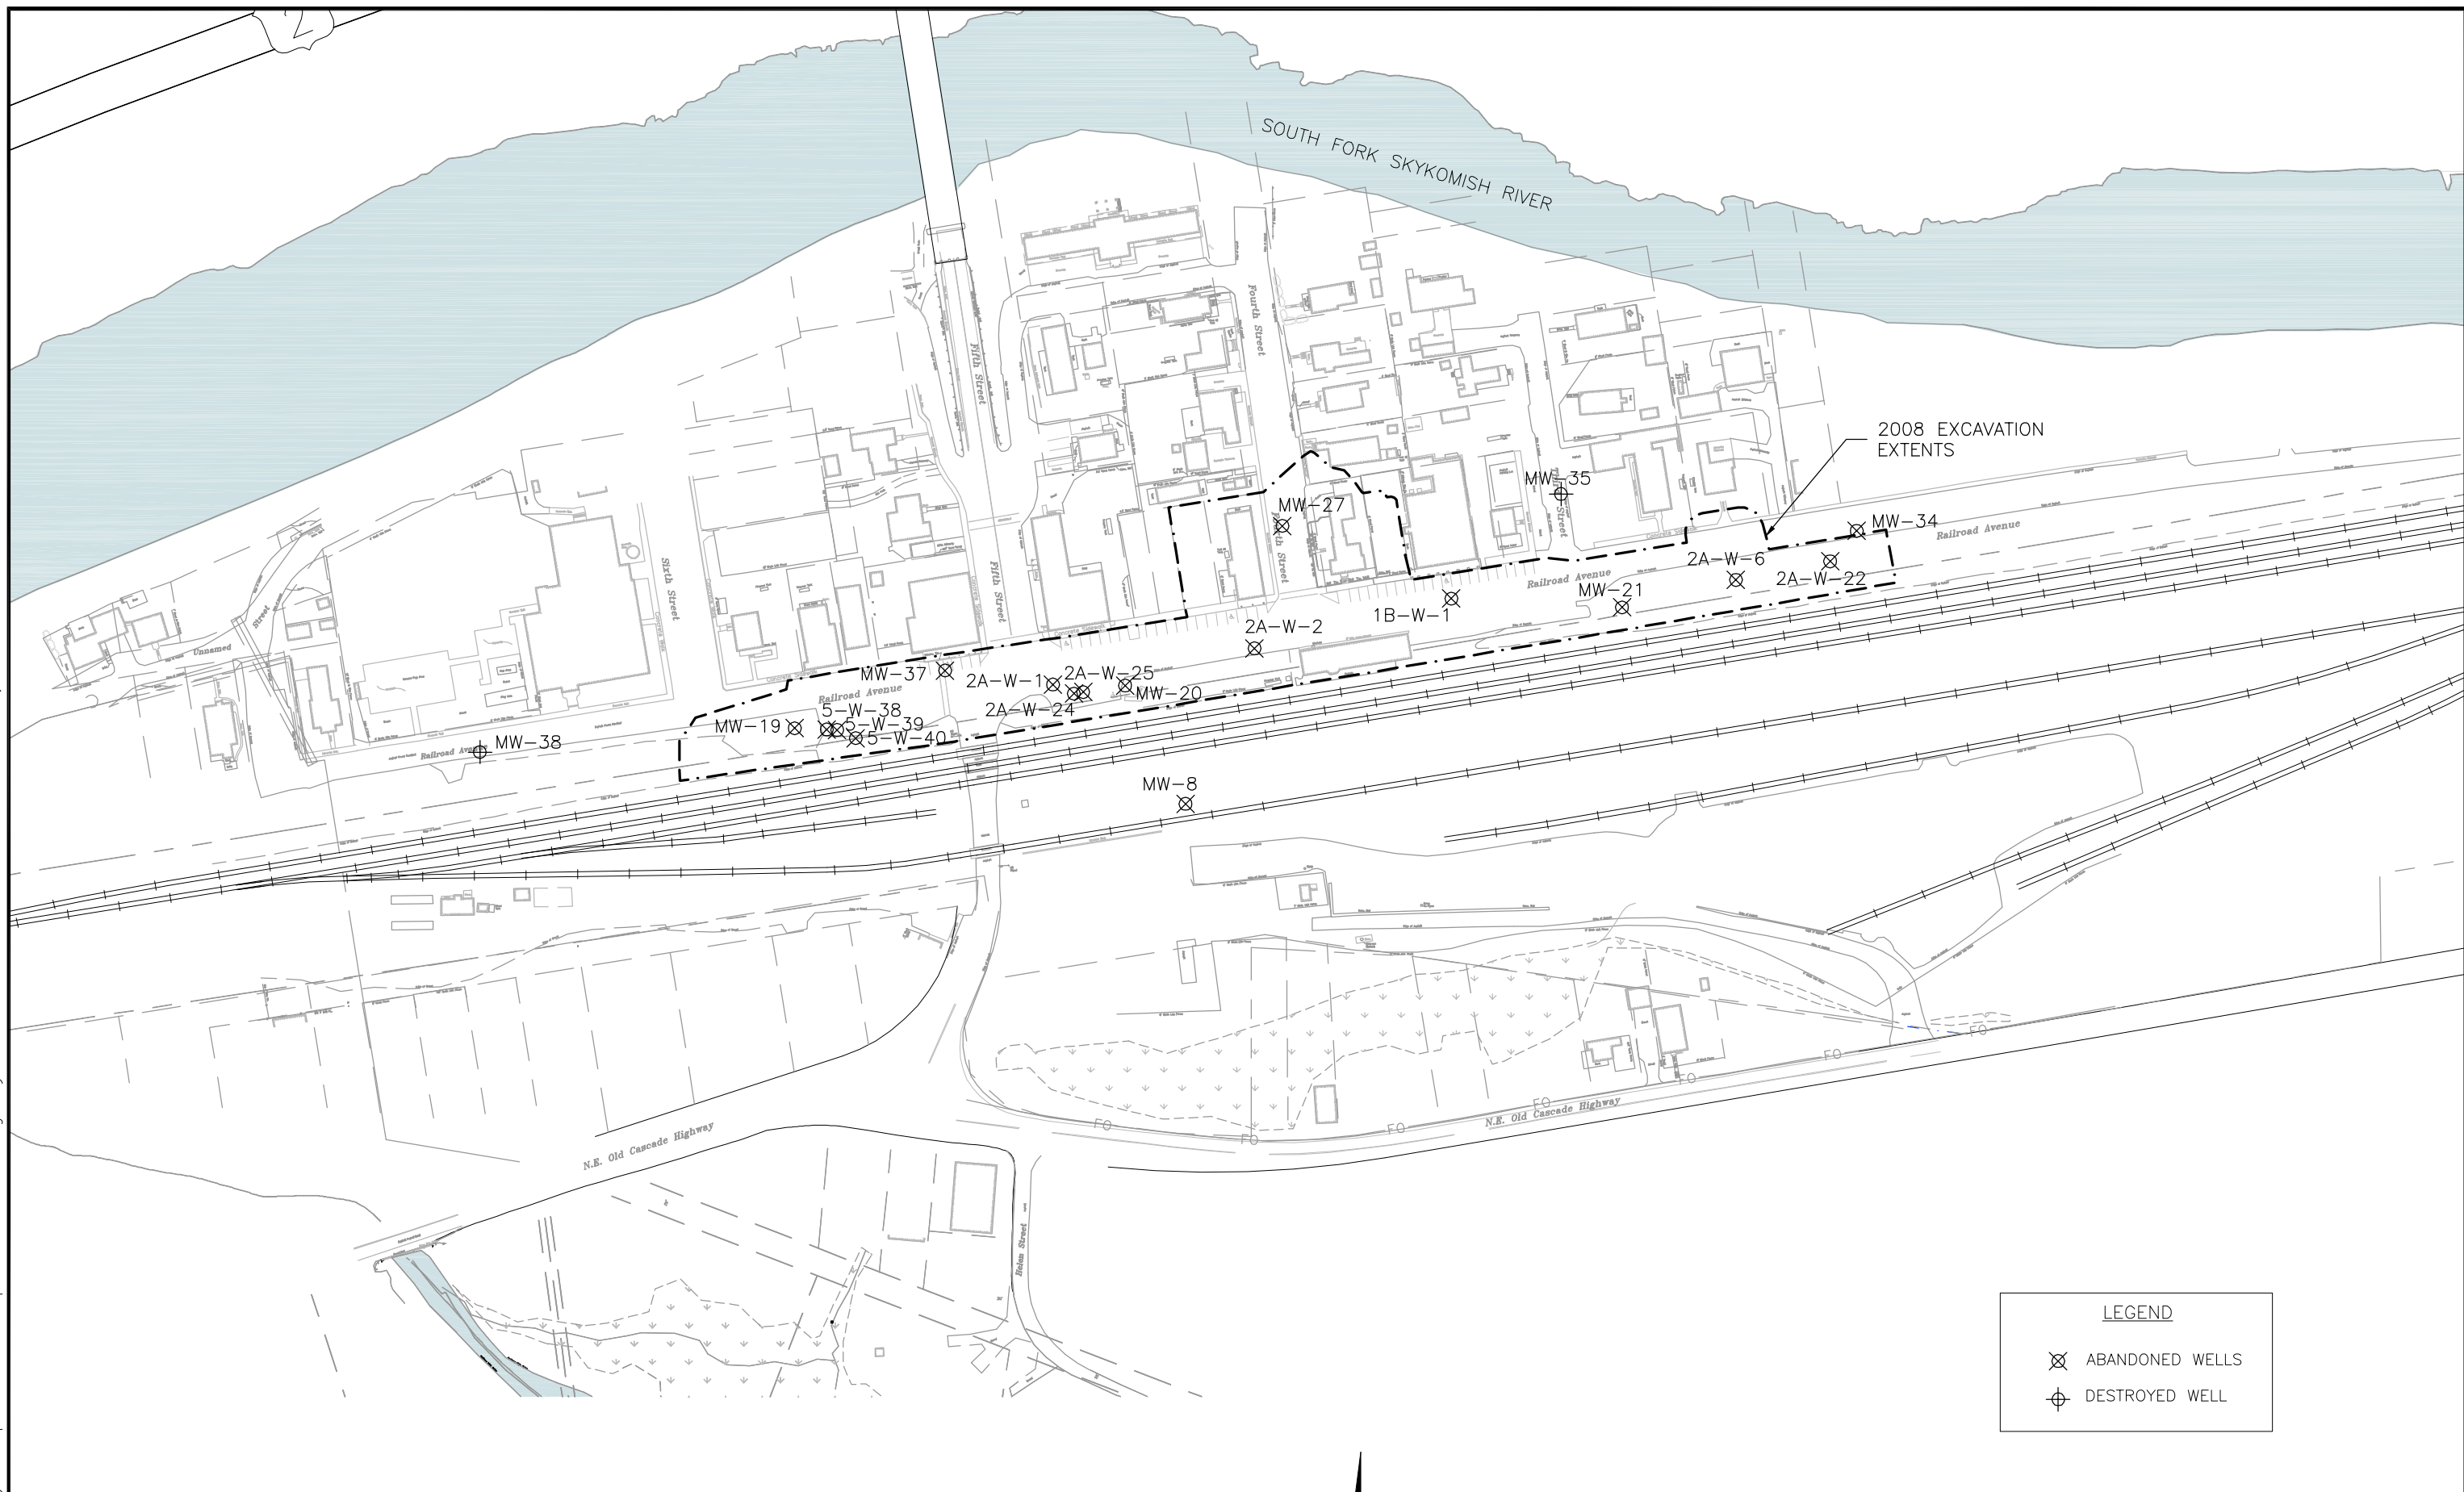
**FIGURE 4-2**

Monitoring well MW-35 was destroyed during construction activities associated with installation of sewer laterals along 3<sup>rd</sup> Street. Measures were taken to avoid the destruction however, the soils around the well were too loose and sloughed into the trench exposing and breaking the well pipe. The monitoring well will be relocated by a surveyor and abandoned per WAC 173-160-460(2)(e) if possible.

MW-38 was accidentally destroyed by personnel from Callen Construction Company, the company building the lift station for the Town. The well was destroyed during trenching for the installation of the sanitary sewer piping that runs to the Town lift station at the west end of Railroad Avenue. The location of MW-38 is shown on Figure 4-2. A replacement well will be installed by the Town in the near future.

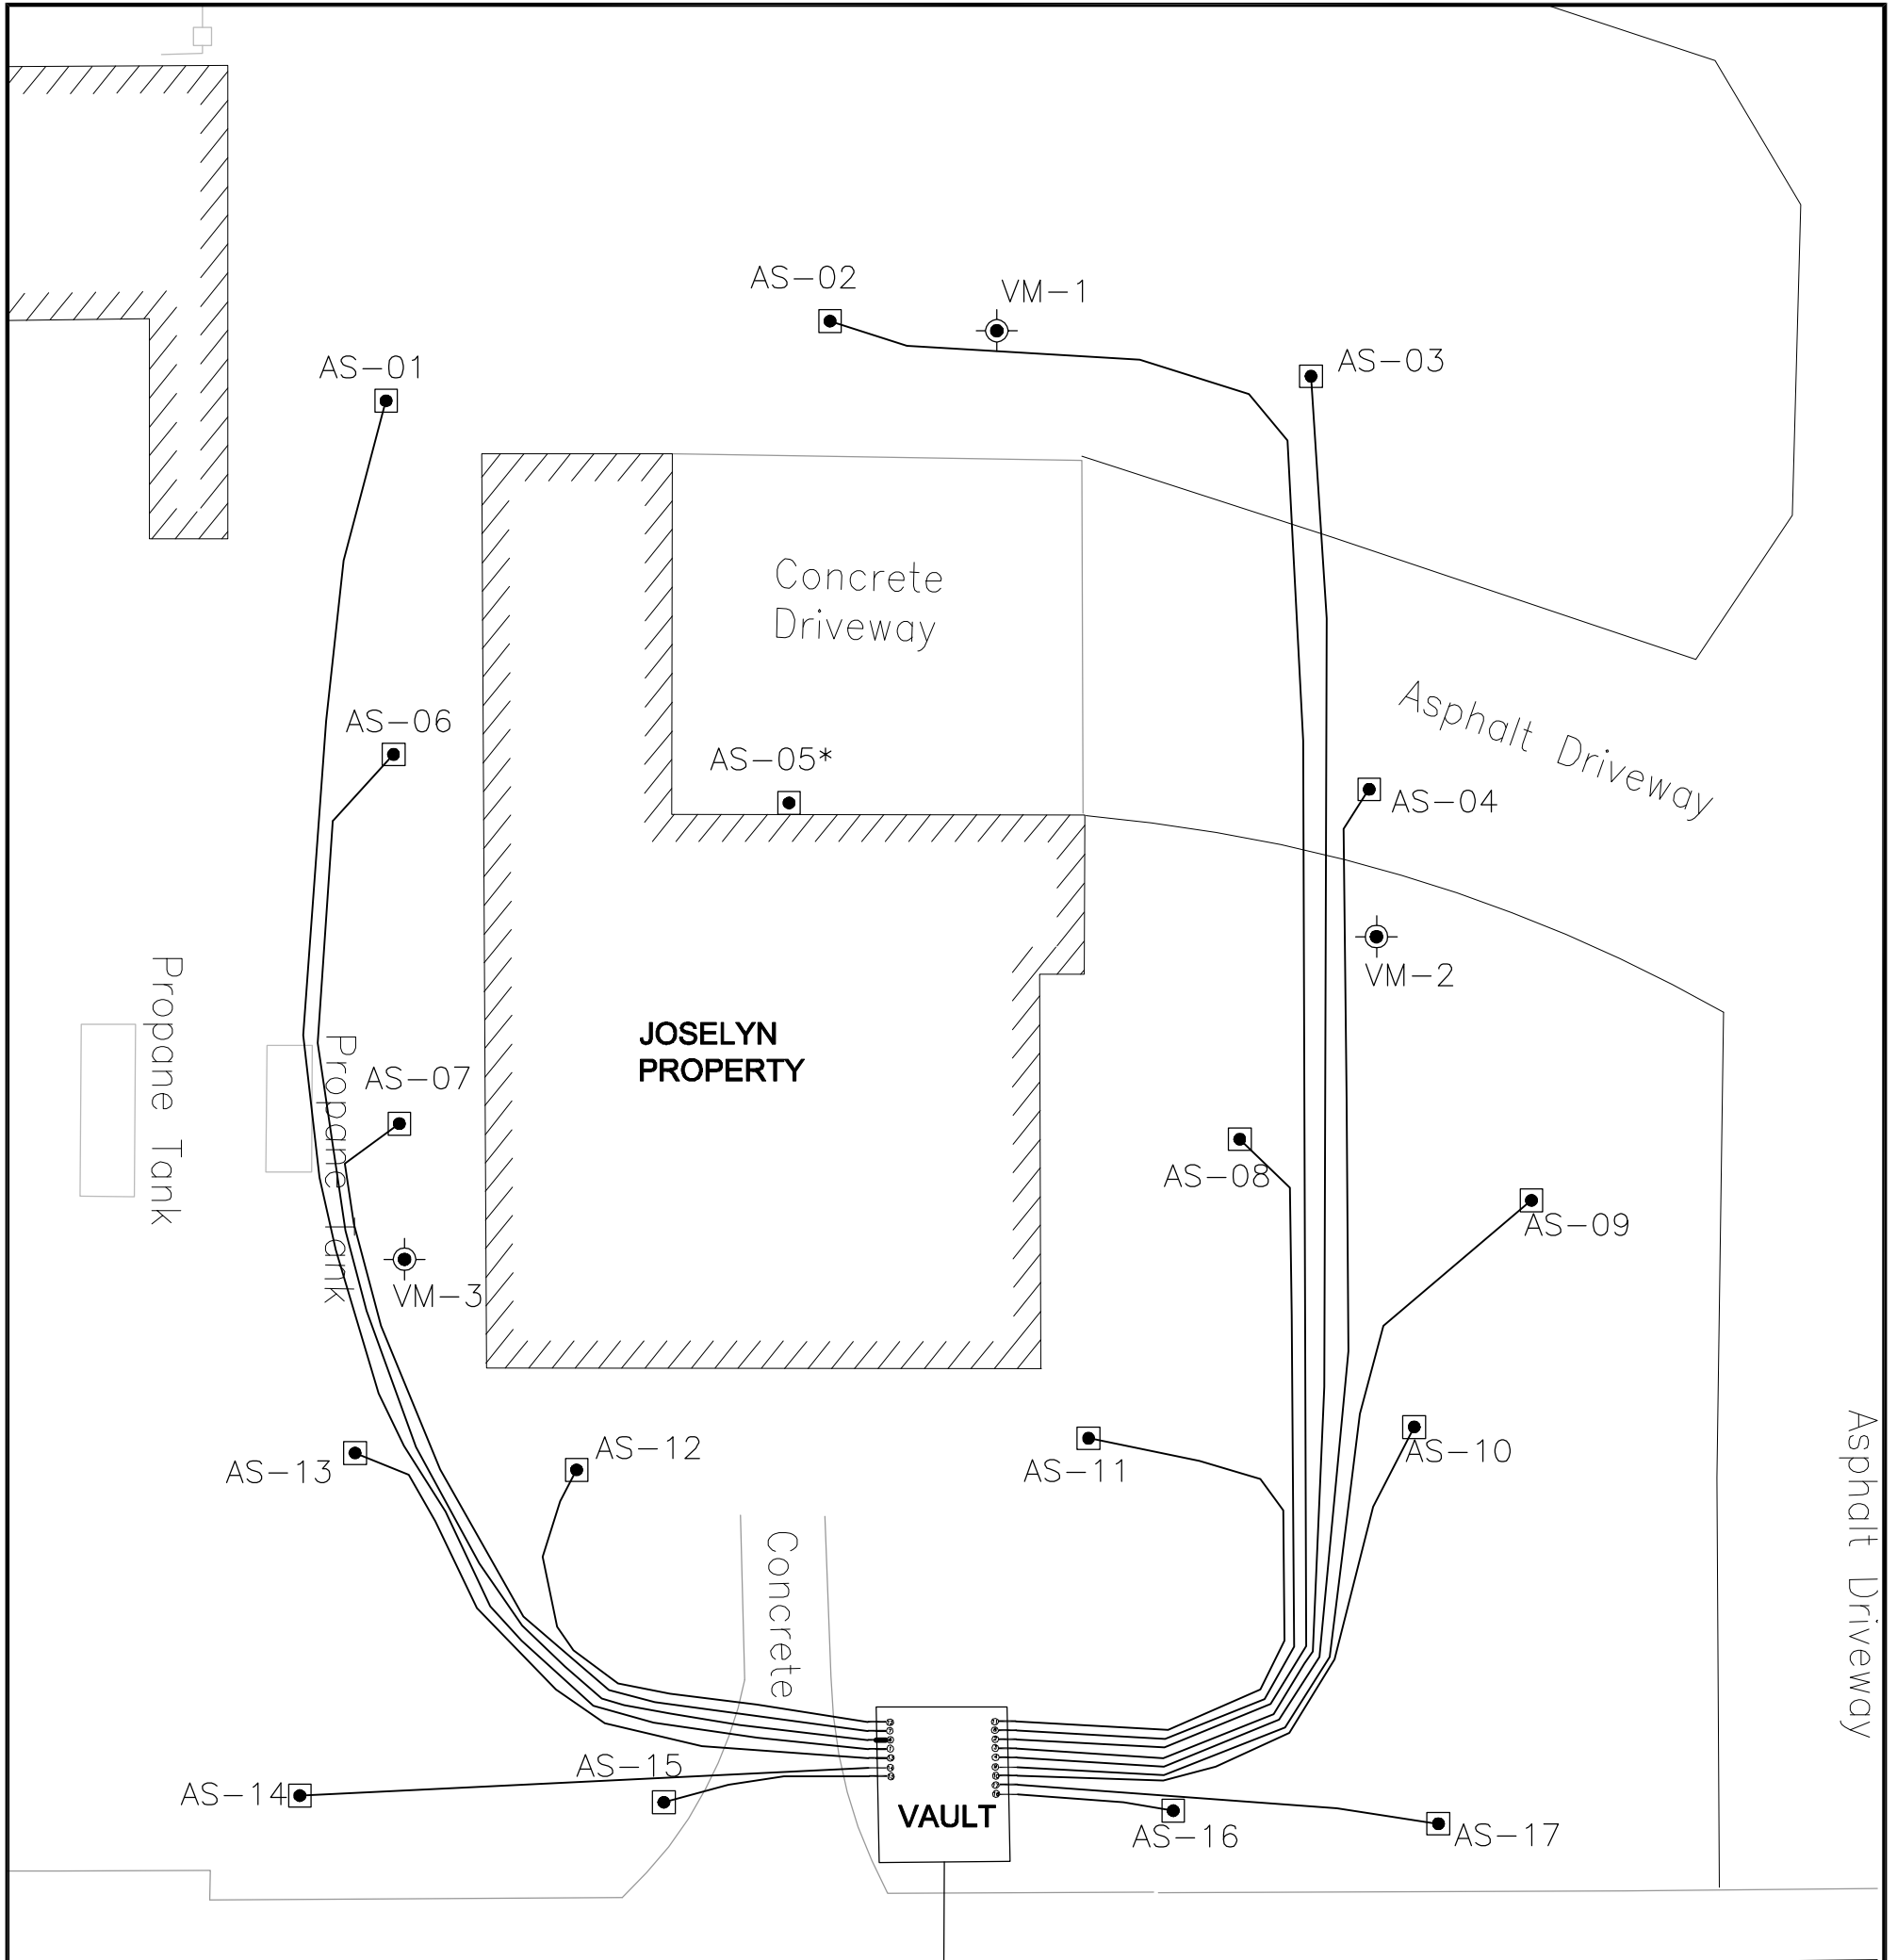
**FIGURE 5-4**

\* AS-05 NOT INSTALLED DUE TO INADEQUATE OVERHEAD CLEARANCE AT PLANNED INSTALLATION POINT.
