Technical Memorandum

TO: Mr. Bryce Robbert, Avista Corporation
FROM: Ryan Reich, LG, and Tom Briggs, PE
DATE: November 22, 2019
RE: **2019 Annual O&M Site Inspection
Hamilton Street Bridge Site
Spokane, Washington
Project No. 0236042.060**

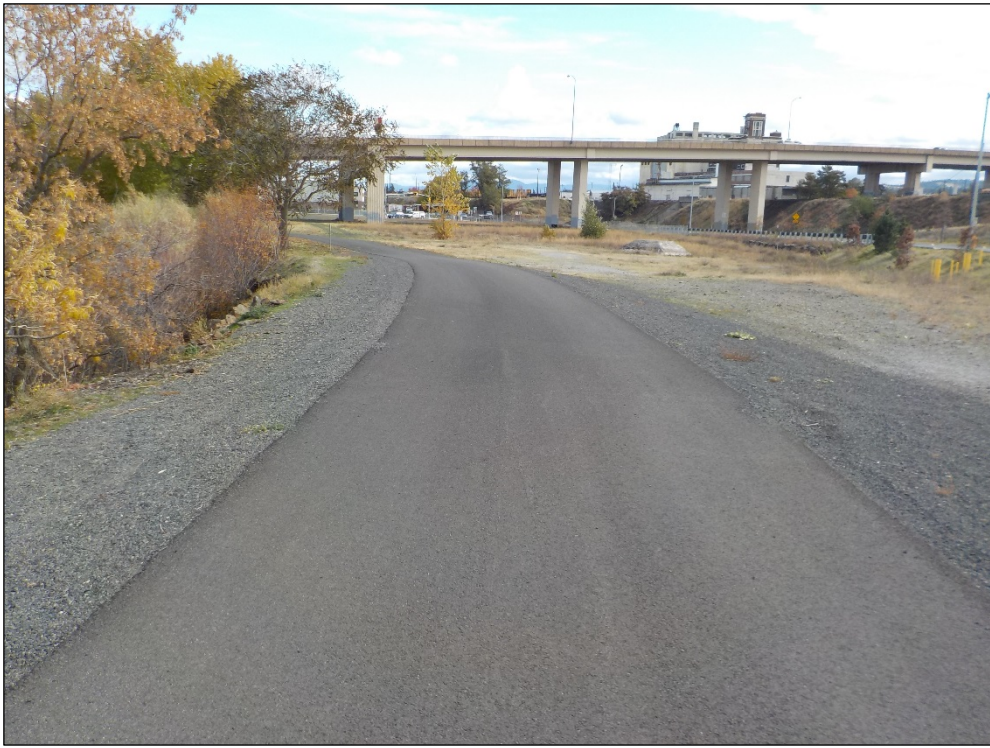
1. View of Ben Burr Trail near western site boundary (looking southwest).

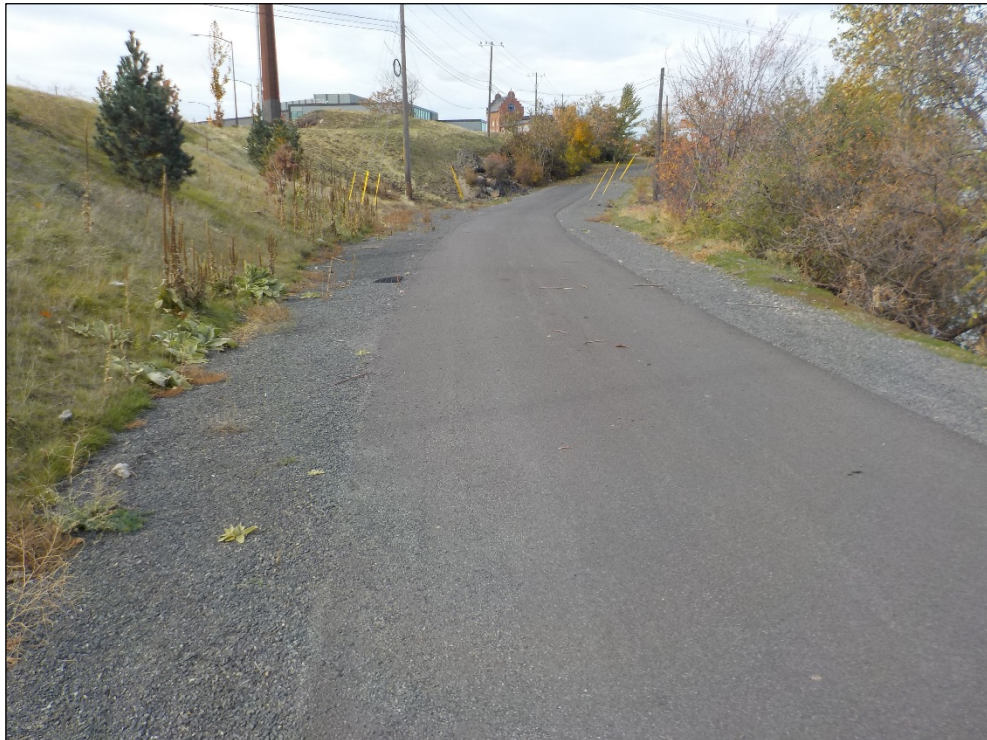
2. View of Ben Burr Trail near western site boundary (looking northwest).

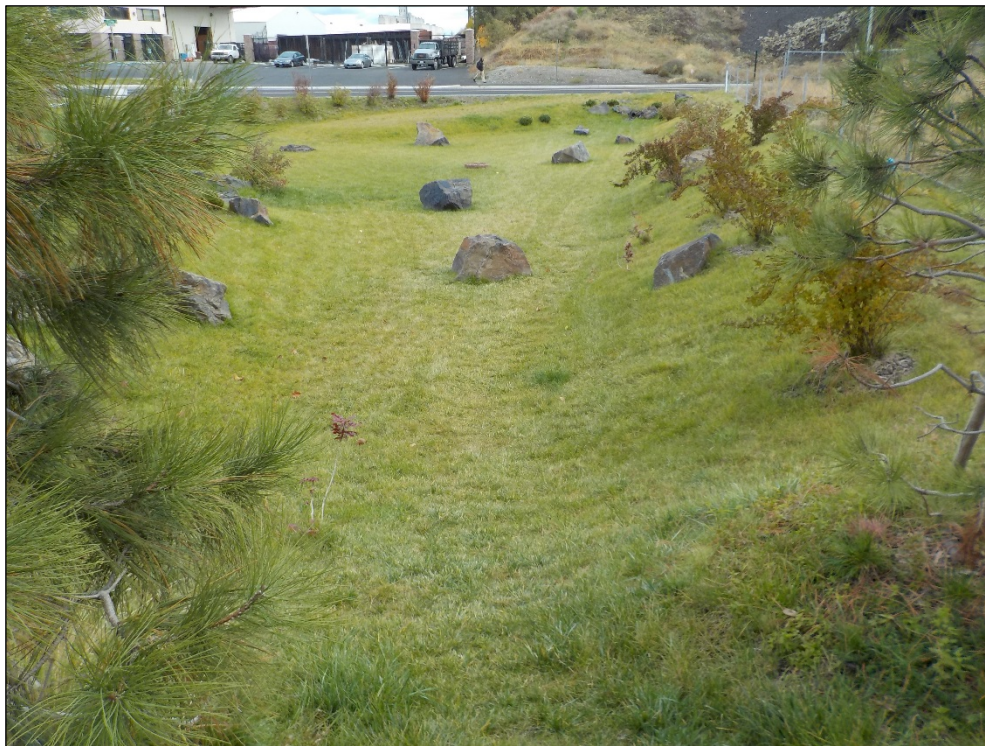
- Evaporation Pond. The City's evaporation pond was dry, contained healthy growing vegetation, and appeared to be in good condition.
- **Shoreline Bioengineering System**. The shoreline riprap face, transition zone, and vegetative cover along the Spokane River appeared to be in good condition. No erosion, ponding, or loose boulders were observed, and mature trees growing from the bank appeared stable and healthy. Some refuse from abandoned transient camps was observed along the shoreline west of James Keefe Bridge.

3. View of lined evaporation pond at southeast corner of site (looking east).

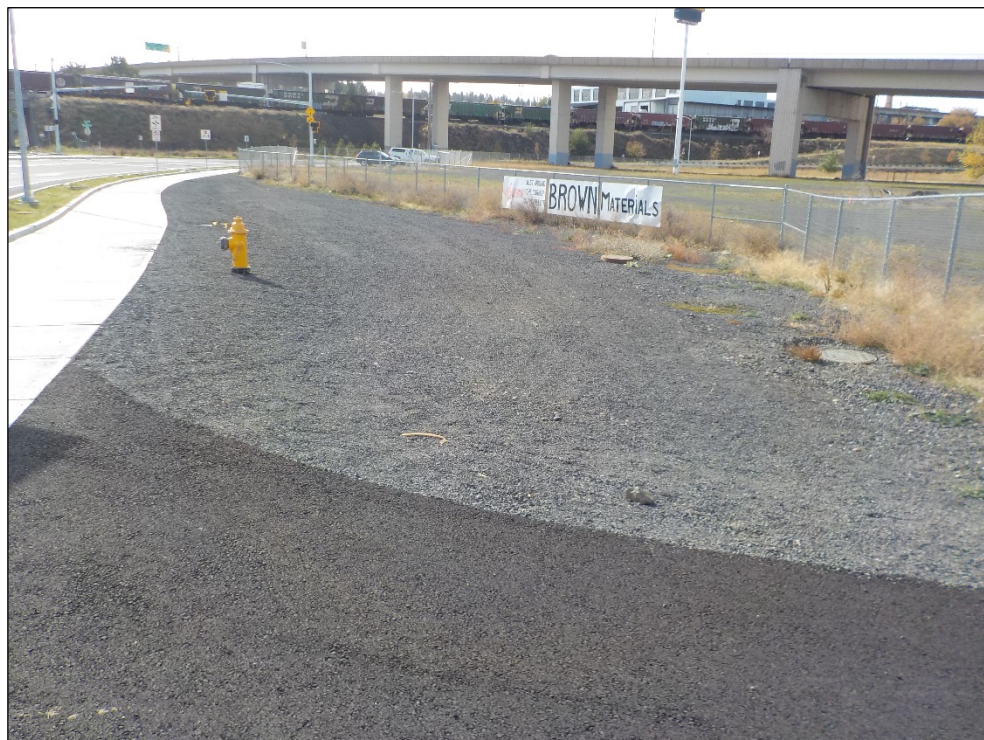
- **Fencing**. A portion of fencing near the east site boundary, where Ben Burr Trail meets North Erie Street, was permanently removed in 2019. Ben Burr Trail, at its intersection with North Erie Street, has bollards to restrict onsite vehicle access. A gate with a lock, for limited onsite vehicle access, was installed near the intersection of MLK Jr Way and North Erie Street.

4. View of new sidewalk and east fence line, where Ben Burr Trail meets North Erie Street (looking southwest).

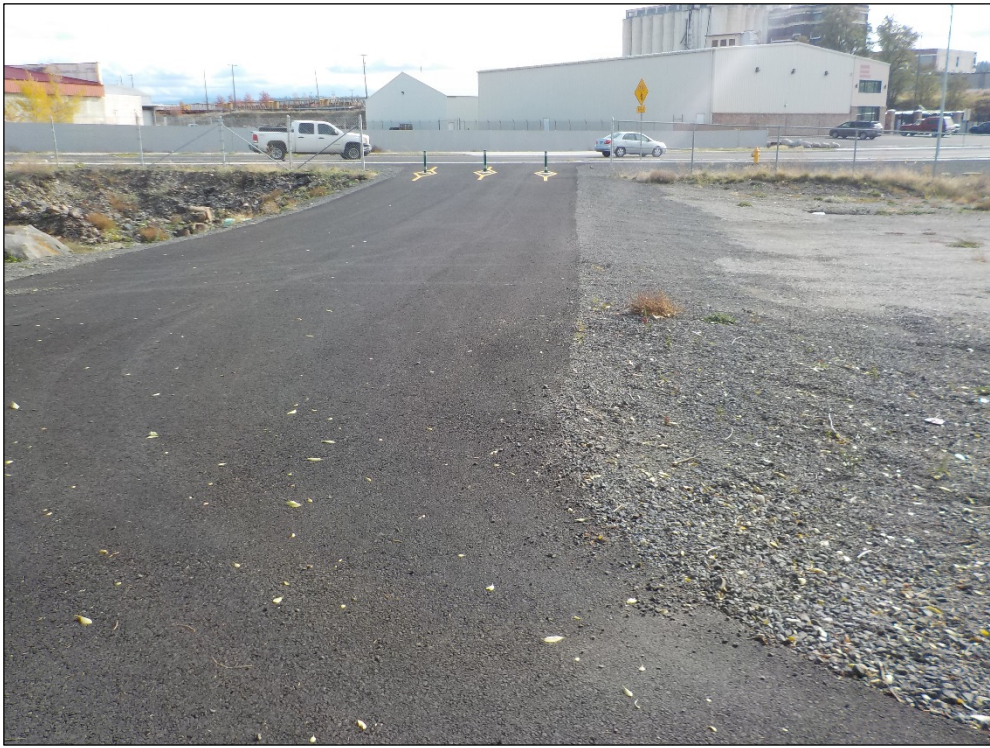
5. New section of Ben Burr Trail near northeast site boundary (looking southeast, toward North Erie Street).

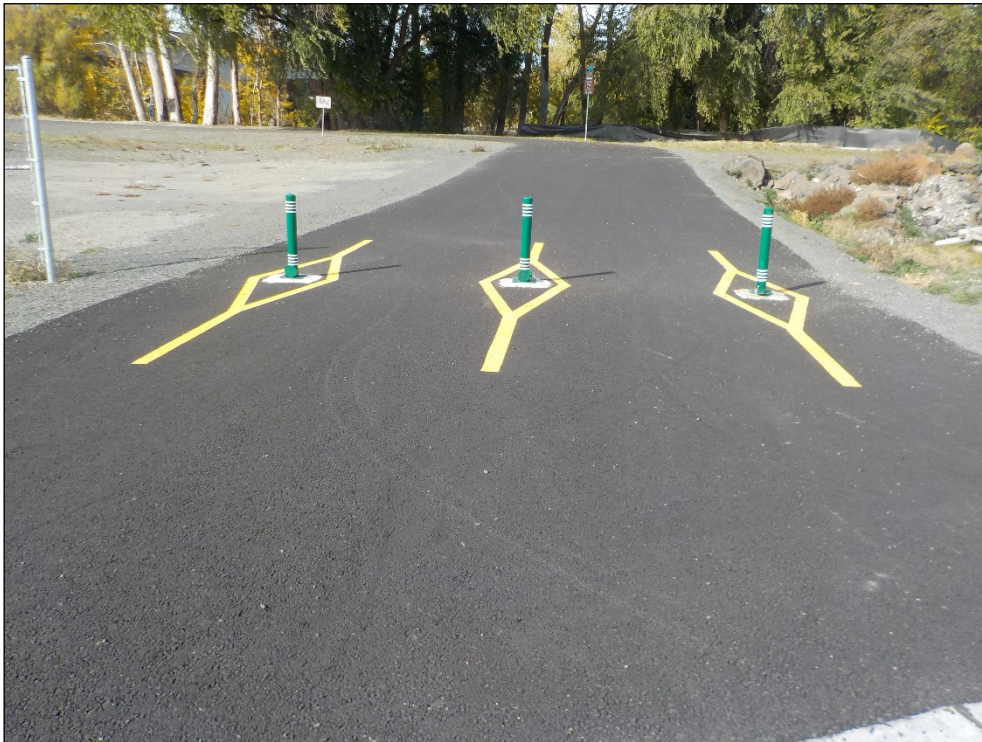
6. View of new section of Ben Burr Trail near northeast site boundary (looking northwest, toward Spokane River).

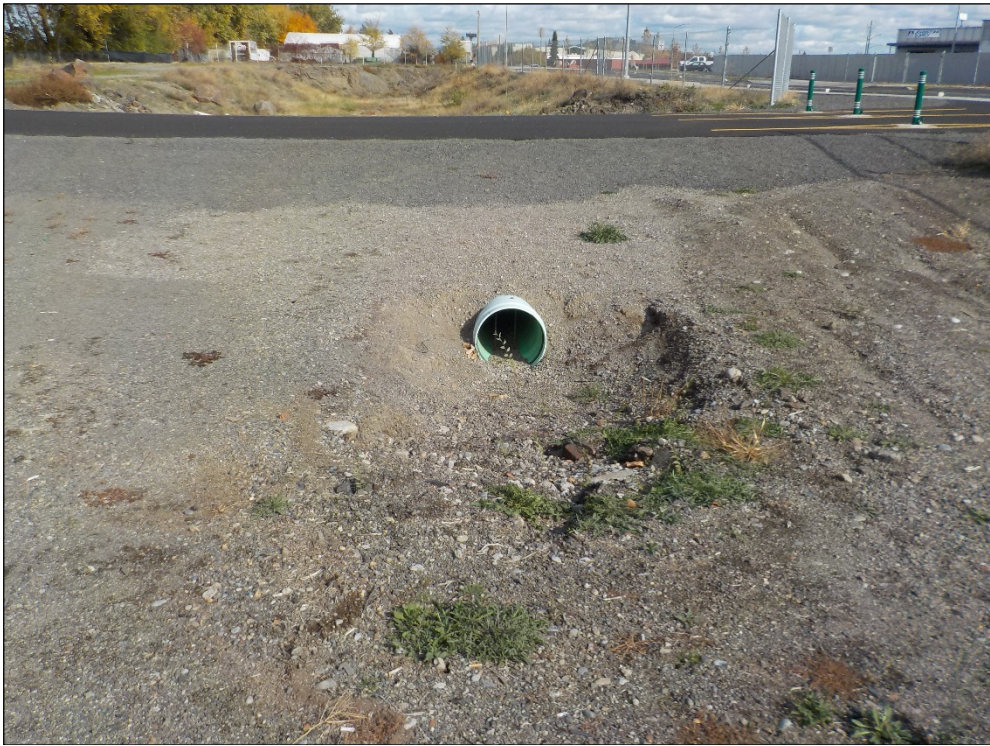
7. Culvert under new section of Ben Burr Trail, near northeast site boundary (looking northeast).

was backfilled and returned to its original condition. Soil was also removed by LAI from the culvert inlet.

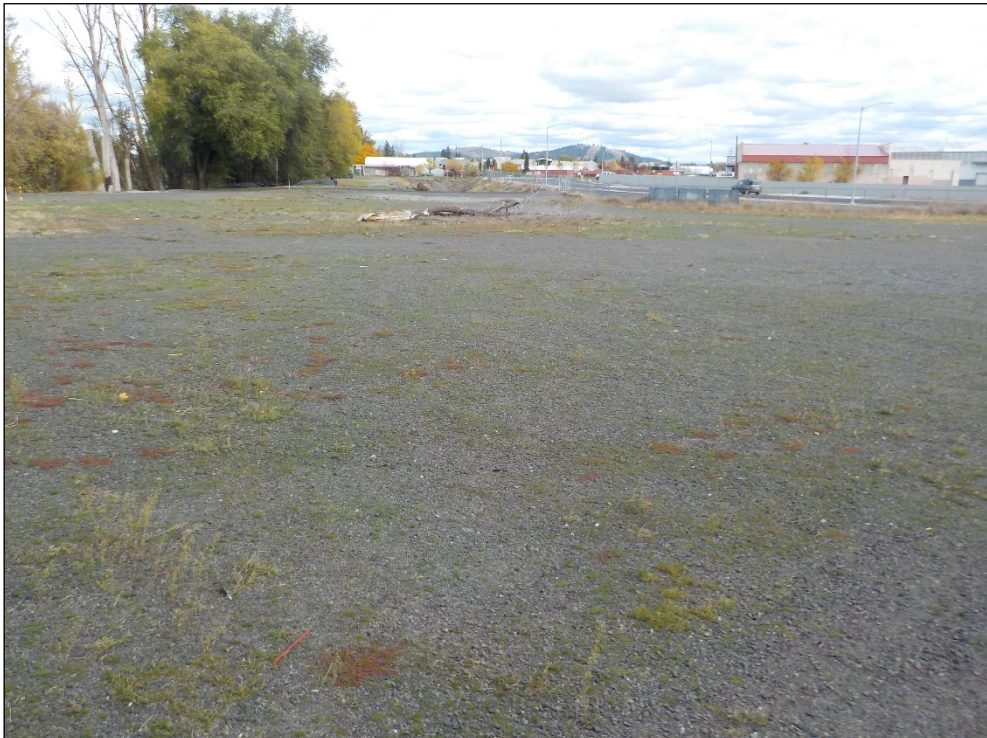
8. View of east portion of site (looking northeast).

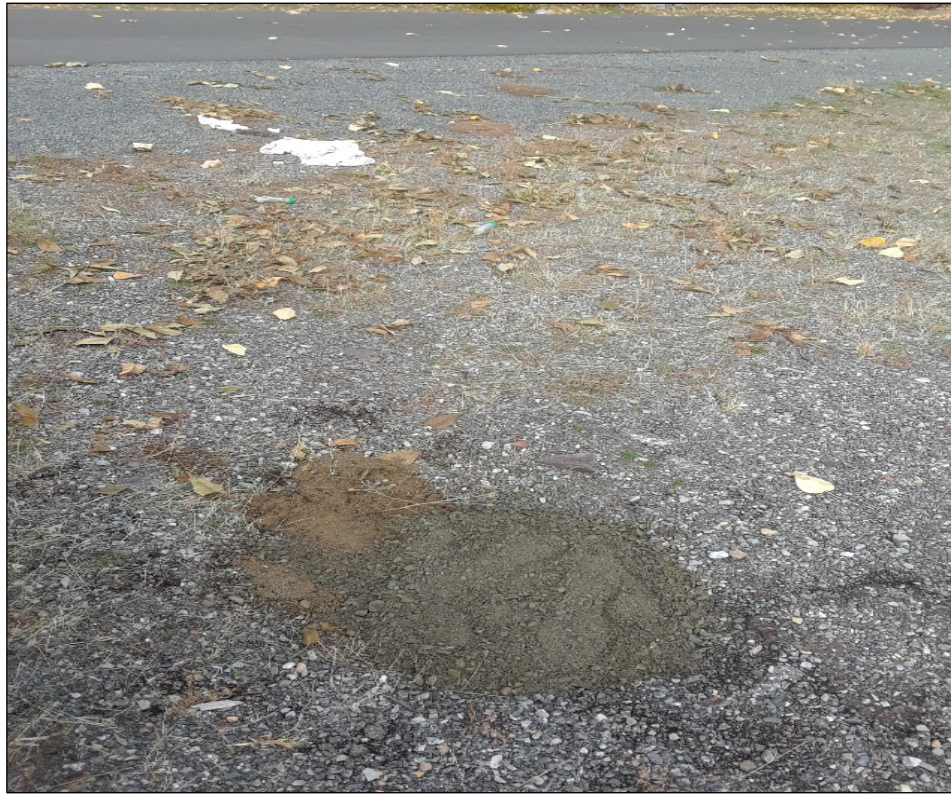
9. View of filled-in animal burrow near Ben Burr Trail, west of James Keefe Bridge (looking north).

- **Soil Cap.** The soil cap was observed to be in good overall condition with no settlement or erosion. A single animal burrow was identified west of the James Keefe overpass (coordinates: latitude 47.65899983, longitude -117.39674965). The burrow was filled in with clean crushed rock on October 24, 2019.

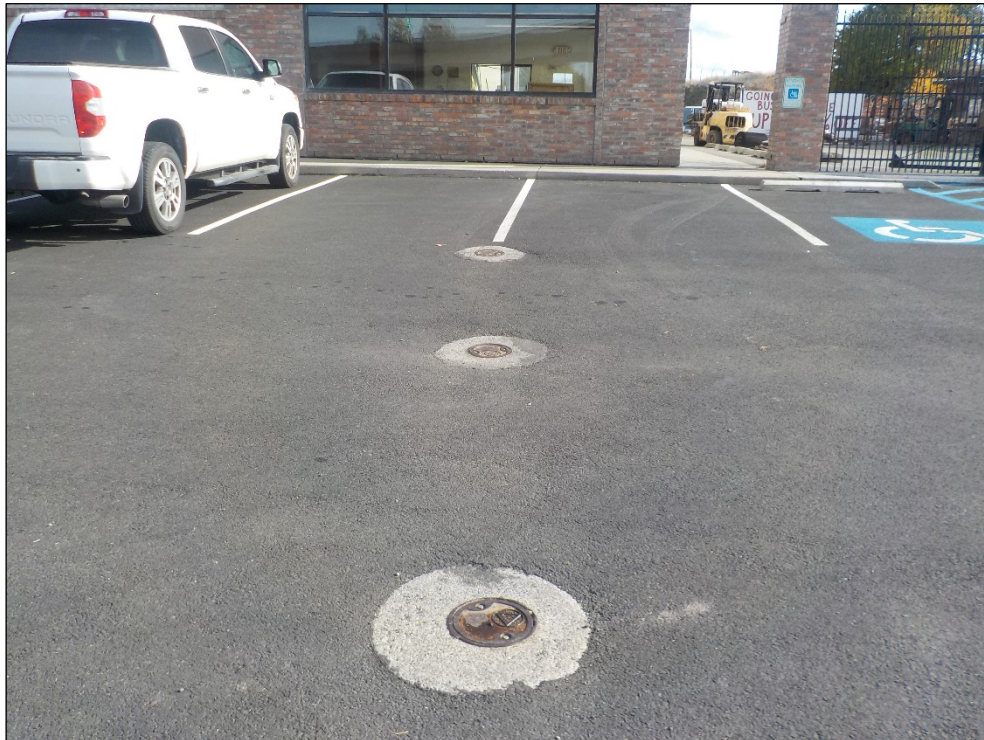
- **Monitoring Wells**. All monitoring wells were secure and observed to be in good condition. The parking lot containing monitoring wells MW9-20, MW9-40, and MW9-100, east of North Erie Street, was repaved in 2019; however, the wells and their monuments did not appear to be affected.

10. New asphalt pavement surrounding monitoring wells MW9-20, MW9-40, and MW9-100 (looking east).
