Memorandum

March 11, 2019

Re: Northern Shelton Harbor Interim Action: Water Quality Monitoring and Cap Construction Status

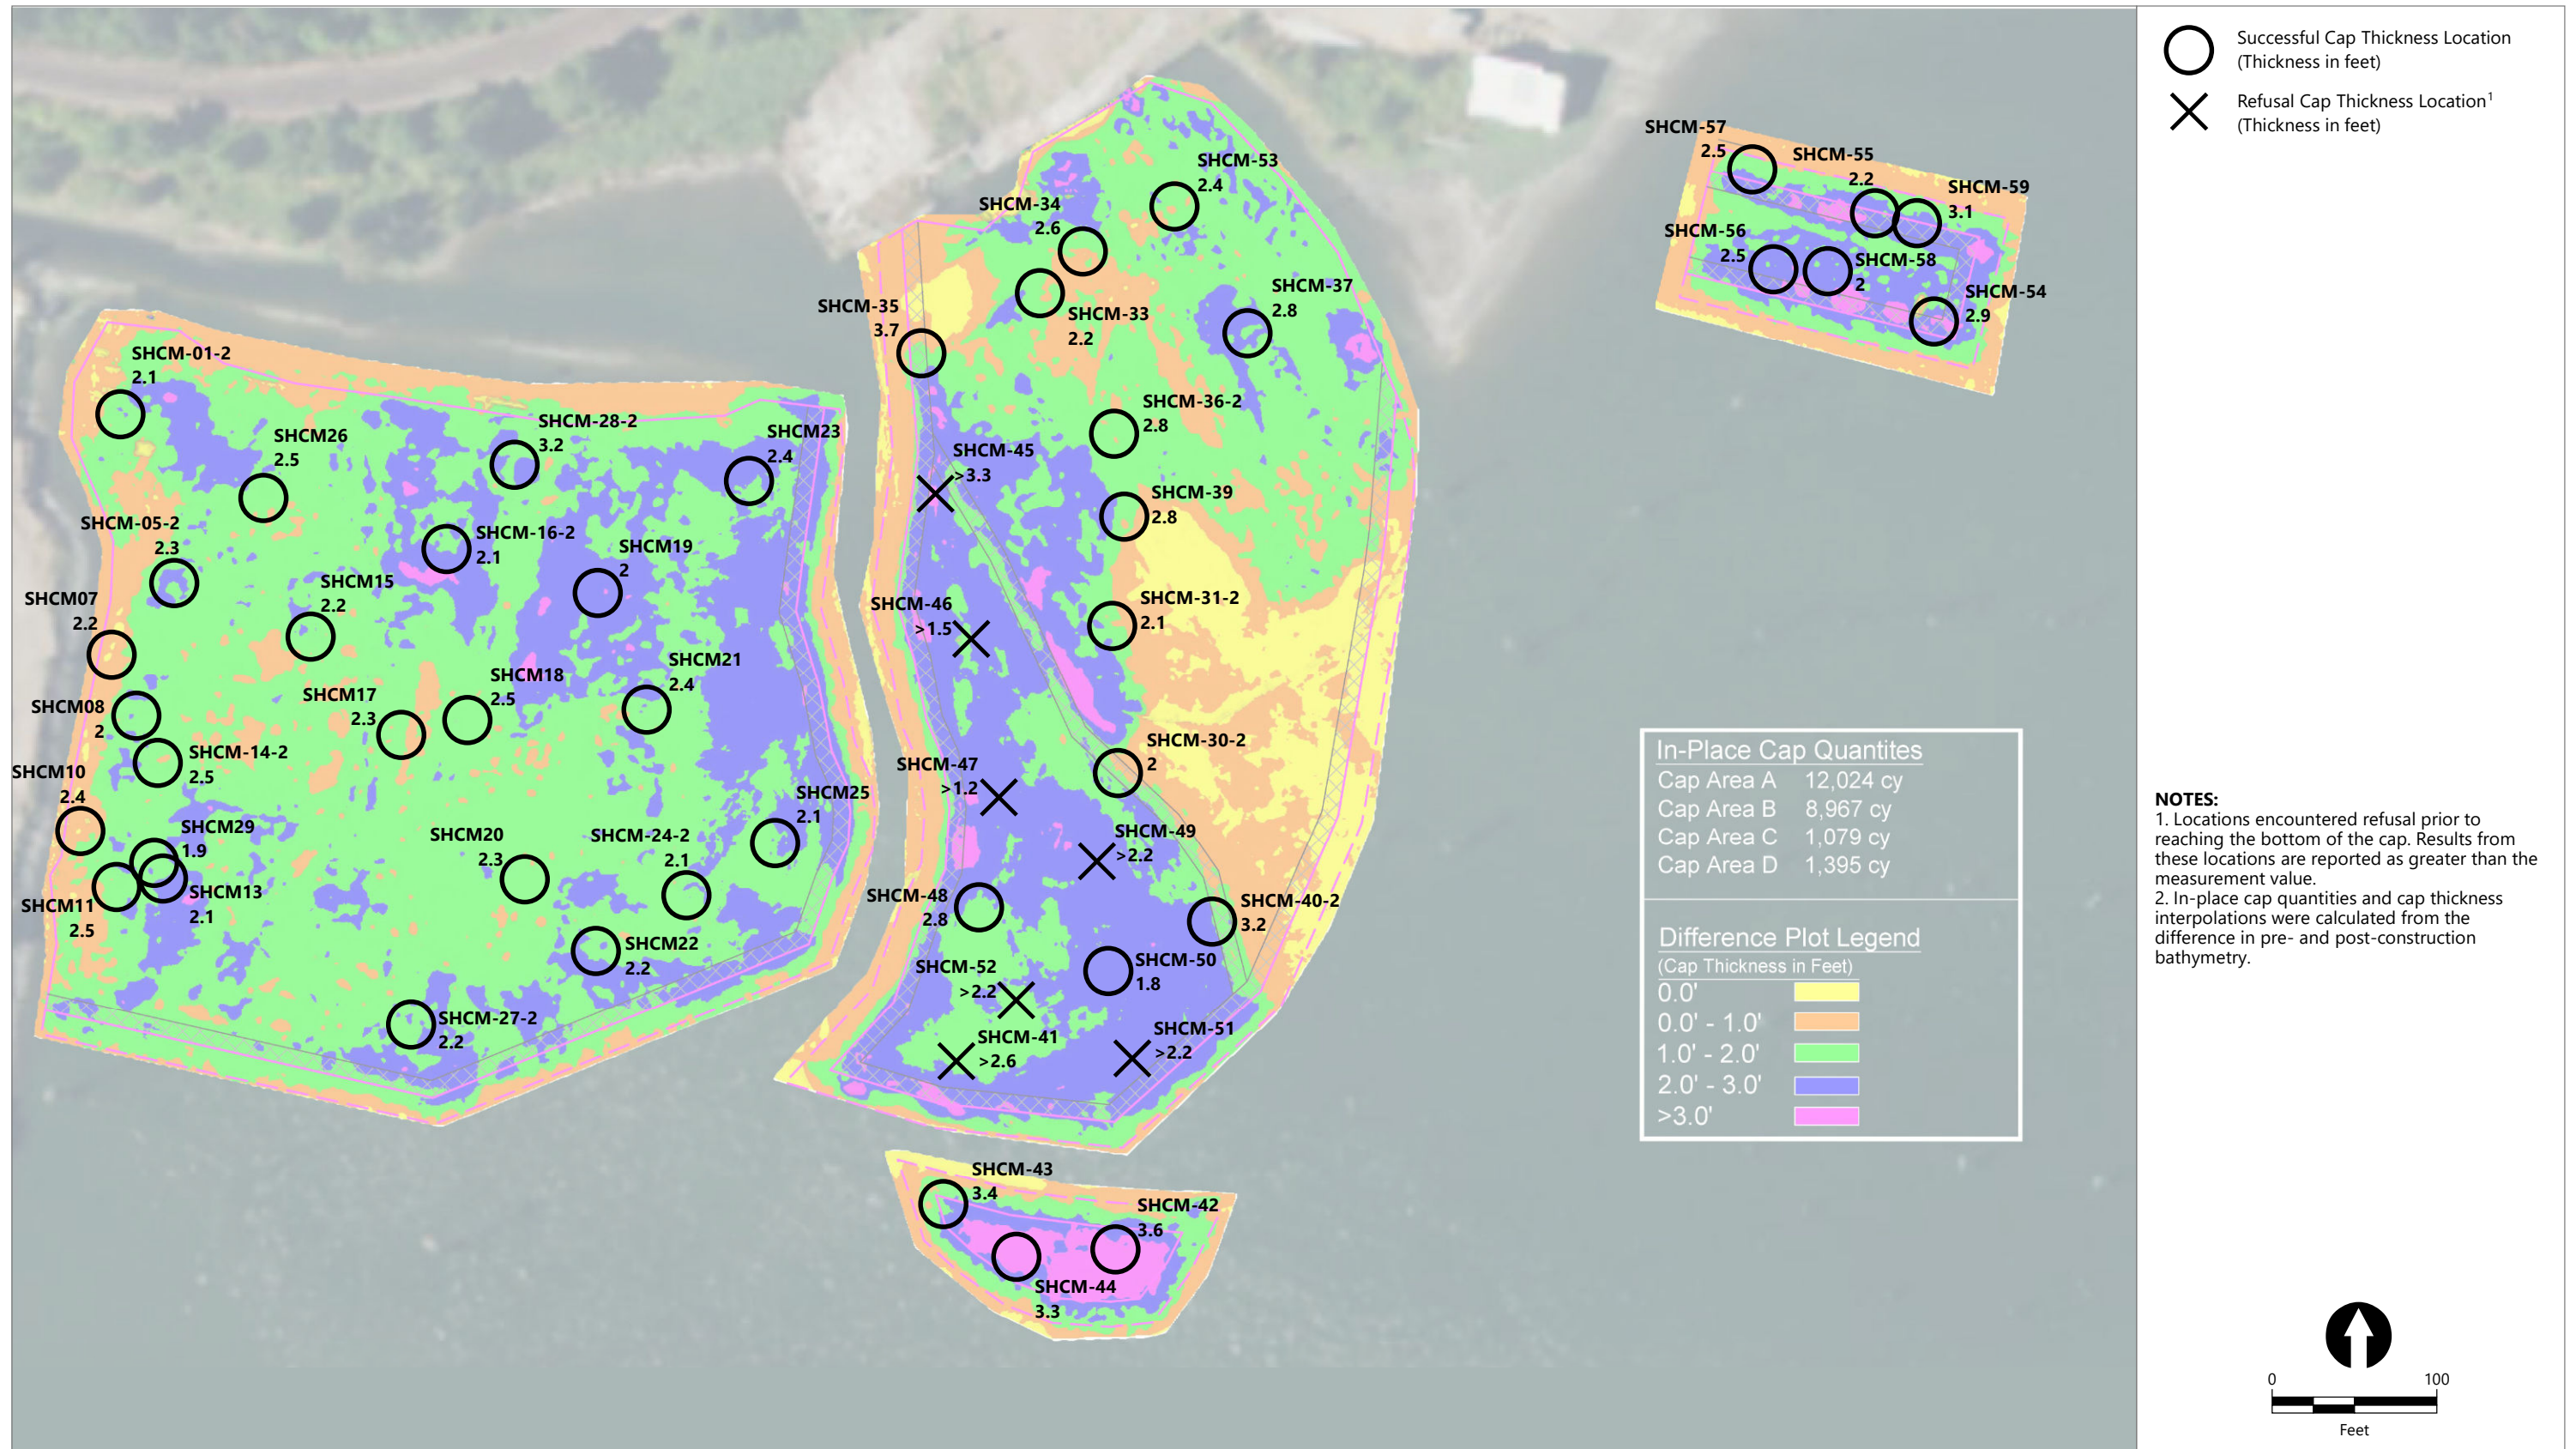
Figure 1
Cap Thickness and Probing Locations
 Northern Shelton Harbor Interim Action: Water Quality and Cap Thickness Status
 Oakland Bay and Shelton Harbor Sediments Cleanup Site

Based on a comparison of pre- and post-construction bathymetric survey data as summarized on Figure 1, cap placement resulted in a net in situ volume increase in areas A through D of approximately 23,500 cy, roughly 67% to 72% of the placed volume. The difference between placed and in situ volumes is attributable to subgrade consolidation settlement, which averaged approximately 1.0 feet, consistent with BODR estimates.

As set forth in the BODR and CQAP, the minimum cap design thickness of 18 inches must be achieved across at least 95% of the cap surface area. This performance criterion was assessed based on direct cap thickness probing measurements to account for subgrade settlement observed below the cap. Because cap probing was impractical in the thickened edges, and probe refusal was encountered at some cap locations, probing measurements were supplemented with pre- versus post-construction bathymetric survey data. As depicted in Figure 1, the combined probing data and bathymetric surveys verified that at least 24 inches of cap material was successfully placed across more than 95% of the cap areas, exceeding the minimum cap design thickness of 18 inches.

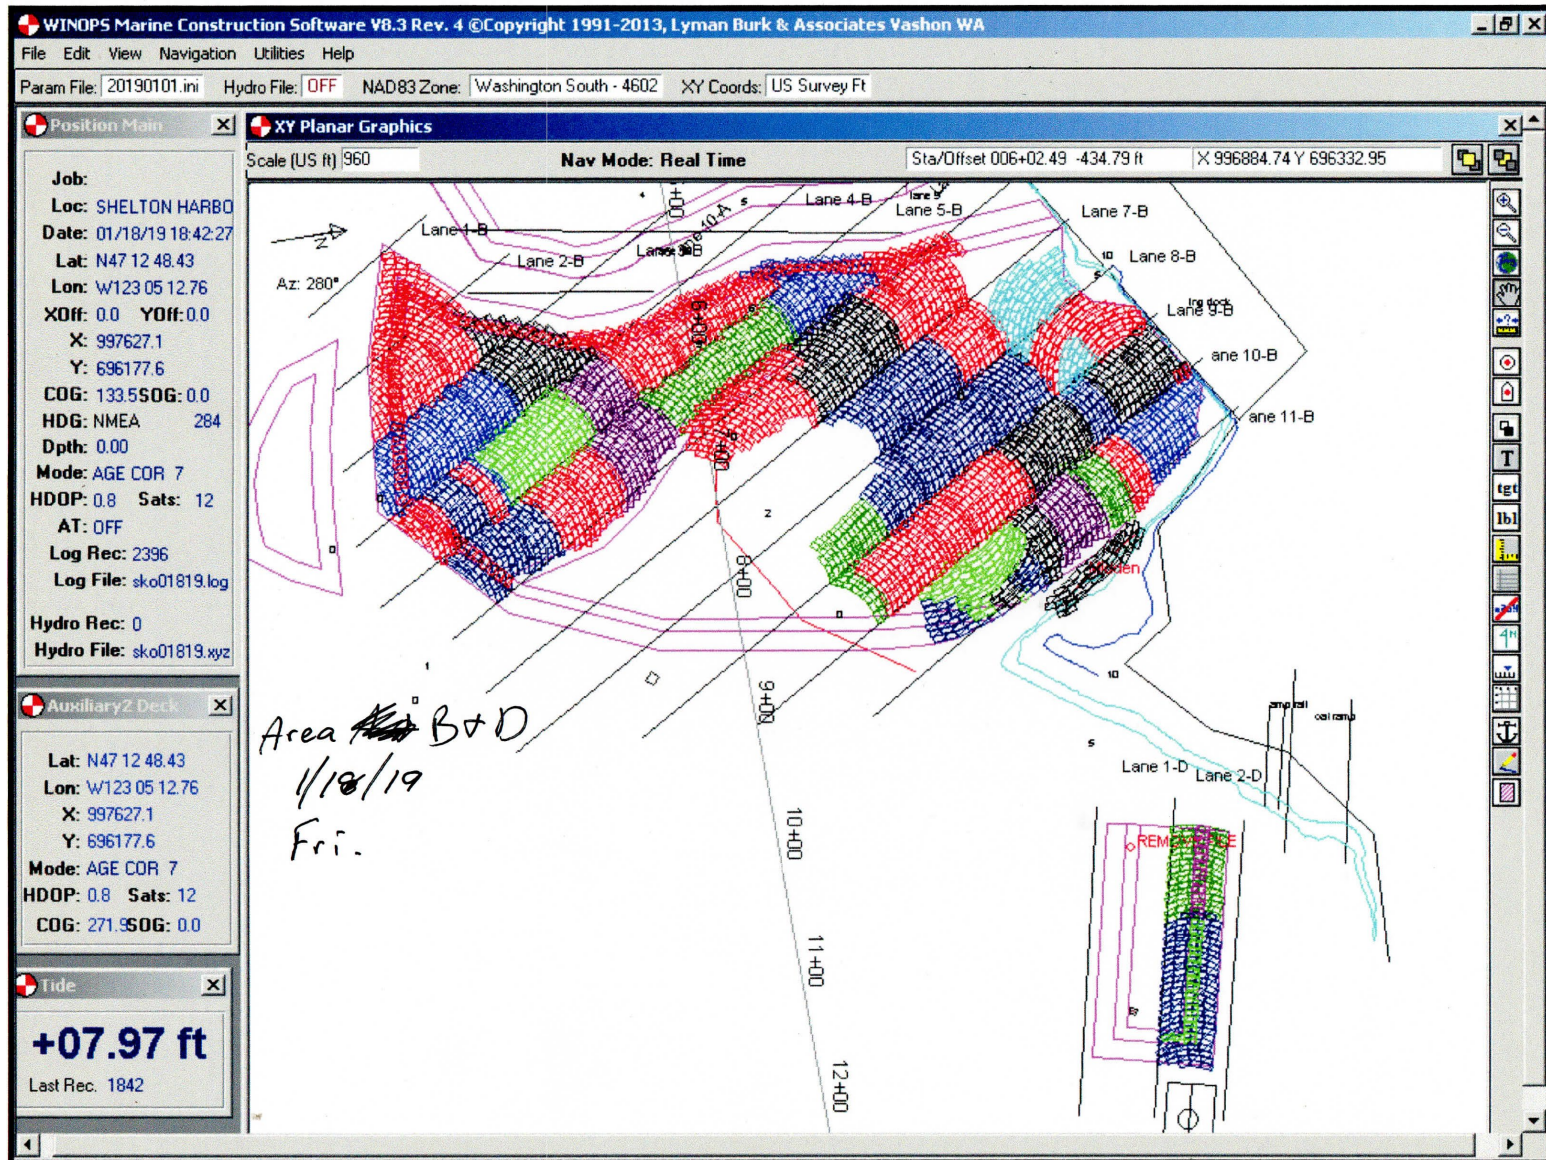
Figure 3
Contractor Bucket Map – Cap B

As discussed above, a section of cap area B remains incomplete to allow access to the upland staging area to support capping planned for the southern portion of the Shelton Harbor SCU in summer 2019. Completion of all interim action caps is scheduled for summer/fall 2019.
