Memorandum

November 13, 2019

Re: Shelton Harbor Interim Action: Season 2 Water Quality and Cap Thickness Monitoring

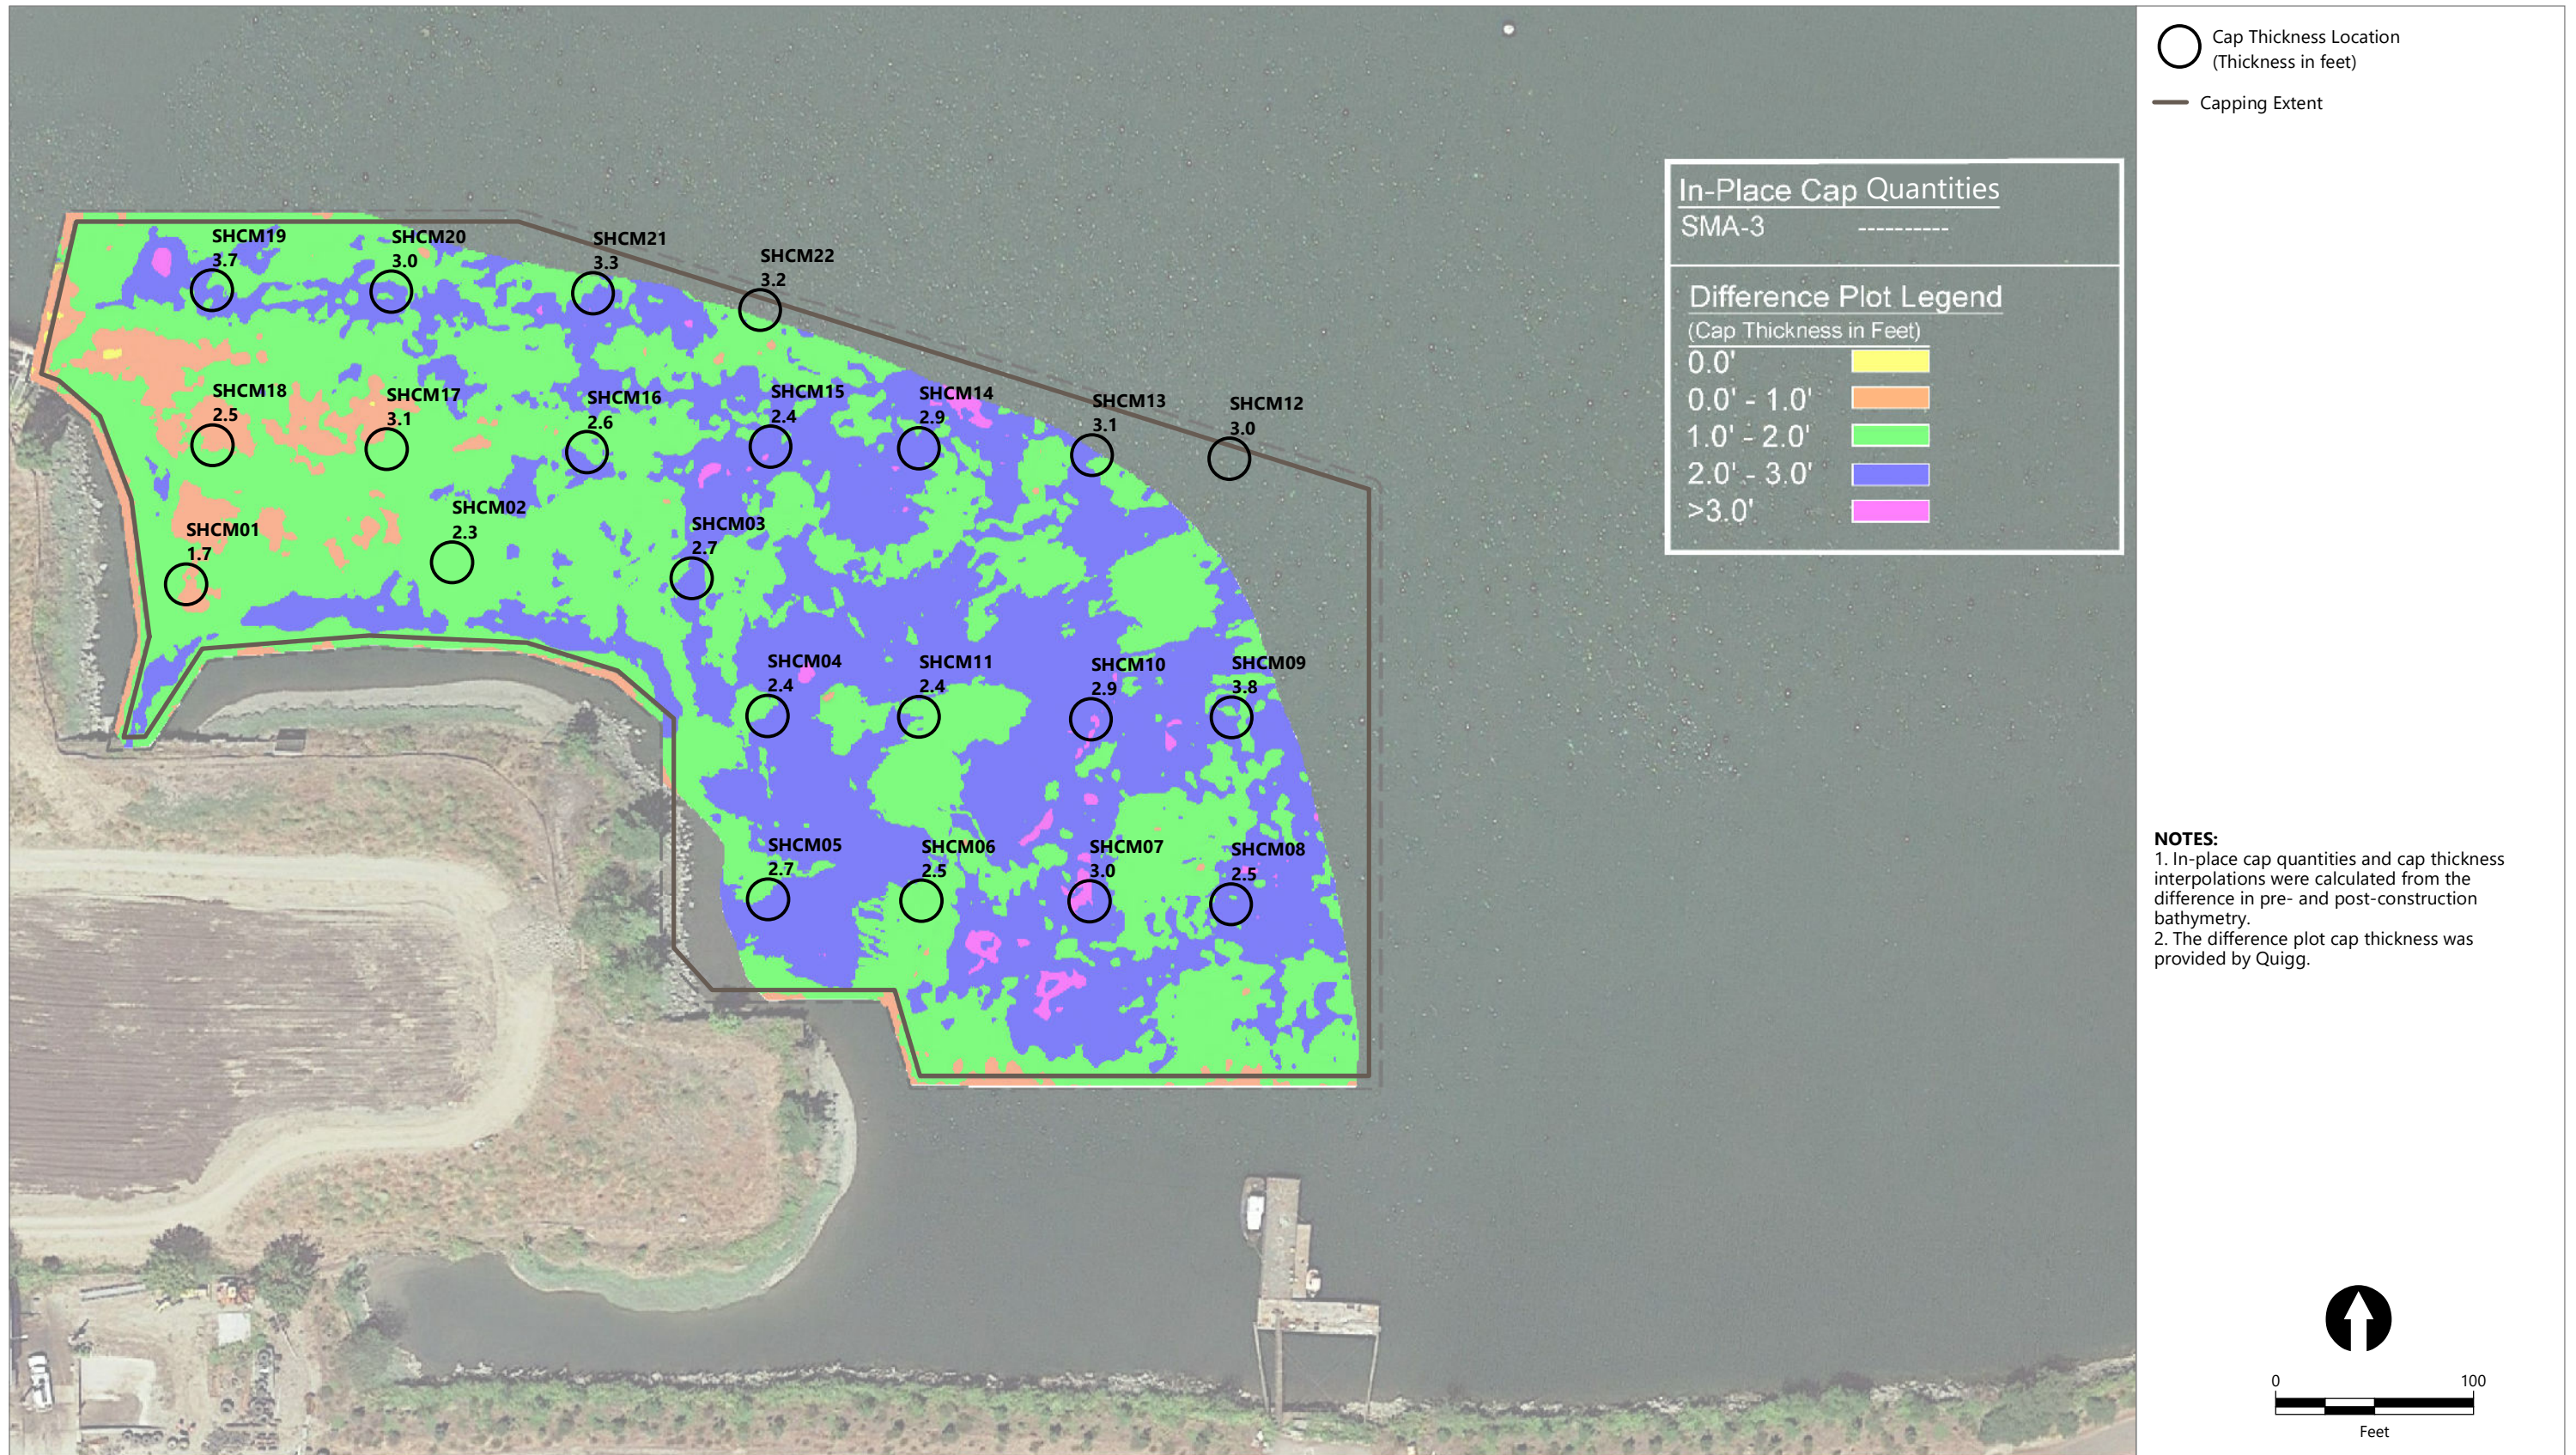
Figure 1
Cap Thickness and Probing Locations – SMA-3
Shelton Harbor Interim Action: Season 2 Water Quality and Cap Thickness Monitoring
Oakland Bay and Shelton Harbor Sediments Cleanup Site

The comparison of pre- and post-construction bathymetric survey data is shown in Figures 1 and 2 within Season 2 placement areas covered by both surveys. As observed in Season 1, due to soft native sediments, significant settlement occurred in the subgrade as a result of cap material placement, resulting in an average apparent thickness from bathymetric surveys that was less than the actual placed thickness. Based on the cap thickness monitoring lines of evidence, the subgrade settled 0.4 to 0.5 foot on average, consistent with BODR estimates (Anchor QEA 2018).

As set forth in the BODR (Anchor QEA 2018) and CQAP (Appendix D of the BODR), the minimum cap design thickness of 1.5 feet must be achieved across at least 95% of the cap surface area. This performance criterion was assessed based on direct cap thickness probing measurements, which account for subgrade settlement below the cap. Because probe refusal was encountered at some cap locations, probing measurements were supplemented with pre- versus post-construction bathymetric survey data. As depicted in Figures 1 and 2, the combined probing data and bathymetric surveys verified that at least 2.0 feet of cap material was successfully placed across more than 95% of the cap areas, exceeding the minimum cap design thickness of 1.5 feet.

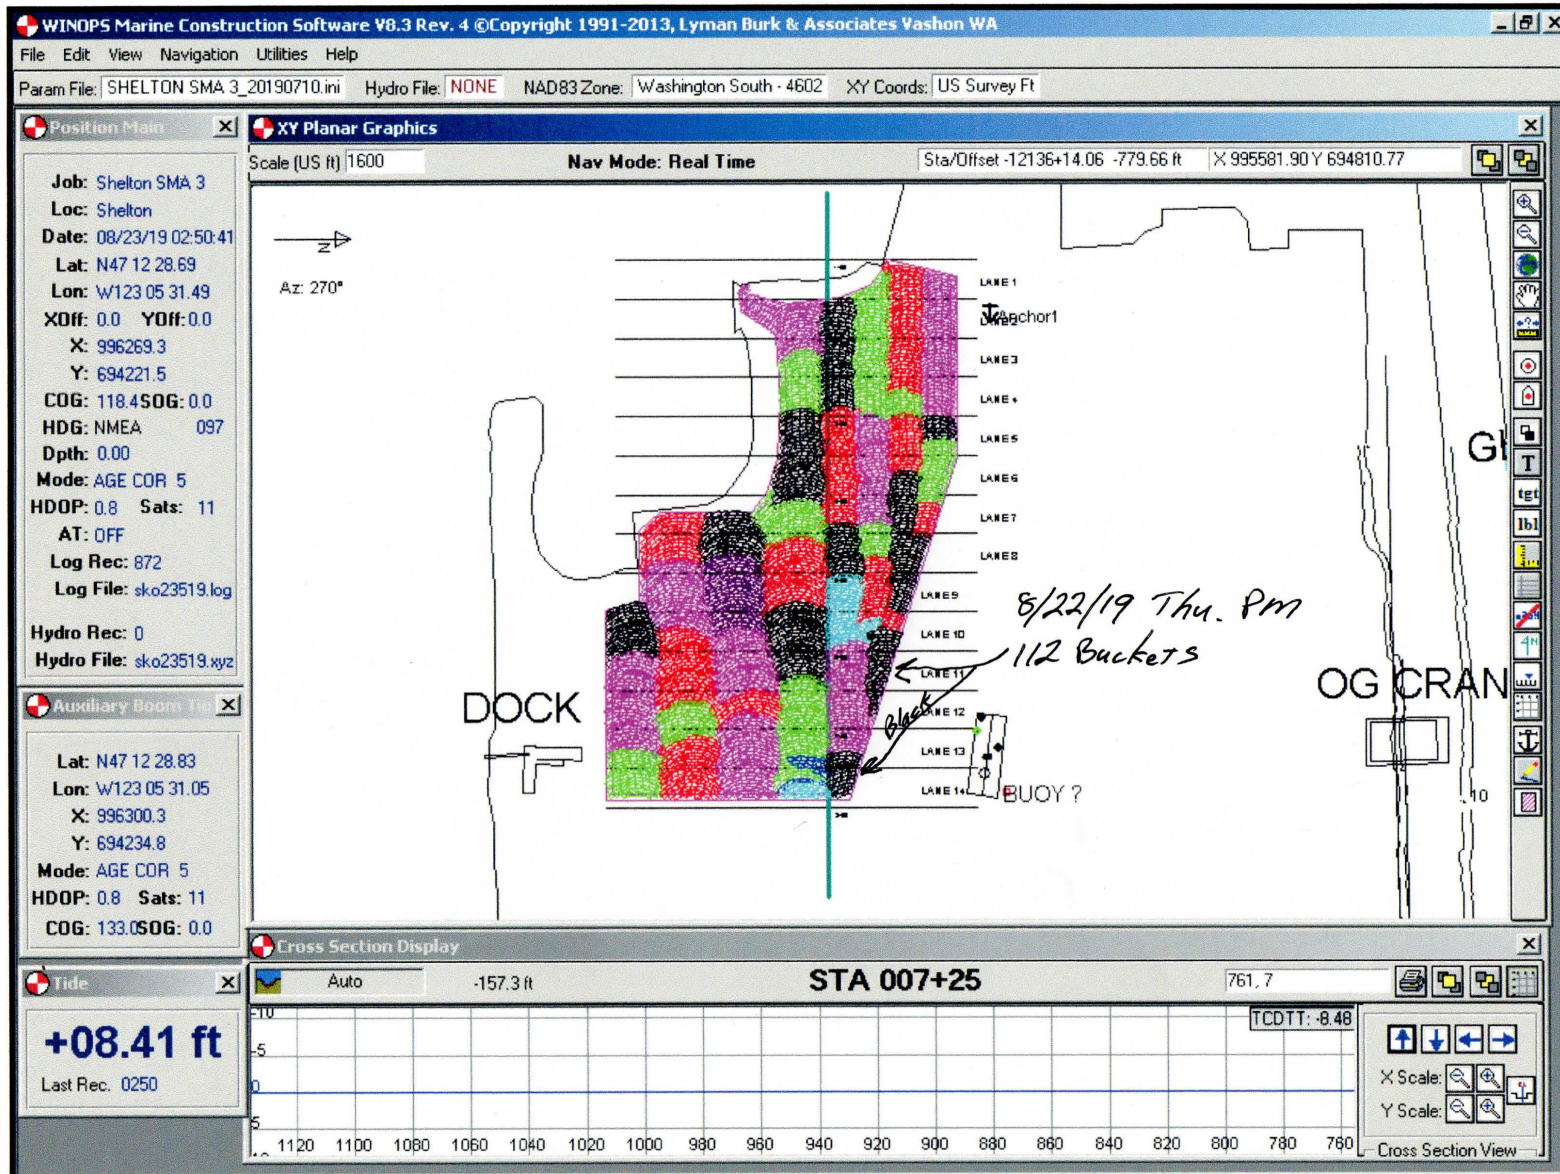
Figure 3
Contractor Bucket Map – SMA-3

Contractor bucket maps demonstrated complete coverage throughout the capping areas (Figures 3 through 5). The average thickness in the capping areas was estimated by dividing the volume placed by the placement area. The total volume of material placed was estimated based on bucket map counts and a calibrated bucket volume of 3.5 cubic yards (5.9 tons). Note that material delivery tickets to the upland transload facility were approximately 14% higher than the calibrated bucket volume, so the bucket volume is considered a minimum estimate. The placement surface area was calculated based on the area covered by the bucket maps. From this method, SMA-3 had an average placement thickness of 2.3 feet, above the minimum post-construction thickness of 2.0 feet (Table 2). SMA-1 Cap B had an average placement thickness of 2.6 feet, above the minimum cap placed thickness of 2.3 feet in the area (SMA-1 Cap B had a thicker average cap than SMA-3 because of thickened edge features in the area).
