LOWER DISPOSAL AREA – INTERCEPTOR TRENCH PROJECT

CONSTRUCTION SUMMARY REPORT

RAVENSDALE SITE

January 8, 2014

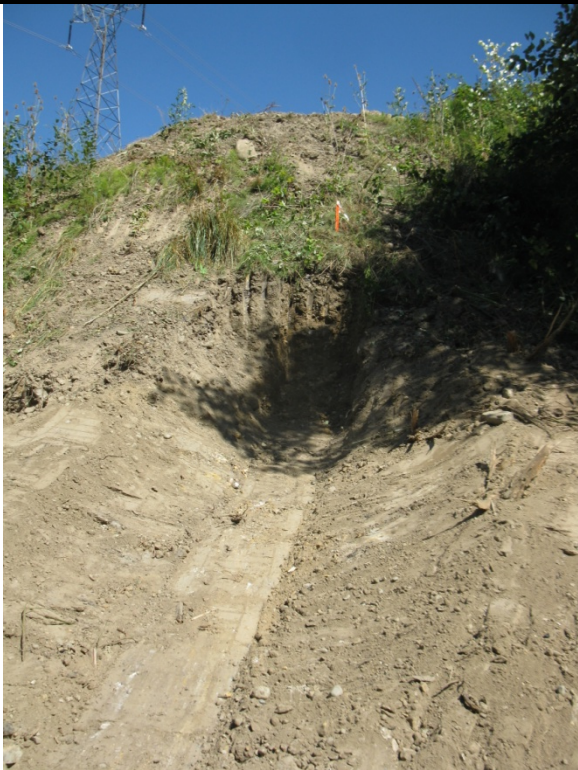
Location of discharge pipe outlet varies from the drawings on plan sheets, outlet is mid-way up slope instead of at toe as shown in drawings. Vanessa Rayner contacted Frank Shuri to inform him of difference in elevations and engineer recommends that rip-rap apron below pipe discharge be extended to bottom of slope.

Discharge pipe outlet.

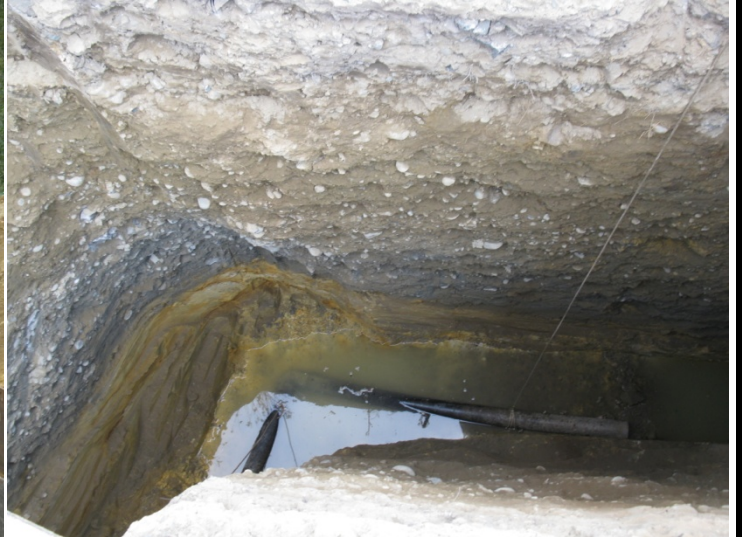
*amount of water observed in interceptor trench today in the corner of trench near piezometer B-11 has increased slightly. Water appears to have migrated through orange sandstone at bottom of trench. Water approx. 6"-7" deep and puddle was 3' x 5'

Water infiltrated into trench near piezometer B-11.

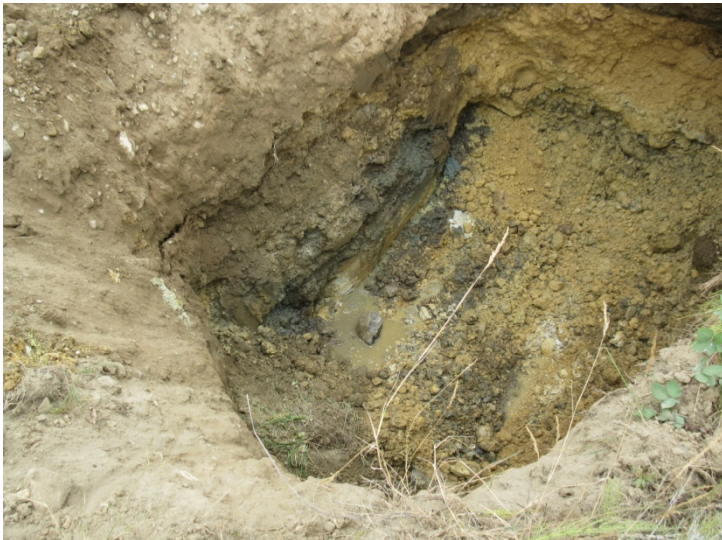
2:20pm at the request of Frank Shuri, Test pit #2 is re-dug.
0'-3' brown, compact silty-sand with gravel and cobbles, dry, organics. (mine spoils/fill)
3'-6' transition to light orange, loose, silty-sand with gravel, wet.
6'-8' water producing gravel lens, brownish-gray, gravel with sand and trace silt, loose, wet, estimated flow 2 g.p.m. flow concentrated in north-east corner of pit indicating water is flowing south(coming from CKD area) see photos. *note this material was not encountered when excavating main infiltration trench.
8'- ? orange, mottled, sandstone, compact, damp. (weathered bedrock similar to what was encountered in main interceptor trench). Pit was only approx. 8' b.g.s. hole caving in frequently loose backfill from previous digging of pit. Stratigraphy somewhat jumbled also most likely due to previous digging in this area.

North and east walls of Test Pit #2 re-dig.

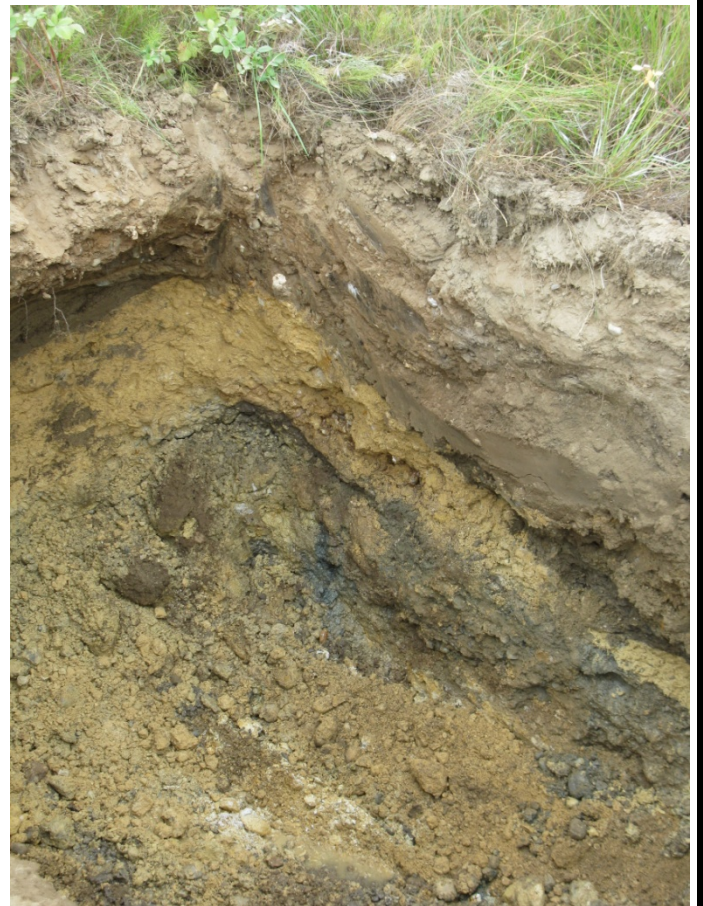
East and south walls of Test Pit #2 re-dig.

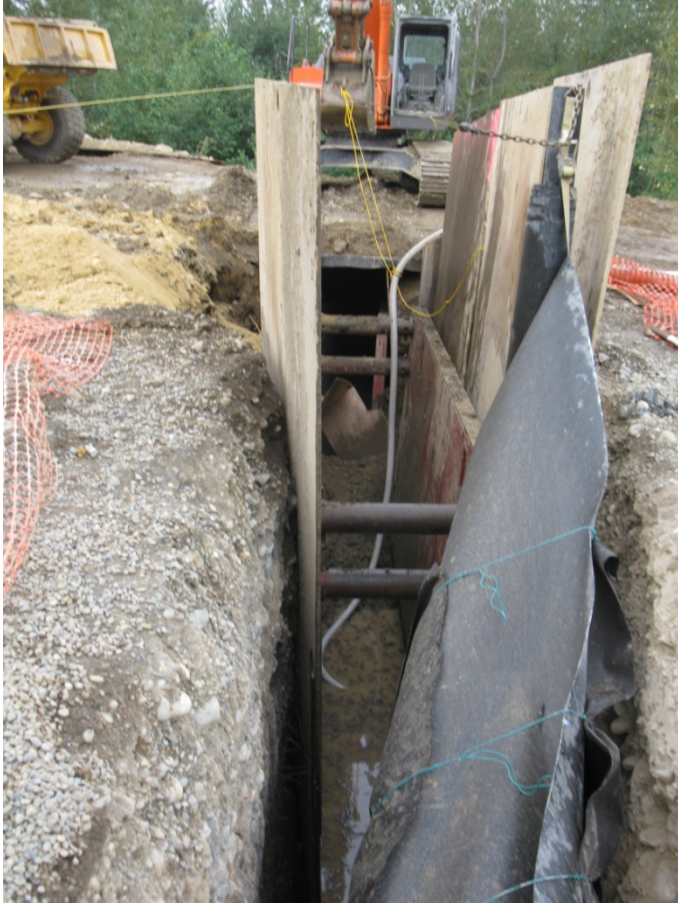
Water in bottom of trench.

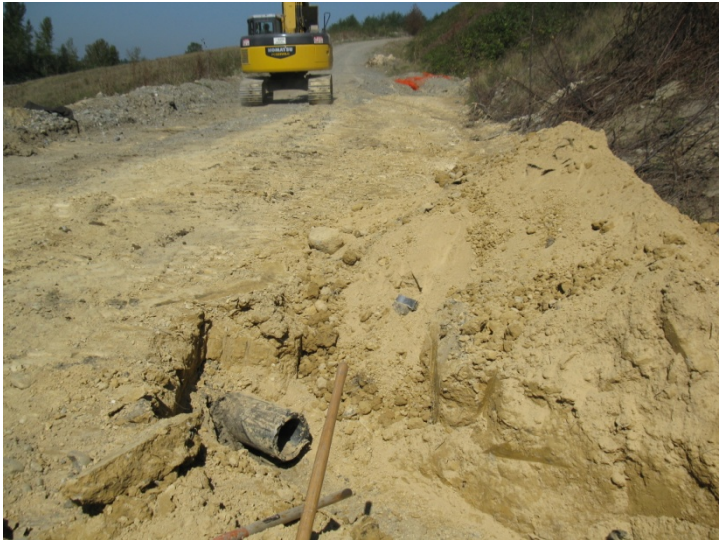
10" HDPE culvert to be repaired.

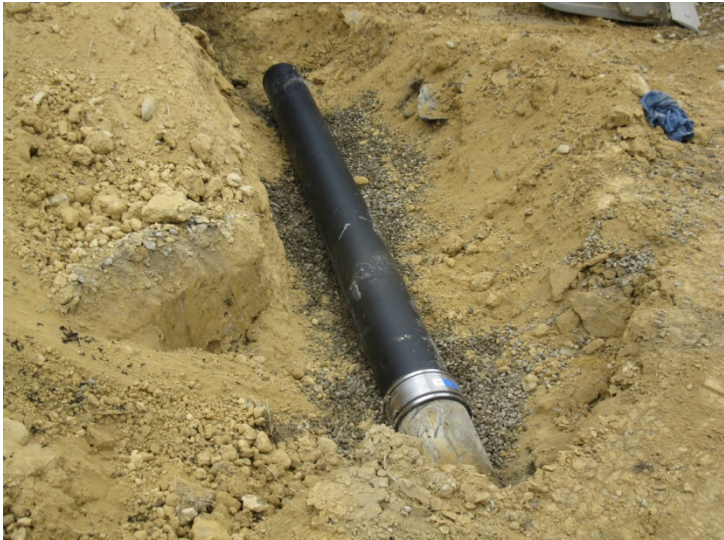
10" HDPE Culvert repair.

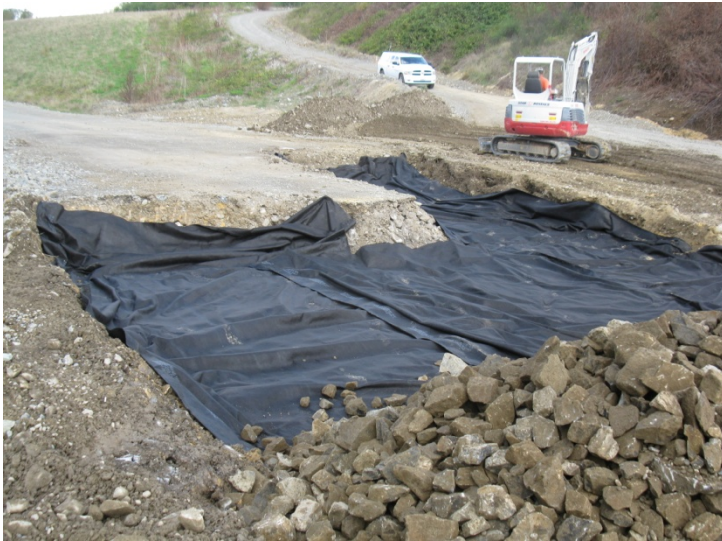
After construction activities were completed, some rutting was observed in the main access road where it crossed the interceptor trench and plug zone, so Clearcreek returned to repair the road as requested by Reserve Silica Corporation. Approximately 2 to 3 feet of material was excavated from an approximate 40-foot by 40-foot area. Geotextile was placed at the bottom of the excavation, followed by a 2- to 3-foot layer of 4- to 8-inch quarry spalls, followed by 2 to 4 inches of 2-inch crushed rock surfacing material. Quarry spalls were bucket-tapped into place, and the 2-inch crushed rock surfacing material was compacted by the Komatsu excavator with hoe-pack attachment.

Haul road repair with geotextile fabric and quarry spalls

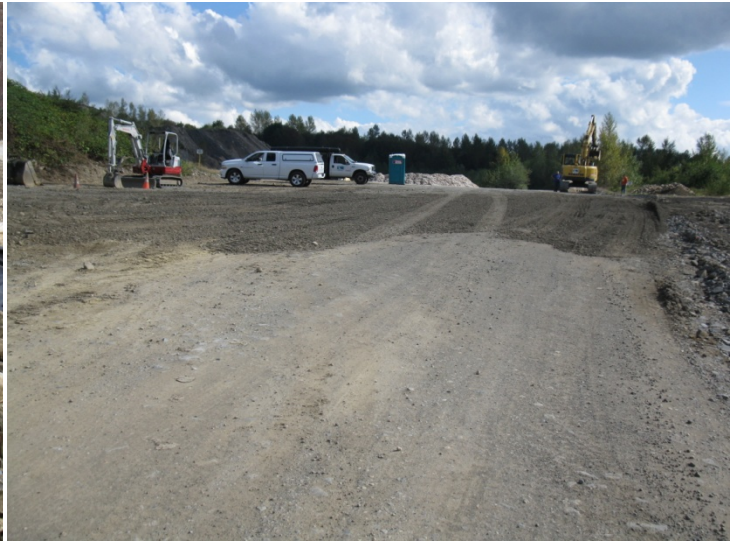
Finished road repair with -2" top course.

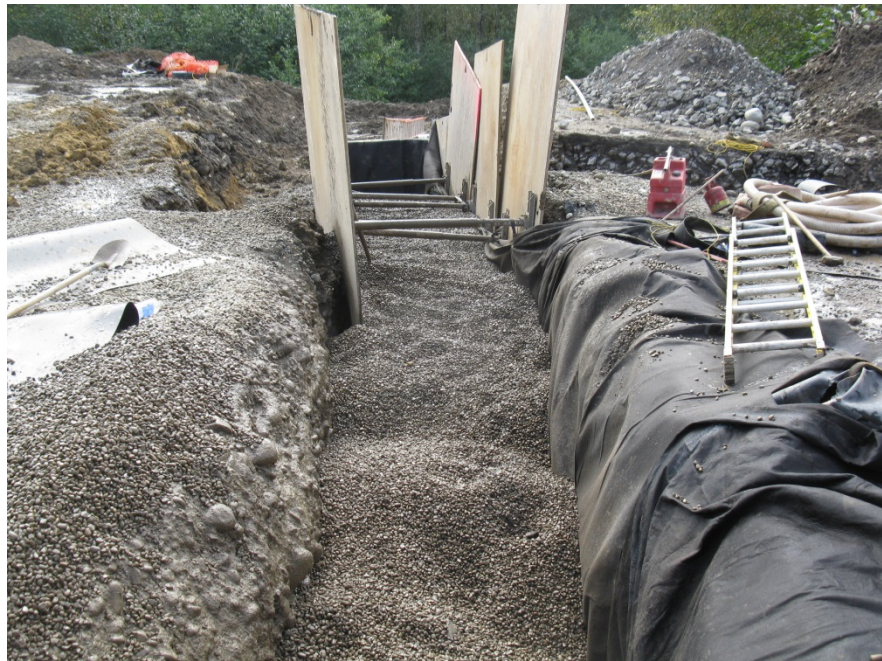
PHOTO 20

Excavation of TP-2 trench; note seepage in TP-2 in foreground (looking south).

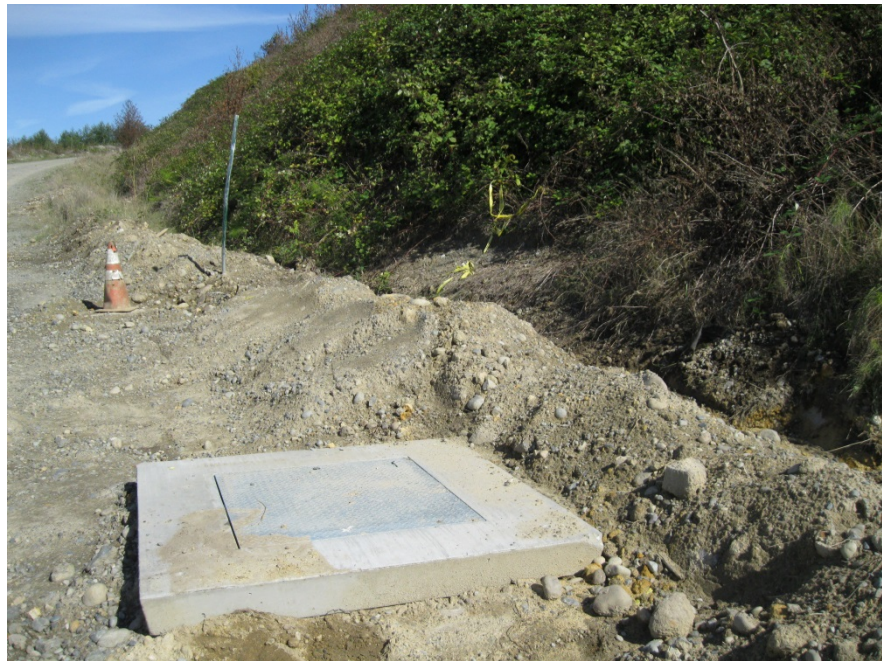
PHOTO 28

Reconstruction of main access road (looking north, north access road in background).
