PERIODIC REVIEW

Newcastle Coal Creek Landfill
Facility Site ID#: 2044
Cleanup Site ID#: 4812

15500 Six Penny Lane
Newcastle, WA 98059

December 2019

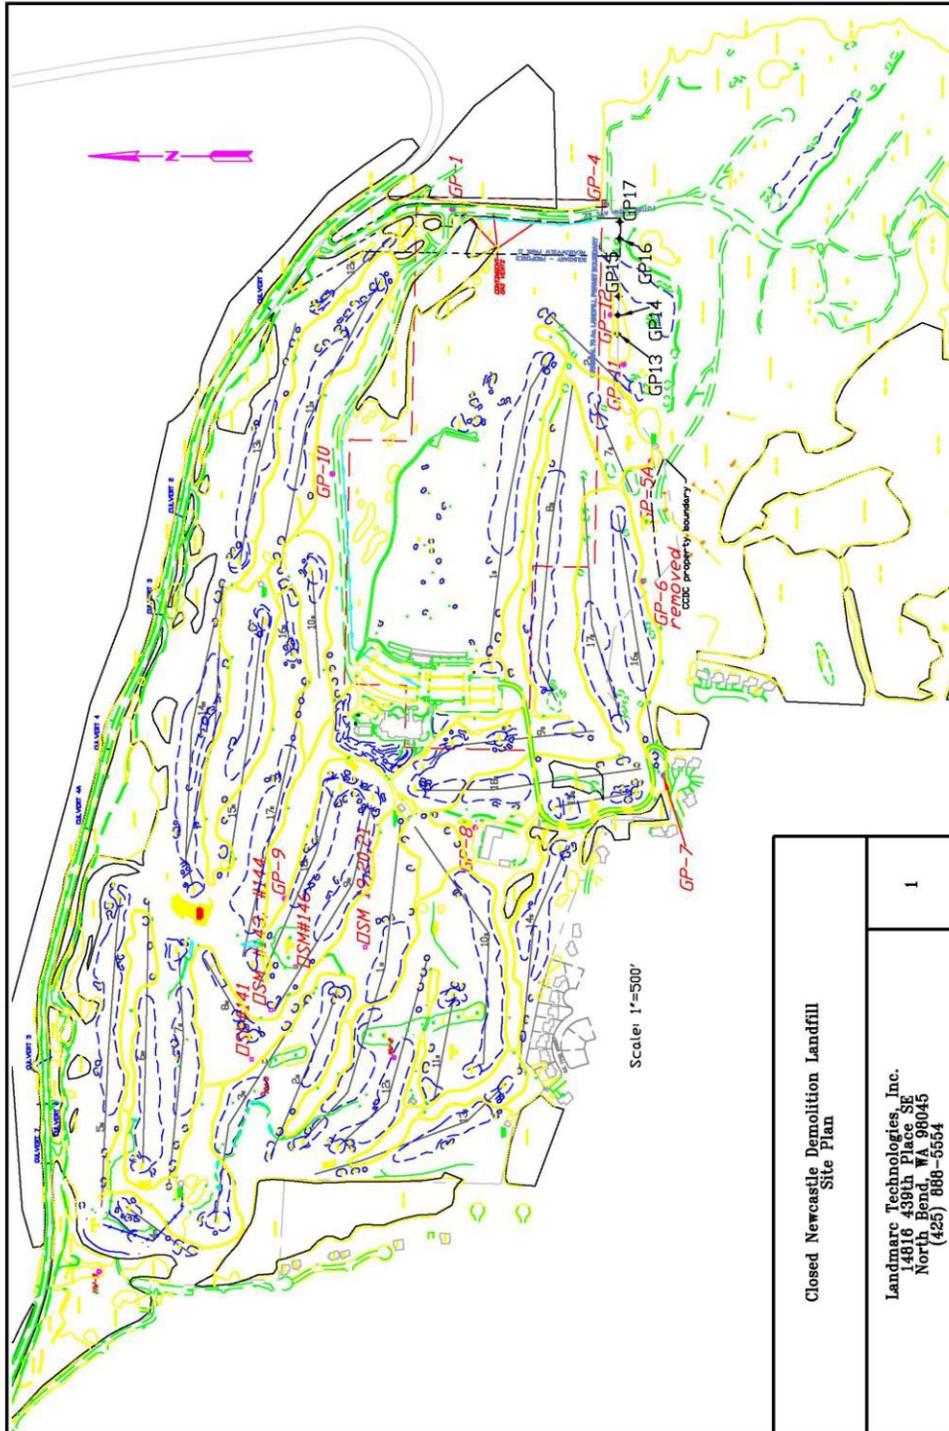
6.5 Gas Probe Locations

Landfill gas is generally undetectable based on data collected from 2002 to 2012. The locations of the gas probes are shown in Appendix 6.5. Methane is generally much lower than 5% in all the probe locations except for Probe G-16. Methane concentration was greater than 50% at the time G-16 was installed in 2004. As a result, a blower was installed and the concentration of methane fell below 5%. However, it was noted that the methane concentration went up to more than 5% in summer 2012. In addition to notification of PHSKC, mitigation procedures were implemented by the golf club and this probe is being monitored at an increased frequency.

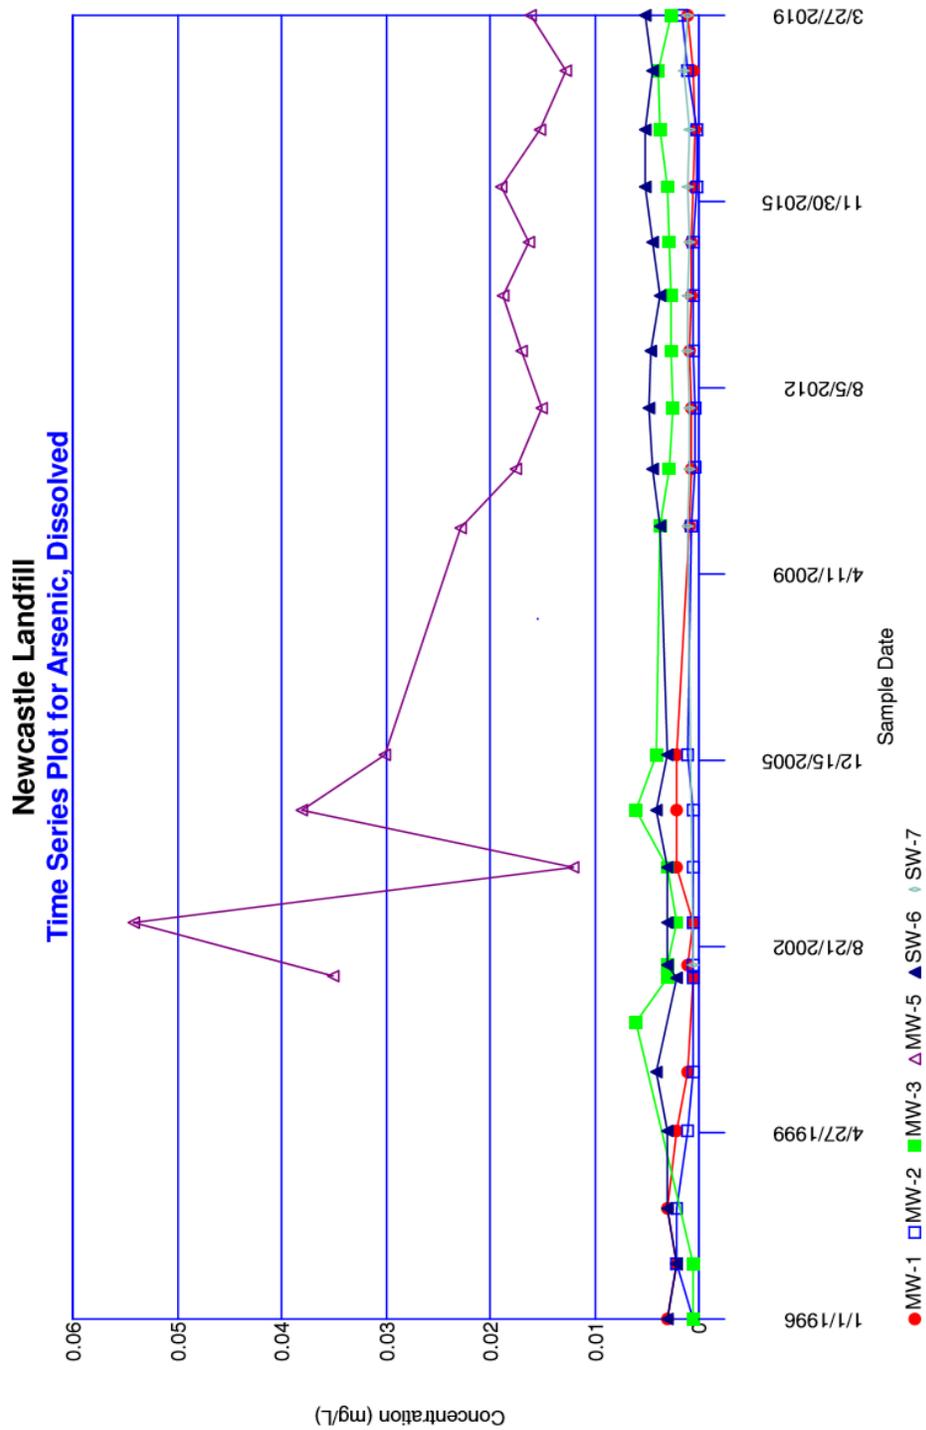
6.11 Time Series Plot for Dissolved Arsenic in Ground Water

Concentrations of dissolved arsenic were above the state ground water quality standards in most sampling events from both upgradient and downgradient wells. However, all the arsenic concentrations were below the state Maximum Contaminant Level (MCL) for drinking water (10 µg/L), except in MW-5 with concentrations ranging from 10 to 50 µg/L over time. The arsenic concentrations in MW-5 have ranged from 11 to 16 µg/L since 2011, so appear to be decreasing. A time-series plot for dissolved arsenic in ground water is shown on Appendix 6.11.

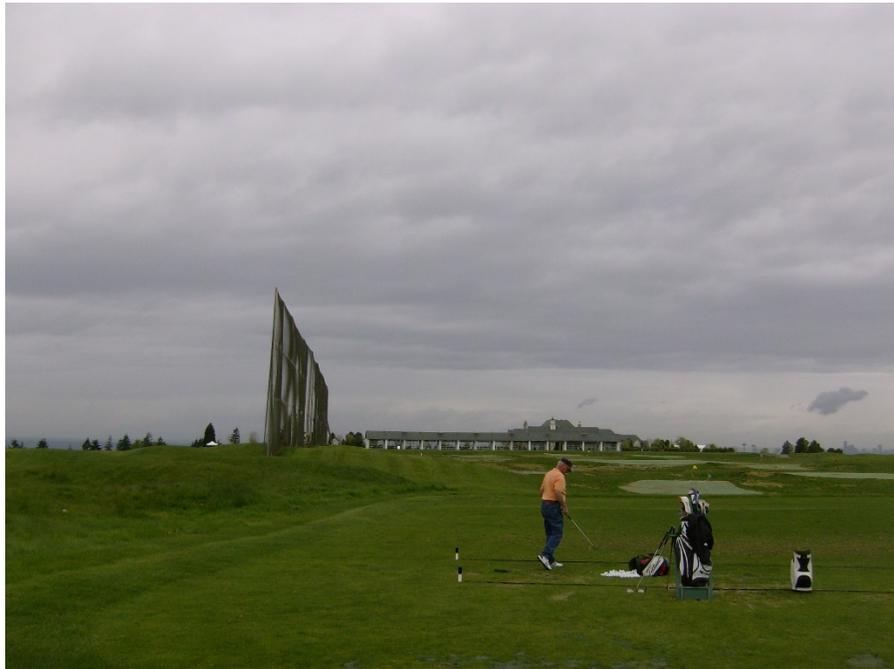
Photo 1: Driving range in the eastern portion of the property

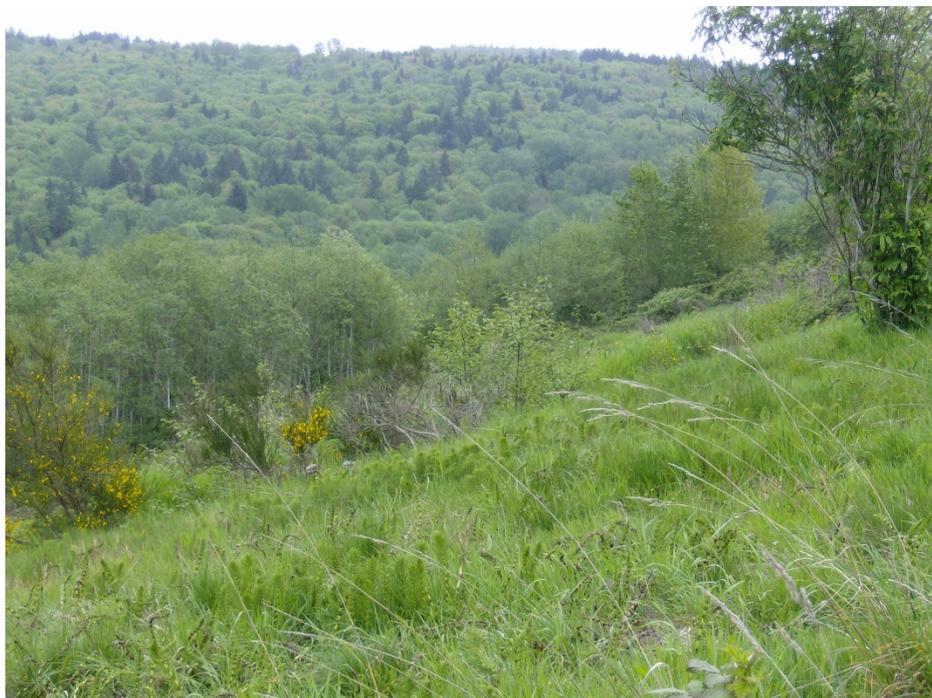
Photo 2: Vegetated slope in the northern portion of the property

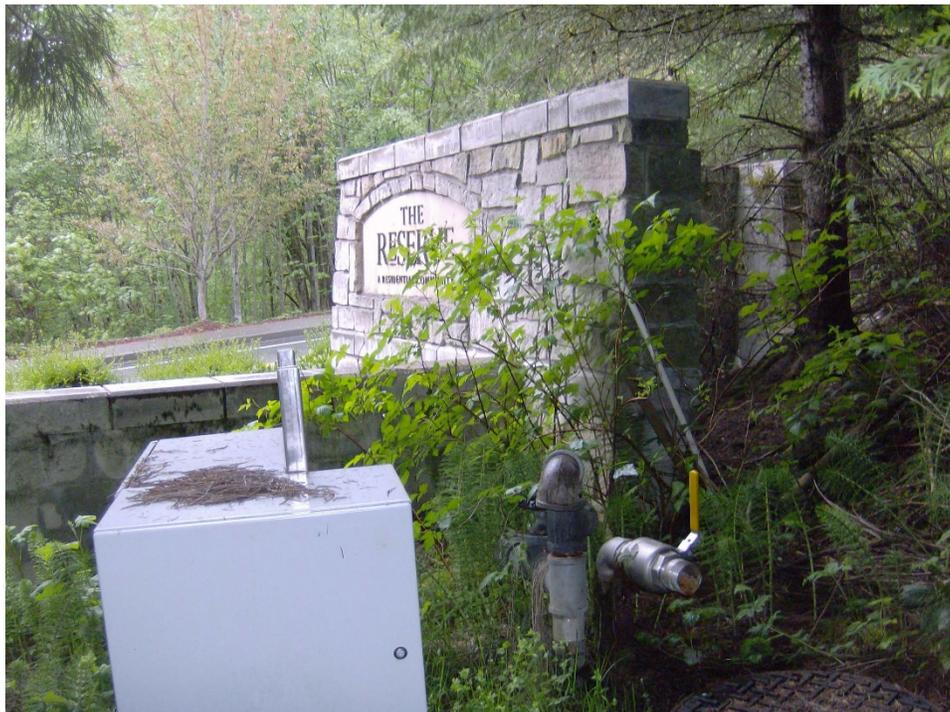
Photo 6: Leachate pump station in the southeast corner of the property

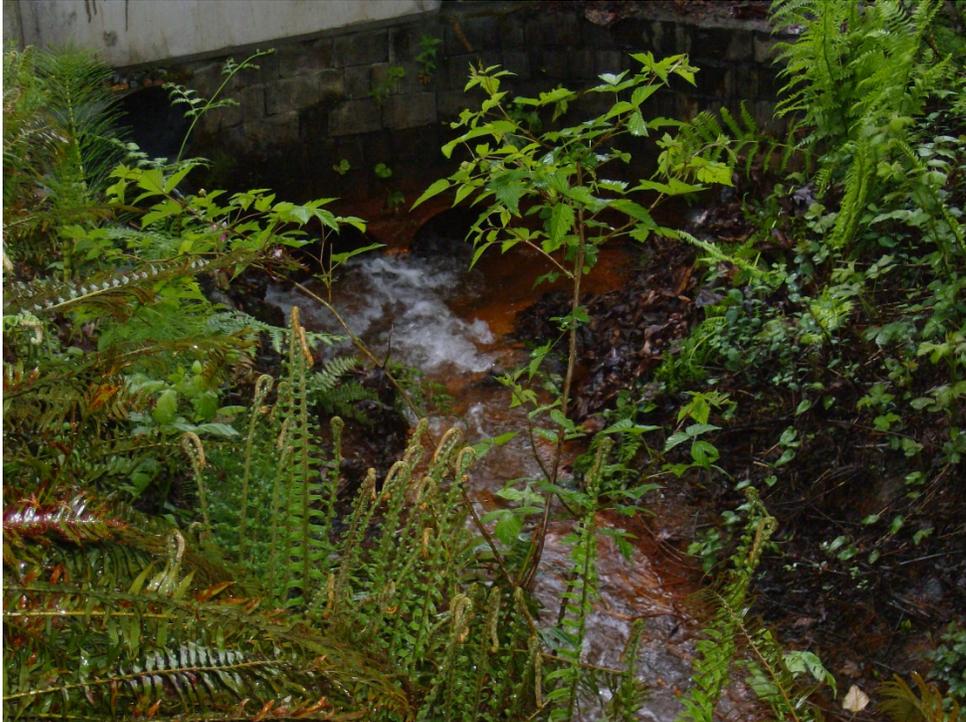
Orange staining (likely iron oxidizing bacteria) was observed at the Richmond Tunnel mine discharge, which is in the vicinity of sampling location SW-6 in Coal Creek. This type of condition can occur at former landfills and mines, but can also be naturally occurring based on the iron content in the soil and oxygen content in the groundwater. Elevated dissolved iron has been detected in groundwater and appears to be associated with local geochemistry rather than the landfill (see Section 2.8).

Photo 7: Orange staining (likely iron oxidizing bacteria) observed at the Richmond Tunnel mine discharge in the vicinity of sampling location SW-6 in Coal Creek
