February 19, 2020

**Re: Further Action at the following Site:**

- **Site Name:** Mutual Materials Newcastle Lot 4 Cr Site
- **Site Address:** 6620 Coal Creek Parkway SE, Newcastle, WA 98056
- **Facility/Site No.:** 50608
- **Cleanup Site ID No.:** 15081
- **VCP Project No.:** NW3248

**YES. Ecology has determined that further remedial action is necessary to clean up contamination at the Site.**

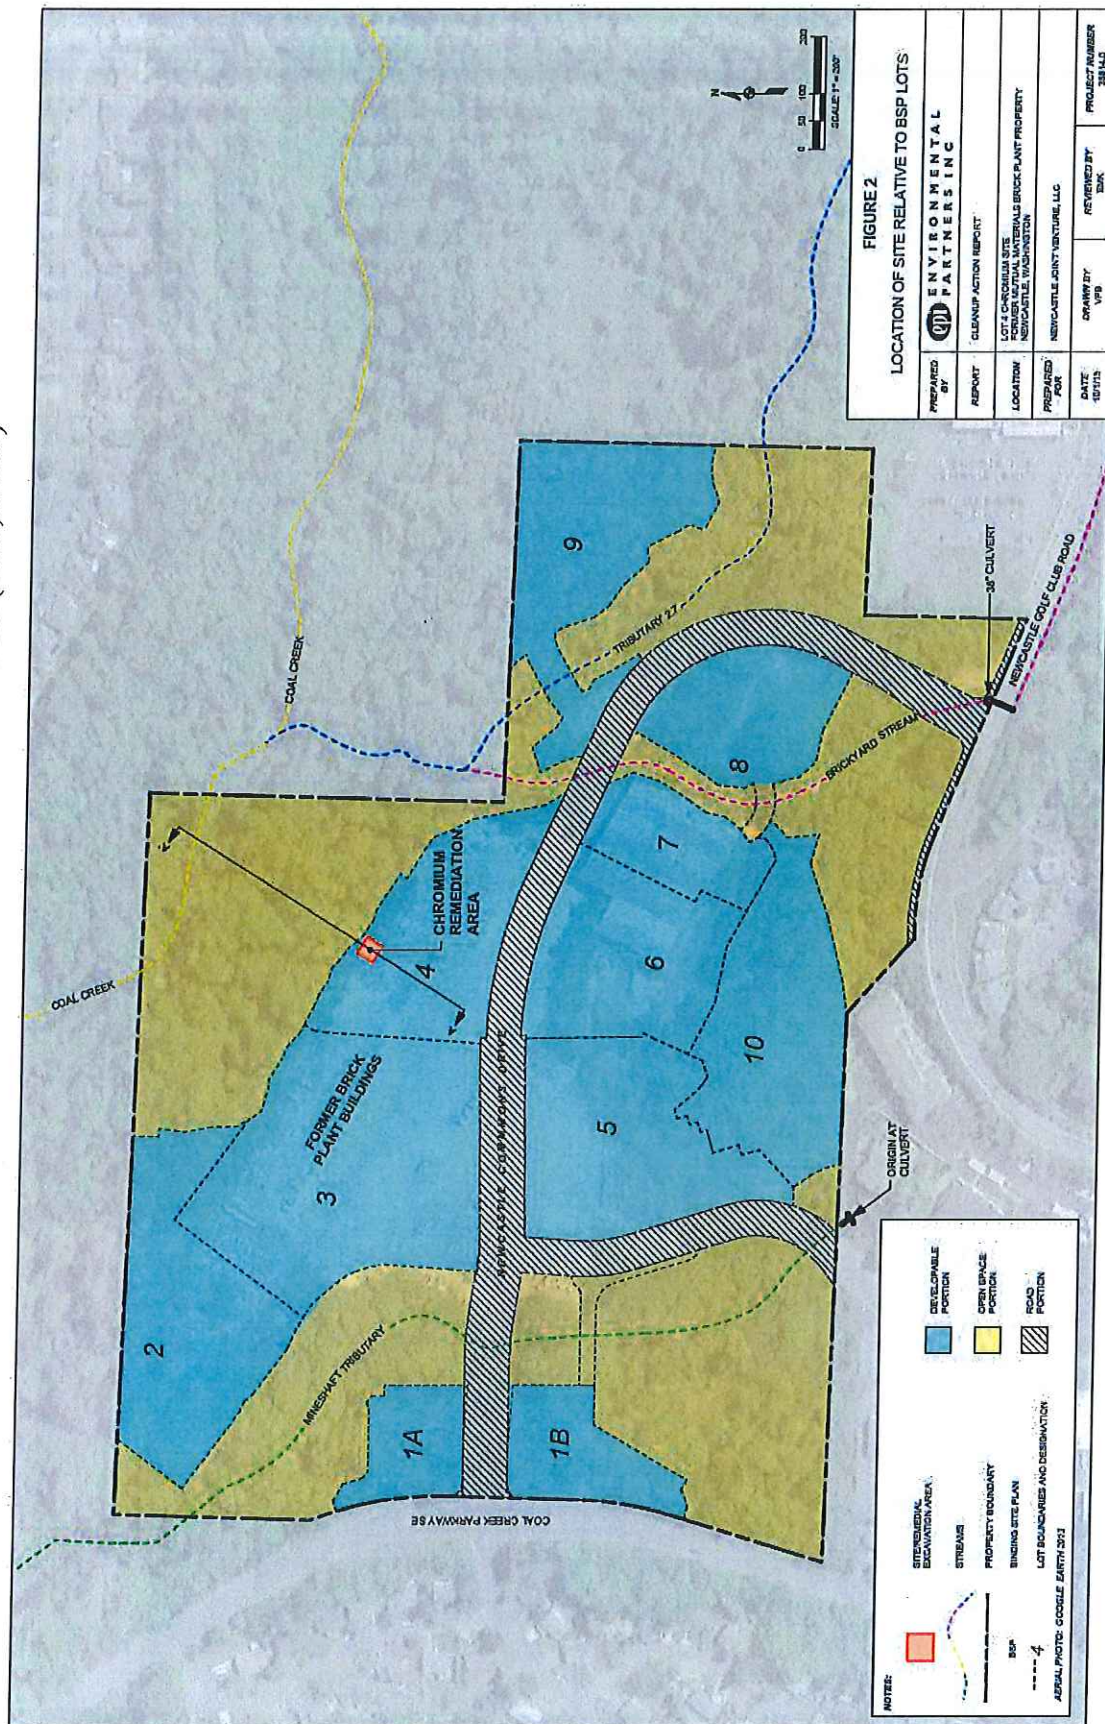
Figure 2 Site Plan and Soil Excavation Area (EPI, 2019)

- Chromium detected in soil was determined as the chemical of concern (COC), at the maximum concentration of 98 mg/kg in a composite sample from Test Pit TP-32, which was analyzed in 2012. The source of the contamination was identified as waste brick debris and product stored at the Site (**Enclosure A, Figure 2**), which resulted from the historical brick manufacturing operation approximately between 1957 and 2011.
- The soil impacted with chromium was defined and limited to an area of approximately 361 square feet within the Property and was not detected above the applicable cleanup level in confirmation samples collected at 3 to 6 feet below ground surface (bgs; see **Enclosure A, Figure 4**).

**Area and Property Description:** The Property, less than 5,000 square feet, is located adjacent to the northern boundary of the City of Newcastle. The Site and surrounding area are currently being developed into apartments, townhomes, retail stores, parks, and shopping plazas. Townhouses are planned for construction on the Site that is bordered by forests to the north and east (**Figure 2**).

**Ground Water:** Ground water was not encountered in the Site investigation and the soil excavation, but it is likely present at approximately 15 feet bgs. The estimate is based on the ground water table existing at depths ranging approximately from 17 to 26 feet bgs at the Lot 4 Dry Well Site (VCP NW3247) immediately adjacent to this Site. The ground water flow direction is also likely to the north toward Coal Creek (**Figure 2**).

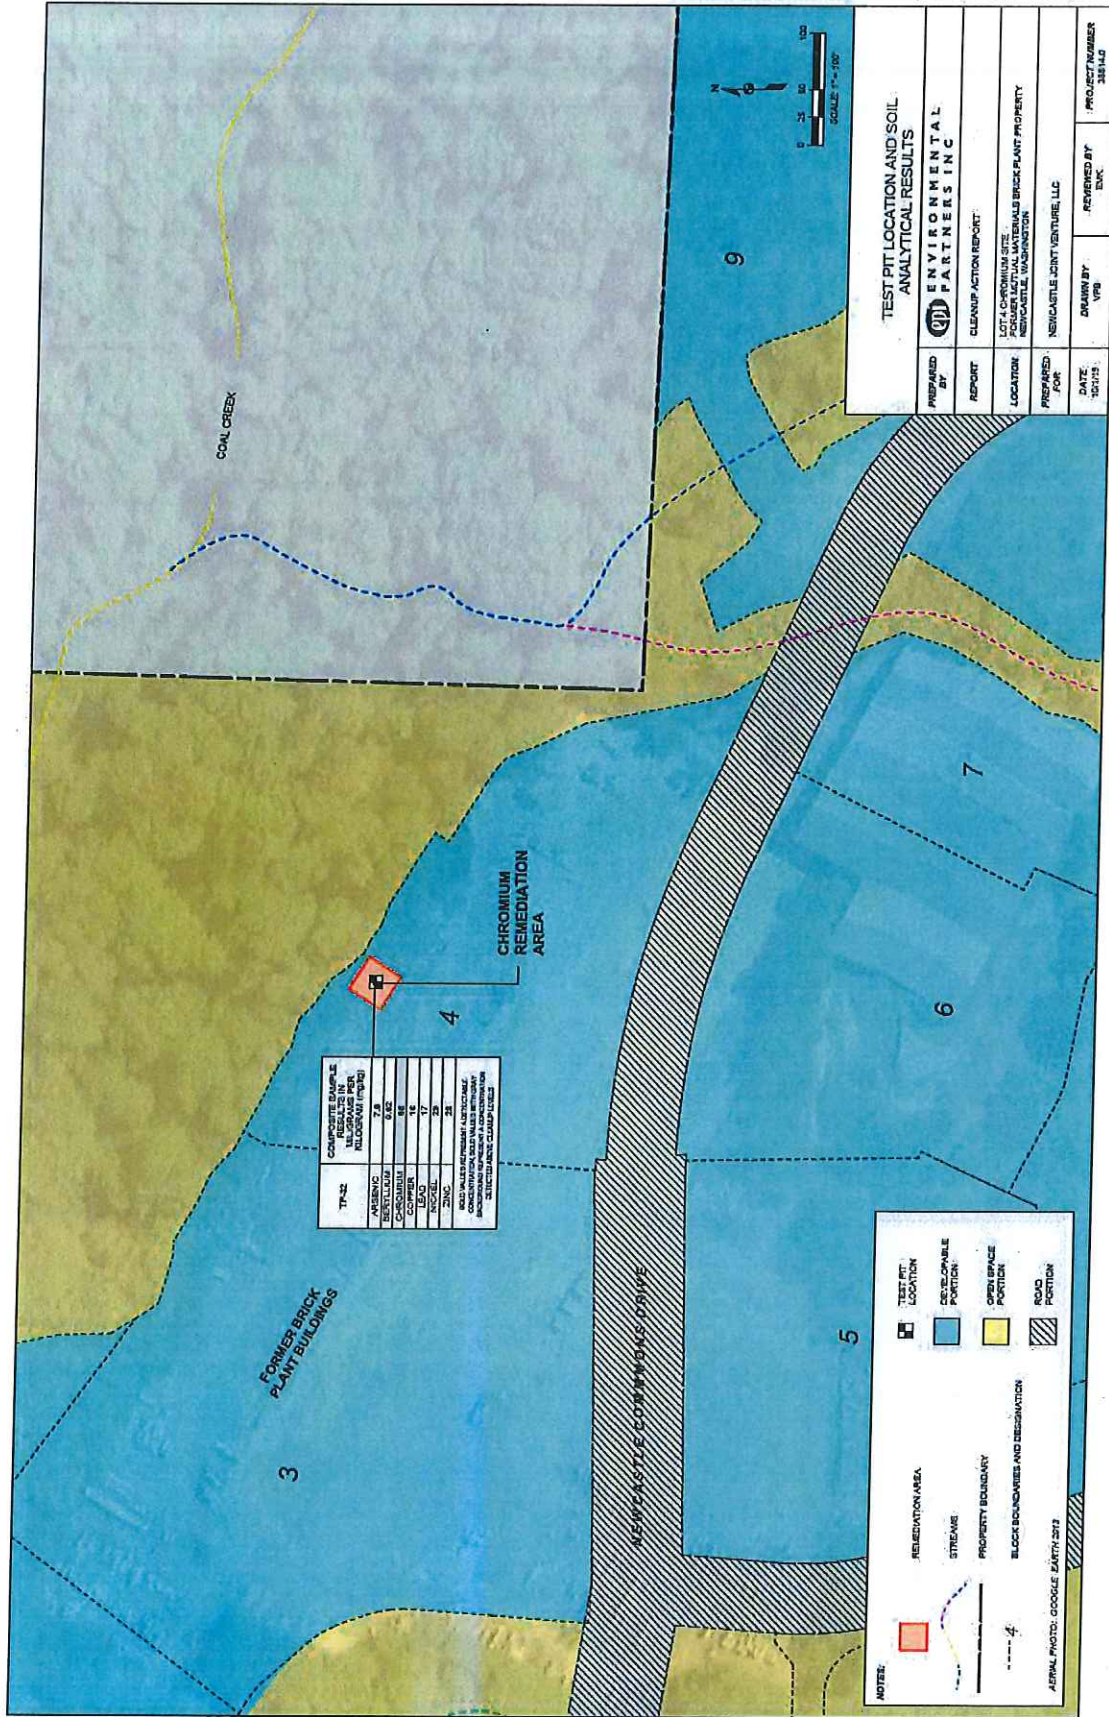
Figure 3 Soil Contaminated by Chromium at the Site (EPI, 2019)

- Revisions
  - Ground surface elevation at TP-32
    - Stated in the CAR report text and Figure 3 (Cross Section A-A') as 390 feet above mean sea level (amsl).

- King County IMAP and the Lot 4 Dry Well report (VCP project, NW3247) both show ground surface elevation as 375 feet amsl.
    - Revise text to identify ground surface elevation as 375 feet amsl.

- Revise Figure 3, including expanding the vertical scale, to show the following:
      - Ground surface elevation of 375 feet amsl.
      - Depth, lithology, soil sample locations, and the associated chromium concentrations for test pit TP-32.

- Depth, lateral extent, lithology, soil sample locations, and chromium concentrations for the remedial excavation (3 feet deep at the margins and 6 feet deep at the center).

- Ground water elevation, reported on the adjacent Lot 4 Former Dry Well Site (NW3247) at 360 feet amsl.

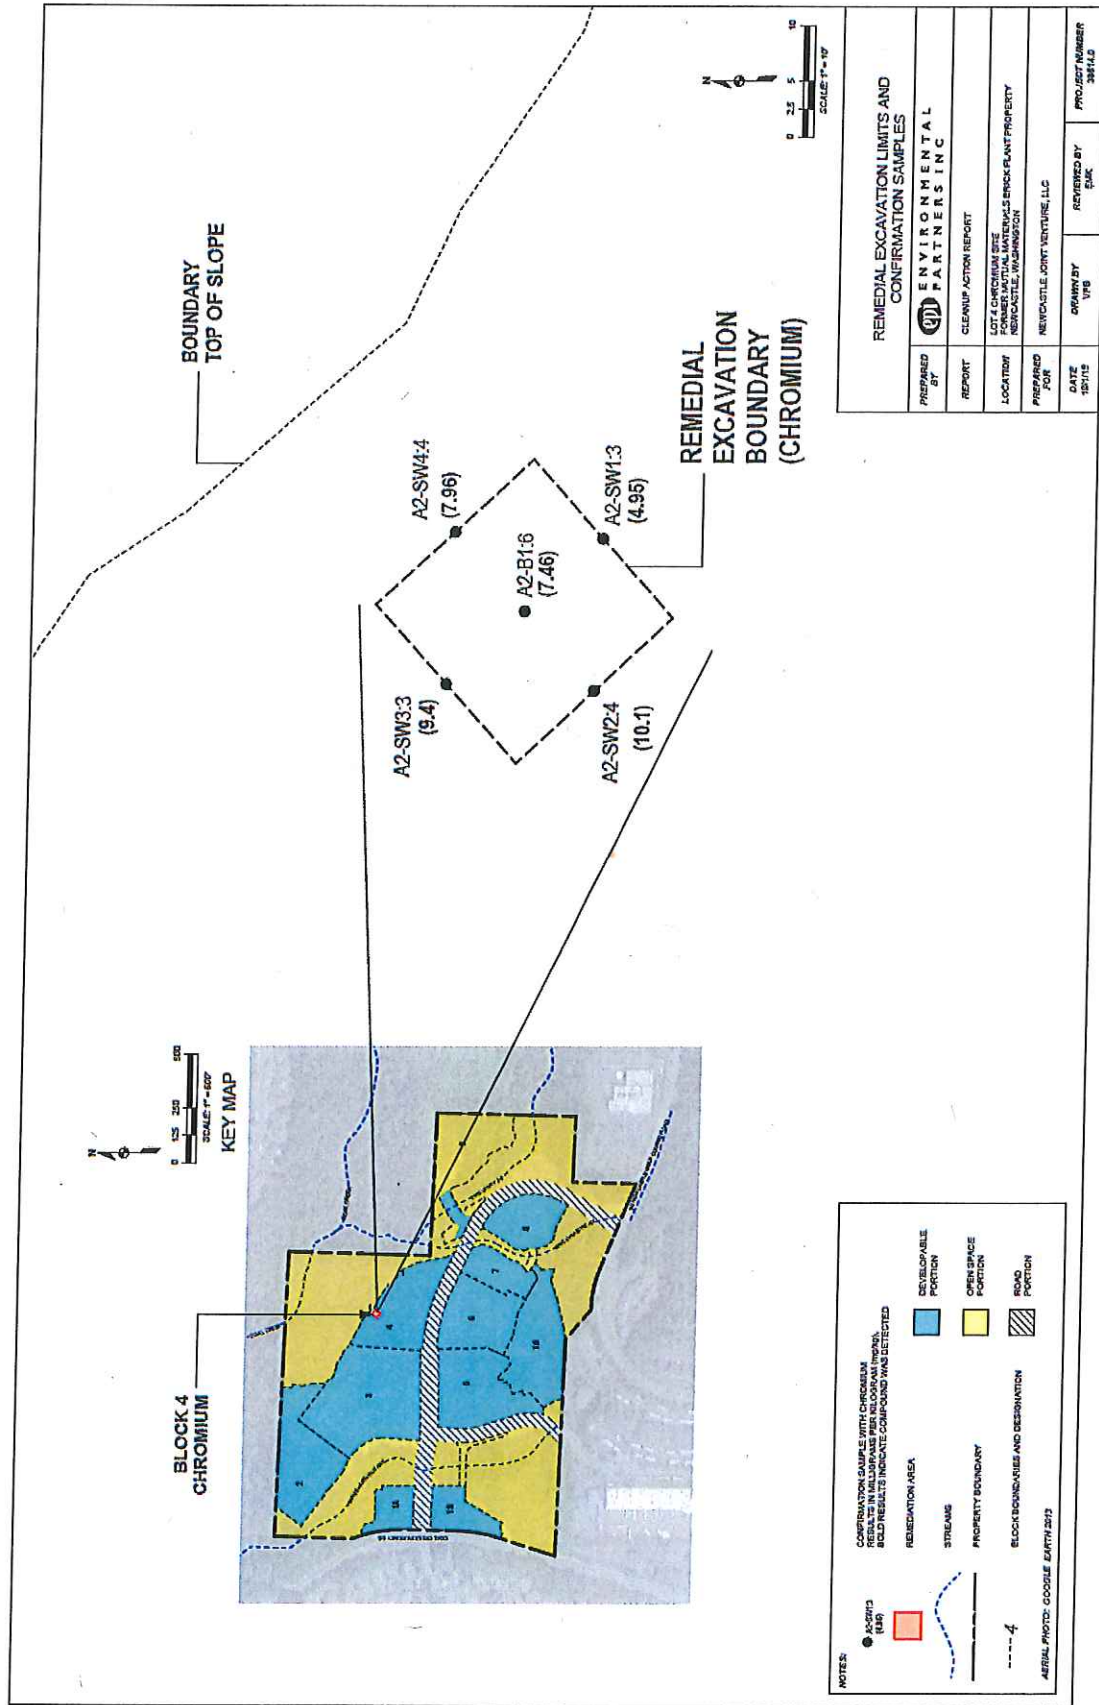
Figure 4 Soil Excavation Boundary and Confirmation Sampling Locations at the Site (EPI, 2019)

- The remedial excavation was a square with an area of approximately 19 feet long, 19 feet wide, and 6 feet in depth (**Enclosure A, Figures 4 and 5**). In April 2015, a total of approximately 142 tons of the impacted soil was removed and disposed at a regulated off-Site facility.
- Five confirmation soil samples collected at bottoms and sidewalls of the excavation demonstrated that the COC was at non-detectable or below the Site cleanup levels (**Enclosure A, Figure 4**).

- Geologic log for Test Pit TP-32, including date of test pit excavation and method/date of test pit backfilling.
- Locations, depths, and lithology of soil samples collected from TP-32 and composited to create the single sample with the Total Chromium result of 98 mg/kg.
- Description of lithology encountered in the 19 feet by 19 feet by 6 feet deep remedial excavation, and of the five confirmation soil samples collected at depths of 3 to 6 feet bgs in the excavation.
