GO EAST LANDFILL

INFORMATION FOR MTCA ASSESSMENT

March 31, 2019

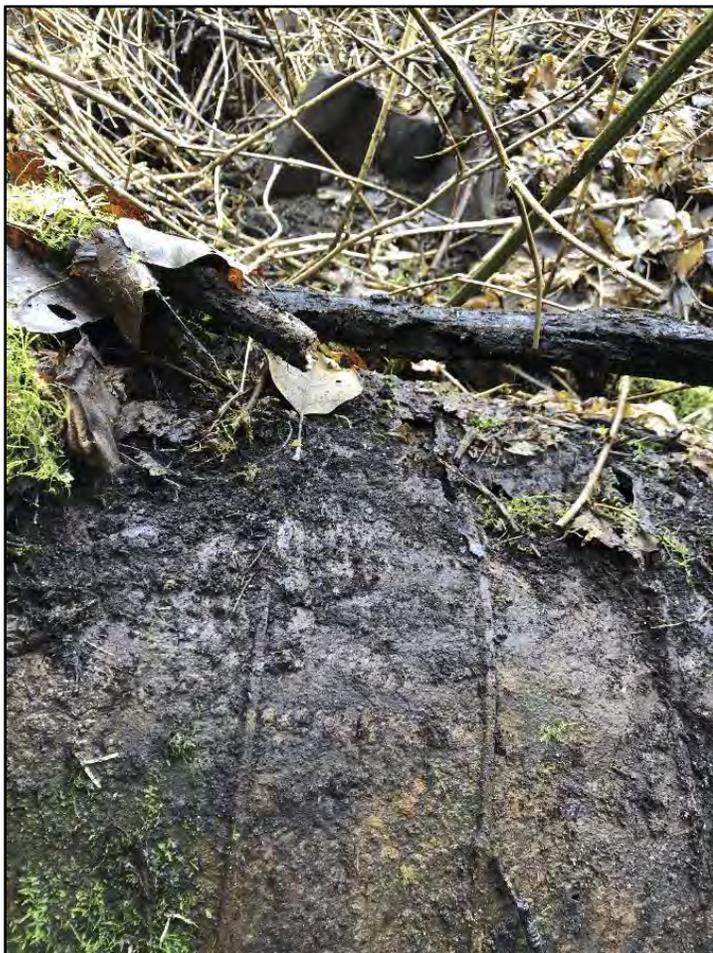
Partially exposed steel drum at toe of steep northeast slope

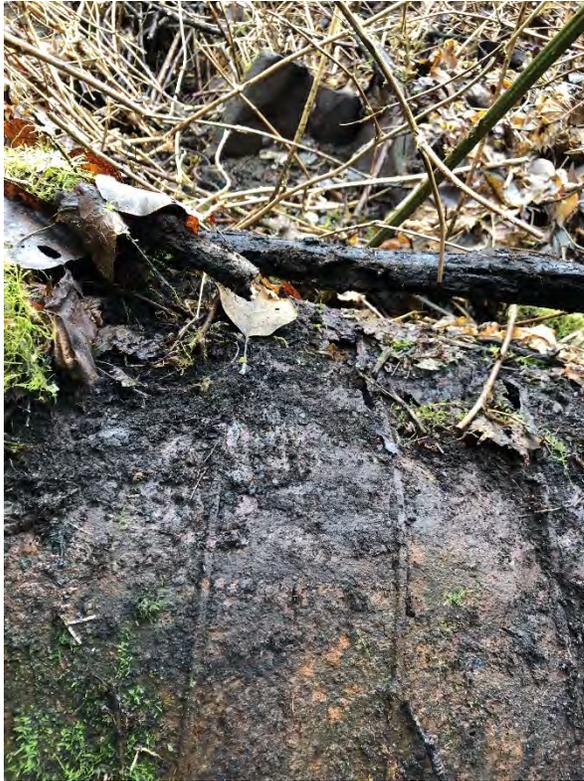
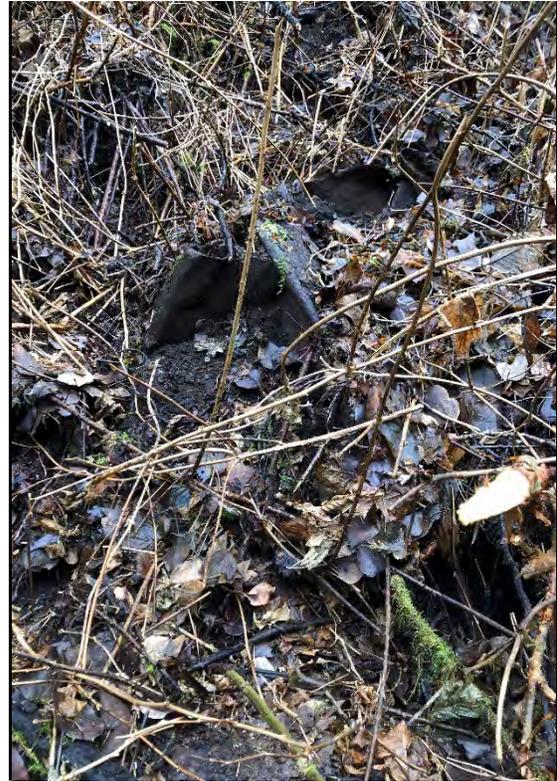
During a two-hour site visit on January 31, 2019, employees of Landau Associates, Inc. observed partially exposed drums and metal debris near the toe of the steep northeast slope. See Figure 4. This is the first evidence that drums and possibly liquid wastes were disposed of at this landfill. The Landau staff also observed a brightly colored sheen and orange mud associated with a spring on the lower portion of the steep northeast slope, Figure 5. They believe the sheen and orange mud are evidence of leachate and the action of iron bacteria and organic material, but not of petroleum products. The Landau site visit report is provided in Attachment F.

Exposed deteriorated drums and crushed steel tank in slope

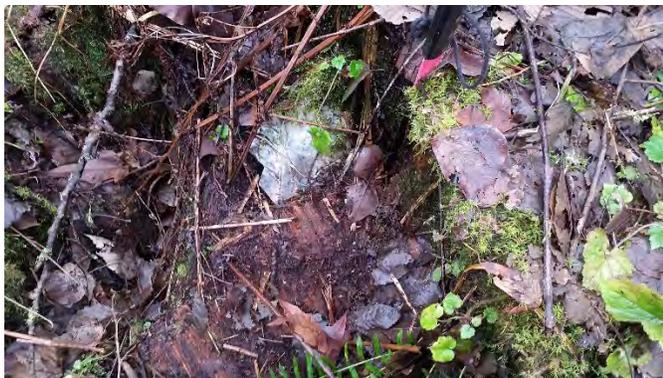
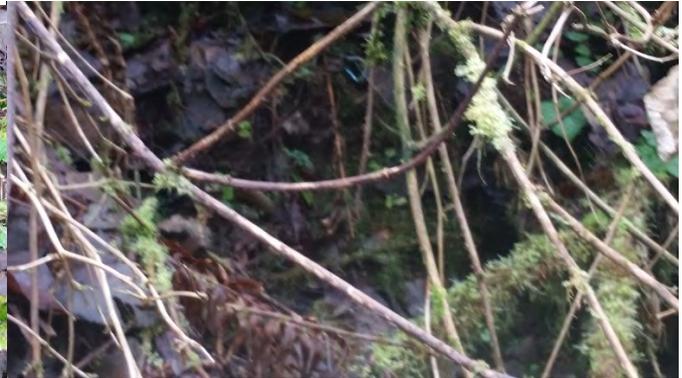
Exposed waste on slope: plastic, plywood, wire, paper debris

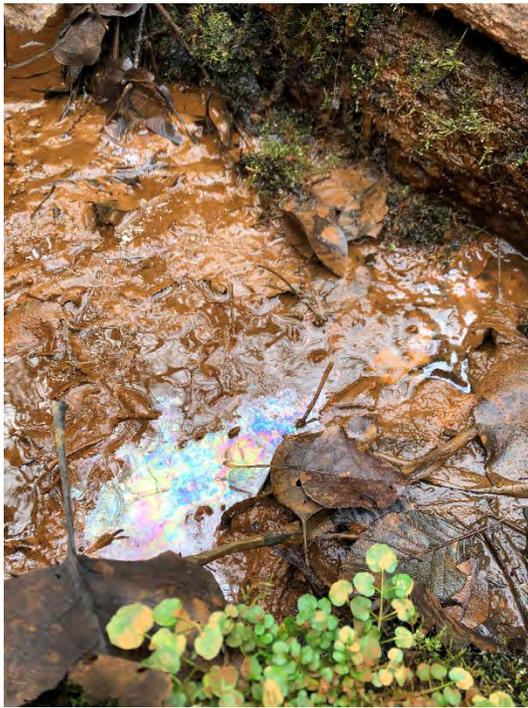
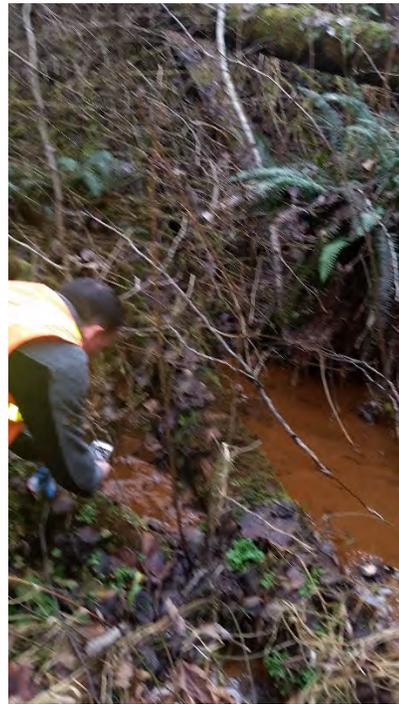
Leachate springs at the toe of the Northeast slope.

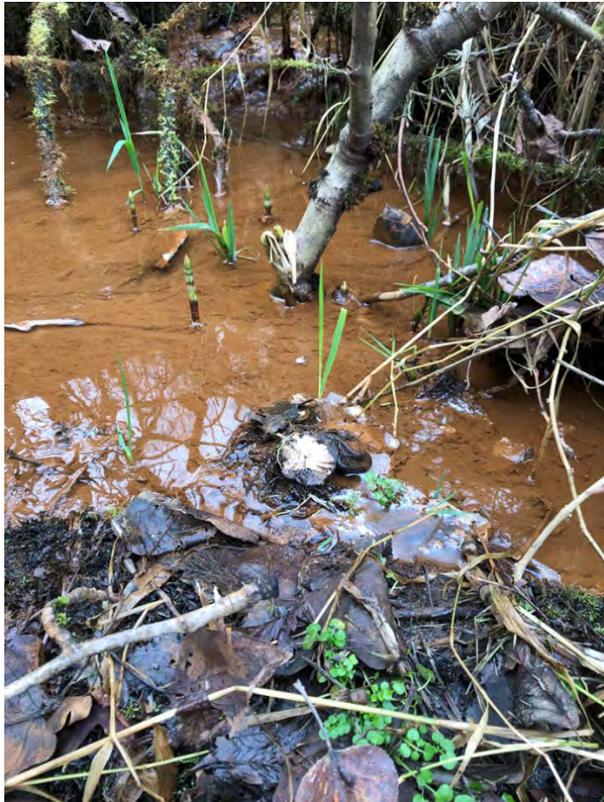
Rust-colored muck wetlands created by leachate springs.

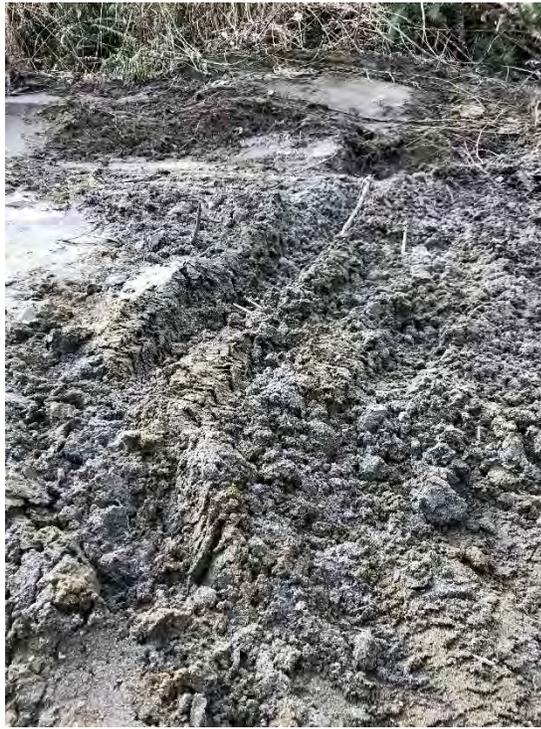
3. One of several apparent recently backfilled test pit areas

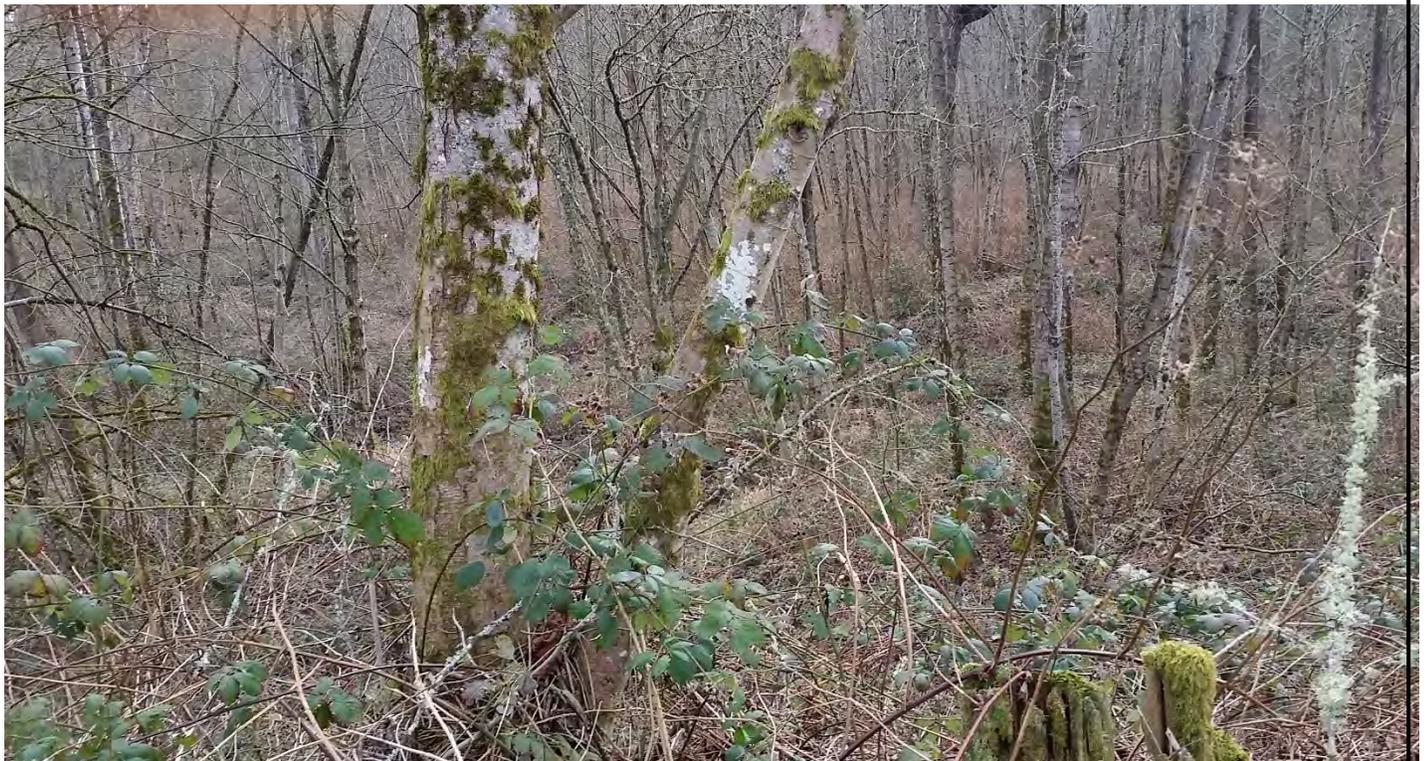
4. Landfill Surface, densely vegetated

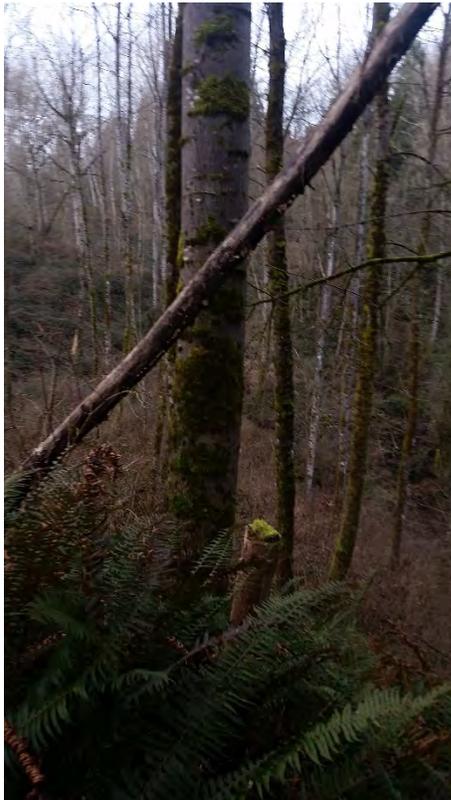
6. Trees in the northeast slope area, showing bends at the base indicative of slope movement.

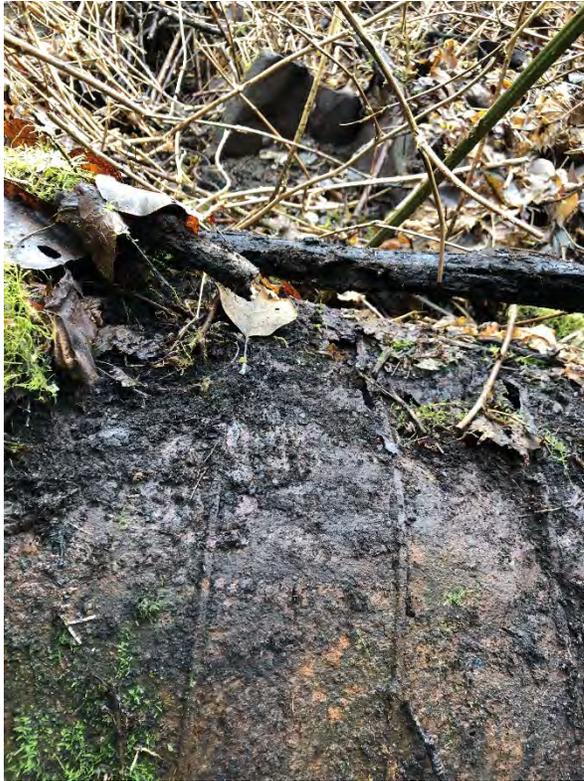
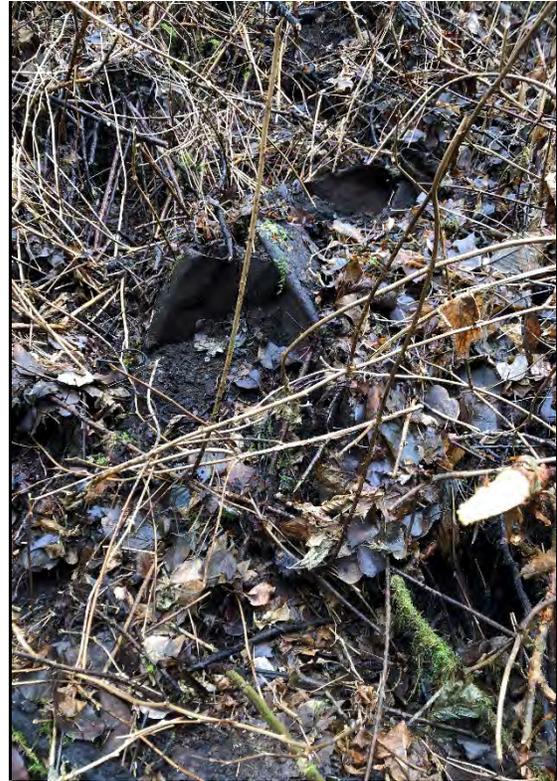
7. Exposed deteriorated drums and crushed steel tank in slope

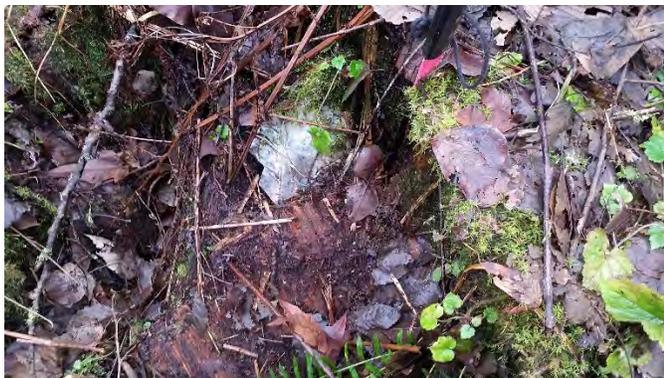
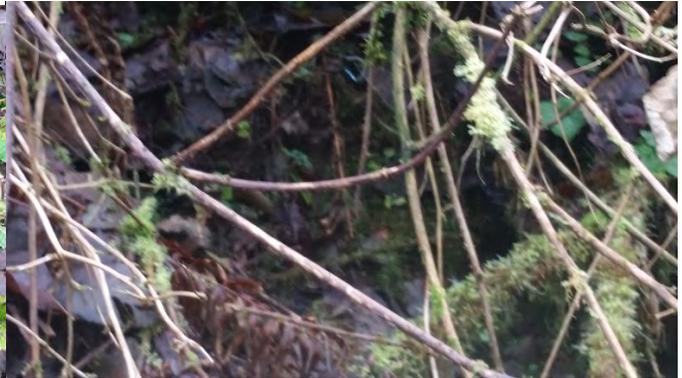
8. Exposed waste on slope- plastic, plywood, wire, paper debris

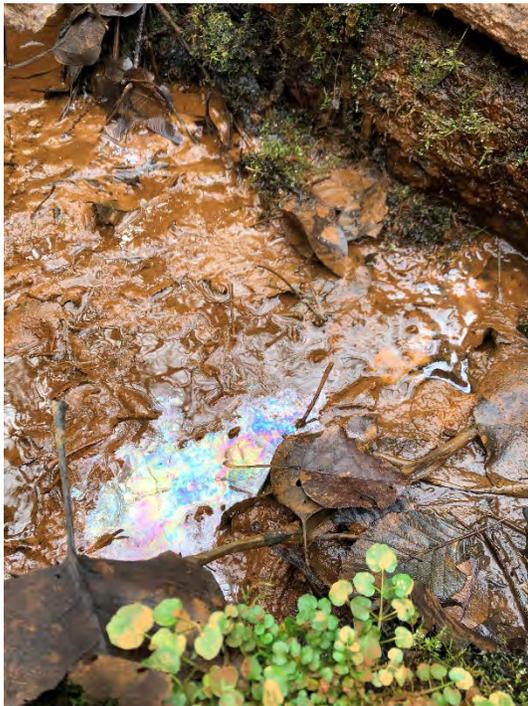
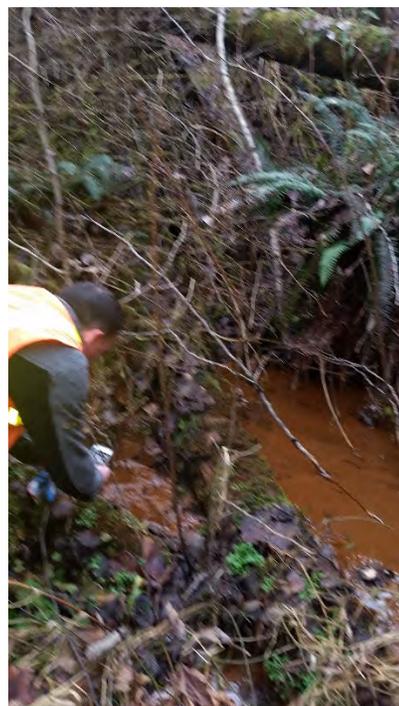
9. Leachate springs at the toe of the Northeast slope.

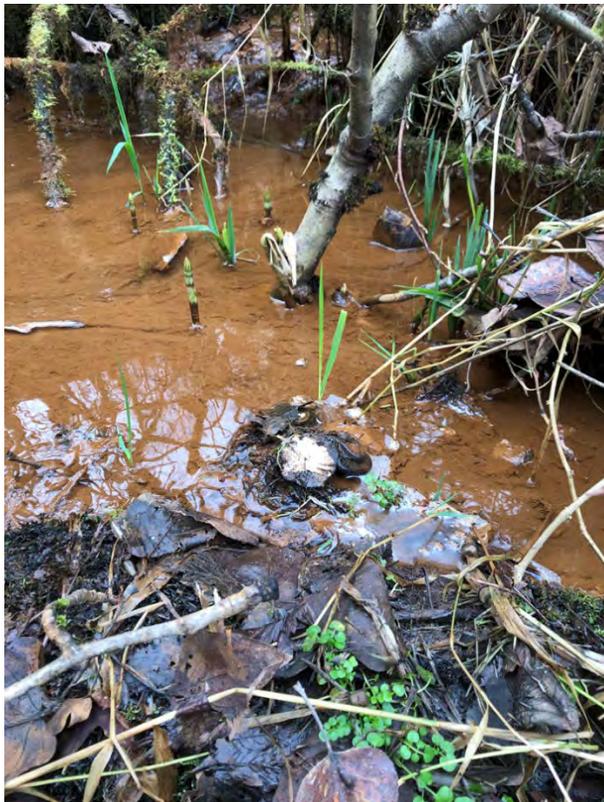
10 Rust-colored muck wetlands created by leachate springs.
