STATE OF WASHINGTON  
DEPARTMENT OF ECOLOGY

**RE: Ecology Review of Draft Supplemental Remedial Investigation Report**

- **Site Name:** Michael Irrigation (aka John Michael Lease Site)
- **Site Address:** 5640 Sunset Highway, Cashmere
- **Facility/Site No.:** 3154383
- **Cleanup Site ID No.:** 2149
- **Agreed Order No.:** DE 15684

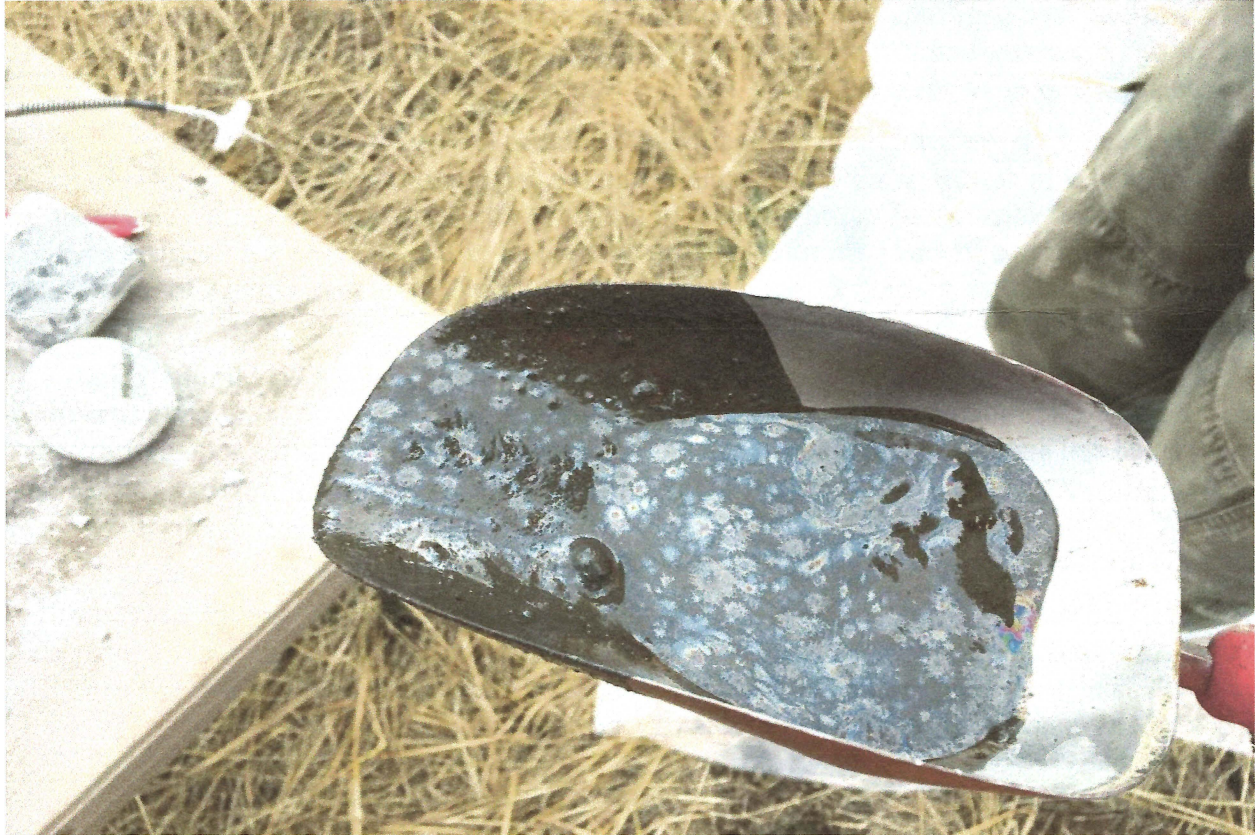
During drilling and installation of MW-5 in October 2018, Ecology witnessed sheen in saturated soils as shown in the following photograph. However, no petroleum was detected in groundwater samples from that monitoring well during four quarterly monitoring events. This further validates the conceptual site model that most remaining contamination is associated with solids (i.e. sorbed) rather than in dissolved phase. The exception to this is MW-7 which had DRO and ORO exceedances in two of five quarterly groundwater monitoring rounds. Based on these data, Ecology concludes that the soil to groundwater pathway appears to be inactive, except in the immediate vicinity of MW-7. Contaminated groundwater above cleanup levels is limited to the area surrounding MW-7, and Ecology agrees that impacts to the Wenatchee River are unlikely.

**Petroleum sheen in saturated soils from MW-5.**
