**ENVIRONMENTAL SITE ASSESSMENT
SEARS PROPERTY AT 1618 CORNWALL
STREET AND 112 OHIO STREET PROPERTY
BELLINGHAM, WASHINGTON**

April 27, 1990

File No. 60-1114-01

Kleinfelder Job No. 60-1114-01

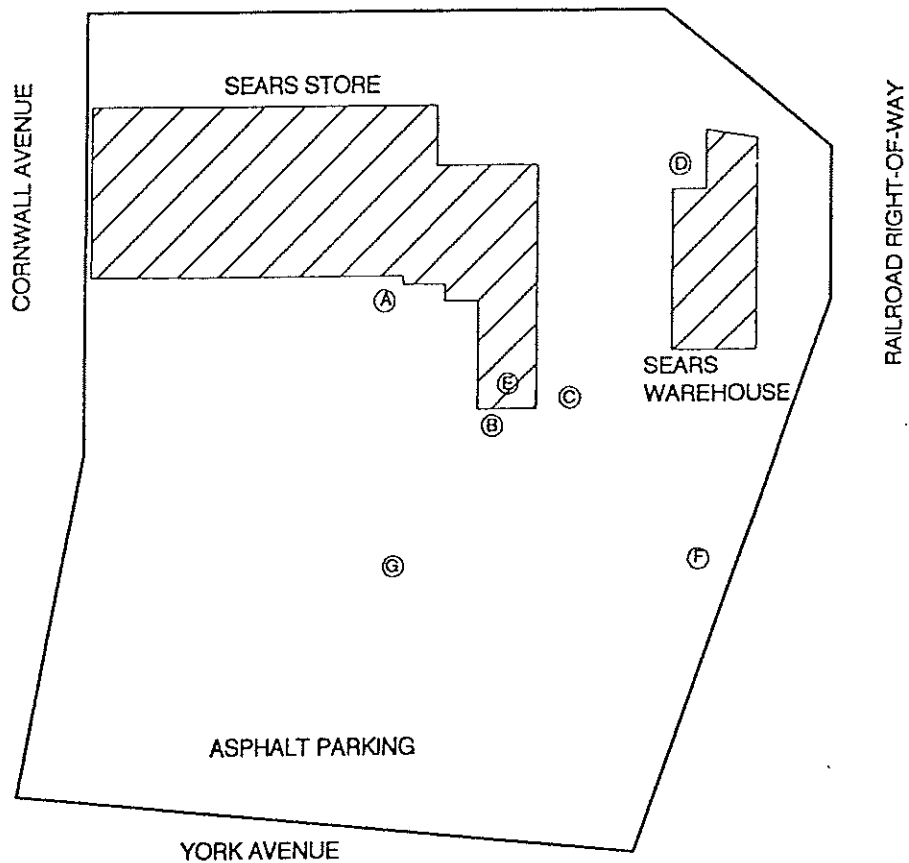
PLATE 2

- Area A An underground fuel-oil storage tank (approximately 10,000 gallon capacity) is located just outside the south entrance of the Sears store. This tank reportedly contained fuel oil for the store's boiler.

- Area B An underground used-oil storage tank (approximately 500 gallon capacity) is located just outside the south wall of the auto service area of the Sears store.

- Area C A rectangular asphalt patch, located just outside the east wall of the auto service area of the Sears store, is the reported location of an underground storage tank. This tank reportedly contained leaded gasoline (approximately 500 gallon capacity).

- Area D An underground fuel-oil storage tank (unknown size) is located outside of the northwest corner of the Sears warehouse. This tank reportedly contained fuel oil for the warehouse boiler.

- Area E Several hydraulic lifts, a battery storage and recharging room, oil-stained concrete, and an oil-stained floor drain were observed in the auto service area of the Sears store. The floor drain is believed to discharge into the underground used-oil tank (Area B, located south of the service area). The battery room contains what appear to be several lead-lined battery-storage areas. The concrete floor in this room is eroded in places, presumably from spilled battery acid.

- Area F Assorted wood debris and several 55-gallon drums, which appear to contain an oil-like substance, have been apparently abandoned south of the Sears warehouse. The debris and drums are inside a locked security fence.

- Area G Oil-water separators were observed at several storm-drain locations within parking areas of the Sears store. The separators do not appear to have been maintained; they were generally clogged with soil.

- Area H Two underground fuel storage tanks (unknown size) are located in the west central portion of the Ohio Street property. These tanks are believed to have been used to contain gasoline and diesel. The tanks and pumps do not appear to have been recently used and are reported to be empty. The tanks' fill-pipe caps are secured with padlocks.

- Area I Numerous surface-soil stains, discarded oil filters, and several 55-gallon drums, which appear to contain oil, are located in the west central portion of the Ohio Street property. Mr. Gordon Laird, Manager of the Ohio Street property, reported this portion of the property currently is leased to a timber logging company.

- Area K Several small (less than three feet across) piles of black sand-like material were observed in the southern portion of the property. We believe this material may be copper slag, which had reportedly been used on the property for sandblasting.

We believe that additional exploration, tank removals, or corrective action in several of the identified areas should be conducted in order to better identify the potential environmental liabilities associated with these properties. Subsurface exploration, visual observation, field instrument screening, and laboratory chemical analysis of soil and/or ground water samples will provide a better understanding of the potential soil and ground water contamination risk that these areas may present.
