**ANACORTES PUBLIC WORKS DEPARTMENT
ENGINEERING DIVISION**

March 11, 2010

Re: City of Anacortes - A Avenue Landfill

**A Ave Landfill
As-Built Drawings
Figures 1-4**

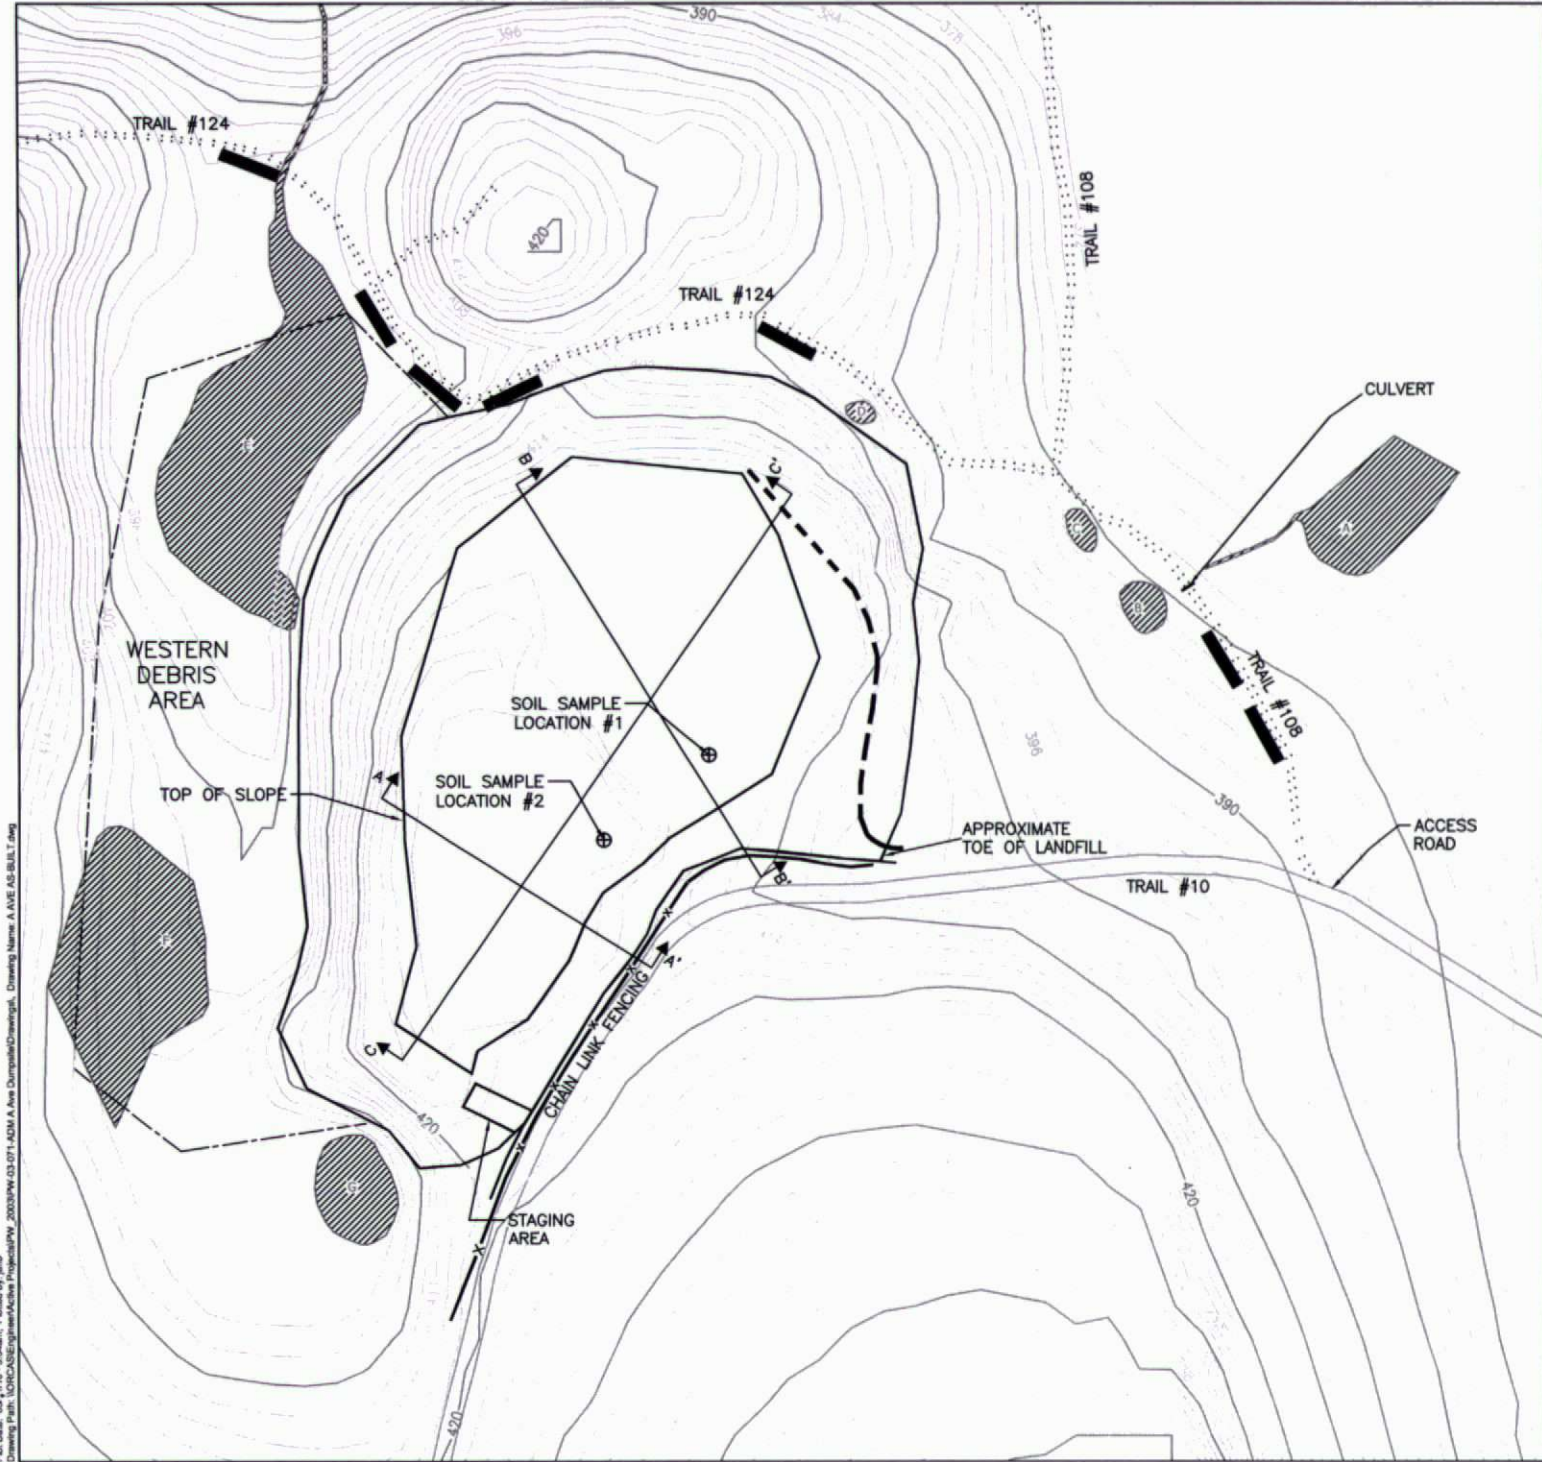
AS-BUILT CONDITIONS & CROSS SECTION LOCATIONS
 Anacortes "A" Avenue Landfill
 Anacortes, Washington

- The existing topography of the landfill was modified by the placement of additional fill and graded to a 5% slope in order to prevent standing water, increase surface water runoff, reduce permeability, and facilitate rapid runoff from the landfill into adjacent undisturbed land (Figures 1, 2, 3, and 4).

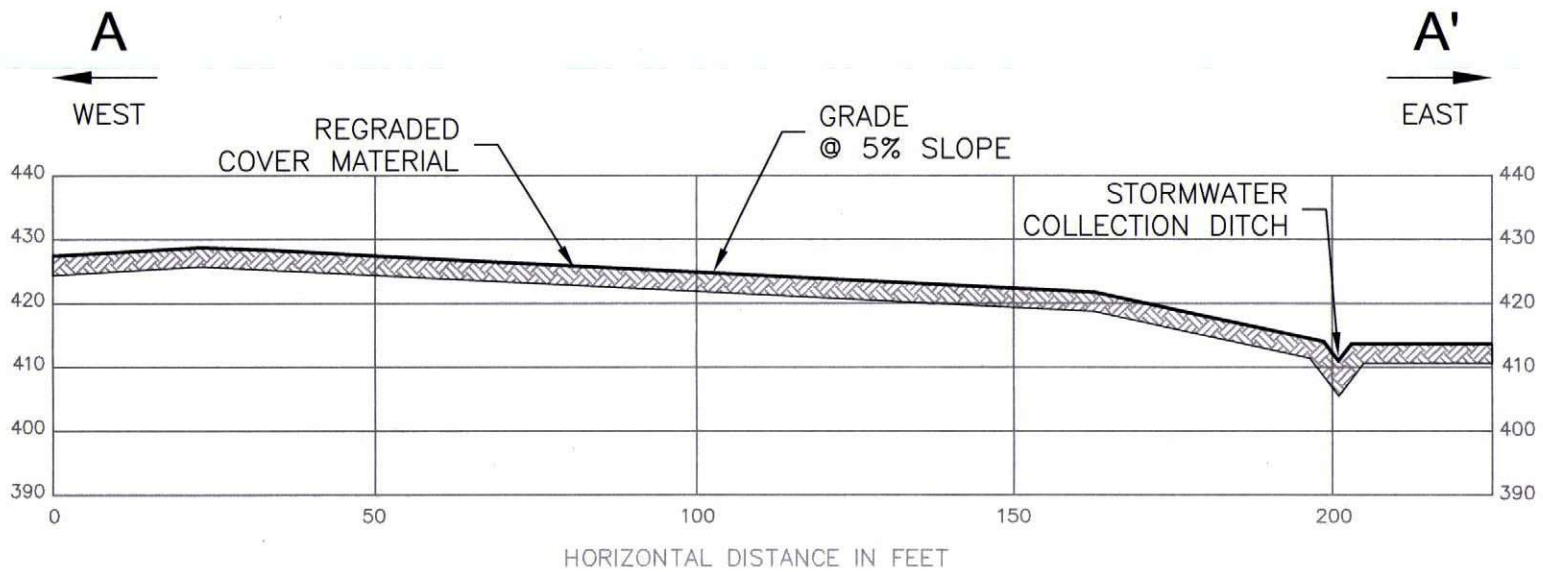
AS-BUILT CROSS SECTION A-A' Anacortes A Avenue Landfill Anacortes, Washington		
By: JRB	Date: 03/11/10	Project No. 09156.000
CITY OF ANACORTES		Figure 2

- * REGRADED COVER MATERIAL COMPACTED WITH A VIBRATING ROLLER.
- * FINAL LAYER IS 6" OF GRADED TOPSOIL AND HYDROSEEDDED.

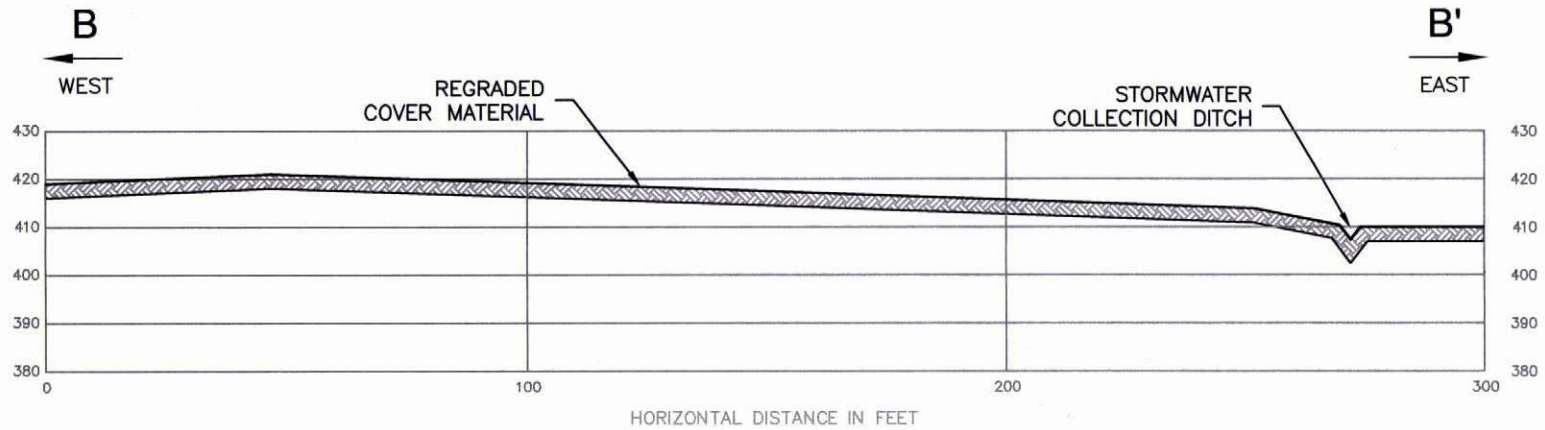
AS-BUILT CROSS SECTION B-B' Anacortes A Avenue Landfill Anacortes, Washington		
By: JRB	Date: 03/11/10	Project No. 09156.000
CITY OF ANACORTES		Figure 3

- * REGRADED COVER MATERIAL COMPACTED WITH A VIBRATING ROLLER.
- * FINAL LAYER IS 6" OF GRADED TOPSOIL AND HYDROSEEDDED.

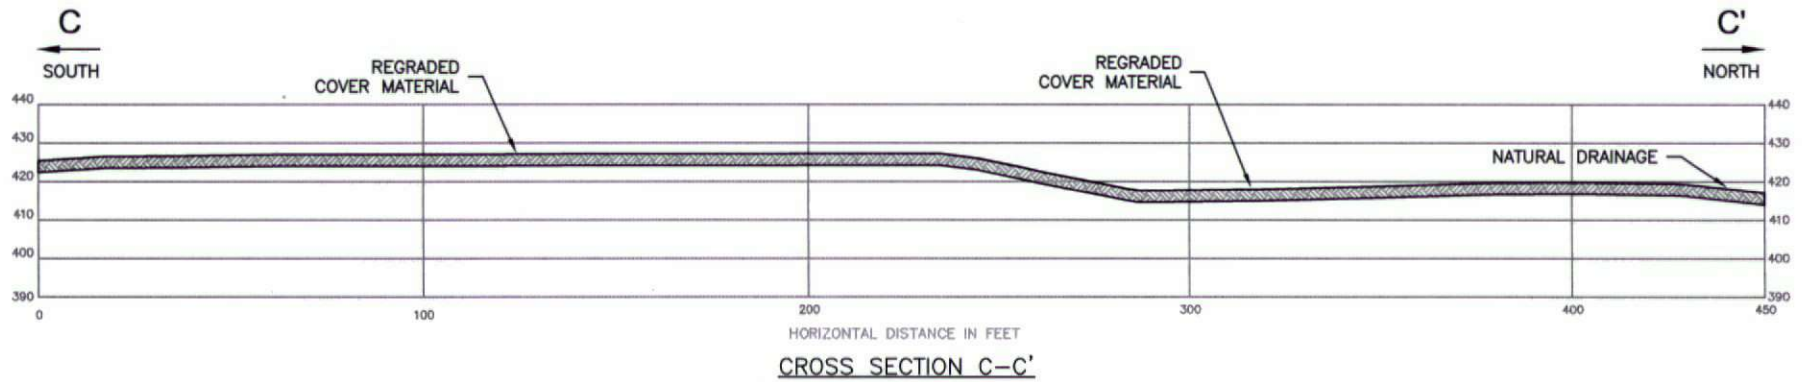
AS-BUILT CROSS SECTION C-C' Anacortes A Avenue Landfill Anacortes, Washington		
By: JRB	Date: 03/11/10	Project No. 09156.000
CITY OF ANACORTES		Figure 4

- * REGRADED COVER MATERIAL COMPACTED WITH A VIBRATING ROLLER.
- * FINAL LAYER IS 6" OF GRADED TOPSOIL AND HYDROSEEDDED.

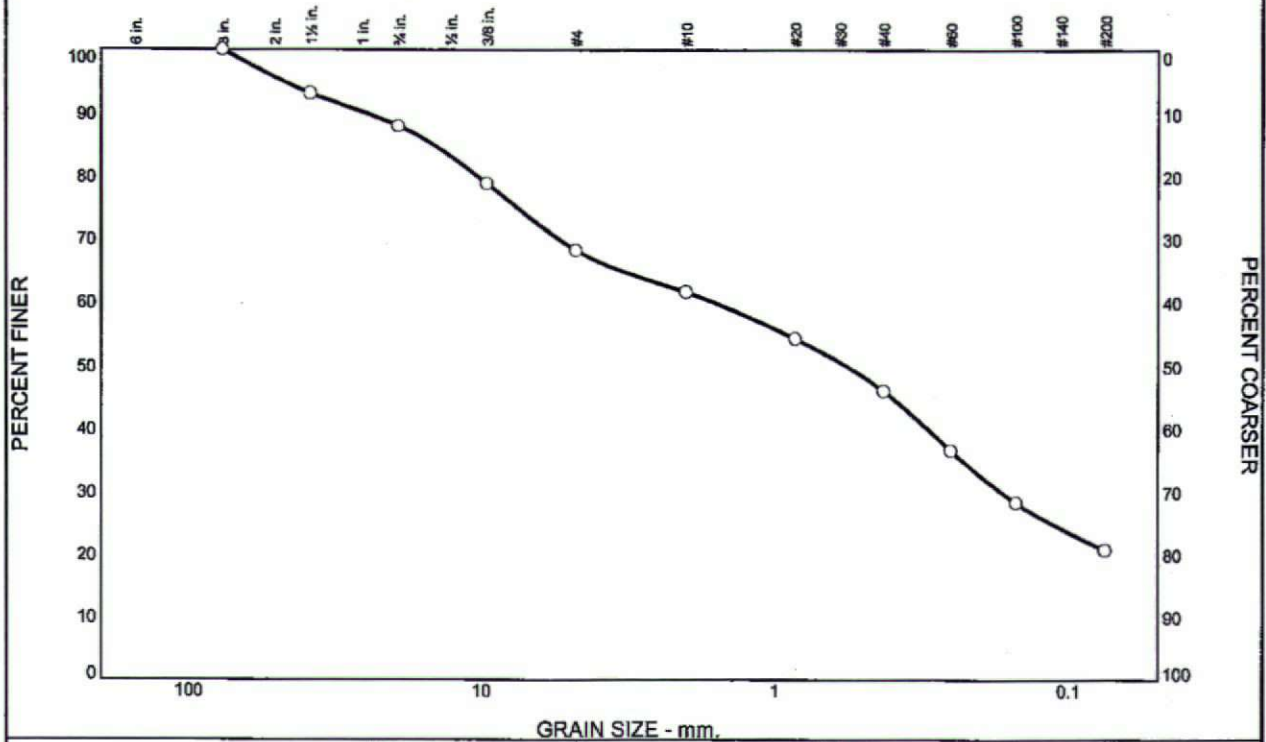
Sieve Analysis Test Report - ASTM C136/C117

Landfill Cap
silty sand with gravel

USCS= SM AASHTO= A-1-b
