March 16,2020
HWA Project No. 98165-670

City of Everett Public Works Department
3200 Cedar Street
Everett, WA 98201

**Subject: Gas Monitoring Annual Report, 2019
Everett Landfill/Tire Fire Site
Everett, Washington**

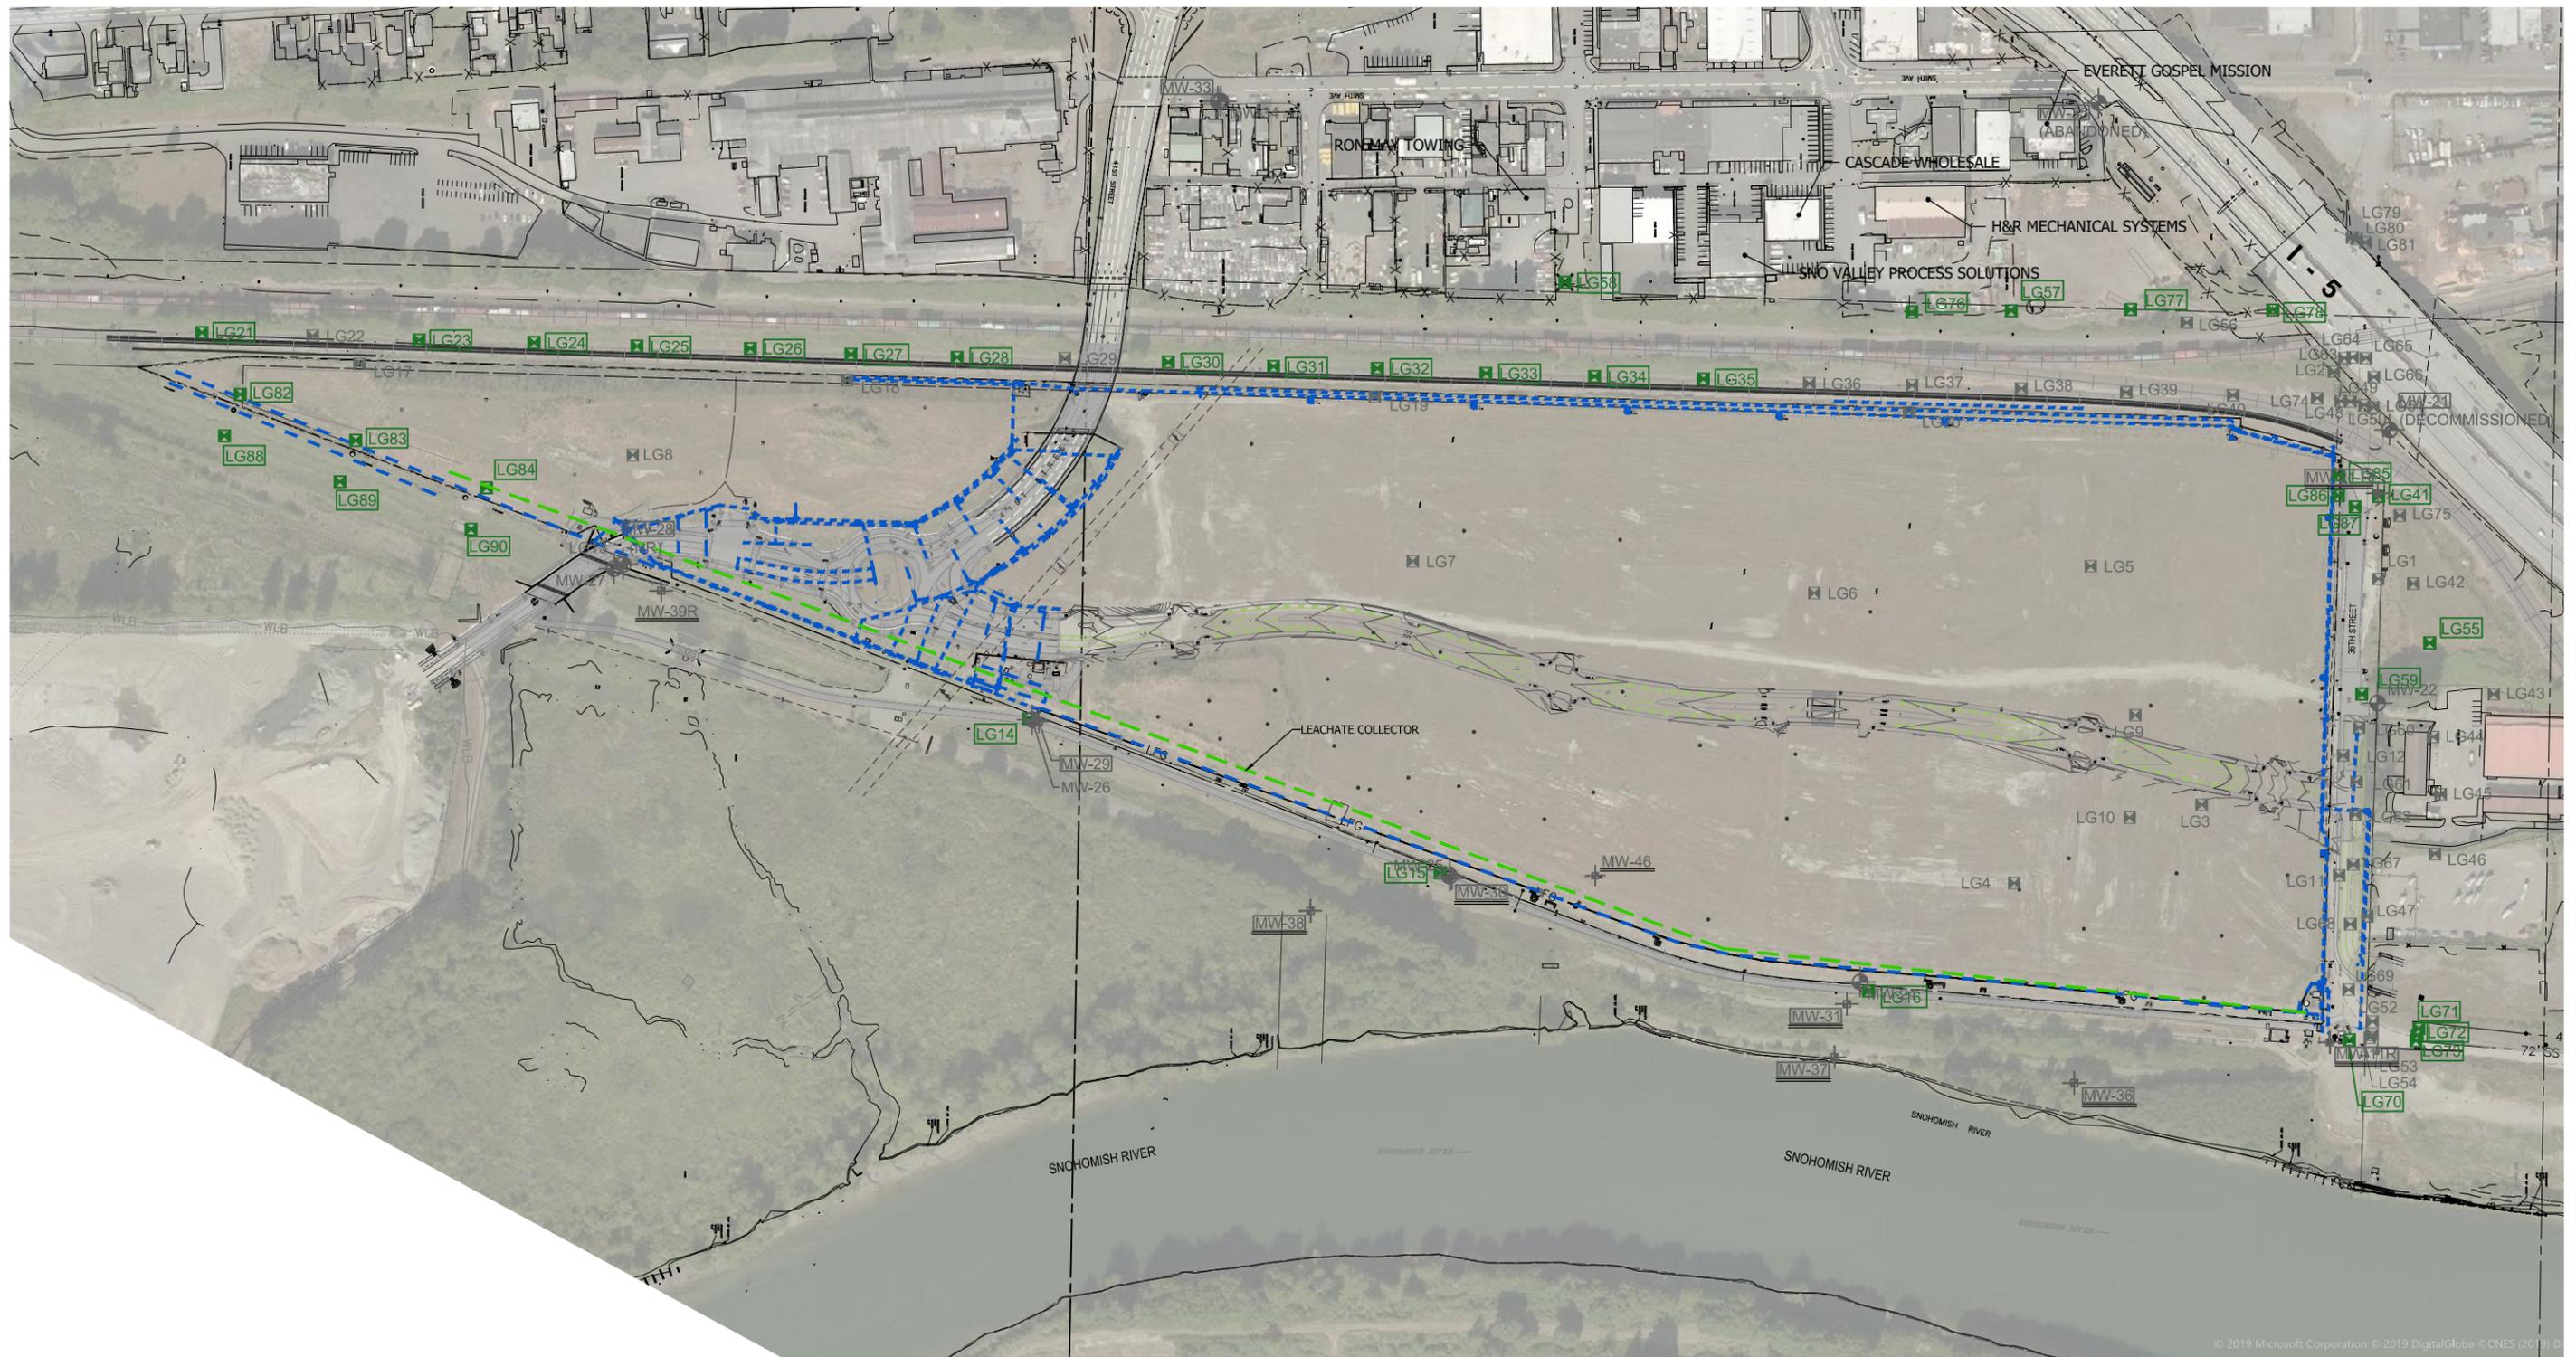
LANDFILL GAS PROBE
 LOCATION MAP

concentrations ranged from 0.1% to 0.2%, likely due to native peat soils. Three new gas probes, LG-88, LG-89, and LG-90, were installed in October 2019 (see Figure 1). Results from the most recent gas monitoring (October 2019 and February 2020) showed no detections of methane in the newly installed gas probes.

Other than as described above, none of the remaining probes that are sampled quarterly for this project were identified as having been damaged or buried during construction activities at and around the Landfill during the 2019 sampling year. Figure 1 shows all active, decommissioned, and damaged probes.

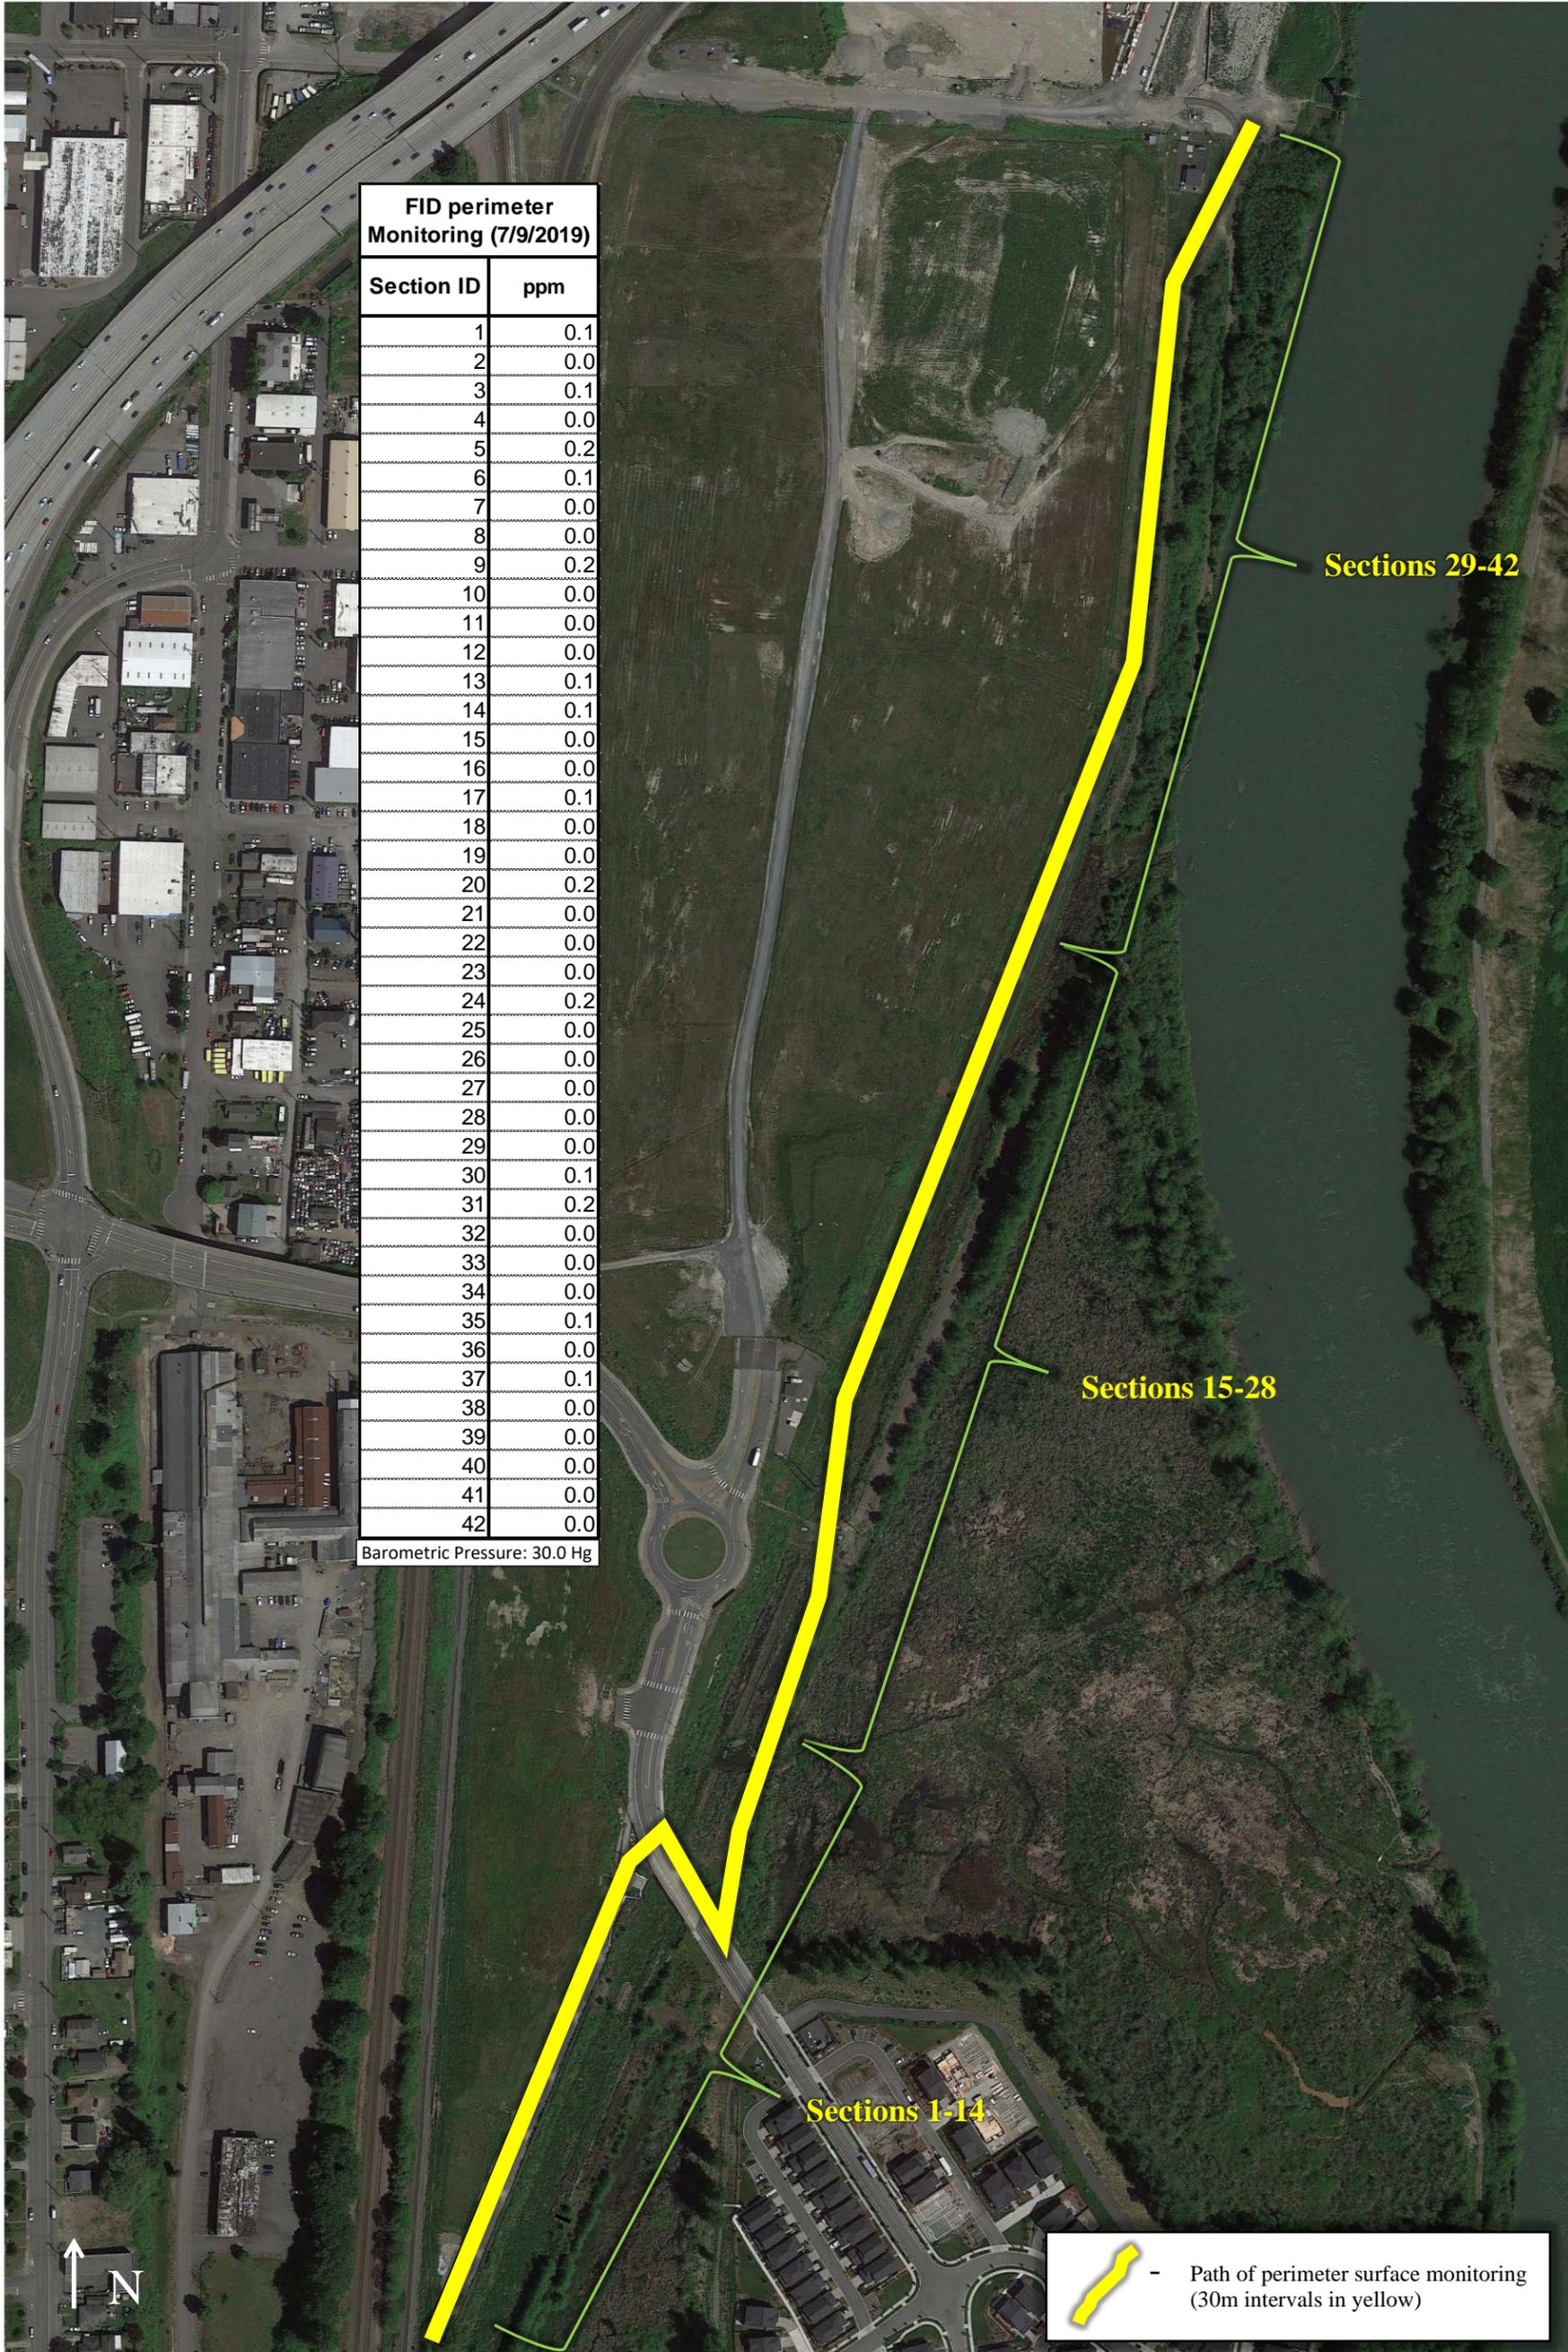
PERIMETER SURFACE GAS MONITORING 7/9/2019

East end of Landfill, offsite - Surface emissions monitoring per 40 CFR 60.753(d) was conducted along the east landfill boundary and trail in July 2019. The monitoring was performed utilizing a flame ionization detector (FID), traversing the eastern landfill boundary in a serpentine pattern and measuring gas at 30-meter intervals, and based on visual observations, e.g., distressed vegetation, cracks, or seeps in the ground. The probe of the FID was held between 5 to 10 centimeters above the ground surface during the survey. Background concentrations were measured prior to conducting the gas survey upwind of the landfill and found to have detections of around 0.2 ppm, which match the highest concentrations detected during the gas survey. Gas concentrations detected during this survey were likely background detections and were well below the 500 ppm (0.05%) action level. All surface gas monitoring procedures were conducted following the Environmental Protection Agency (EPA) Code of Federal Regulations (CFR) Part 60 Subpart WWW *Standards of Performance for Municipal Solid Waste Landfills*. The survey locations and results of the initial survey are displayed on Figure 3.

Moving forward, HWA will continue to implement surface emissions testing along the eastern perimeter and trail as part of the quarterly gas monitoring events.

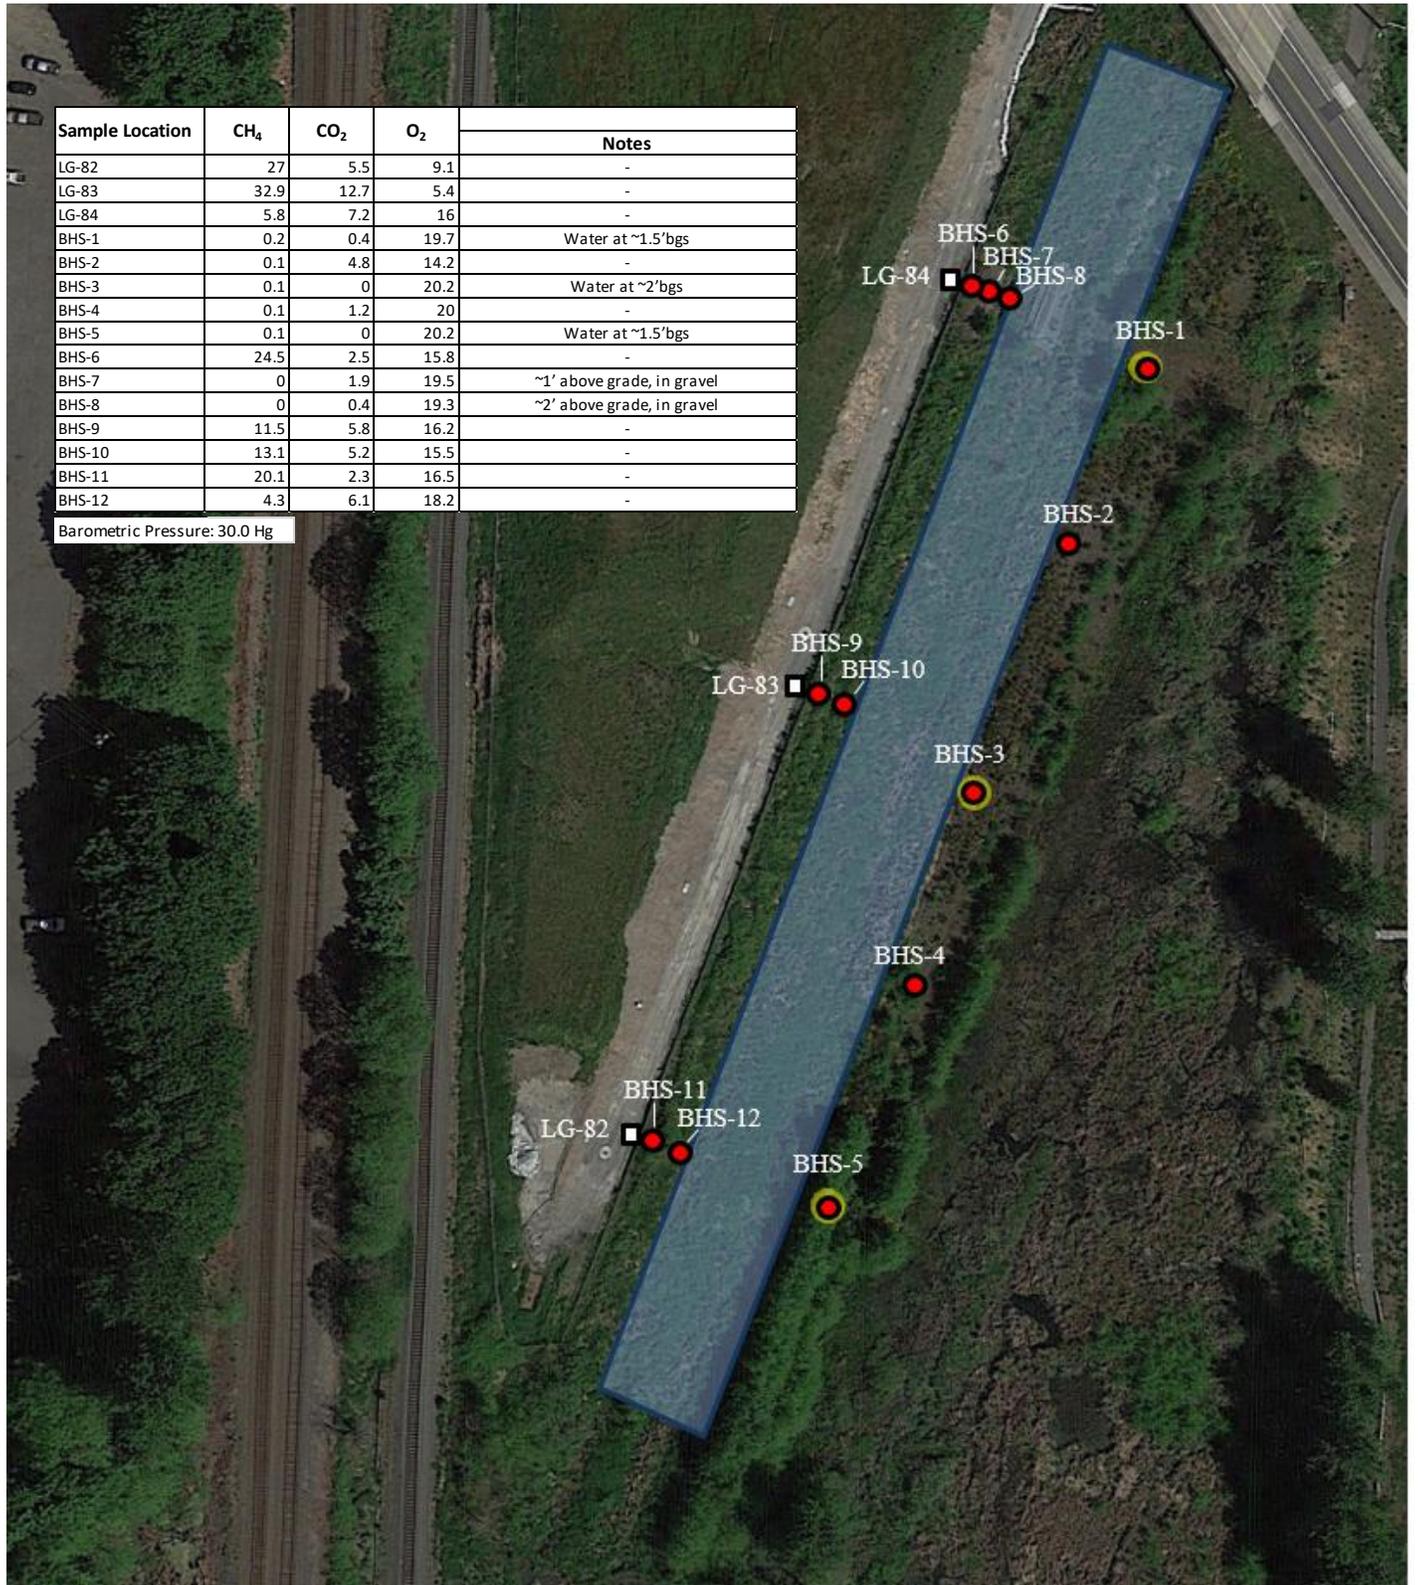
SHALLOW SOIL GAS SURVEY 7/9/2019

HWA conducted a bar hole survey in July 2019 to investigate the gas concentrations east of these probes. The survey was conducted using a slide hammer to bore an approximately 0.5-inch hole to a depth of 3.5-feet below ground surface (bgs). Rigid polyethylene tubing was lowered halfway down the bore hole and the surface opening sealed prior to testing. If groundwater was encountered above this, readings were taken just above the ground water level. Surficial soils were found to be saturated at shallow depths (1 to 2 feet bgs) at a few of the locations. Figure 4 shows the results of the bar hole survey. Results from the bar hole survey showed methane concentrations near LG-82, LG-83, and LG-84 ranged up to 25%. Around 105 to 115 feet east of these probes,
