Subject: First Quarter 2020 Progress Report, Southwest Harbor Project Remediation Areas 1, 2, 3, and 5 Ecology Facility/Site Numbers 2384, 2385, 2127, and 2383

**RE:** **Terminal 5 Landfill Gas Collection System Monitoring Results**  
**First Quarter 2020**  
17627-06

2019 end-of-year inspection

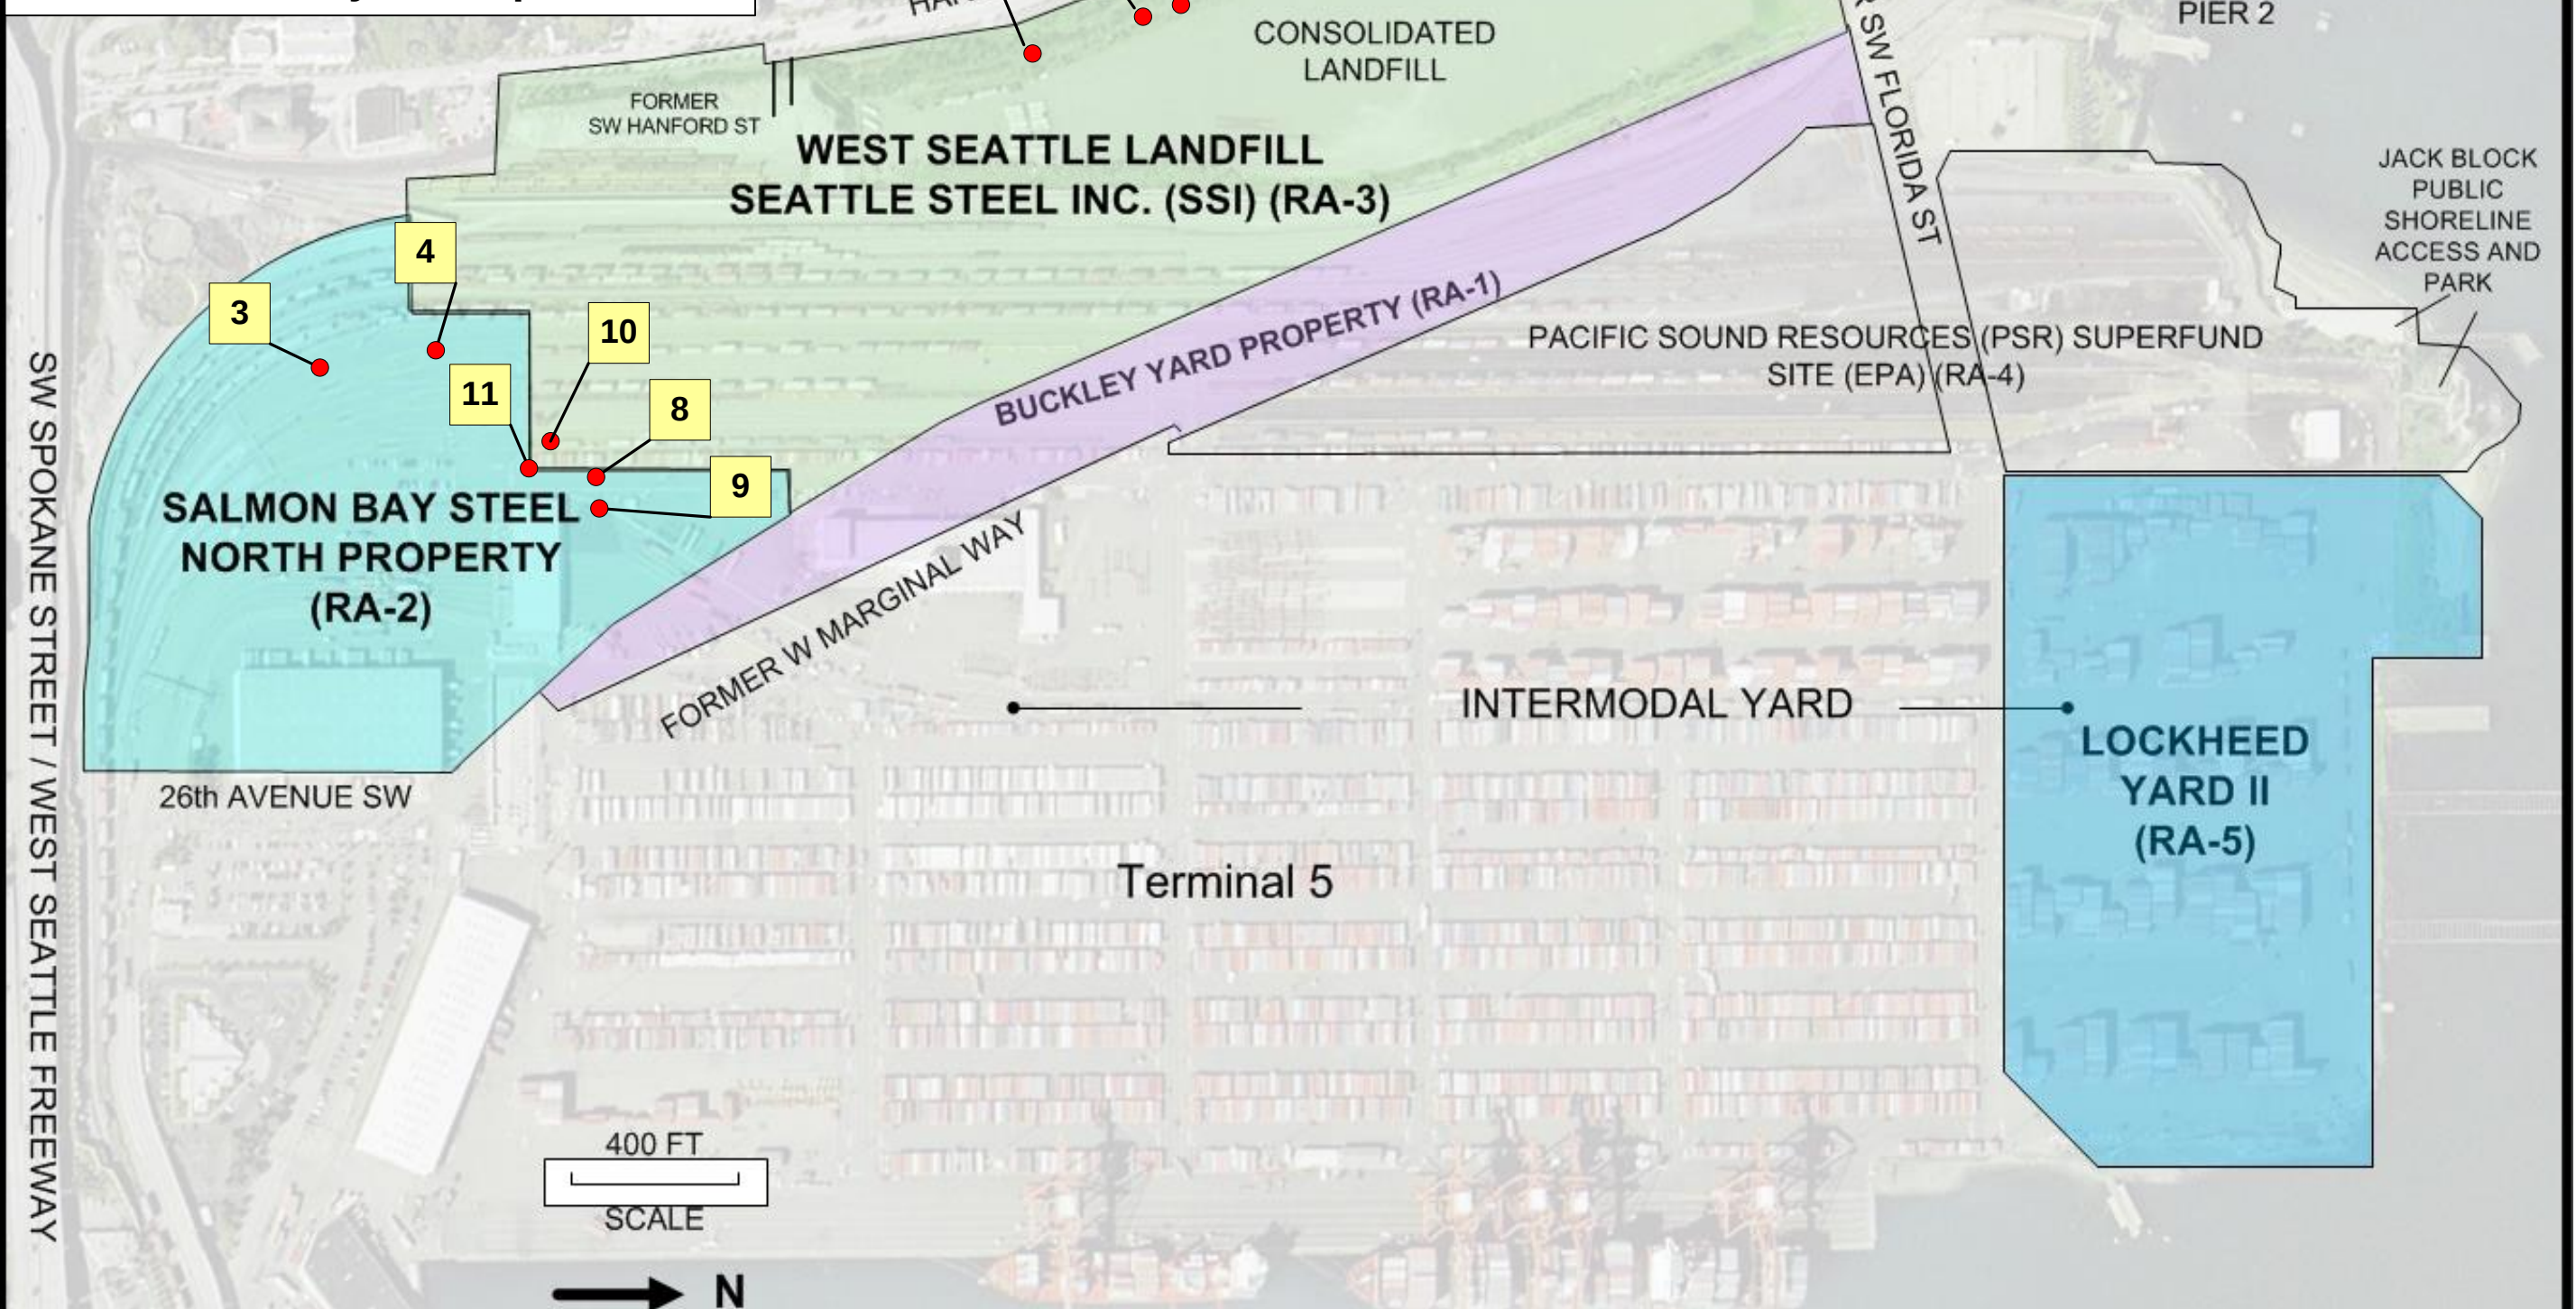
Terminal 5 Ecology-lead remediation areas –  
Locations of observations noted in report

- 1. Hole in chain-link fence
- 2. Hole in chain-link fence
- 3. Vegetation growth near south rail gate
- 4. Vegetation growth near south rail gate

- 5. Damage to drainage swale pavement
- 6. Damage to drainage swale pavement
- 7. Crack in swale drainage pavement
- 8. Pavement mounding with cracks wider than ¼ in.

- 9. Pavement mounding with cracks wider than ¼ in.
- 10. Pavement mounding with cracks wider than ¼ in.
- 11. Pavement deterioration

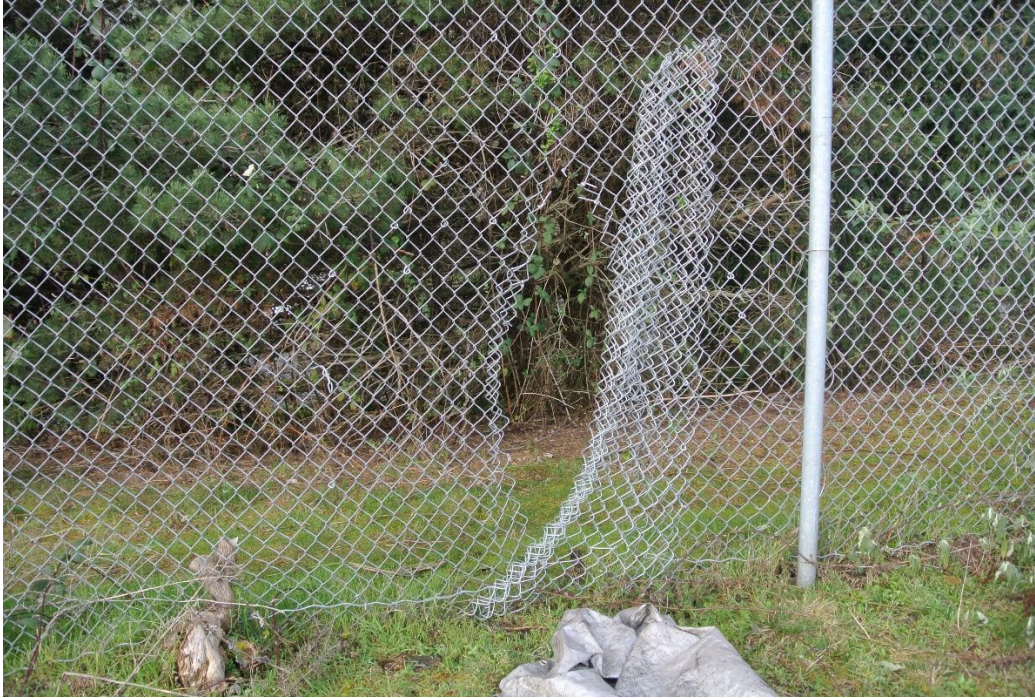
The chain-link security fencing surrounding the consolidated landfill was examined. Most of the vegetation along the fence on the west and south sides of the landfill has been removed, aiding in this inspection. Several Holes were observed in the fencing on the west side of the landfill area and should be repaired (Attachment 1: map notes 1 and 2; Attachment 2; photos 1 and 2).

**Photo 1. Hole in fence, west side of consolidated landfill: RA-3 (map note 1)**

The holes in the fence on the west side of the consolidated landfill should be repaired. The areas of pavement mounding and cracking located in RA-2 should be addressed as described in Section 2.

Repair Type/Location: The two holes in the fence on the west side of the consolidated landfill should be patched.

| Condition Noted | Map (Attachment 1) reference | Recommendation |
|---|---|---|
| Holes in fence on west side of consolidated landfill | 1,2 | Repair holes. |

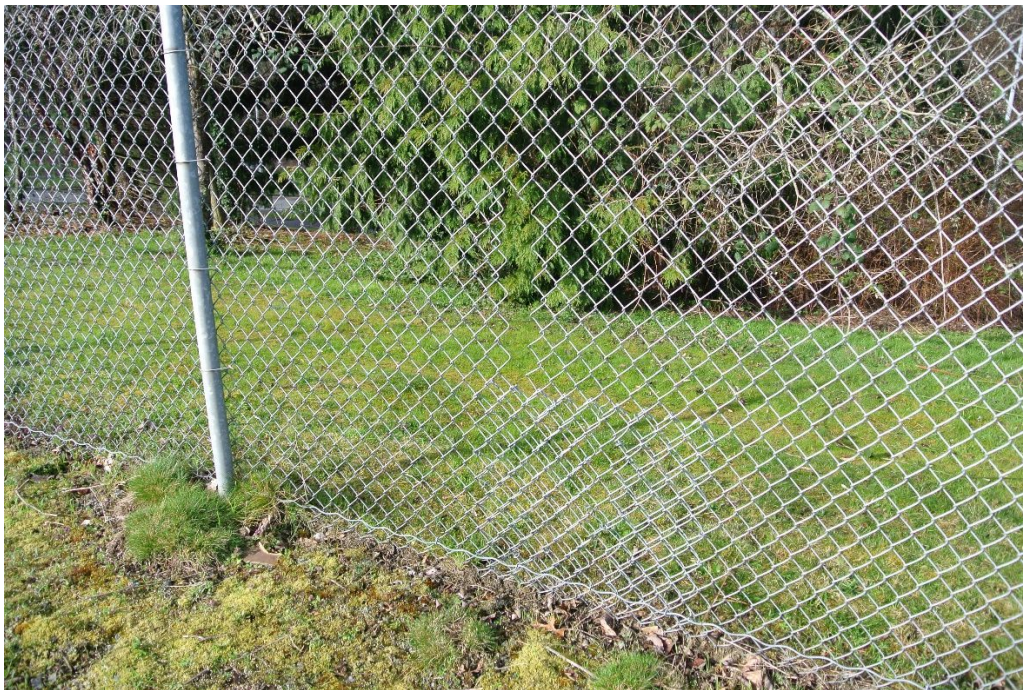
**Photo 2. Hole in fence, west side of consolidated landfill: RA-3 (map note 2)**

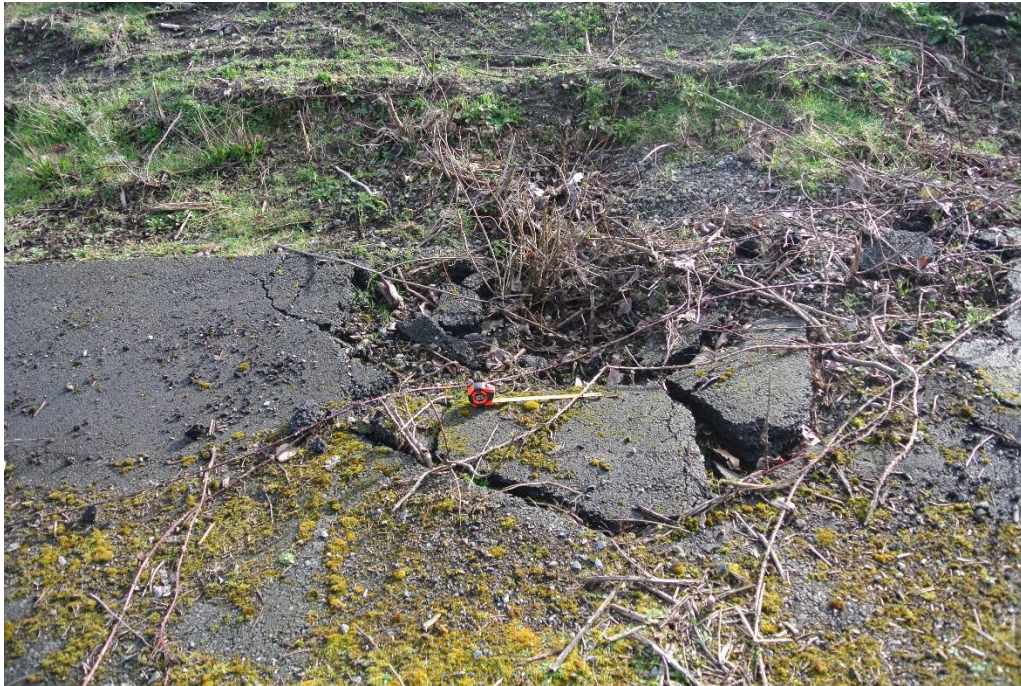
The pavements, ballast covers, fencing, and surface features associated with the stormwater drainage systems were examined during this inspection. Port Maintenance has been applying mulch to the west slope between the consolidated landfill pavement and the west drainage swale. Heavy machinery used in the area has caused damage to the swale asphalt pavement at three locations (Attachment 1, map notes 5, 6 and 7; Attachment 2, photos 3, 4 and 5).

**Photo 3. Damaged pavement in drainage swale (map note 5)**

Repair Type/Location: See Sections 1, 2, and 3 for information pavement areas in RA-2 where cracks are present in areas of pavement mounding. Three small areas of pavement damage in the west drainage swale (west side of consolidated landfill) should be repaired to prevent future erosion.

| Condition Noted | Map (Attachment 1) reference | Recommendation |
|---|---|---|
| Small areas of damaged pavement in landfill drainage swale | 5,6,7 | Replace damaged asphalt pavement |

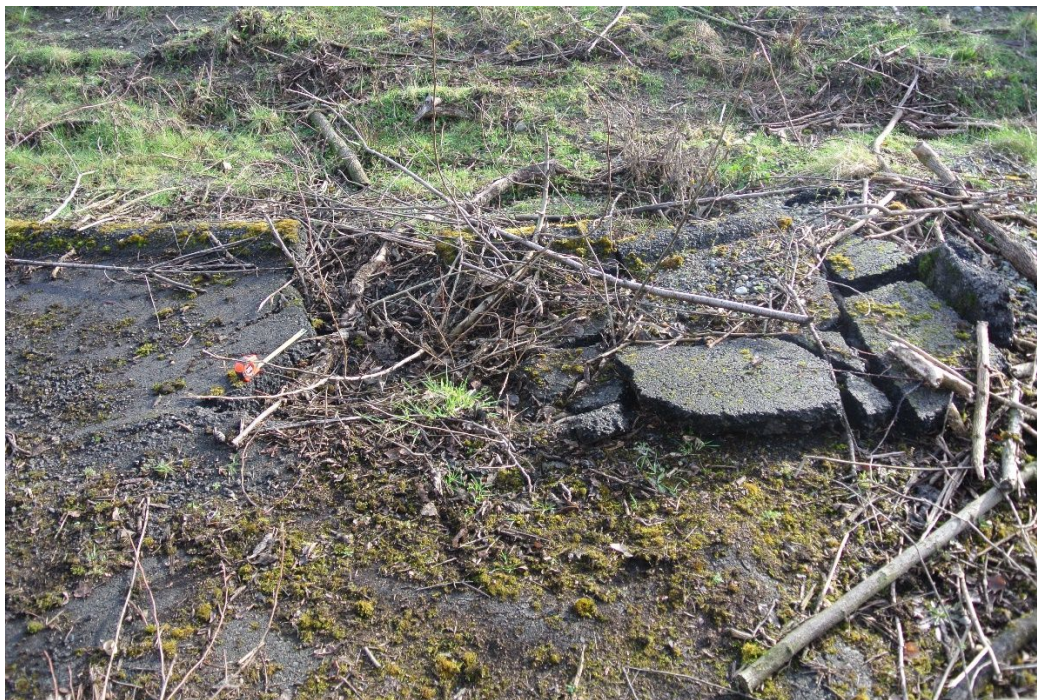
**Photo 4. Damaged pavement in drainage swale (map note 6)**

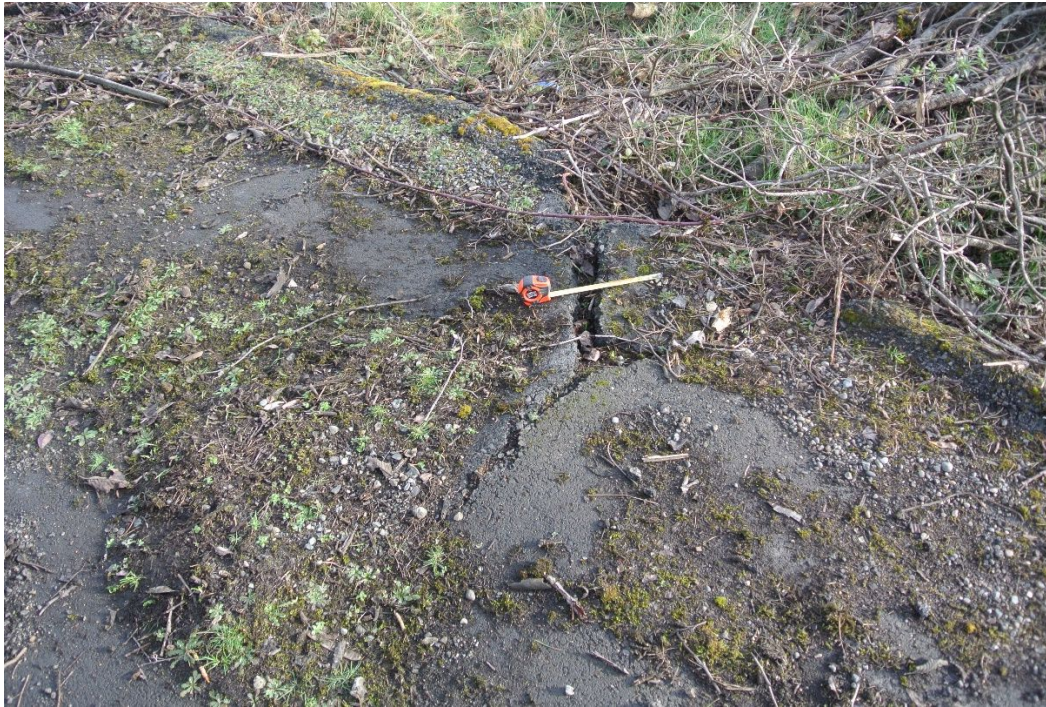
**Photo 5. Damaged pavement in drainage swale (map note 7)**

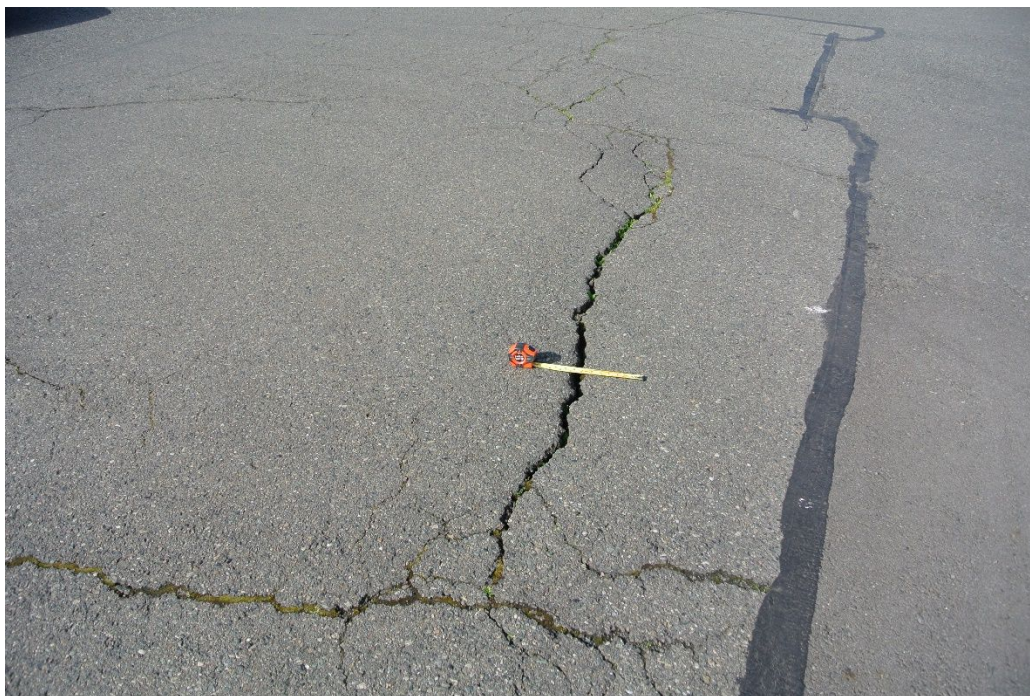
Two areas of pavement mounding with cracks wider than ¼ in. observed in previous inspections are still present in RA-2 (Attachment 1, map notes 8 and 9; Attachment 2, photos 6, and 7) , and a new similar area was observed to the west (map note 10, photo 8). The cracks at three of these locations should be sealed. The mounding at these locations are in high traffic areas and should be addressed. The cause(s) of the mounding in the areas (possibly buried piles or old foundations) should be determined and, if possible, removed.

**Photo 6. Pavement mounding and cracking in RA-2 (map note 8)**

| Condition Noted | Map (Attachment 1) reference | Recommendation |
|---|---|---|
| Elongated pavement mounding with cracks wider than ¼ in., RA-2 | 8,9,10 | Evaluate and repair prior to new tenant occupancy. Clean and seal cracks where needed. Check during future inspections. |

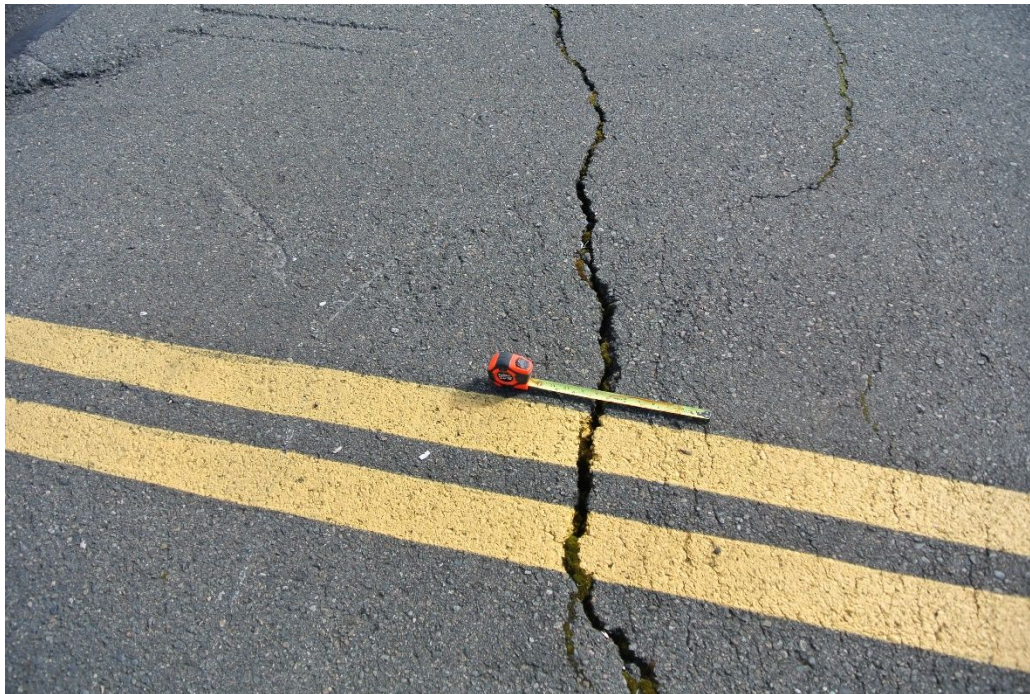
**Photo 7. Pavement mounding and cracking in RA-2 (map note 9)**

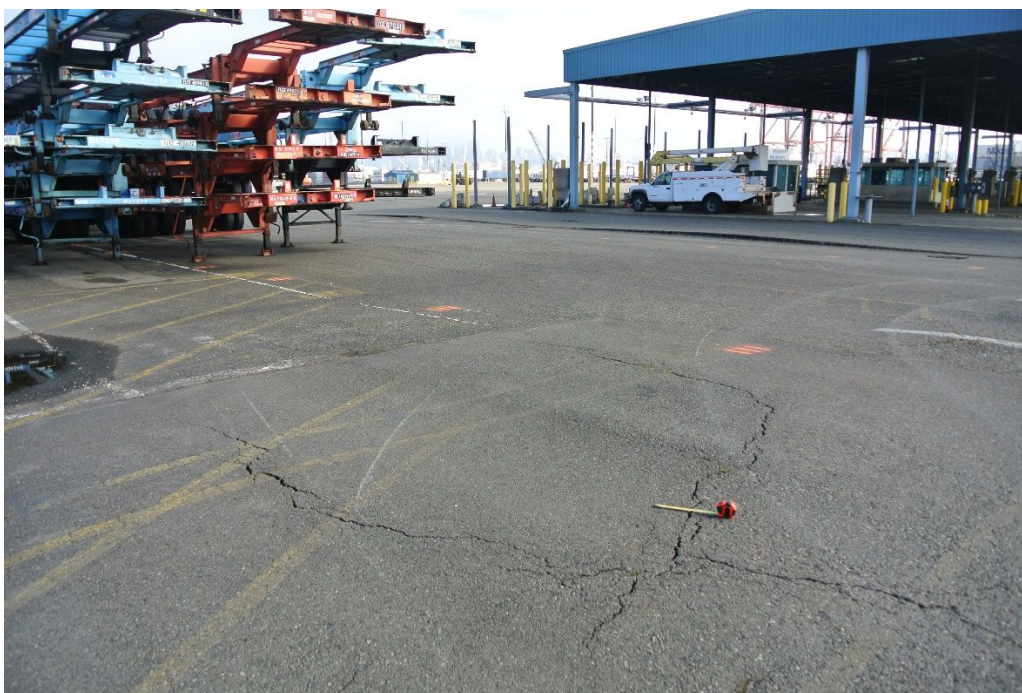
**Photo 8. Pavement mounding and cracking in RA-2 (map note 10)**

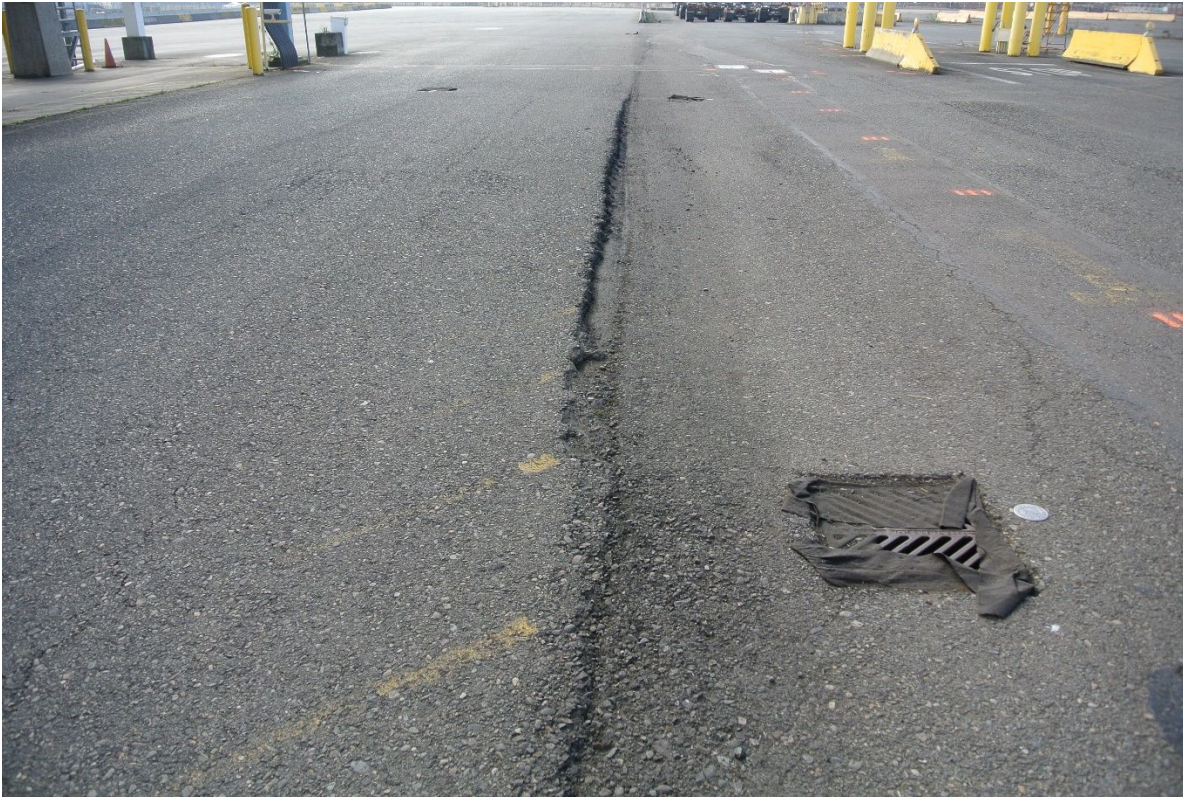
Deterioration was observed at an area of pavement just west of the truck weight scales in RA-2 (map note 11). It appears that Ecology blocks were removed from the area, exposing a difference in grade between two areas of pavement (photo 9). Underlying material is not exposed; this area was noted during the last inspection and no additional deterioration has occurred. No action is required at this time.

**Photo 9. Pavement deterioration (map note 11)**

| Condition Noted | Map (Attachment 1) reference | Recommendation |
|---|---|---|
| Pavement deterioration at interface of lifts at different grades | 11 | Monitor during future inspections. |
