SITE HAZARD ASSESSMENT Worksheet 1: Summary Score Sheet

SITE NAME: Time Oil Bulk Terminal

Cleanup Site ID: 14604

Completed on 7/7/2020 for inclusion

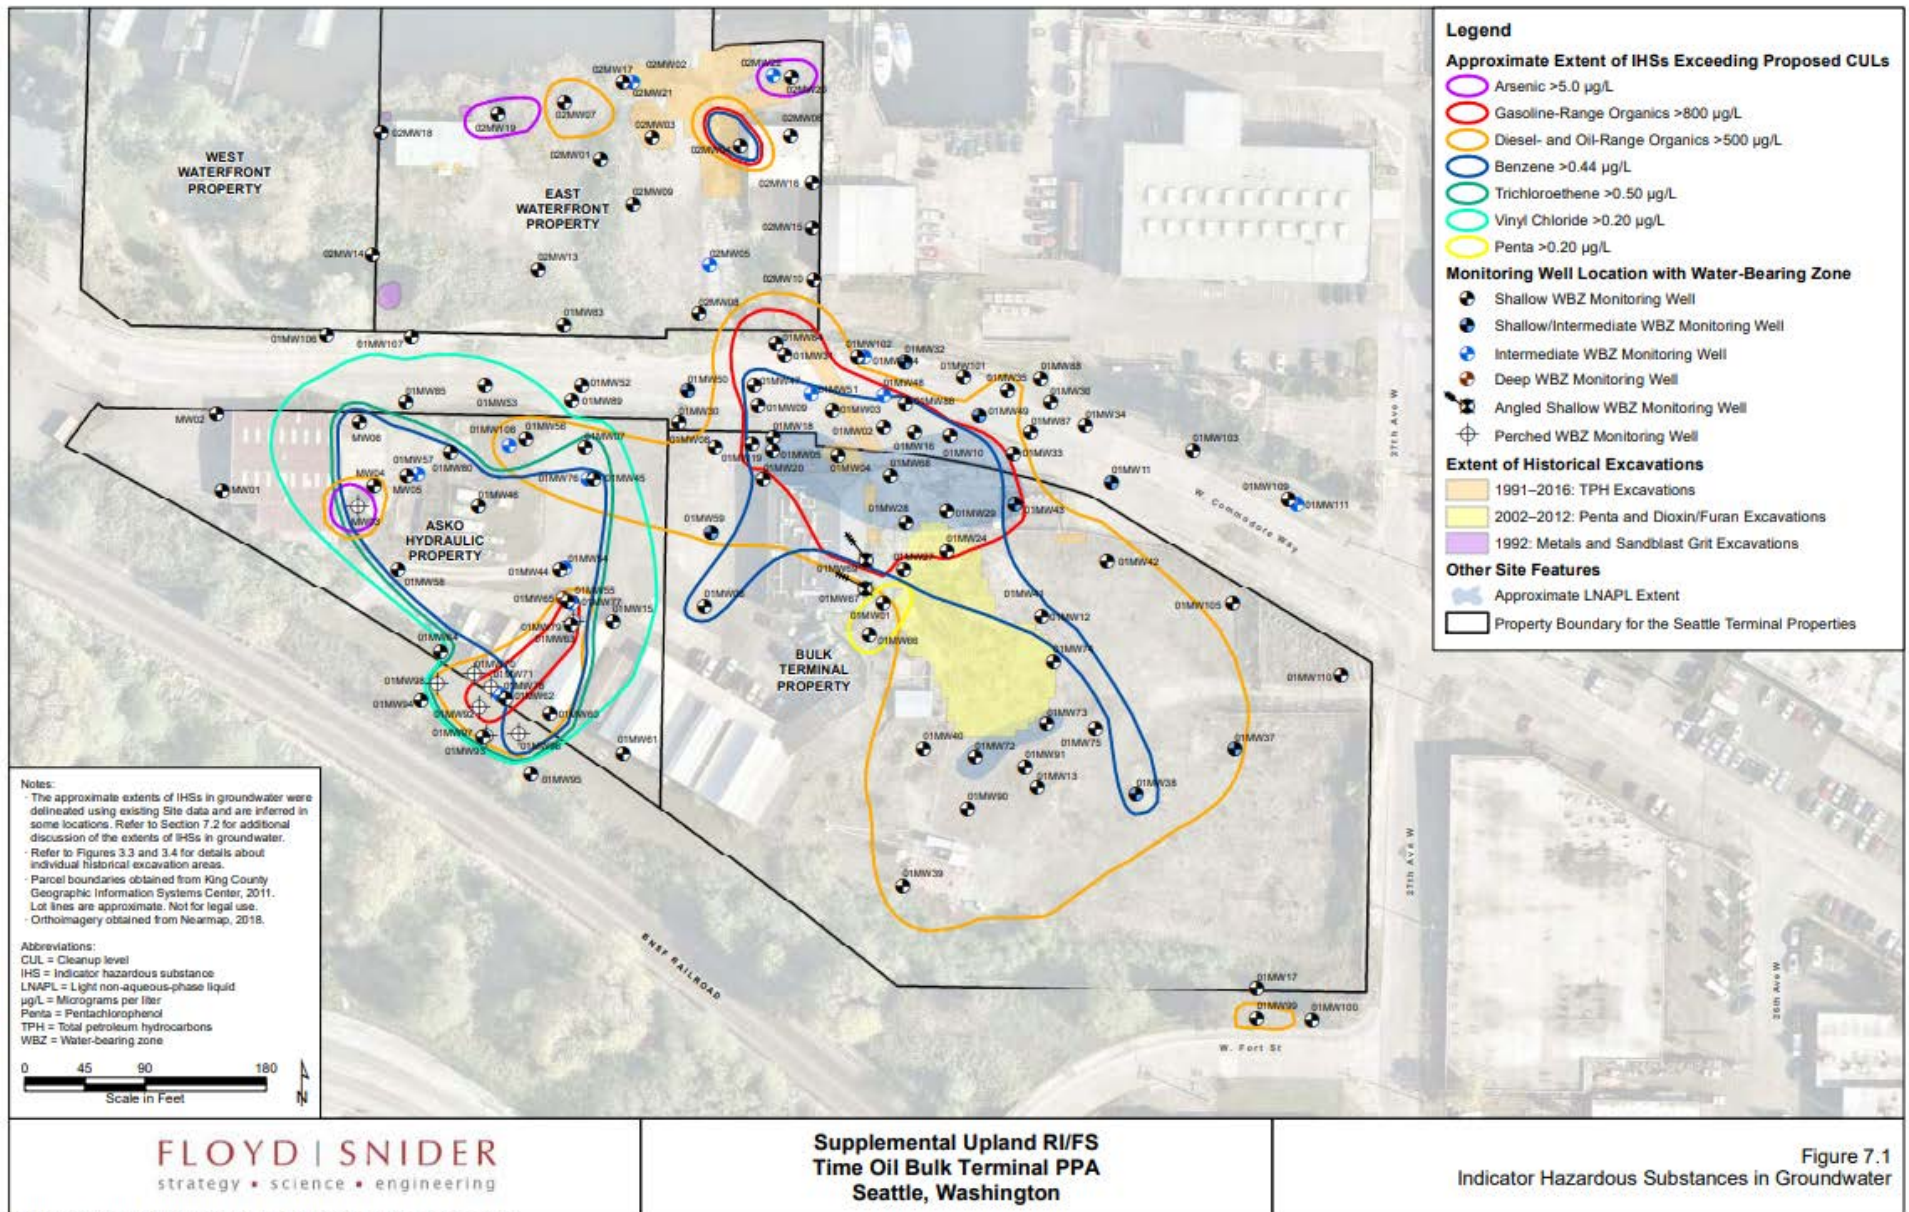
Figure 5. Areas of groundwater contamination on the Site.

Groundwater contamination is less extensive on the East Waterfront property than the Bulk Terminal and ASKO property, but is present, primarily in the northern portion of the property (see Figure 5).

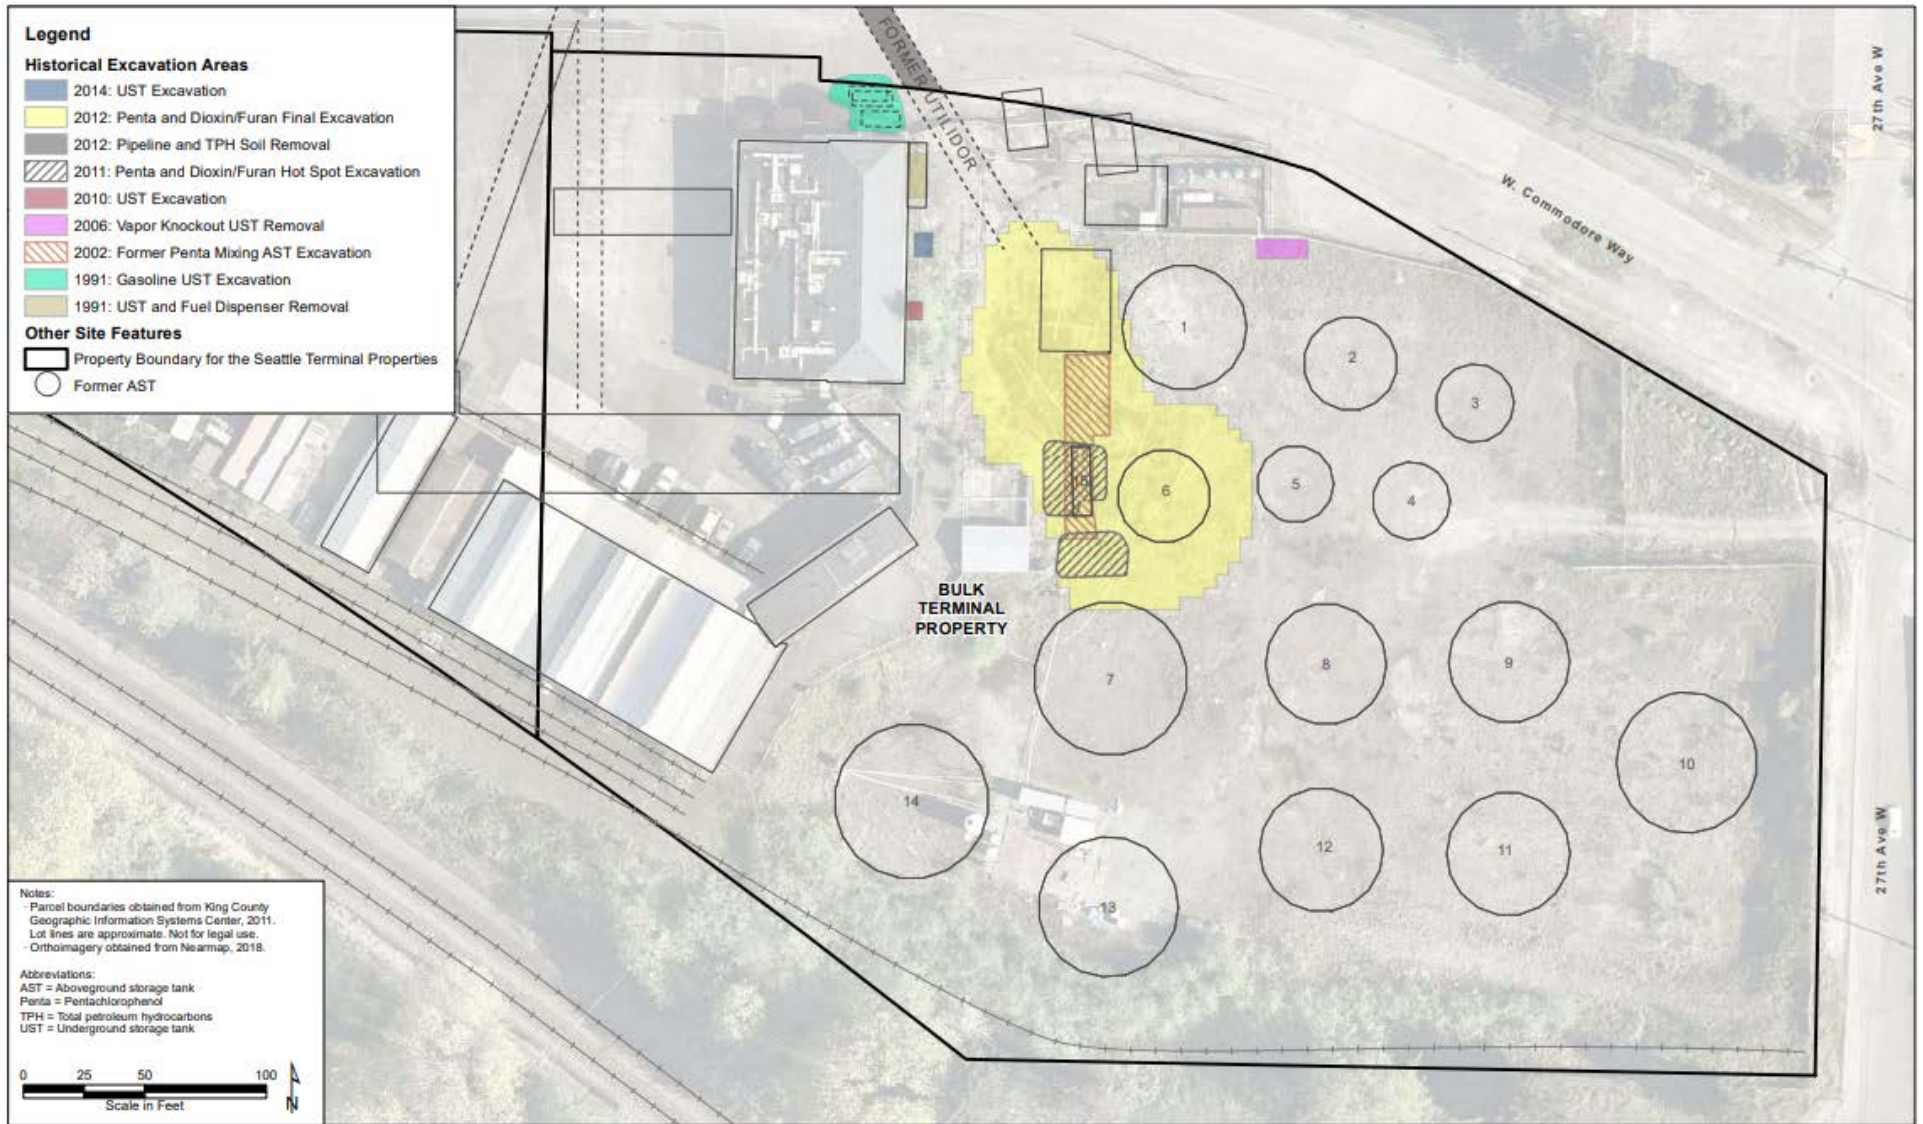
Figure 6. Areas of prior interim actions on the Bulk Terminal property.

Multiple interim actions have occurred on the Bulk Terminal property to address petroleum contamination (see Figure 6). In 1991, the USTs near the office building were removed and replaced. During the removal, approximately 140 cubic yards of contaminated soil was removed. Confirmation samples indicated that contaminated soil remained outside of the excavation boundaries. In 2002, 13 cubic yards of soil were excavated following a hydraulic fluid leak from a truck at the western edge of the parking area. Confirmation samples indicated that all contaminated soil was removed. In 2003, a pilot test was run to determine the efficacy of a dual-phase extraction system to address Site contamination. An estimated 19 pounds of TPH were removed from the subsurface during the pilot test. In 2006, the UST near the office building, fuel dispensers, and a vapor knockout tank were removed. Confirmation sampling indicated remaining TPH-G, TPH-Dx, and benzene in soil in this area. In 2010 and 2014, additional USTs were removed east of the headquarters building. A groundwater and NAPL recovery system was operated on the property between 2012 and 2017. The system removed groundwater through recovery wells and treated it prior to discharge into the sanitary sewer. Additional details of system operation and duration of use are not available in Ecology's files.

Multiple interim actions have occurred on the Bulk Terminal property to address pentachlorophenol contamination. In 2002, approximately 70 cubic yards of contaminated soil were excavated and removed from the Site. In 2010, heat-activated sodium persulfate was injected into the subsurface in an attempt to decrease pentachlorophenol concentrations in groundwater. A total of 302,500 gallons of 10% aqueous phase sodium persulfate was injected through 144 injection wells. Groundwater monitoring in the years following injection

(2011-2013) indicated an approximately 85% decrease in concentration of pentachlorophenol. Multiple rounds of soil excavations were performed in 2011 and 2012 to remove areas with the highest concentrations of pentachlorophenol and dioxin/furans, a related contaminant. Soil targeted for removal had concentrations of pentachlorophenol above Method B cleanup levels protective of direct contact with soil and dioxin/furan concentrations above Seattle background (determined as the 90th percentile of Seattle area concentrations, 46 ng/kg). Approximately 4500 tons of soil were removed during these excavations.

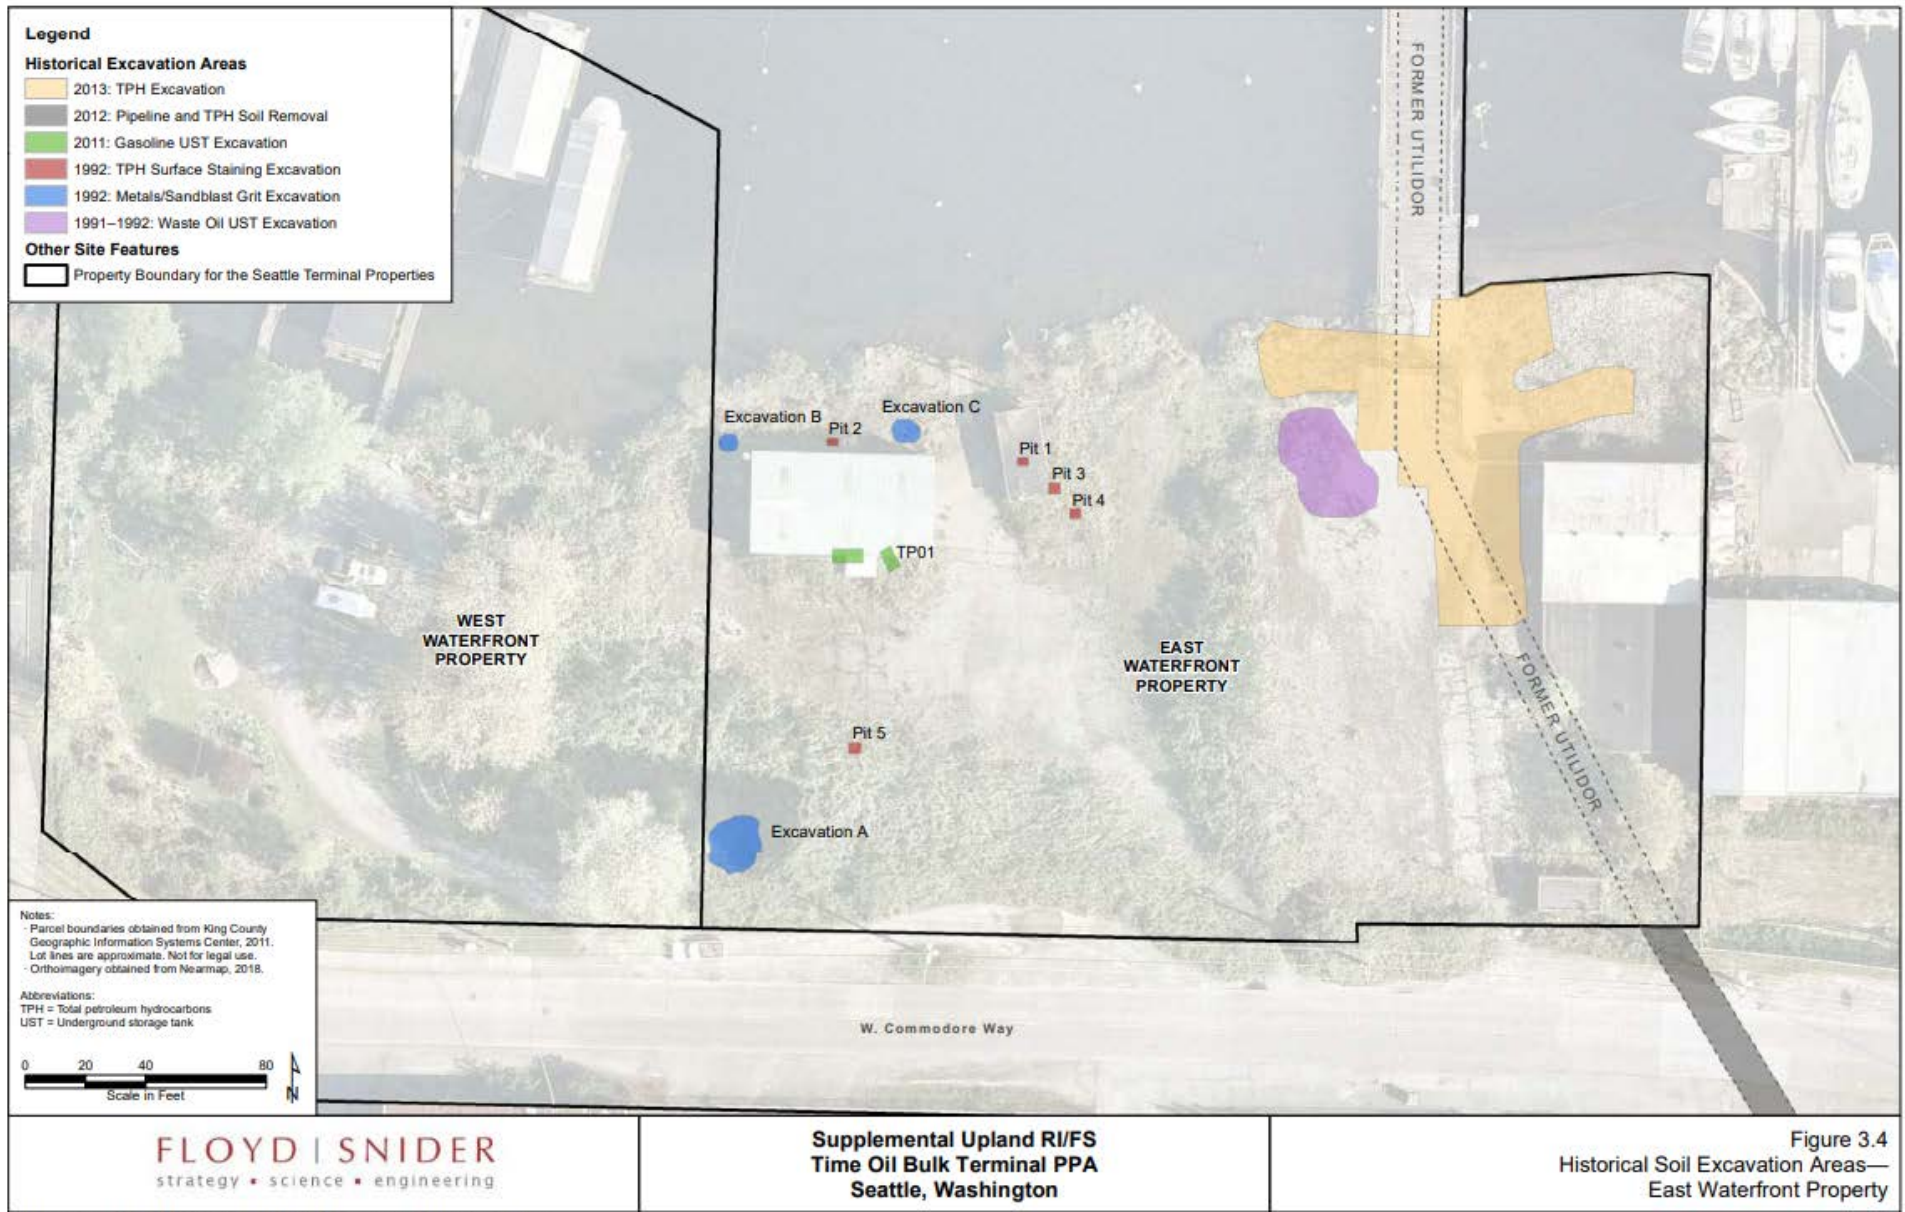
Figure 7. Areas of prior interim actions on the East Waterfront property.

Interim actions to address contamination on the East Waterfront property began in the early 1990s (Figure 7). In 1991, a 500 gallon UST west of the former warehouse building was removed. The UST stored waste oil generated by Time Oil fleet vehicle maintenance. Between overexcavation at the time of tank removal and an additional excavation in 1992, approximately 250 cubic yards of petroleum contaminated soil was removed. Groundwater in this area is very shallow (2-6 feet bgs), and a sheen was observed on groundwater during excavation. Confirmation soil samples taken on the north and east excavation boundaries indicated remaining TPH-G, TPH-Dx, and benzene above preliminary cleanup levels. An additional excavation was done in 2013, removing 1700 cubic yards of contaminated soil north and east of the original excavation boundaries. Contamination remains on the east side of the excavation underneath the shed and garage buildings.

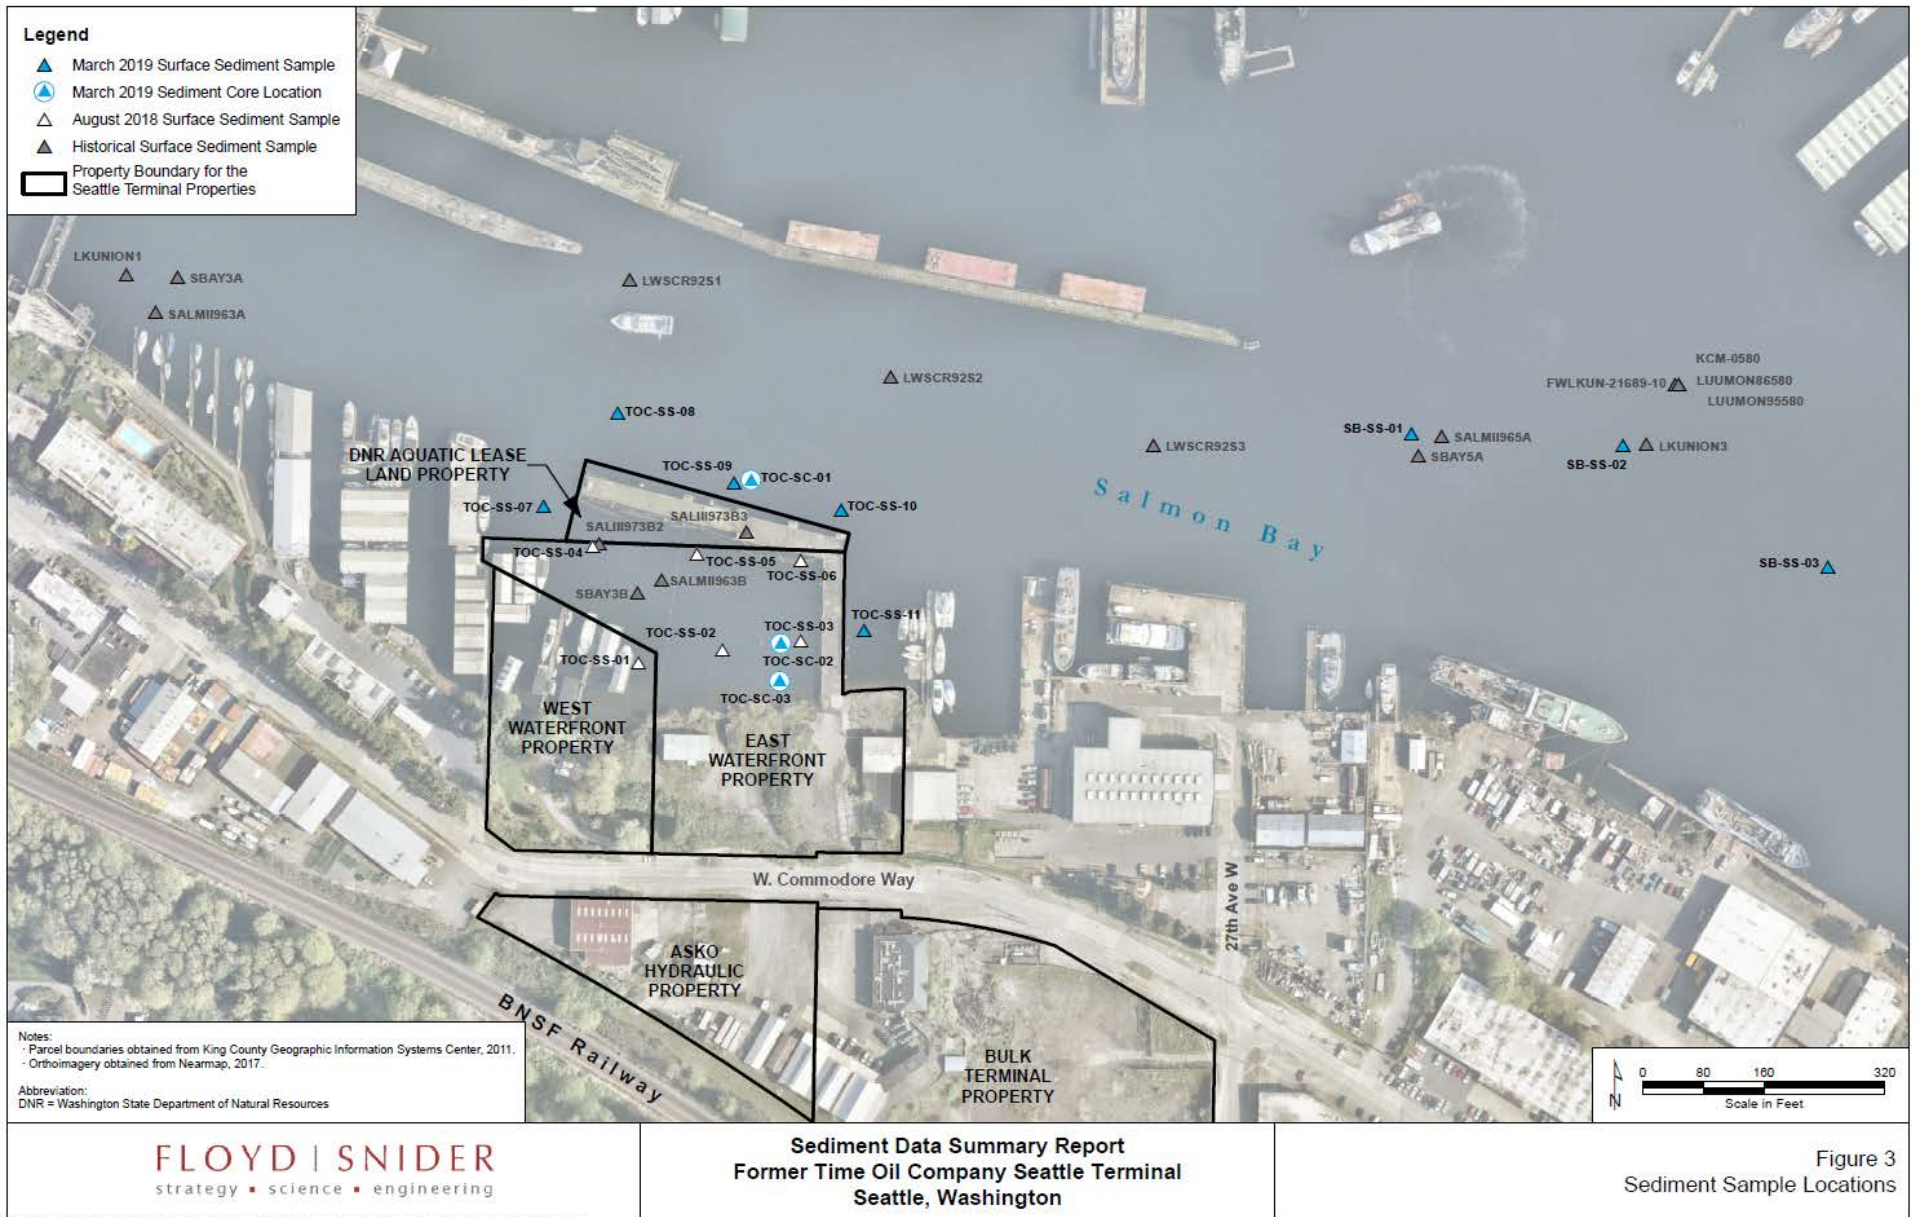
Figure 8. Sediment sampling locations.

Samples were collected near the Site as part of a series of studies Ecology conducted on the contamination status of Salmon Bay sediments between 1995 and 2000 (see Figure 8). These samples are identified as location 3B in the Phase II sediment report and locations 3B2 and 3B3 in the Phase III report. Sediment collected in these locations had elevated concentrations of metals, PAHs, and tributyltin. Multiple bioassays were positive for sediment toxicity for sample 3B3.
