Phase I Environmental Site Assessment North Marina Redevelopment Project Port of Everett Everett, Washington

November 28, 2001

LANDAU ASSOCIATES, INC.

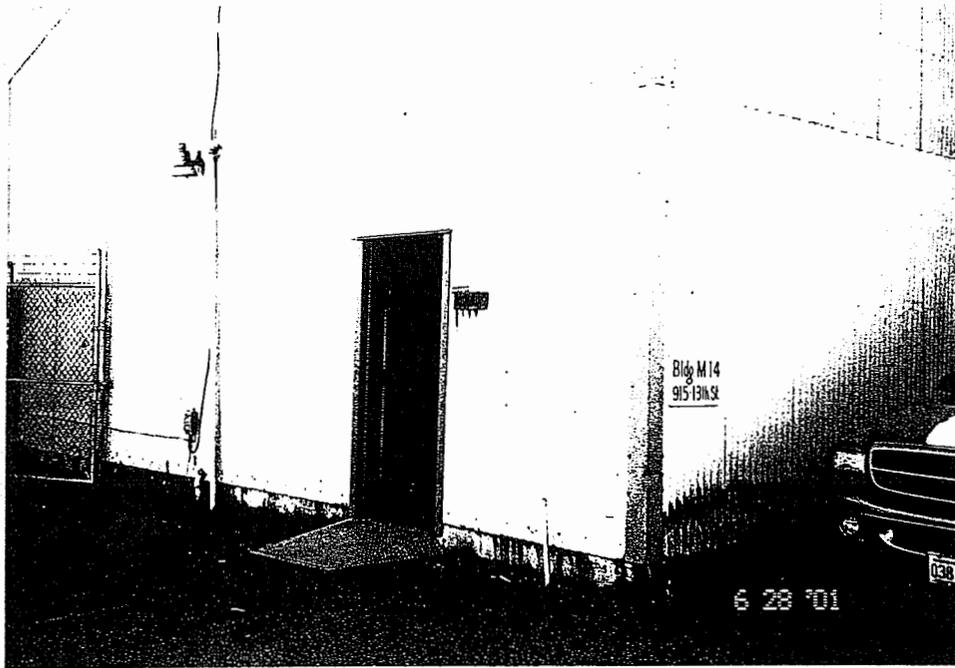
JL Brooks Welding – Possible UST vent and product piping (left side of doorway).

- A potential UST vent line and product piping was identified at JL Brooks Welding. Determining the presence or absence of a UST in that location could likely be accomplished with a magnetometer.
- Sandblast grit exists in the yard north of Everett Engineering Building M11. This material may require analysis to determine if it needs to be disposed as a dangerous waste.
- Records regarding product inventory and leak monitoring should be maintained for the UST at the Port Boatyard to determine if the UST has potentially leaked product.

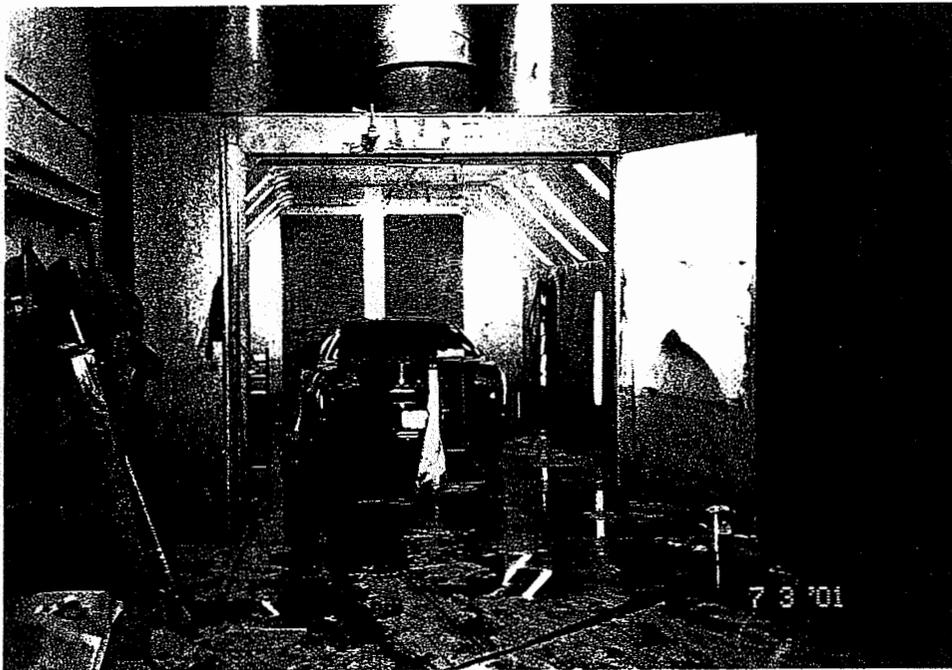
Sunset Body Works – Automobile paint booth and air filtration system.

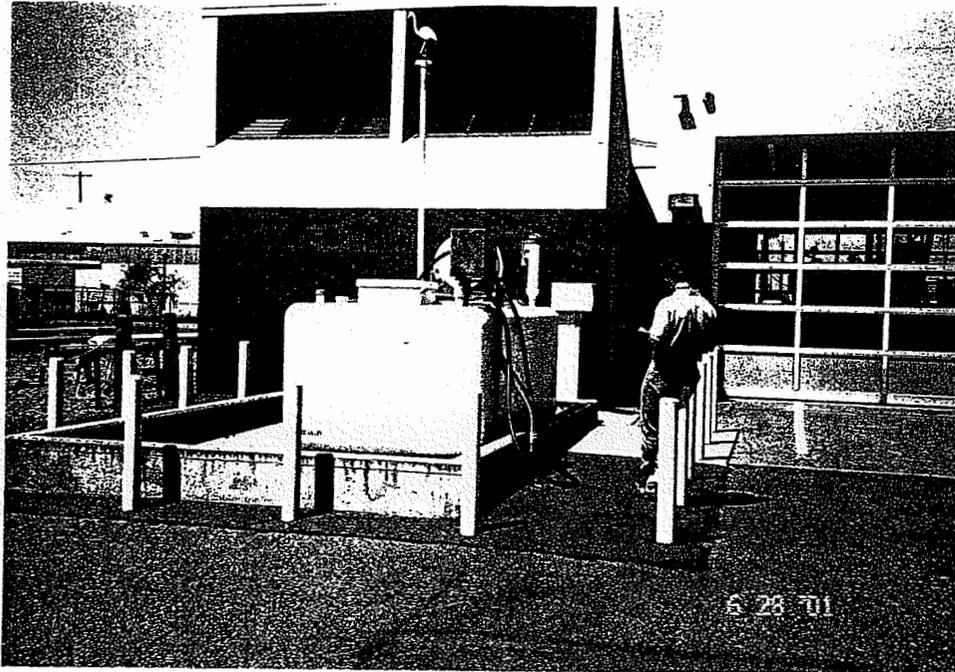
Everett Fire Station No. 3 – 1,000-gallon diesel AST south side of firehouse building.

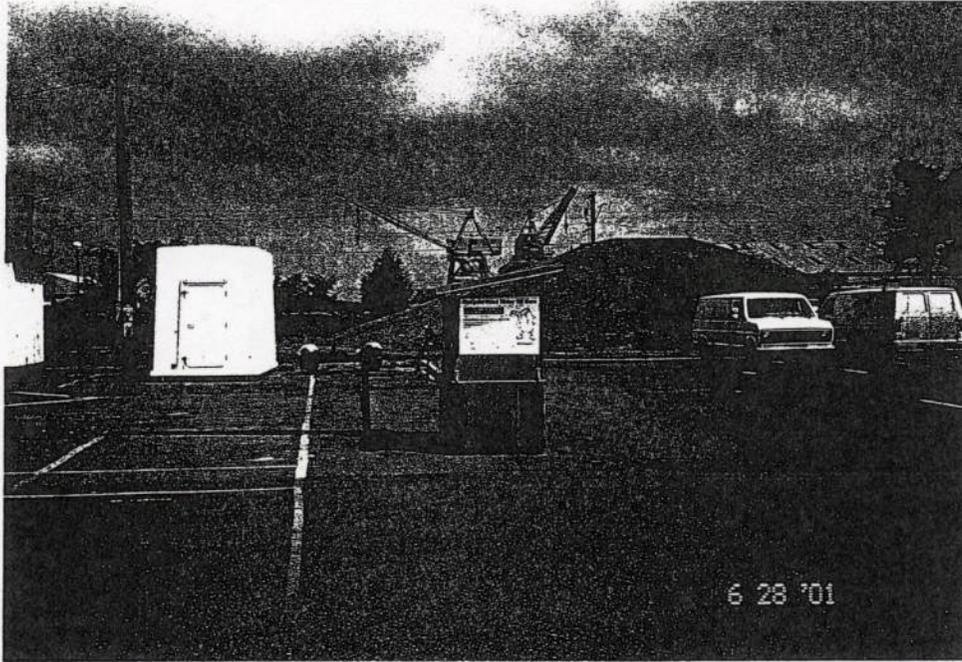
Former United States Coast Guard Station – Waste oil recycling station and fiberglass fuel storage shed in foreground; Jordan Park in background.

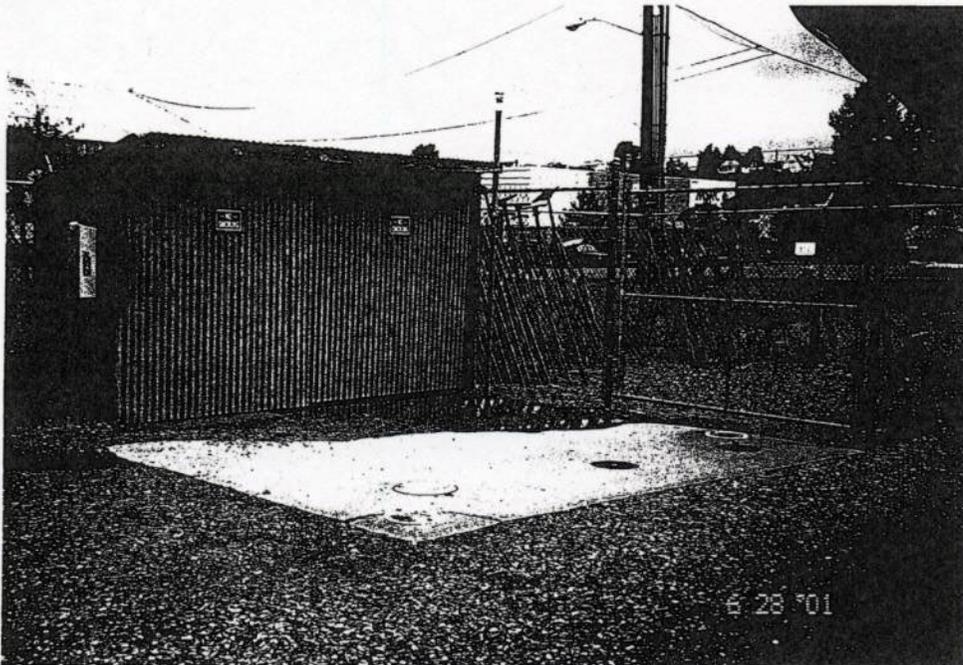
Port of Everett Yacht Basin Marina – Concrete pad over unleaded gasoline UST and observation wells.

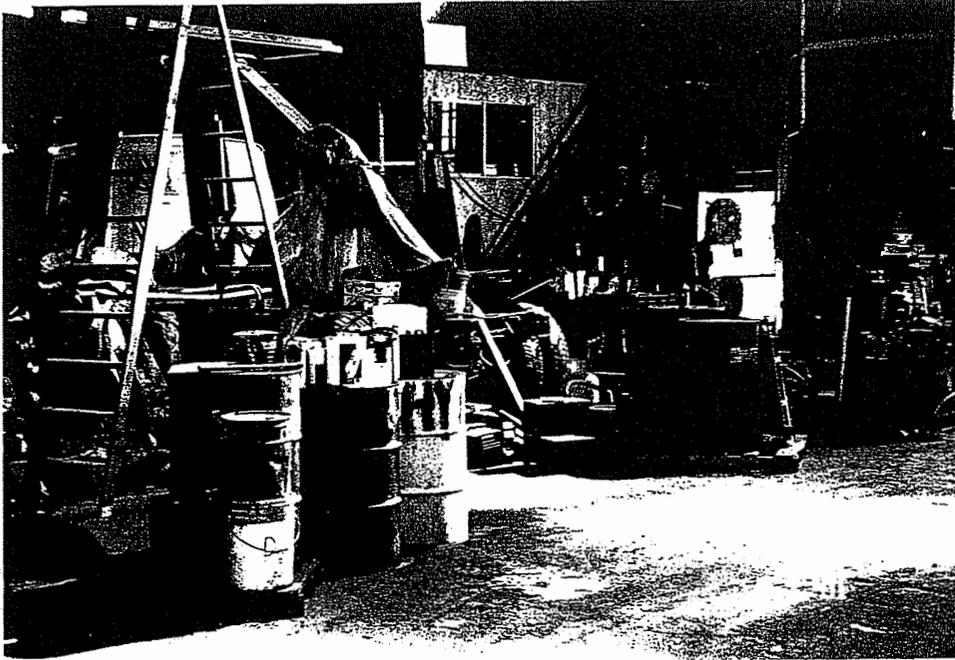
Everett Engineering Building M11 – Drums containing hydraulic oil, motor oil and diesel fuel.

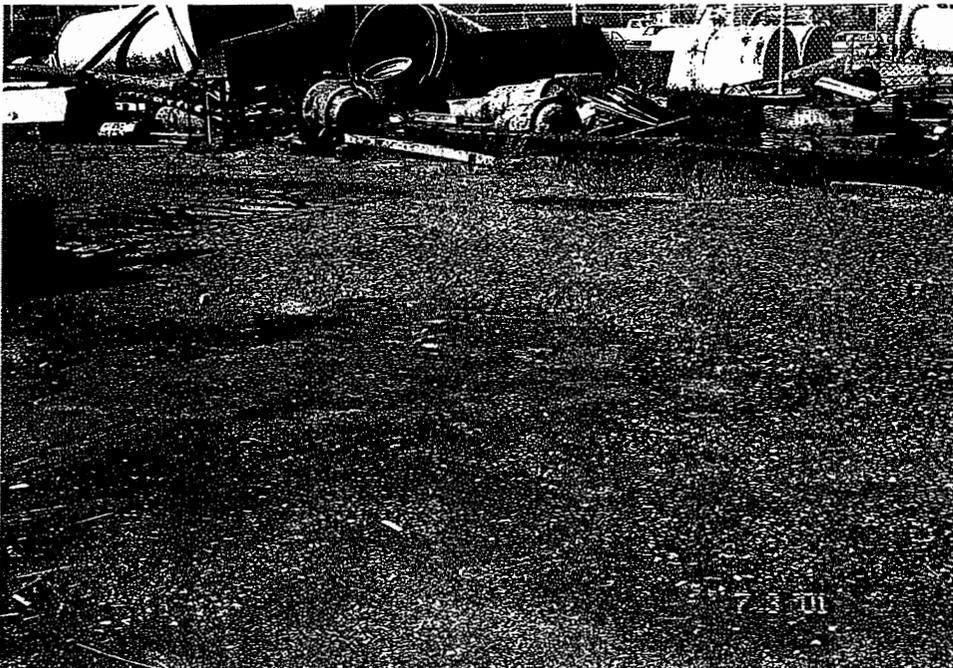
Everett Engineering Building M11 – Sandblast grit on surface of gravel lot north of site building.

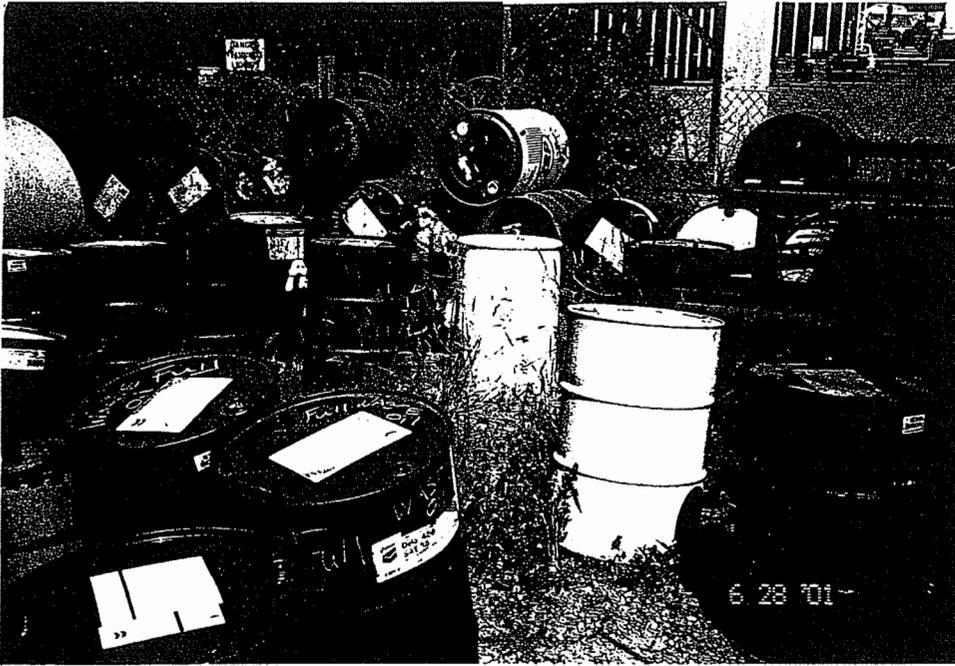
American Construction Company – Drums containing motor oil, used antifreeze and hydraulic oil along east edge of property.

- A subsurface assessment may be advisable at the American Construction Company property. The site was not documented in the Environmental Data Resources, Inc. (EDR) database search; however, site reconnaissance noted the presence of petroleum storage tanks, drums potentially containing hazardous materials, and several piles of creosote treated timber.
- The former presence of railroad spurs adjacent to 13th and 14th Streets could include the potential for environmental impacts to be present related to the cleaning of railcars and /or the maintenance and fueling of locomotives.

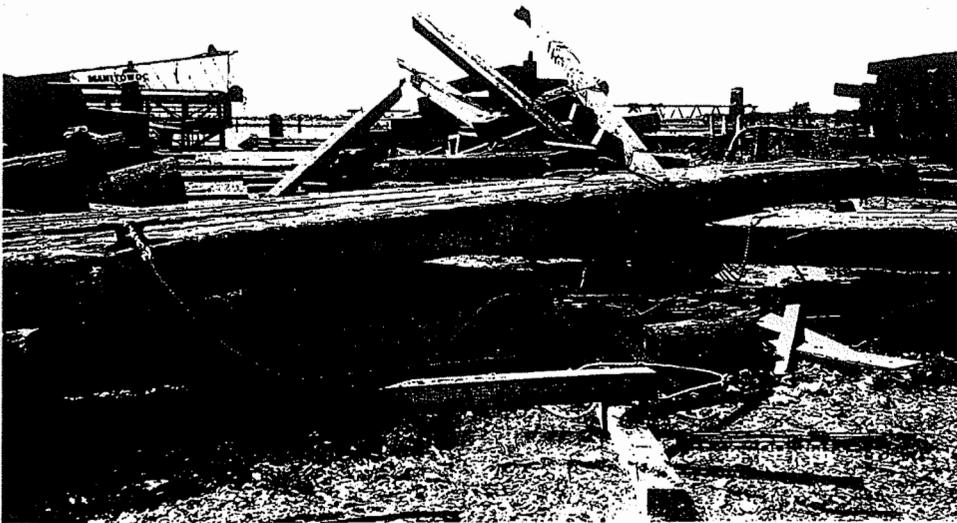
American Construction Company – Creosote-treated pilings stacked in north yard.

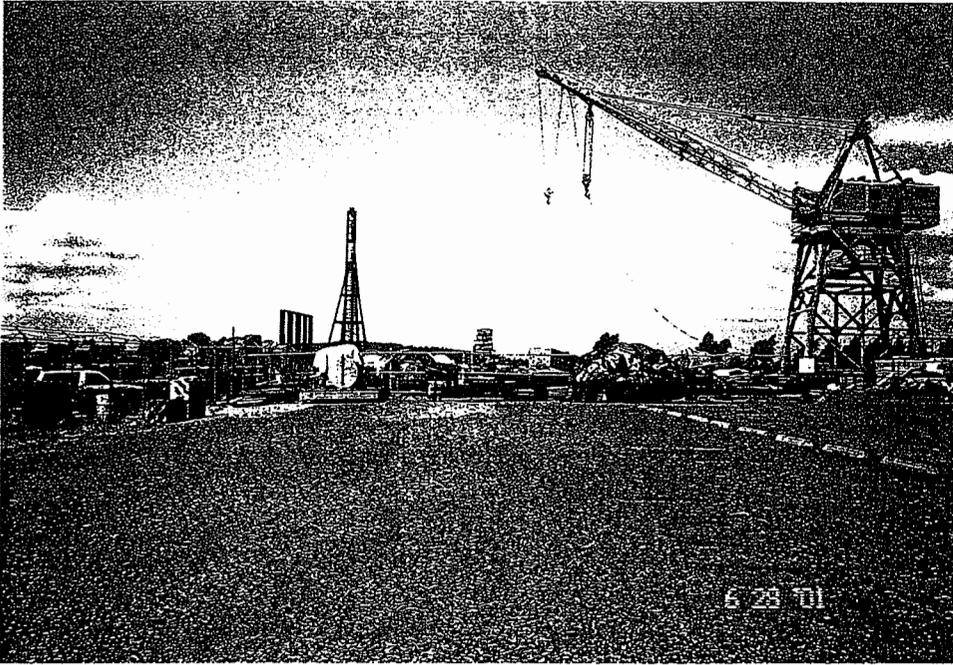
Port of Everett Overflow Parking Lot – Moveable AST used for sewage removal from boats stored on north side of property.

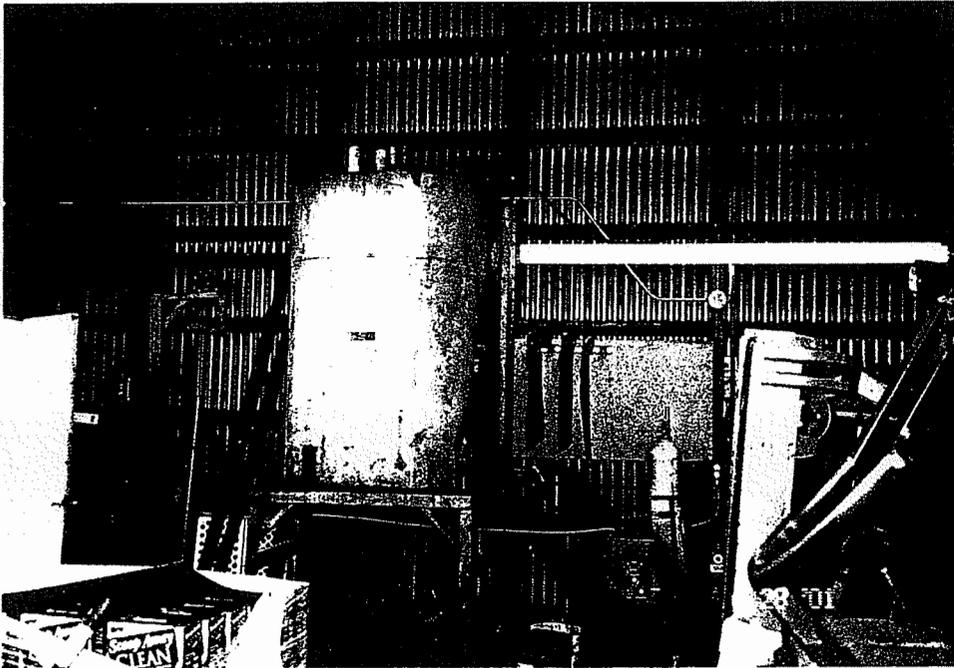
Puget Sound Truck Lines – Fresh motor oil AST in shop building.

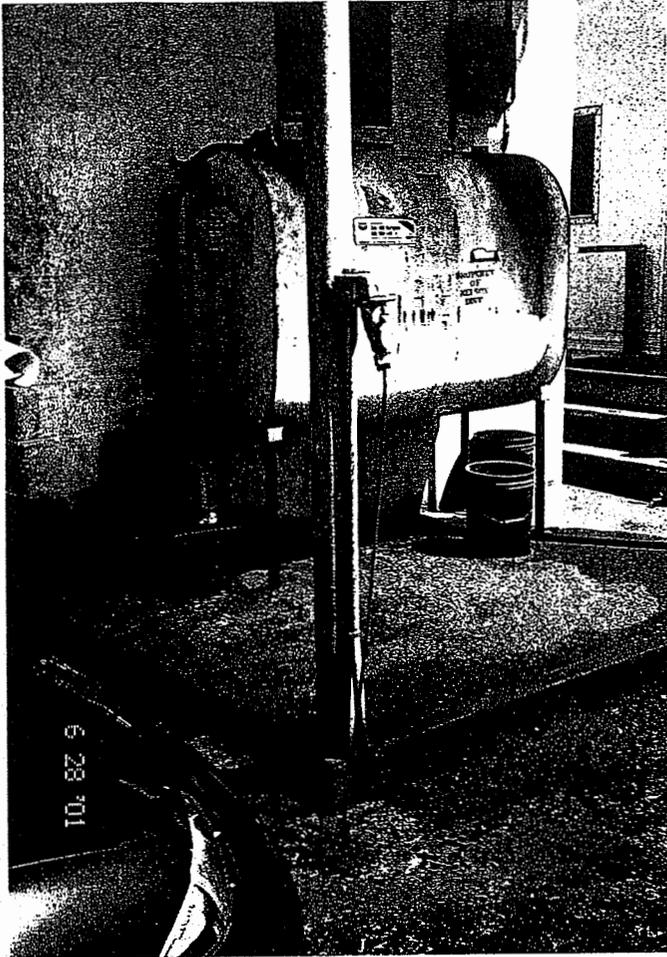
Puget Sound Truck Lines – Oil stains on ground surface beneath 275-gallon motor oil AST.

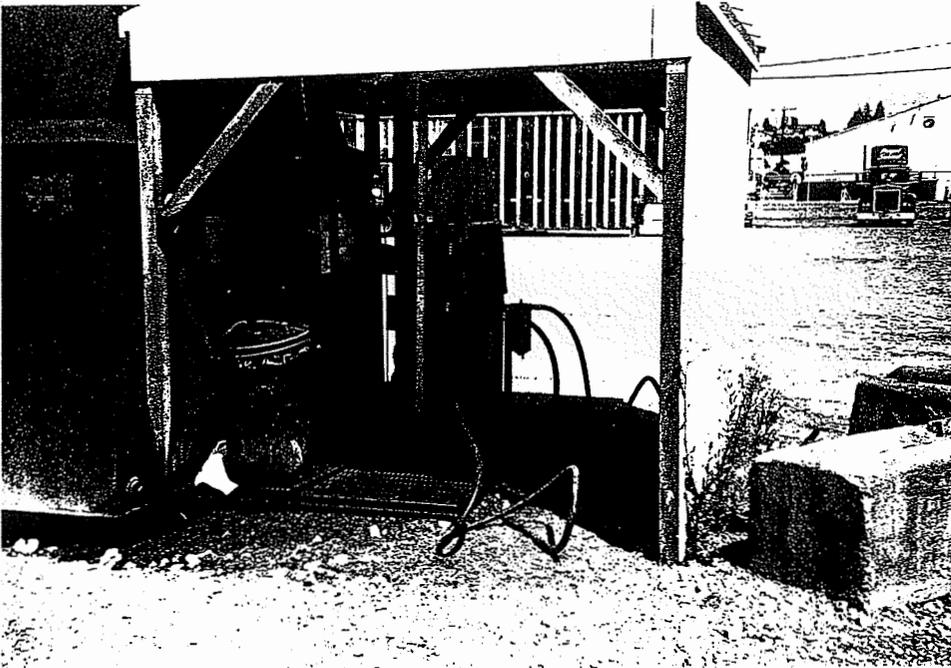
Puget Sound Truck Lines – Stained ground surface beneath dispensers of diesel AST.

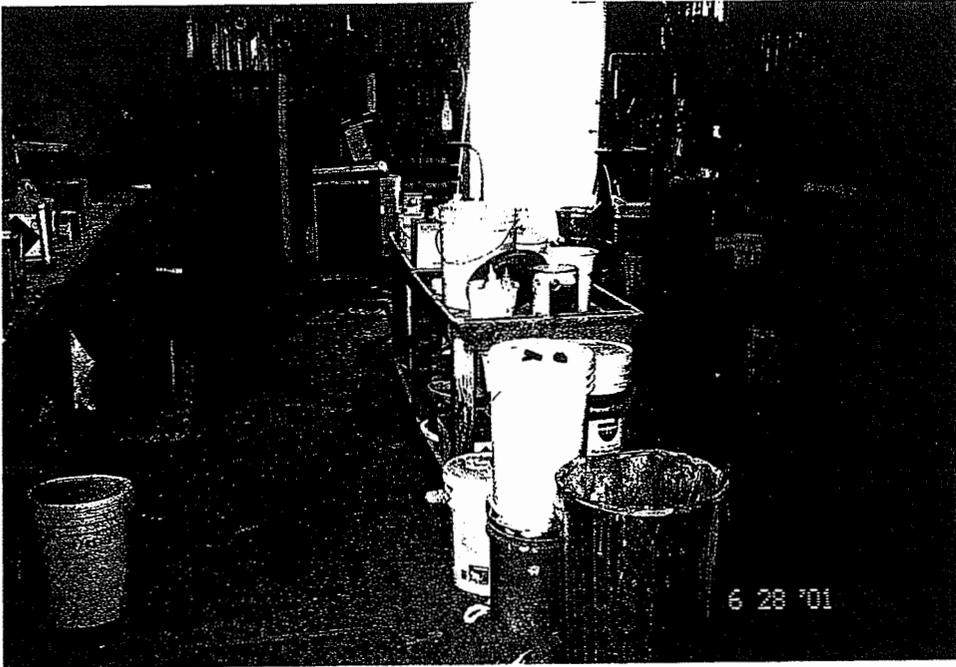
Harbor Marine Maintenance – Paint products and epoxy storage area.

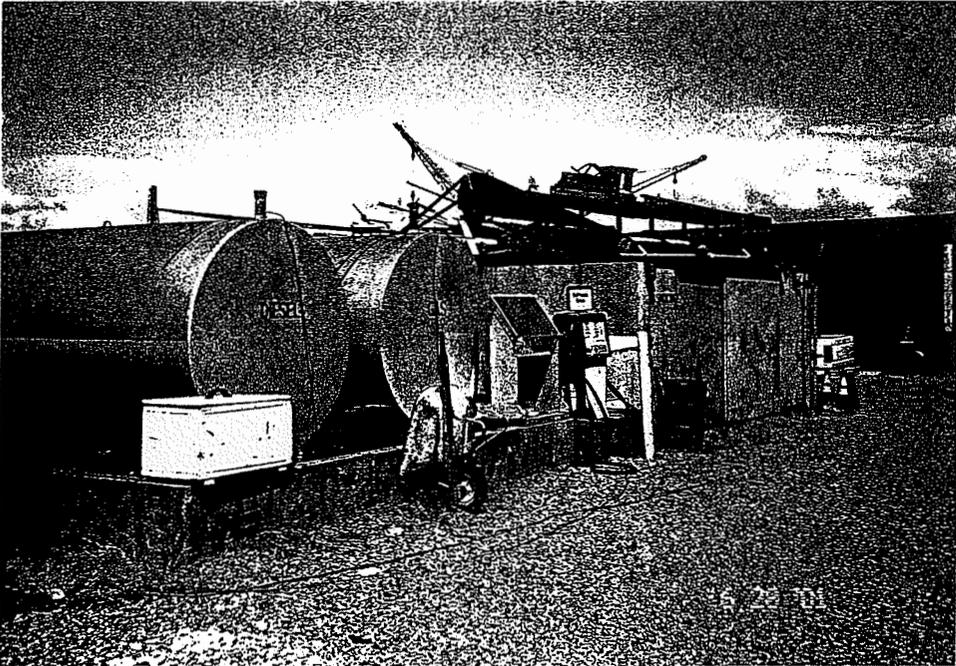
American Construction Company – Diesel and gasoline ASTs.

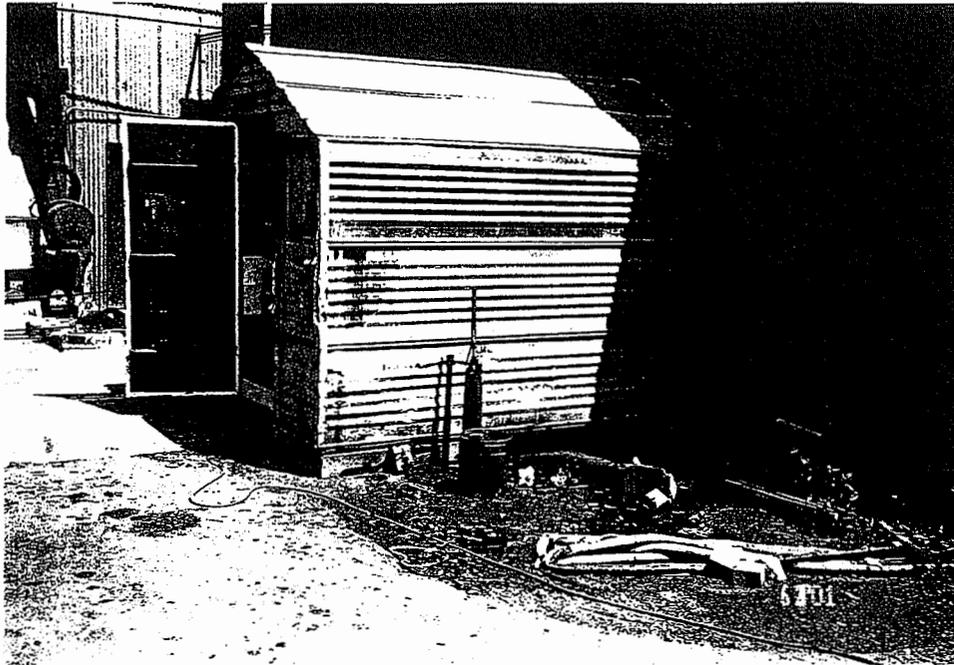
The impacted soil media at these sites associated with the surface stains is expected to be minimal (less than 50 total cubic yards (yd³) per site)

Fishermen's Boat Shop – Stained ground surface beside paint storage shed.

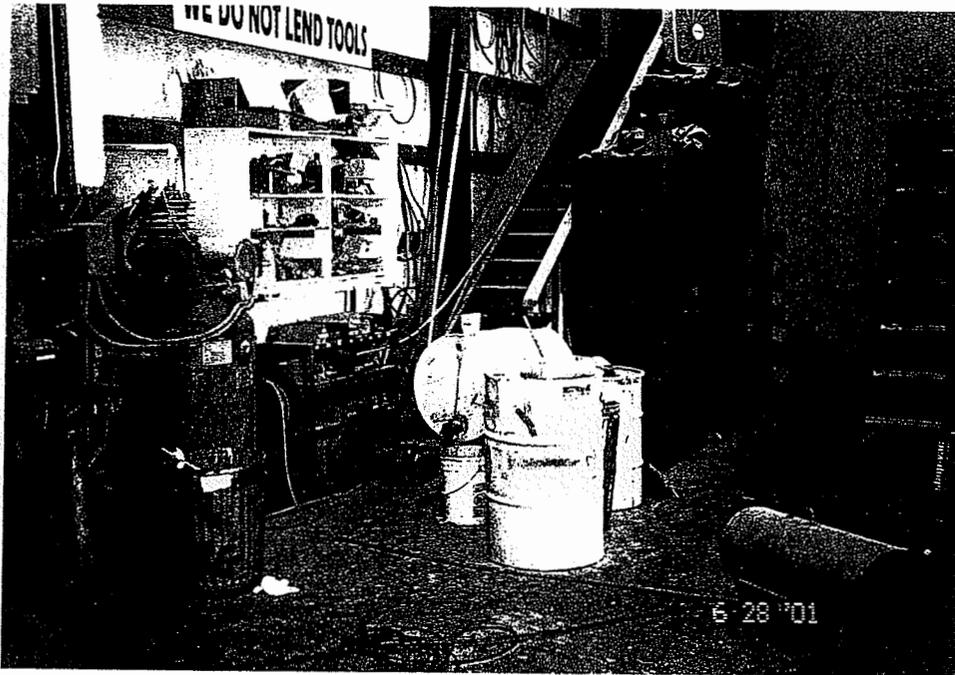
Harbor Marine Maintenance – Fiberglass resin drums in boat repair building.

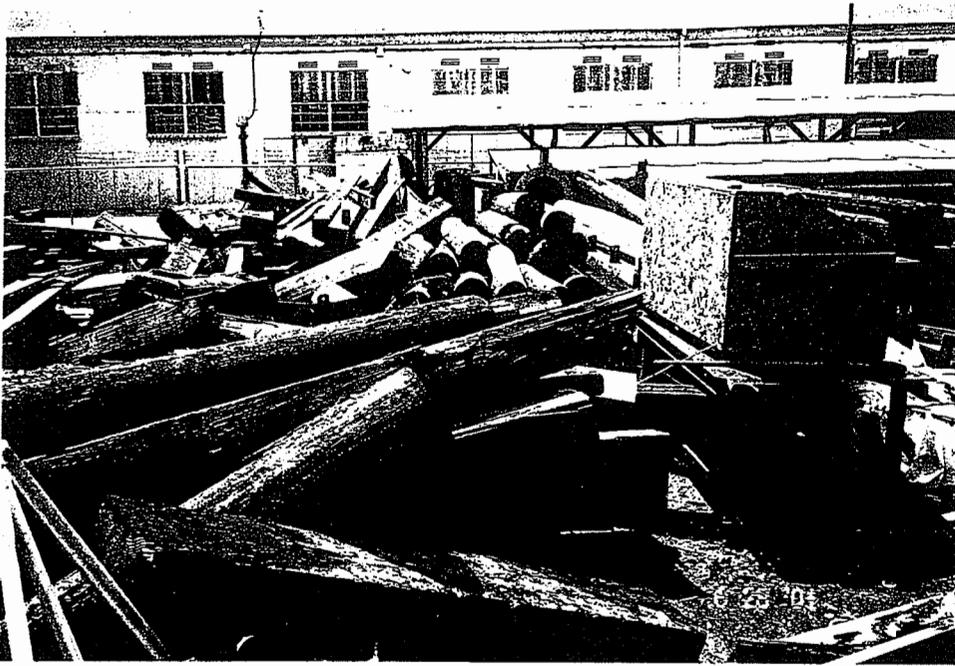
Fishermen's Boat Shop – Creosote treated pilings in boat yard.

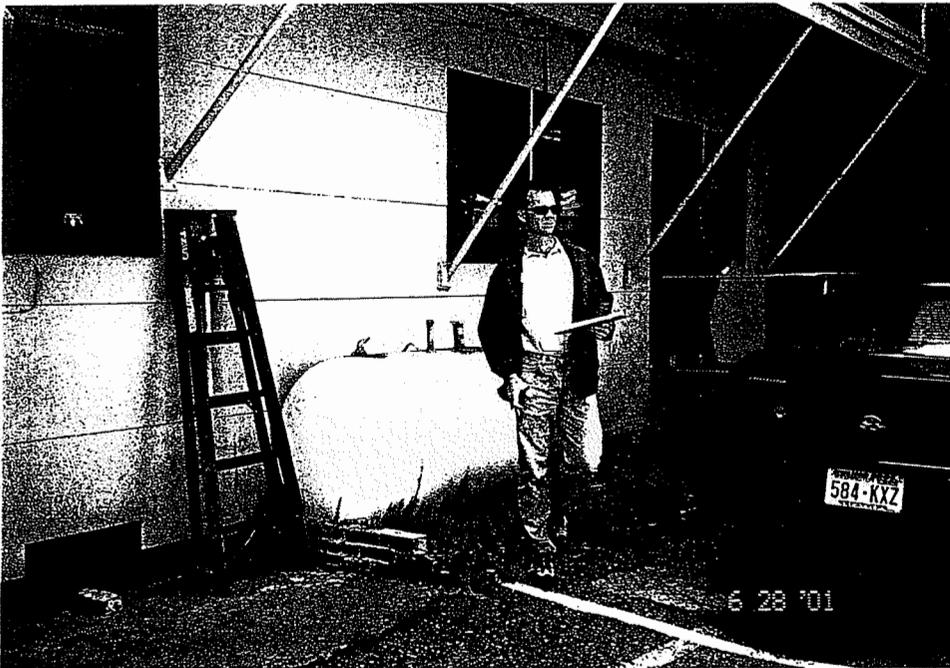
Fishermen's Boat Shop – Fuel oil AST in use onsite.

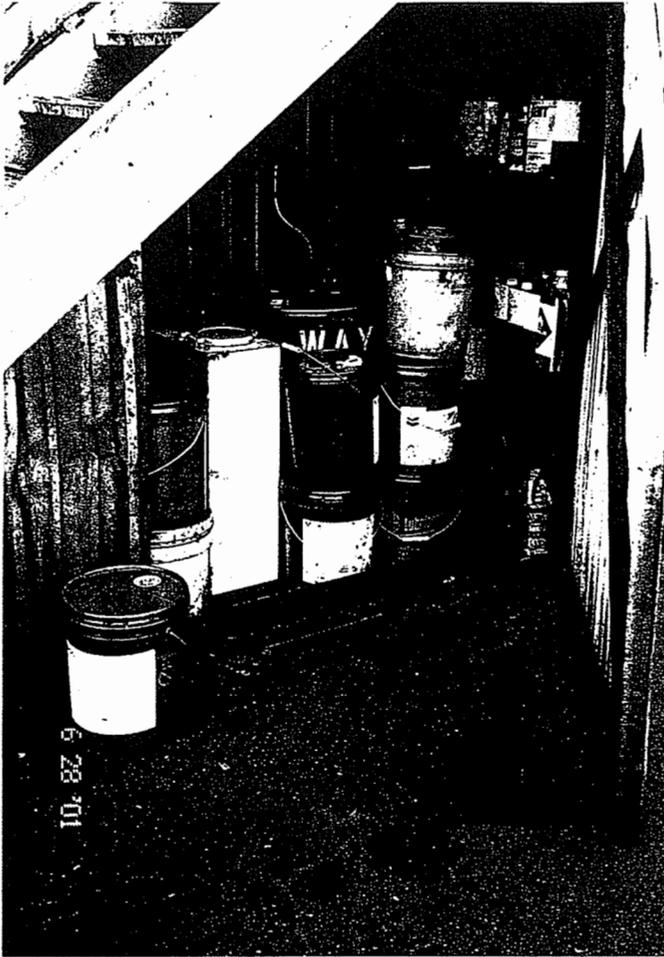
Everett Engineering Building M11 – Solvents, cutting oil and lube oil in flammables storage closet.

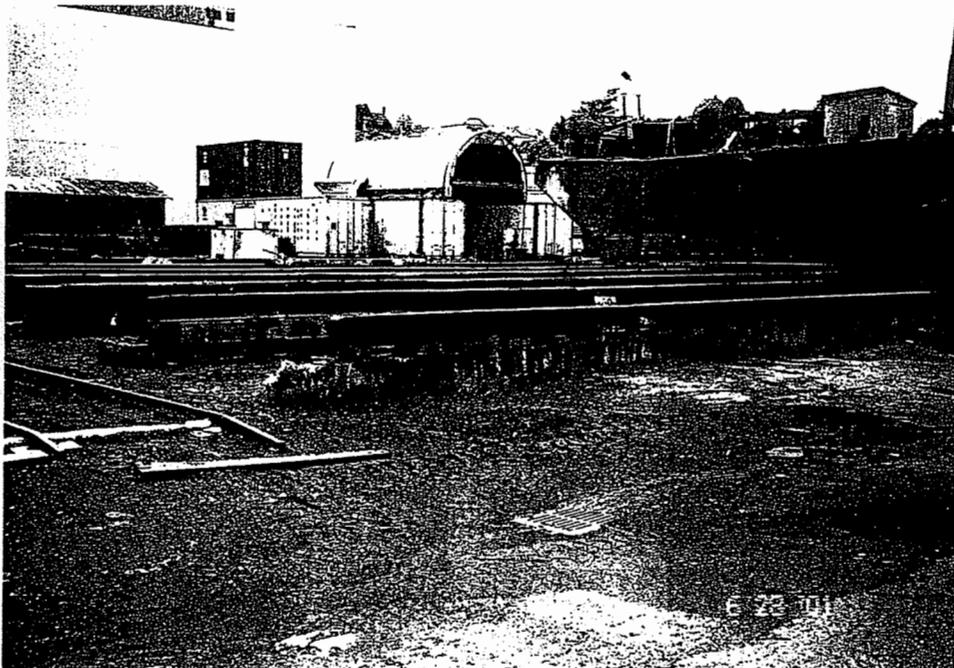
- The facility had reportedly “cleaned up” an area of sandblast grit in the storage yard at the request of Ecology in 1990, however the details of the cleanup were not provided and the Ecology inspectors noted that “much more cleanup may be required”. Piles of sand blast grit were observed on the ground.

Fishermen's Boat Shop – Boatyard and sandblast grit surrounding storm sewer catch basin.

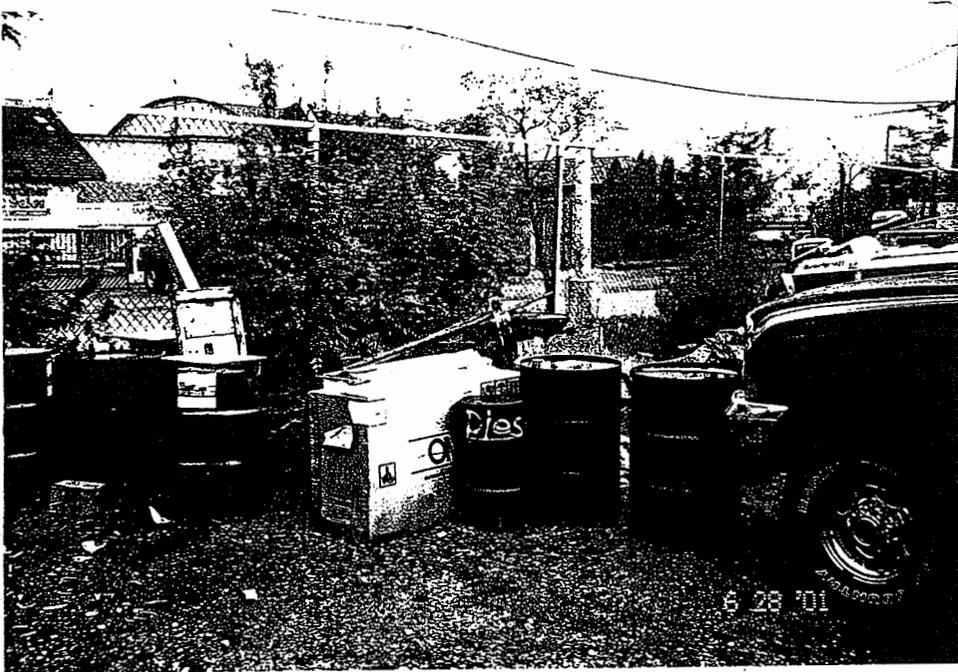
Everett Bayside Marina – Drums containing motor oil and lubricating oil.
