**Re: Environmental Review and Workplan for Site Closure**

Fifth Wheel Truck Repair Site  
307 to 309 East Arlington Street, Yakima, Washington Cleanup Site ID: 1914  
Facility/Site ID: 554  
Project No. 190558

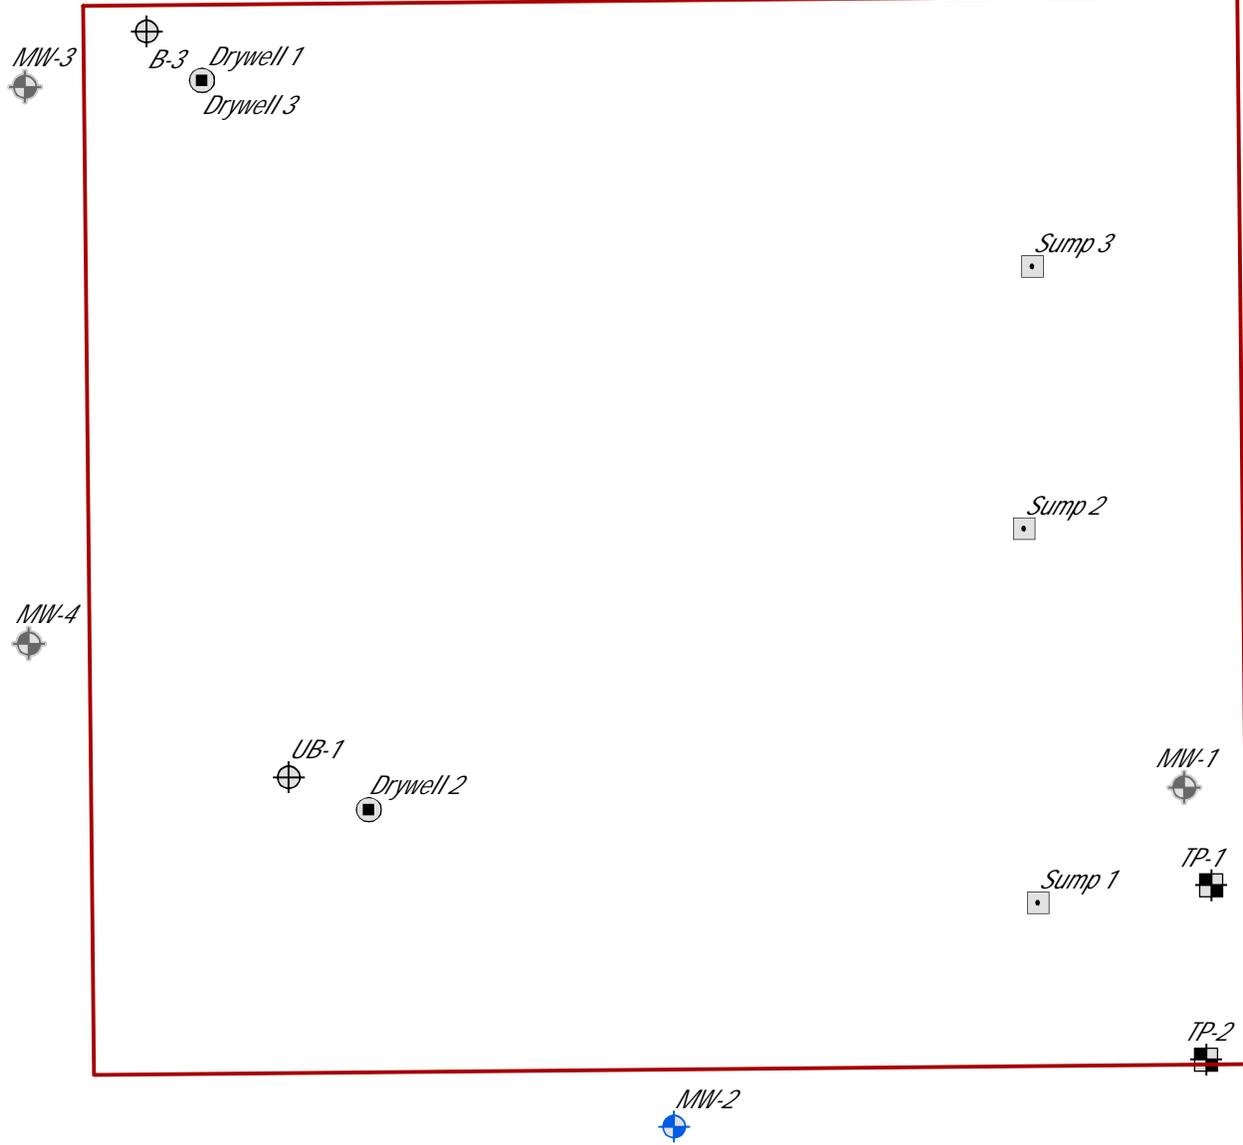
## Site Plan

The locations of the former sumps and former and existing drywells are shown on Figure 2. Removal of the former sumps and drywells and associated remedial actions are described in the following section.

- **1989 to 1991 Investigation, Removal and Remedial Action at Drywell 1.** In October 1989, one soil boring (B-3; Figure 2) was advanced near Drywell 1 to evaluate the potential for subsurface soil and groundwater contamination. Total petroleum hydrocarbons (TPH) were identified in soil between 3 and 15 feet below ground surface (bgs) at concentrations exceeding the MTCA cleanup level of 200 mg/kg used for screening; the specific range(s) of TPH identified by this study was not identified by the laboratory testing.

- **1991 to 1993 Discovery, Removal, and Interim Action at Drywell 2.** In February 1991, during installation of the existing drain and oil/water separator system in the west tenant space, an interior catch basin was discovered to discharge directly to soil beneath the floor slab, functioning as a drywell (Drywell 2; Figure 2). Environmental sampling of soil from

- At Sump 1 and Sump 2 (located inside the building; see Figure 2) excavation occurred to 2 feet below each sump and confirmation sample results showed TPH, lead, and/or cadmium at concentrations above the MTCA Method A cleanup levels at the time. Contaminated soil remains in-place at these locations, below the existing building floor slab.

- At Sump 3 (just north of the building, see Figure 2) excavation extended to 10 feet bgs, and no constituents were detected in confirmation soil samples above their respective MTCA cleanup levels.

In 1995, two additional groundwater monitoring wells were installed downgradient of the Site boundary to the south and east to evaluate groundwater quality (MW-1 and MW-2; Figure 2). Due to poor soil sample recovery while drilling MW-1 and MW-2, two test pits were excavated at the southeast property corner to characterize soil in the top 15 feet bgs. Six soil samples obtained between 5 and 15 feet bgs were analyzed for VOCs, heavy oil, and metals, with none detected above the State cleanup levels at the time (Huntingdon, 1995).

Historical exploration locations are shown relative to existing property features on Figure 2. Data tables summarizing the soil and groundwater analytical results are included as Appendix A.
