**PHASE I ENVIRONMENTAL SITE ASSESSMENT
AND PHASE I ENVIRONMENTAL AUDIT
BUSINESS ON THIRTY ACRES
NORTHWEST CORNER OF 13TH STREET AND
MARINE VIEW DRIVE
EVERETT, WASHINGTON**

SUBJECT: Phase I Environmental Site Assessment and Phase I Environmental Audit
Business on Thirty Acres
Northwest Corner of 13th Street and Marine View Drive
Everett, Washington

Kleinfelder Job Number 60-1167-01

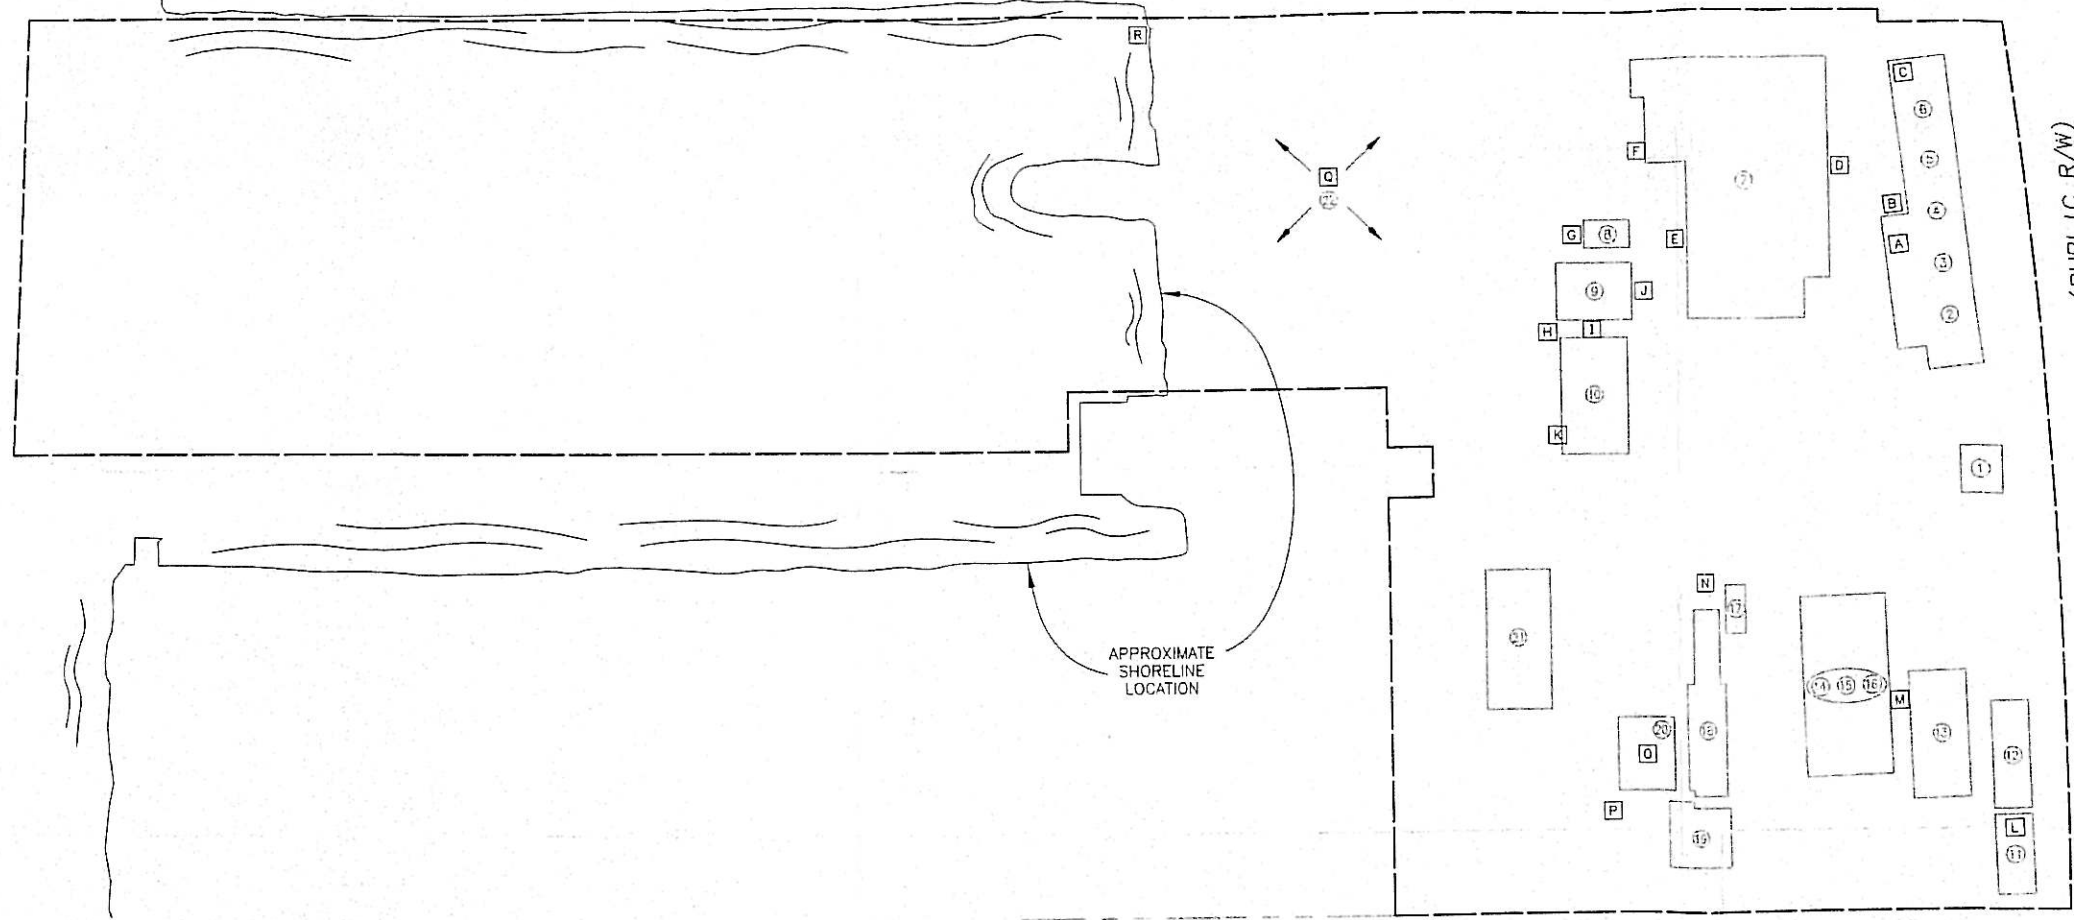
Sunset Body Works is a vehicle repair shop. Kleinfelder observed two paint booths, a solvent still, and two flammable storage areas for paints and solvents (Plate 2, Area A).

This building is used for concrete pole manufacturing. Kleinfelder observed the following in and around this building: drum storage outside of the building on the east site with soil staining (Plate 2, Area B), three concrete settling basins (Plate 2, Area D), a series of sumps and storm drains around the building on the east and north, drum storage areas (Plate 2, Area E) and sandblasting (Plate 2, Area F) on the west, a compressor room inside the building in the northwest corner, and one basin inside the building collecting ground water.

During our site visit, the sandblasting area on the northwest side of the manufacturing building showed areas of accumulated sandblasting waste varying in color from brown, rust, and light green.

Directly south of the above-mentioned storage building is Ameron's pole polishing building. Fifty-five-gallon drums, (Plate 2, Area H) evidence of sandblasting, and concrete pole polishing were observed at this location.

Air pollution control equipment (baghouses) were observed between buildings 9 and 10 (Plate 2, Area I). According to Mr. Scharf, Ameron has been permitted to operate these baghouses to collect the dust produced in the polishing area.

A warehouse and spray booth are directly south of Ameron's concrete polishing building. Kleinfelder observed Ameron employees applying spray sealant on a concrete pole product in the west side of this building (Plate 2, Area K). Only one of the two workers was using respiratory protection. Kleinfelder also observed open-drummed flammable materials in use. The drums did not appear to be grounded. The west side of the building appeared to be ventilated with several fan-type air circulatory devices. No air pollution control equipment was observed on this system. Evidence of sandblasting debris was present to the west of this building. A storm drain was also noted west of this building.

Washington Belt and Drive systems mainly provides retail sales of machinery parts. During Kleinfelder's site visit, a sanitary sewer drain (Plate 2, Area L) was observed in the retail parts storage area. Mr. Bob Norling, store manager, stated that the drain occasionally backs up with high tides. Kleinfelder noticed unopened containers of ORM-A (1,1,1 trichloroethane) and flammables stored in the shop for retail sale. MSDSs were available during our site visit. Due to time constraints, they were not reviewed.

The Smoke Shack is owned by Collins Casket and is so named because the building was used as an employee break room. During our visit, Kleinfelder noticed waste paint containers and stained soils in the vicinity of the building. (Plate 2, Area N). This building was locked and the interior was not visited by Kleinfelder. Mr. Hulbert said that the building contained lumber, roofing, galvanized pipe and similar building materials.

Kleinfelder noticed that the building was equipped with an eye wash station. A storm drain in the building floor had dark staining on the surface grating (Plate 2, Area O). Water was

Members of Kleinfelder observed a fuel pump island on the property grounds (Plate 2, Area P). According to Mr. Bill Hulbert, there are three underground storage tanks. Thirteen 55-gallon drums of hazardous materials were stored nearby. None of the drums observed were covered or had secondary containment. A storm drain was also observed near the pump island.

Commercial Steel Fabricators currently uses this part of the property to construct prefabricated buildings (Plate 2, Area Q). We noticed an open hazardous materials shed with 55-gallon drums of diesel and gasoline stored inside. The drums did not appear to be grounded. Soil staining was present in and to the west of the shed.

- Areas of concern (e.g., drum storage, stained soil, paint chips) identified in the Earth Consultant Reports. (Area Q).
- Inattentive waste management practices (Areas A, B, C, E, F, H, J, K, N, O, P, and Q).

- Hazardous waste generators (Operations 3, 6, and 19)
- Dust from concrete polishing operations (Areas I and J)
- Drum storage areas (Areas B, C, E, G, H, P, and Q)
- Sand blasting disposal areas (Areas F, K, and Q)
- Above ground fuel tank (Area M)
- Inattentive worker health and safety practices (Operations 3, 6, 7, 9, and 10)
- Stained soil areas (Areas B, E, H, N, and Q)
- Floor Drains (Areas L and O)

Kleinfelder recommends that a work scope be prepared, with assistance from Anderson Hunter and the Port of Everett. The work scope should be of sufficient detail to address the risk management objectives of the Port of Everett, and their counsel, Anderson Hunter. This work scope should include additional data collection (outstanding reports) subsurface exploration, visual observation, field instrument screening, and laboratory chemical analysis of soil and/or ground-water samples. The work scope also should include procedures and schedules for the businesses located on the property to present documentation regarding their waste management, storage, and disposal practices.
