MEMORANDUM

Date: August 11, 2020 **RGI Project Number:** 2012-107M

Subject: 2020 Annual Inspection Summary
Alamo Manhattan Main Street
10505 Main Street
Bellevue, Washington 98004
Ecology VCP No. NW2811

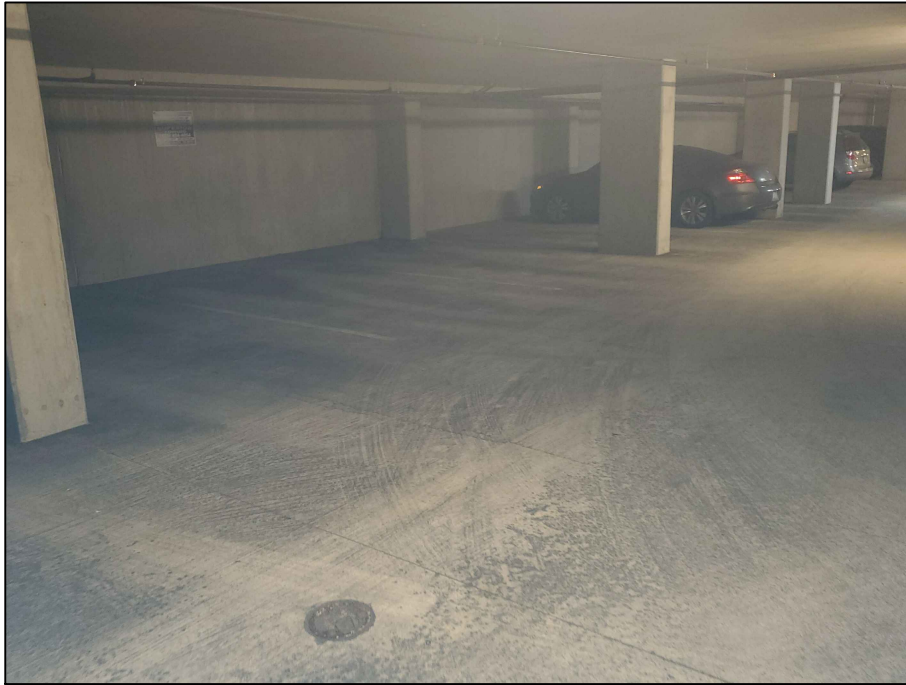
The portions of the concrete garage floor slab situated above Areas 1 and 2 were in good condition and no damage was observed (see Photos 1 through 4). Groundwater monitoring wells RW1, RW2, and MW6 were also in good condition with no damage observed (see Photos 5 through 10).

Photograph 1: View looking northwest at the garage floor slab that covers Area 1.

No further work is recommended at this time. The next annual inspection is scheduled for mid-2021.

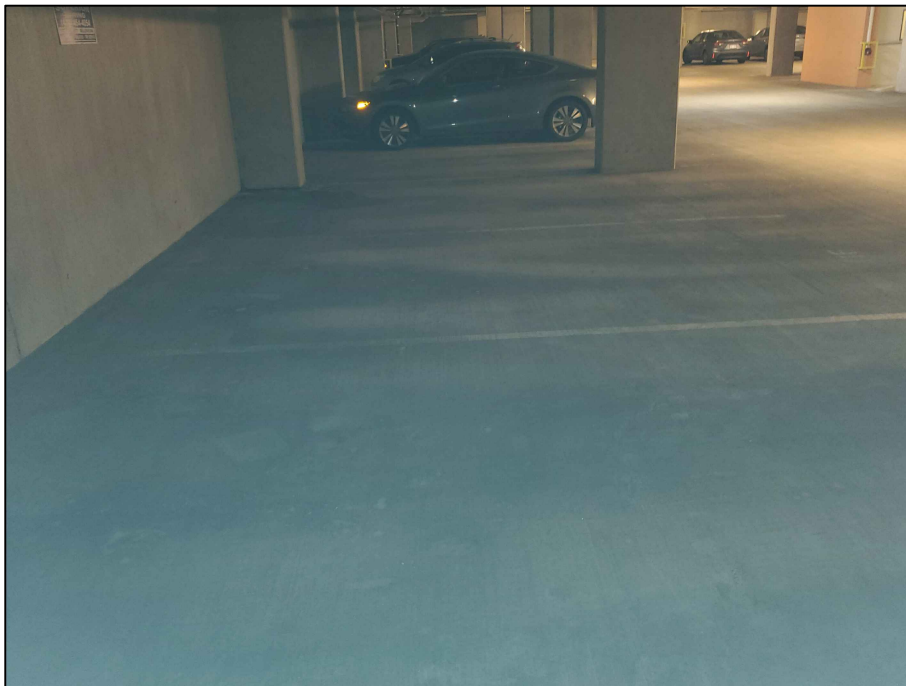
Photograph 2: View looking north representing the condition of the garage floor slab in Area 1.

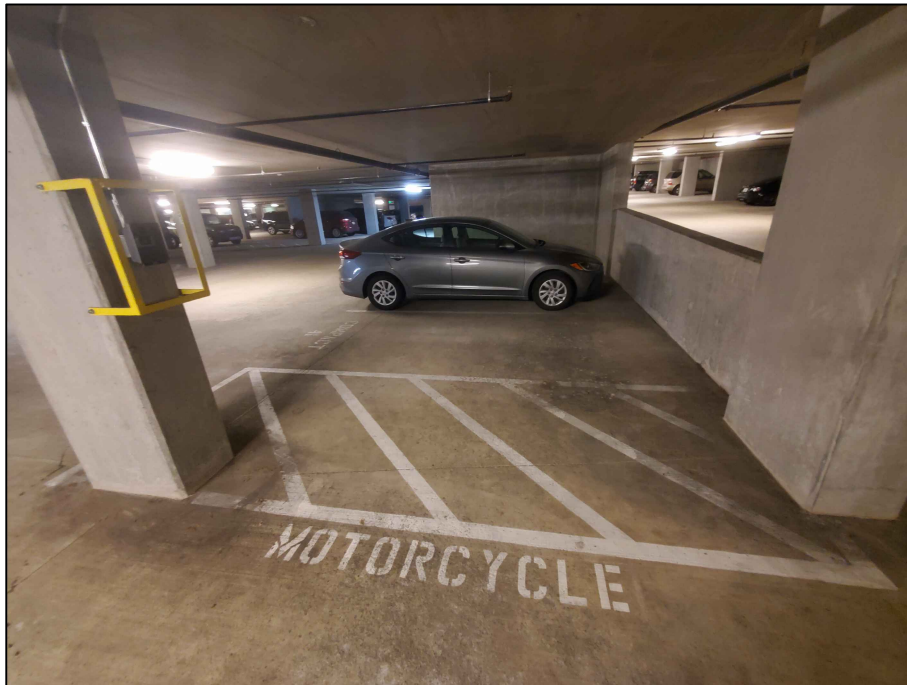
Photograph 3: View looking east representing the condition of the garage floor slab in Area 2.

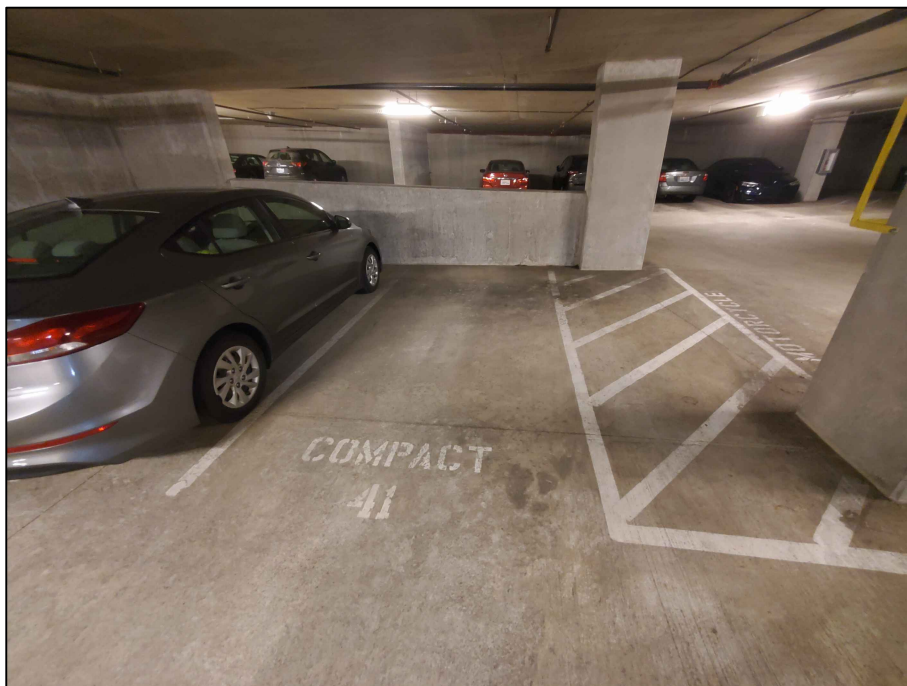
Photograph 4: View looking south representing the condition of the garage floor slab in Area 2.

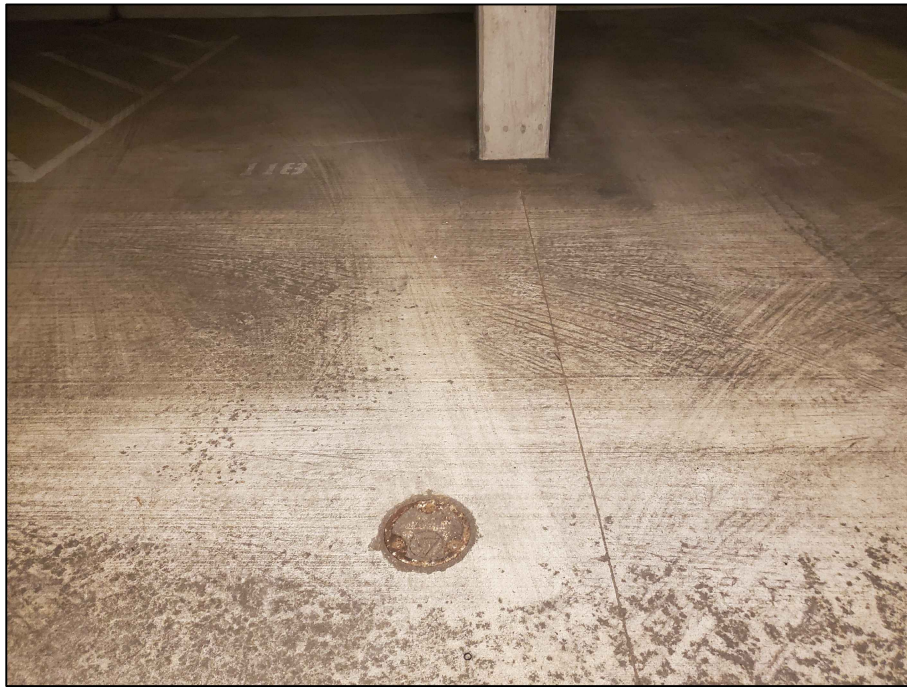
Photograph 5: View looking south at well RW1.

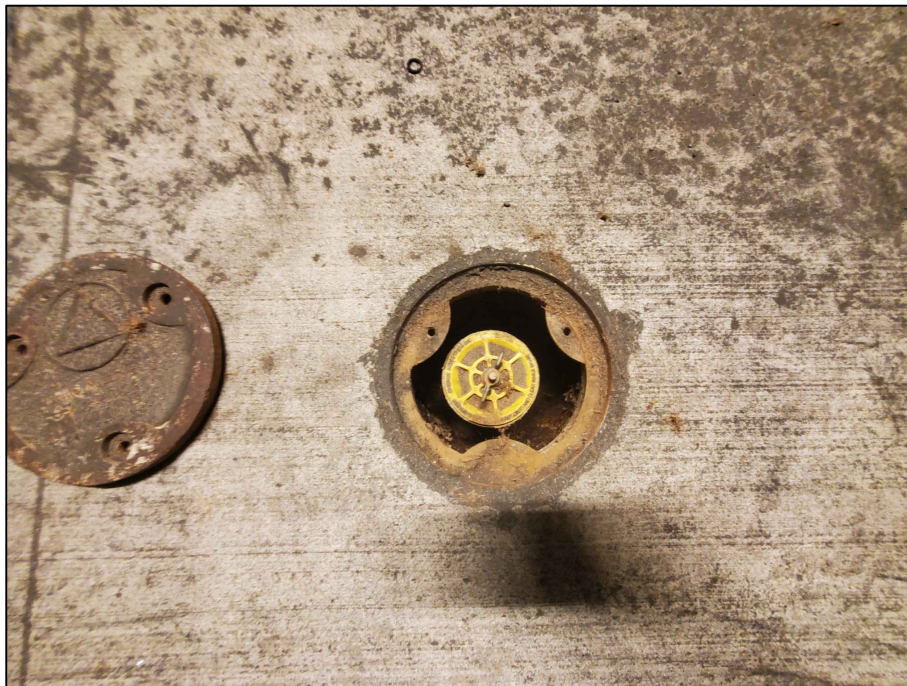
Photograph 6: View of well RW1 without the well cover.

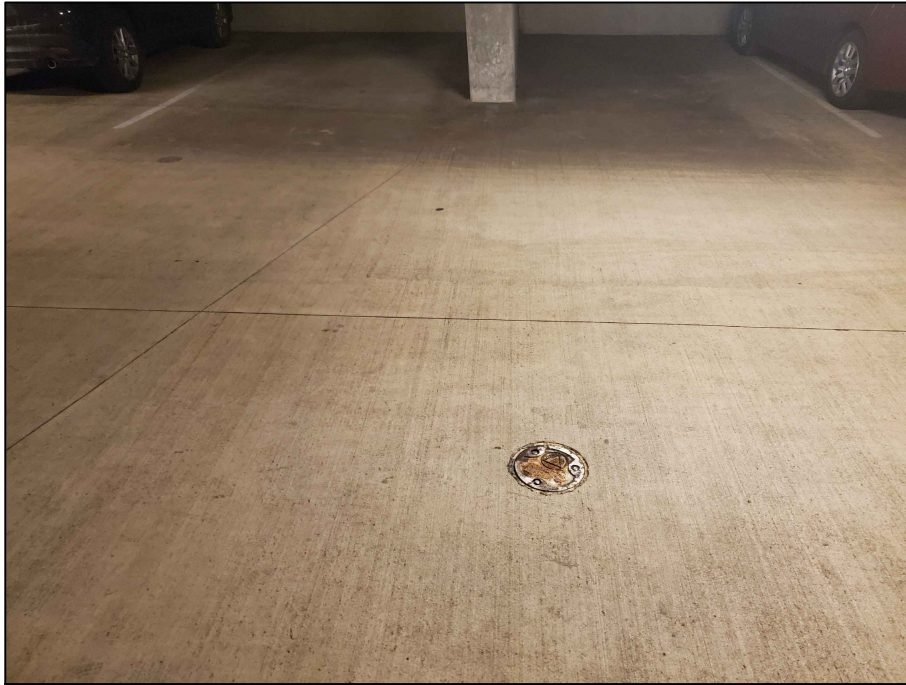
Photograph 7: View looking south at well RW2.

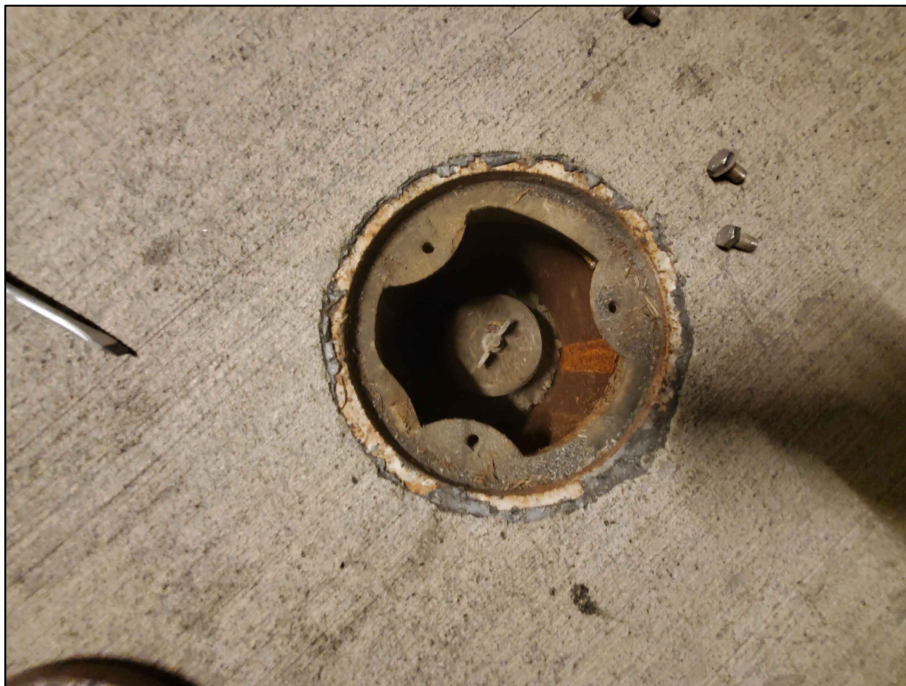
Photograph 8: View of well RW2 without the well cover.

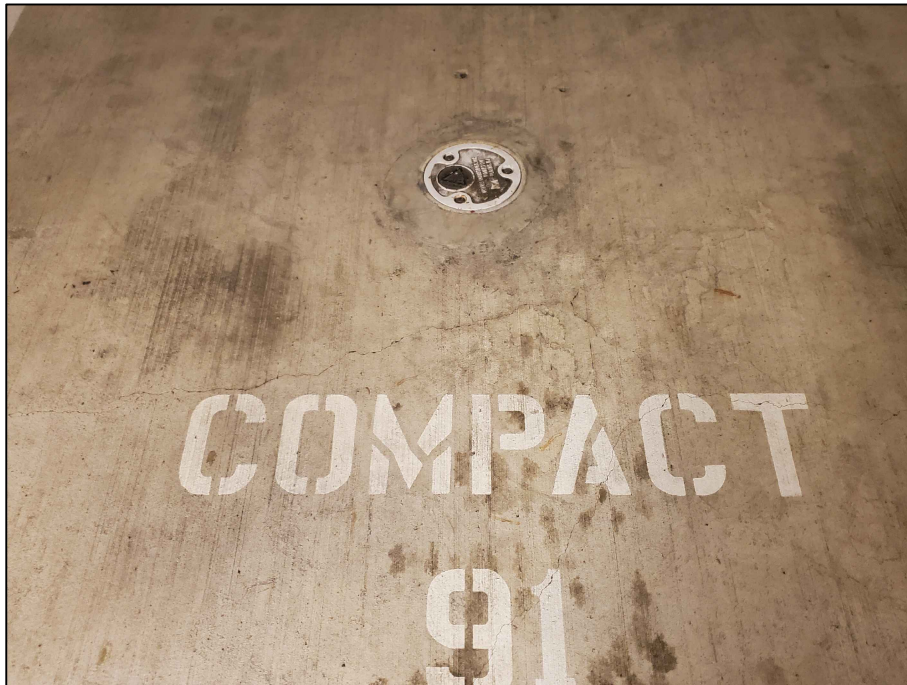
Photograph 9: View looking south at well MW6.

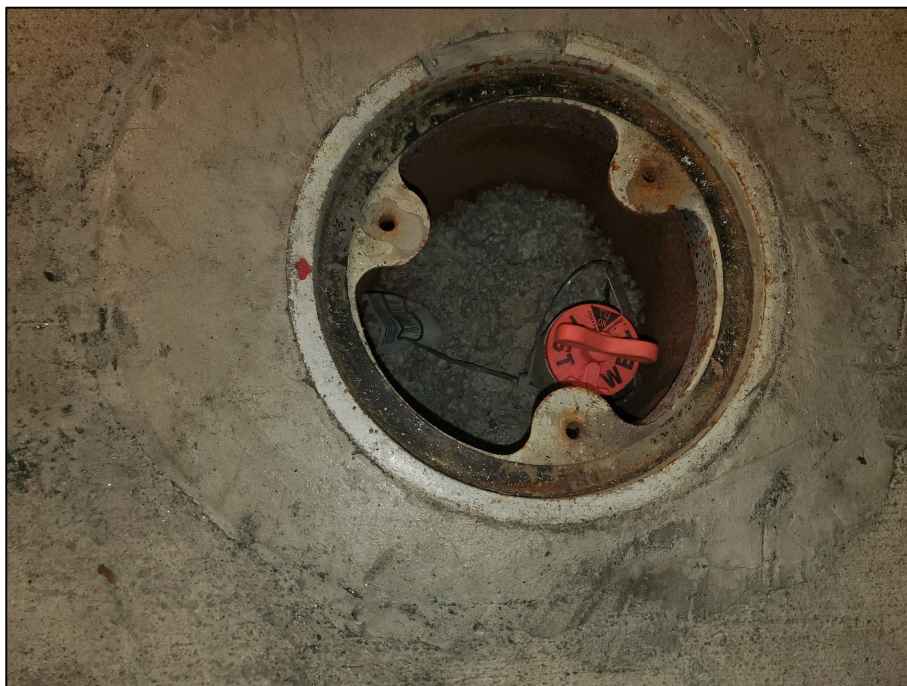
Photograph 10: View of well MW6 without the well cover.
