INSPECTION FORM
for Pavement and Surface Water Collection Systems

Date of Inspection: May 23, 2016

Employer: Floyd|Snider

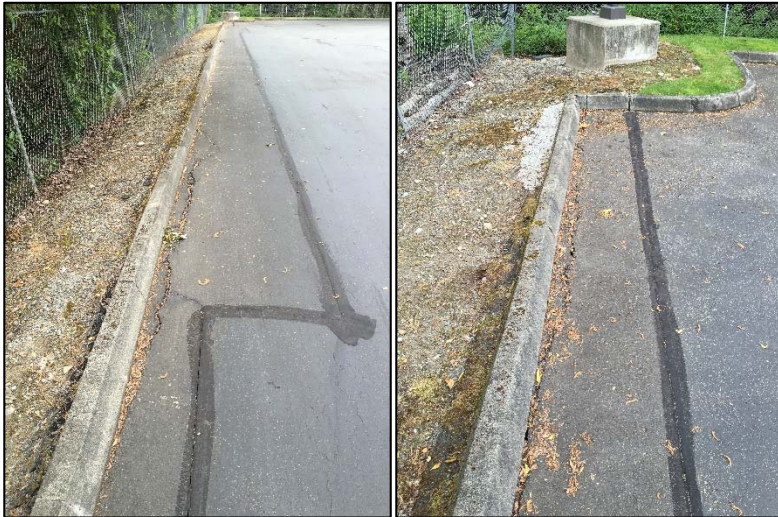
- Cracking was observed along the curbing running south to north at the northwest corner of the property. It appears sloughing of the subgrade on the west side of the curbing has caused the pavement to crack. The cracks are approximately 1 inch wide. We recommend the cracking be repaired and the subgrade stabilized. These areas are identified on the attached Figure 1 and photographs of the cracks are included on the attached Figure 2.
- A catch basin in a parking stall on the east side of the building appears to be subsiding along its western edge. The catch basin is located along the east side of the facility parking lot. We recommend repairing the crack and stabilizing the catch basin. The catch basin is identified on the attached Figure 1 and a photograph is included on the attached Figure 2.

Photographs 1 and 2. Cracking along curbing at northwest corner of property.

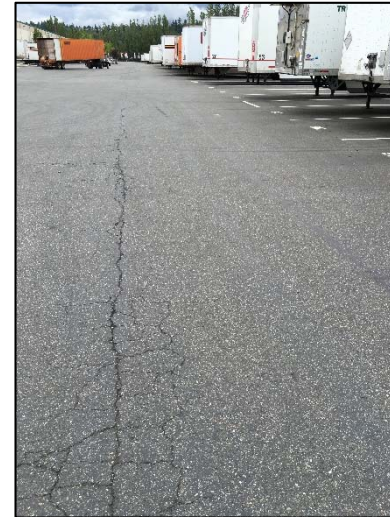
- Areas that appear to have degraded since the last inspection include surficial cracking in the pavement on the west side of the warehouse, crack sealant and repairs on the south side of the warehouse, and sealant on a catch basin in front of bay #19 at the north side of the warehouse. As of now, no repairs are needed; however, it is

recommended that these areas be monitored. They will likely need to be repaired in the next 1 to 2 years.

Photograph 3. Sealant condition on south side of warehouse near stalls #910 to 913.

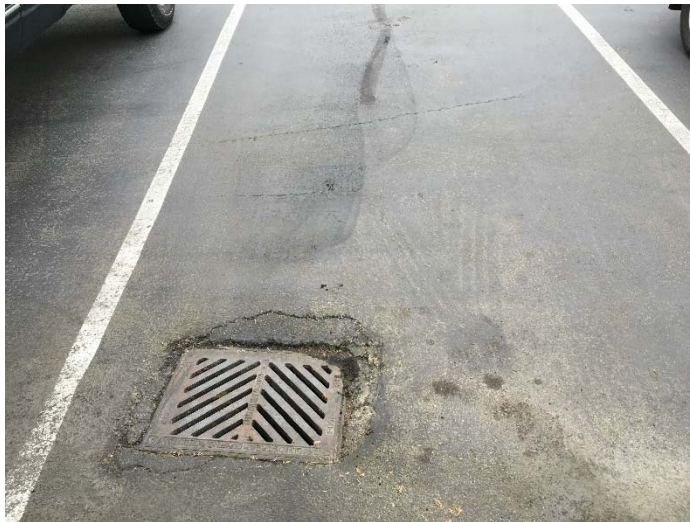
Photograph 4. Cracking and subsidence of catch basin on east side of building.

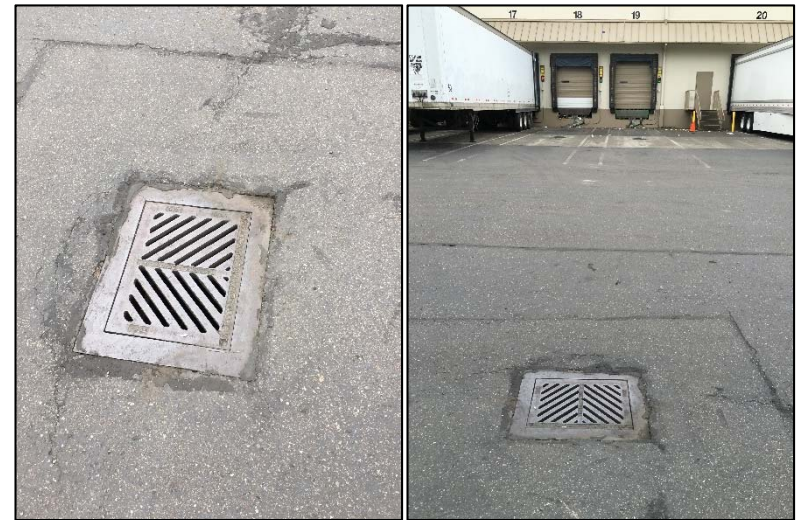
Photographs 5 and 6. Catch basin on north side of warehouse with deteriorated sealant in front of bay #19.
