# **INDEPENDENT REMEDIAL** **ACTION REPORT**

**NATIONAL AUTO PARTS PROPERTY  
SUMNER, WASHINGTON  
ECOLOGY VCP PROJECT #SW1547**

September 3, 2020

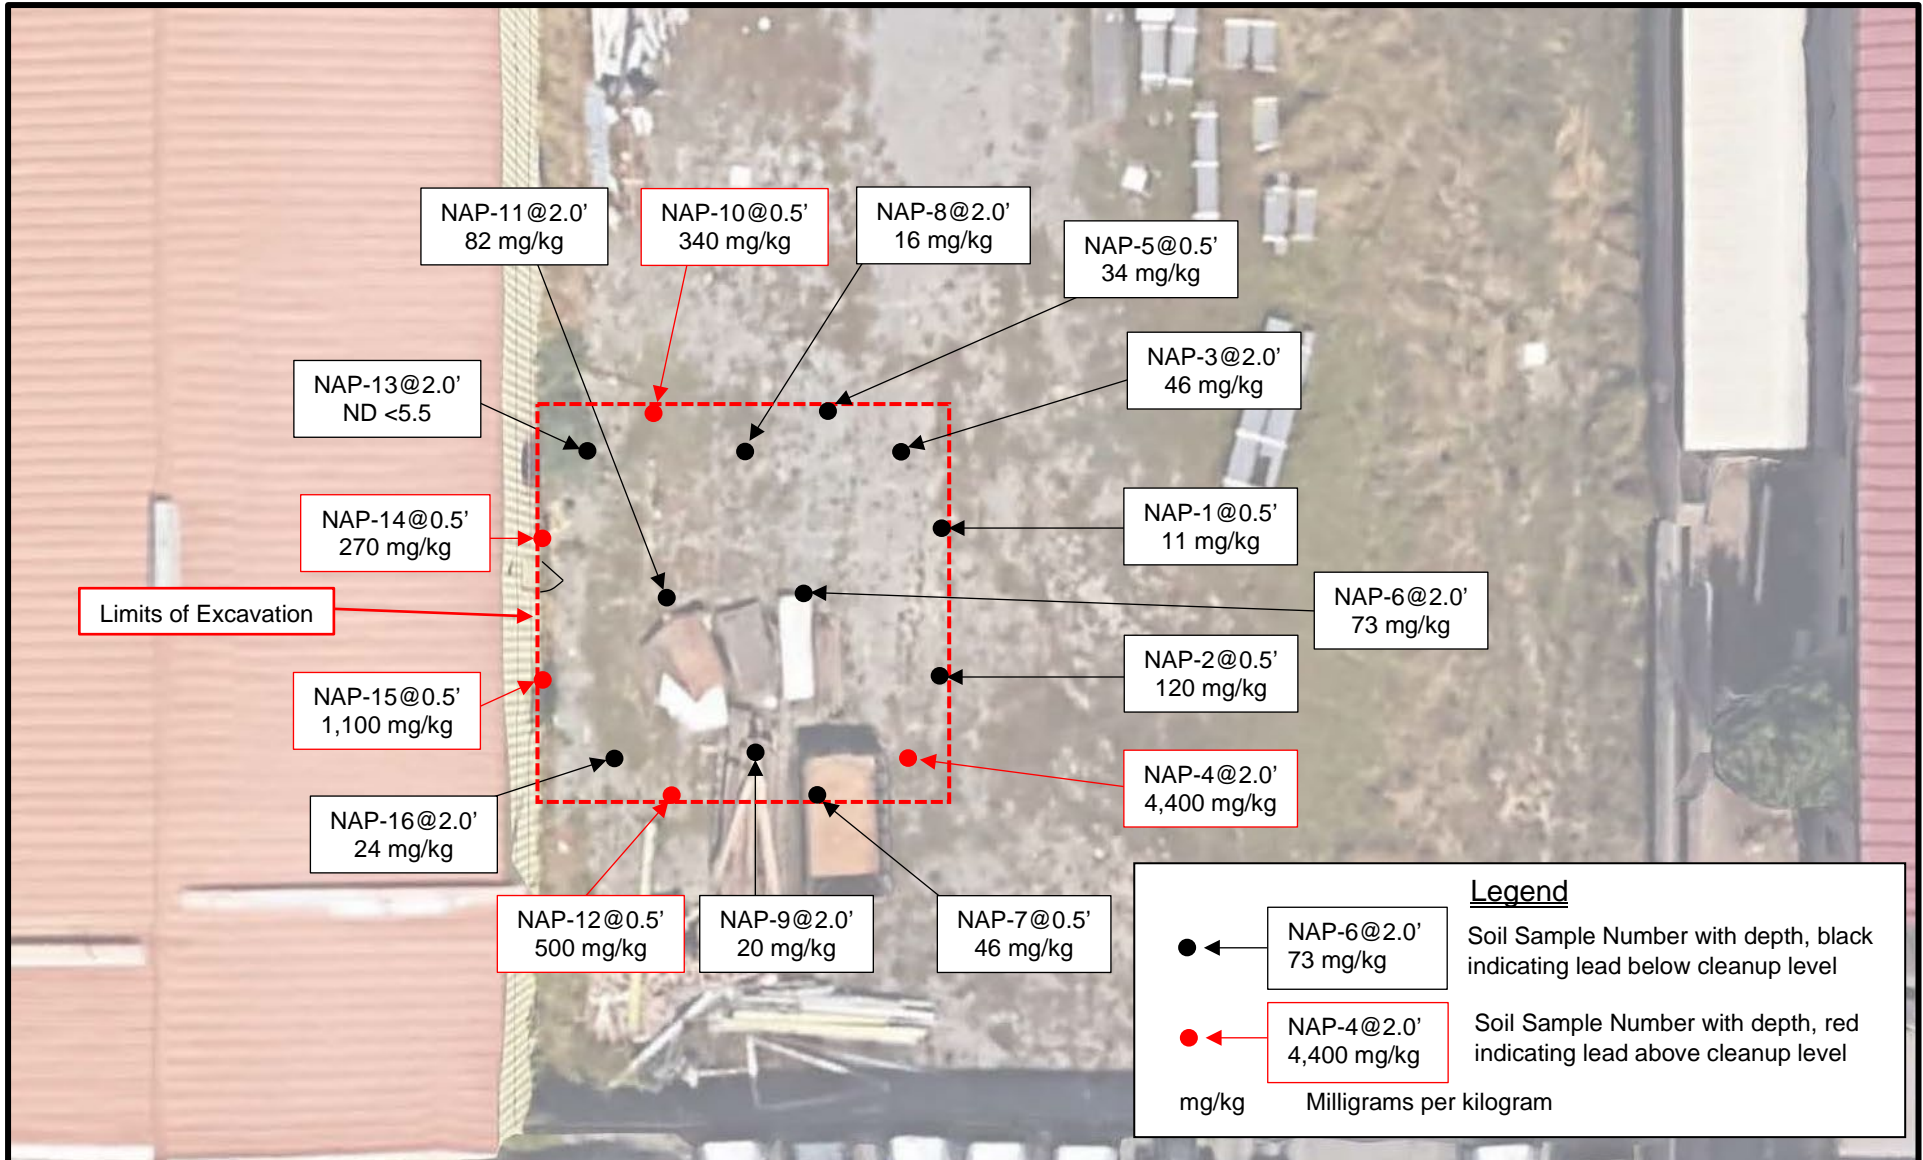
**FIGURE 2 — OCTOBER 6, 2017 REMEDIAL EXCAVATION**

During the initial remedial excavation work in October 2017, GEI collected a total of 16 soil samples from within the limits of excavation and four from the stockpiles. All samples were analyzed for total petroleum hydrocarbons as gasoline (TPH-Gas), total petroleum hydrocarbons as diesel (TPH-Diesel), total petroleum hydrocarbons as oil (TPH-Oil), VOCs, and MTCA 5 Metals. Laboratory analyses resulted in the detections of one analyte (i.e., total lead) at concentrations exceeding its MTCA Method A CUL of 250 milligrams per kilogram (mg/kg) in five of the 16 excavation soil samples and one stockpile soil sample. All other analytes in all other samples were either detected at concentrations below their respective CULs or were not detected at concentrations equal to or exceeding their respective laboratory practical quantitation limits (PQLs). Based on these data, GEI identified the COC driver for the Site soils to be total lead.

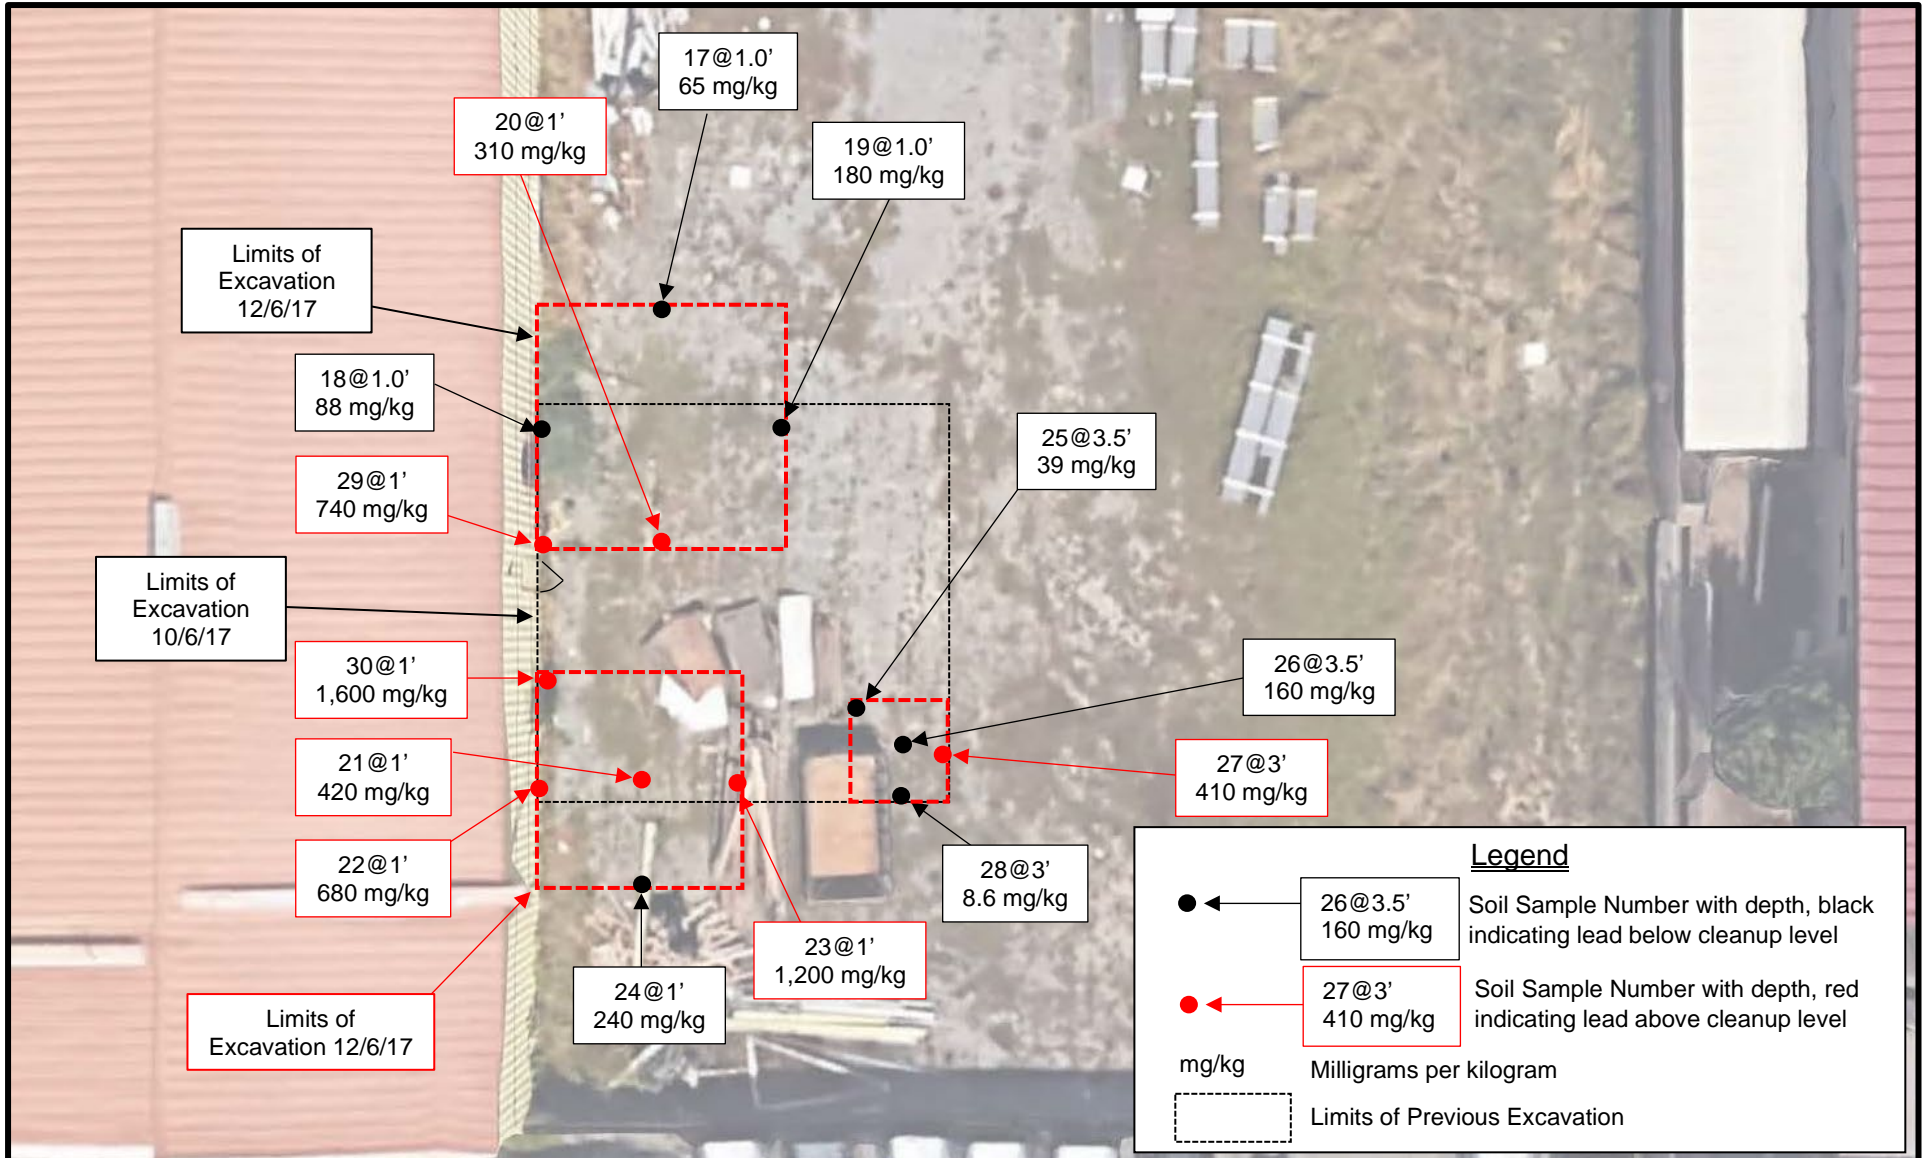
**FIGURE 3 — DECEMBER 6, 2017 REMEDIAL EXCAVATION**

The areas of total lead exceedances that were detected during the October 2017 excavation event were further excavated between December 6, 2017 and December 10, 2017 and resampled. A total of 14 excavation soil samples and two stockpile soil samples were collected and analyzed for total lead. Of the 14 excavation soil samples, 10 resulted in detections of total lead at concentrations exceeding its MTCA Method A CUL of 250 mg/kg. Laboratory analyses of the two stockpile soil samples resulted in the detections of lead at concentrations of 220 mg/kg and 240 mg/kg.

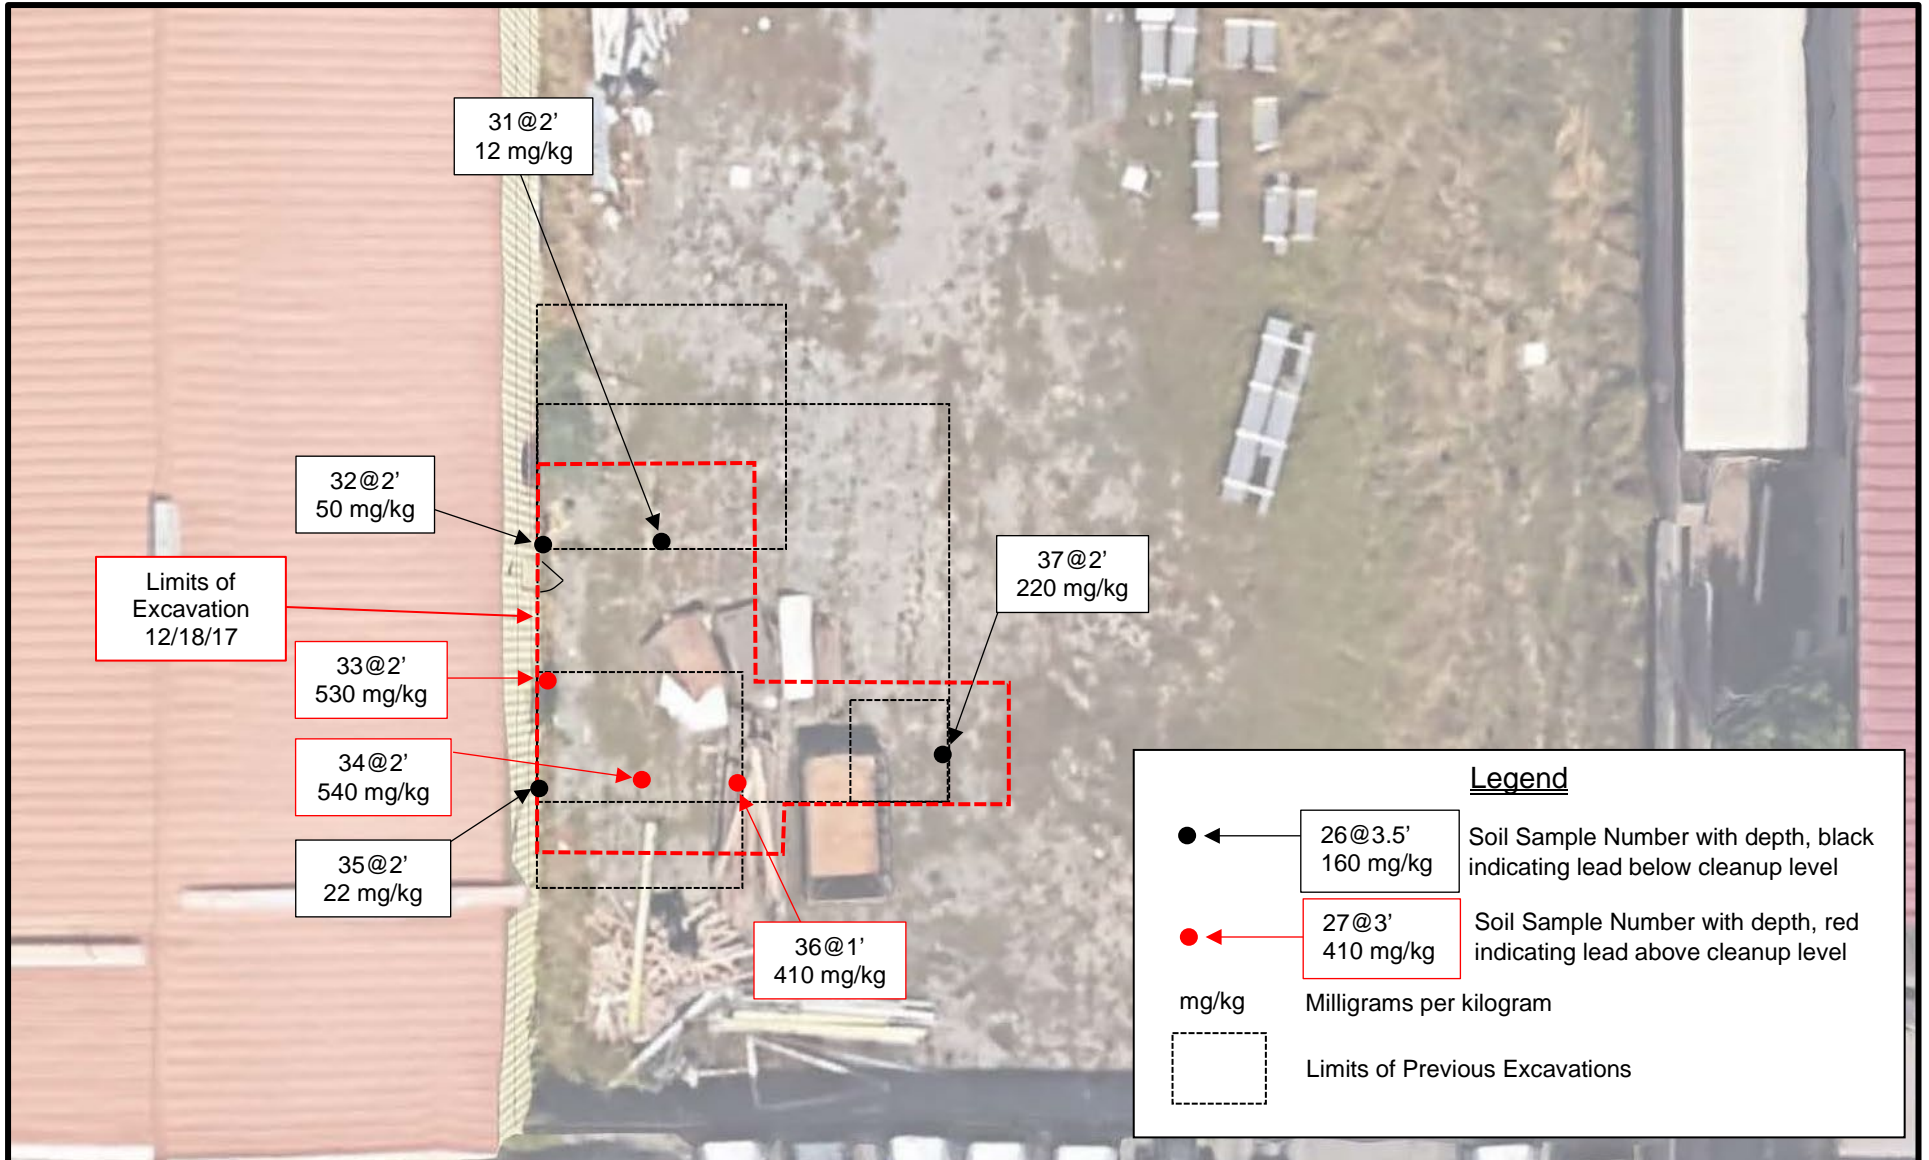
**FIGURE 4 — DECEMBER 18, 2017 REMEDIAL EXCAVATION**

The areas of total lead exceedances that were detected during the December 6 and 10, 2017 excavation event were further excavated between December 18, 2017 and resampled. A total of seven excavation soil samples were collected and analyzed for total lead. Of the seven excavation soil samples, three resulted in detections of total lead at concentrations exceeding its MTCA Method A CUL of 250 mg/kg.

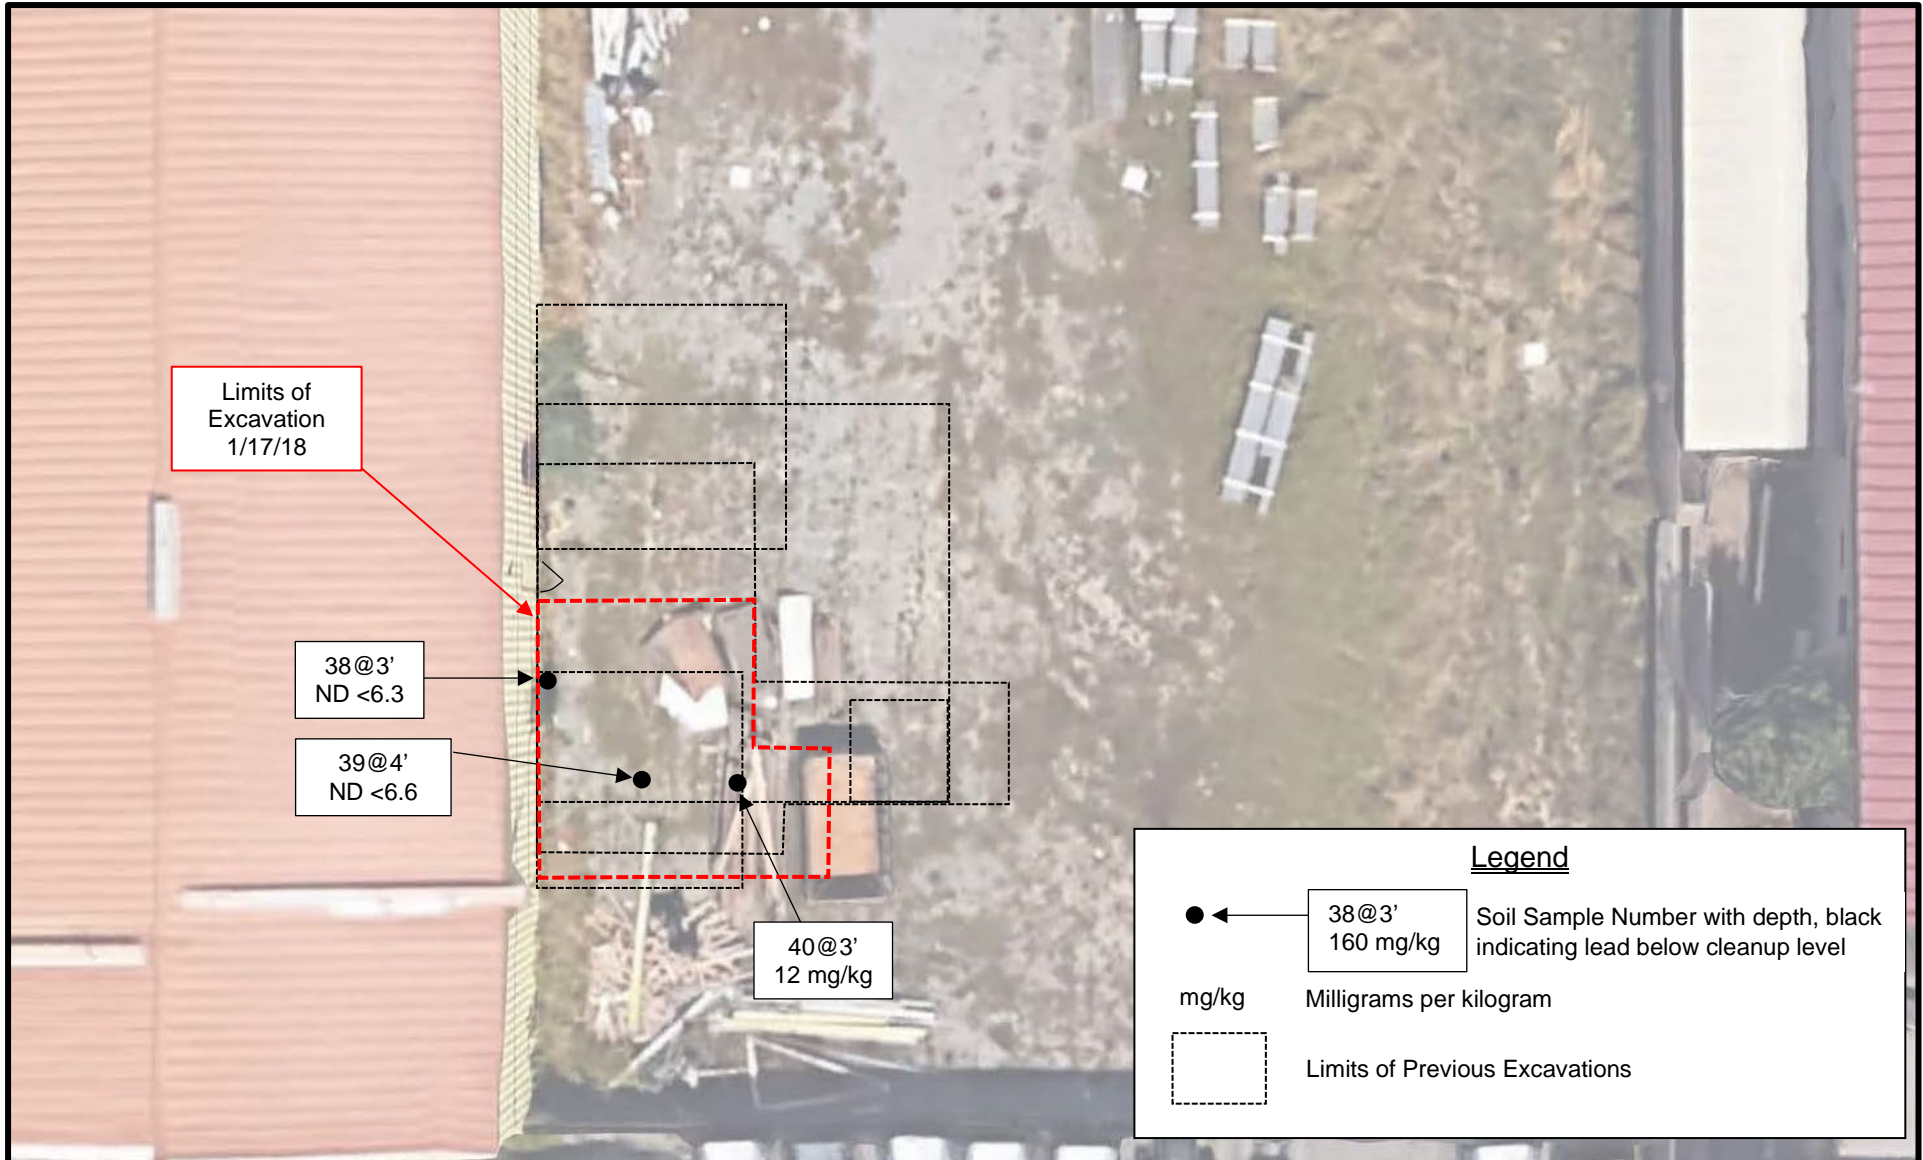
**FIGURE 5 — JANUARY 17, 2018 REMEDIAL EXCAVATION**

The areas of total lead exceedances that were detected during the December 18, 2017 excavation event were further excavated on January 17, 2018 and resampled. A total of three soil samples were collected on January 17, 2018 and analyzed for total lead. Of the three soil samples, one resulted in a detection of total lead at a concentration of 12 mg/kg, below its MTCA Method A CUL of 250 mg/kg. Laboratory analyses of the other two soil samples did not result in concentrations of total lead at levels equal to or exceeding their respective laboratory PQLs.

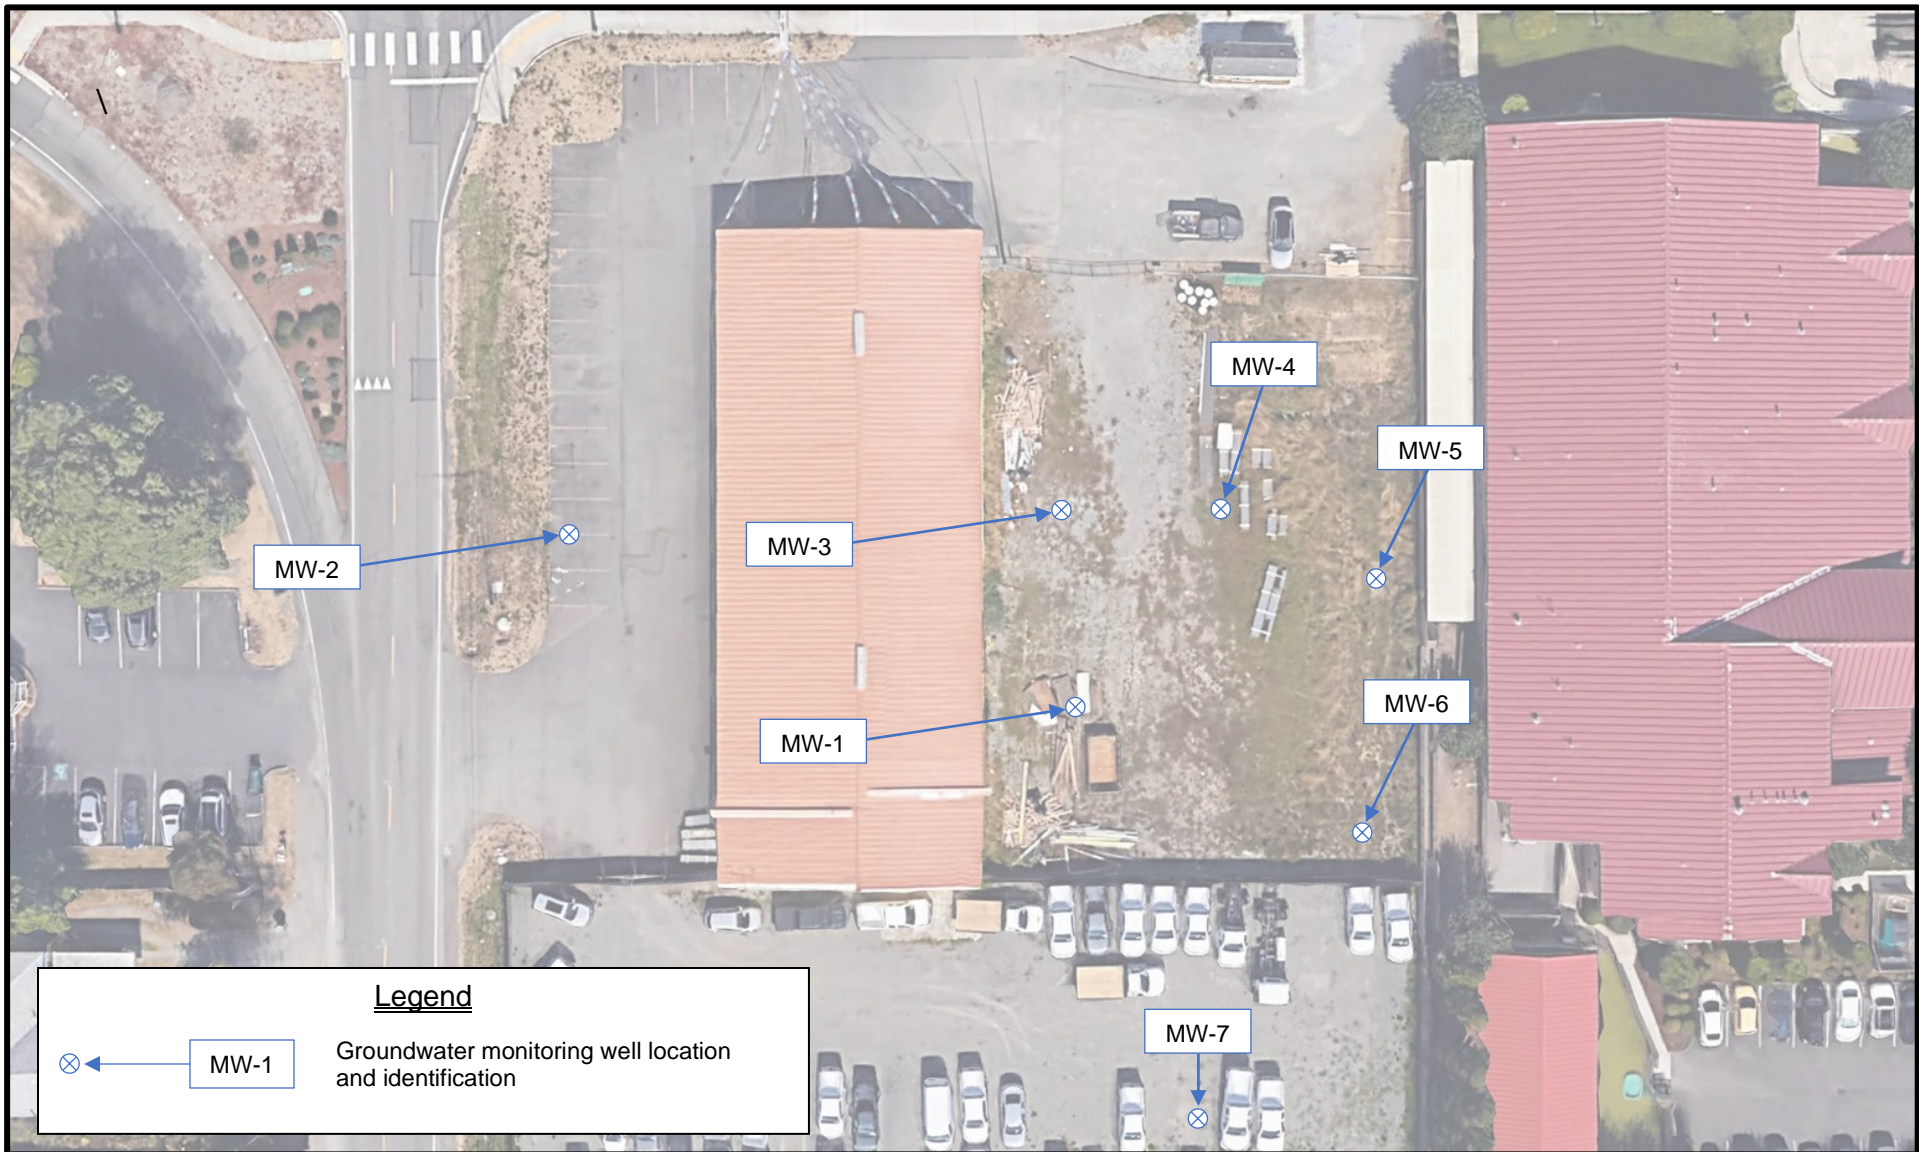
**FIGURE 6 — GROUNDWATER MONITORING WELLS**

Between August 13, 2018 and August 14, 2018, GEI observed the installation of groundwater monitoring wells MW-2 through MW-7 as noted in the Work Plan and Ecology's Opinion Letter, dated July 12, 2017. The installation included one cross/downgradient well west of the remedial excavation area (MW-2), two downgradient wells north of the remedial excavation area (MW-3 and MW-4), two cross/upgradient wells east of the remedial excavation area (MW-5 and MW-6), and one upgradient well south of the remedial excavation area (MW-7). One pre-existing well (MW-1), situated in the central region of the Site, was installed on October 30, 2015 by others.

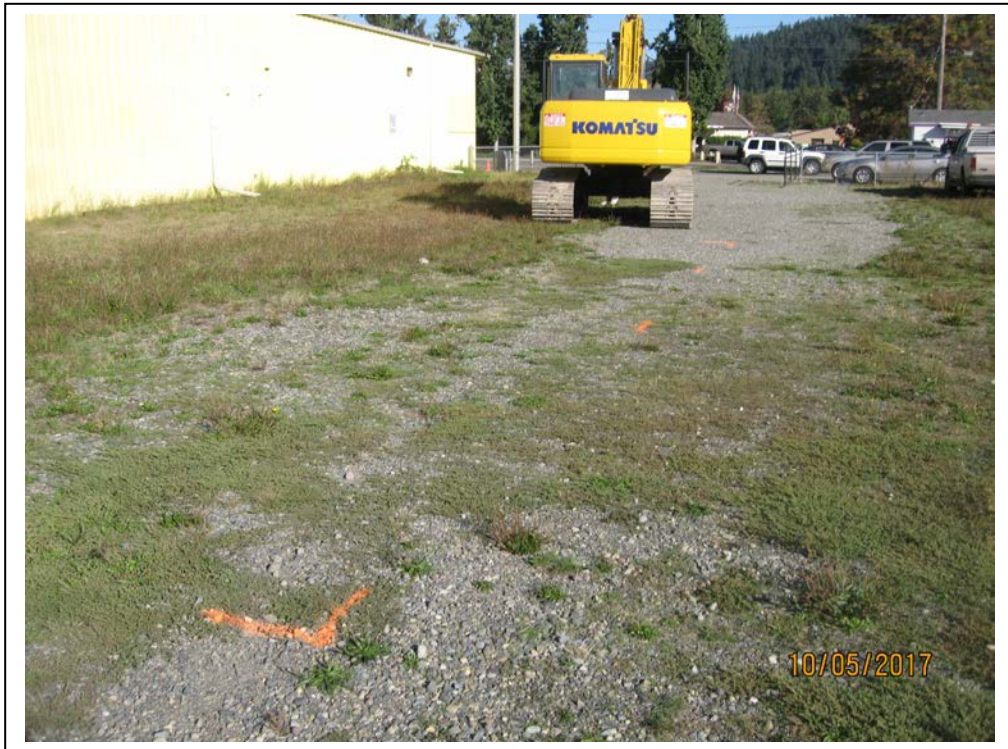
<b>Project No. 37018</b>	<b>Description</b>	Photo of initiation of remedial excavation, facing N	<b>Photo 1</b>
	<b>Site Name</b>	Former National Auto Parts, 16008 60 <sup>th</sup> St E, Sumner, WA	<b>Photo Date</b>
	<b>Client</b>	Sunset Chevrolet/Mitchell Development	October 5, 2017

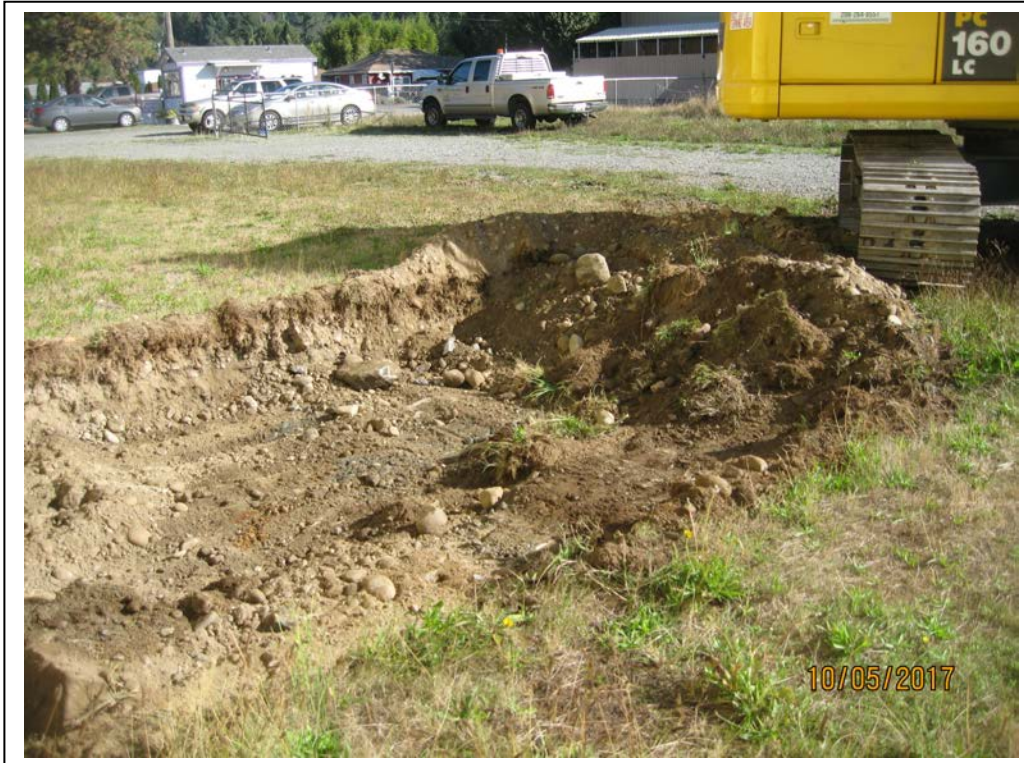
<b>Project No. 37018</b>	<b>Description</b>	Photo of initiation of remedial excavation, facing NE	<b>Photo 2</b>
	<b>Site Name</b>	Former National Auto Parts, 16008 60 <sup>th</sup> St E, Sumner, WA	<b>Photo Date</b>
	<b>Client</b>	Sunset Chevrolet/Mitchell Development	October 5, 2017

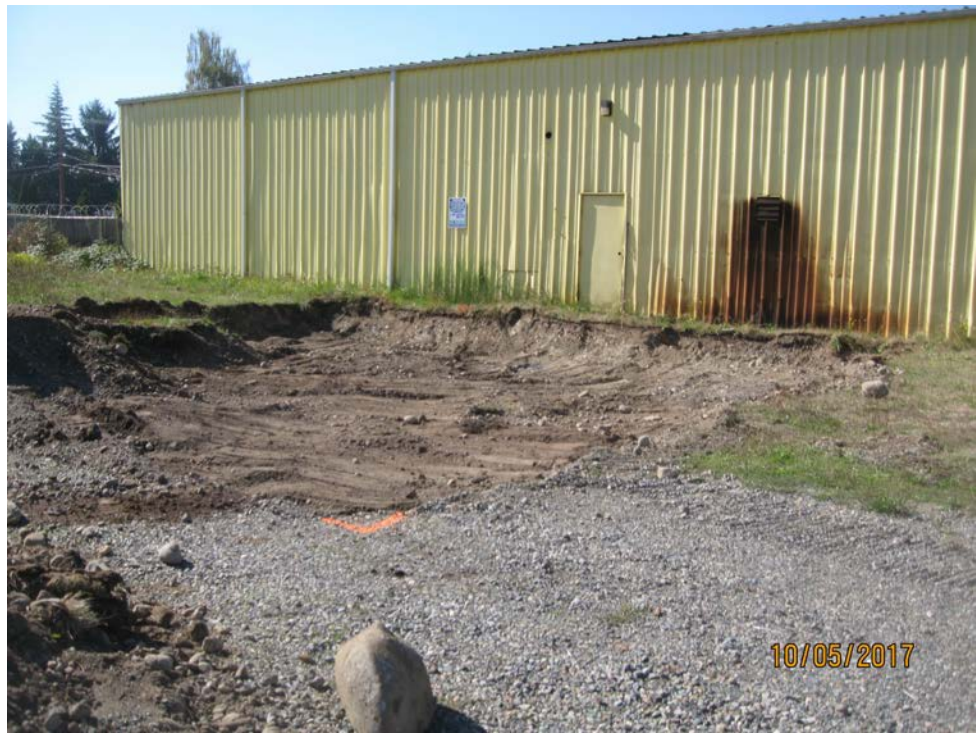
<b>Project No.</b> <b>37018</b>	<b>Description</b>	Photo of initiation of remedial excavation, facing SW	<b>Photo 3</b>
	<b>Site Name</b>	Former National Auto Parts, 16008 60 <sup>th</sup> St E, Sumner, WA	<b>Photo Date</b>
	<b>Client</b>	Sunset Chevrolet/Mitchell Development	October 5, 2017

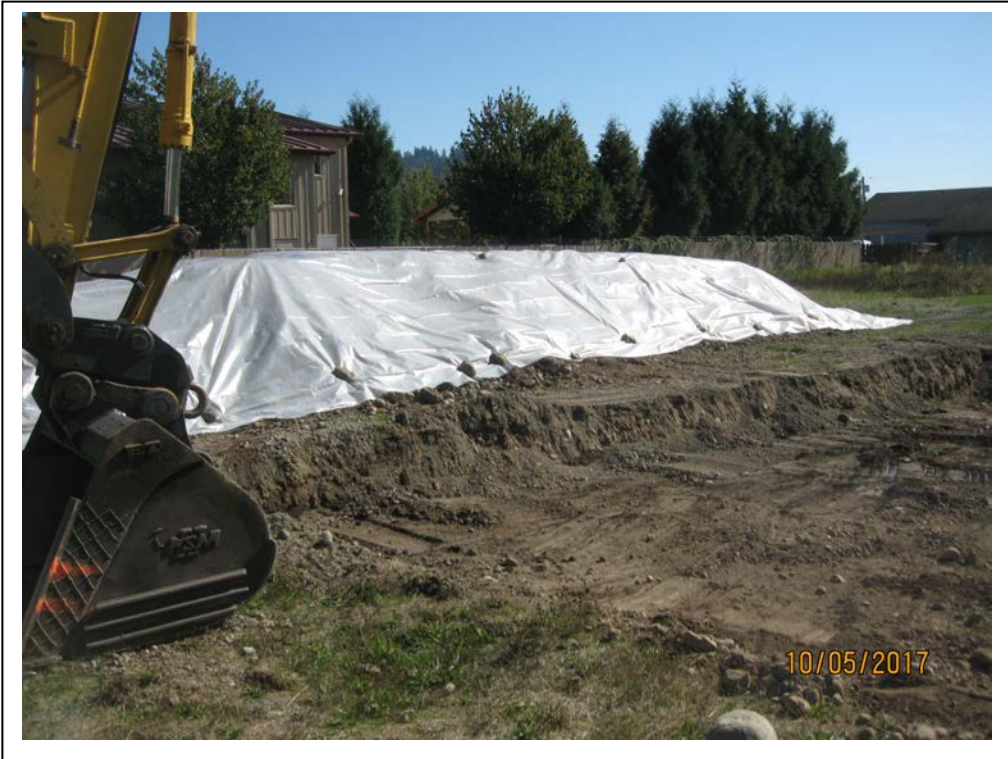
<b>Project No.</b> <b>37018</b>	<b>Description</b>	Photo of initiation of remedial excavation, facing SE	<b>Photo 4</b>
	<b>Site Name</b>	Former National Auto Parts, 16008 60 <sup>th</sup> St E, Sumner, WA	<b>Photo Date</b>
	<b>Client</b>	Sunset Chevrolet/Mitchell Development	October 5, 2017

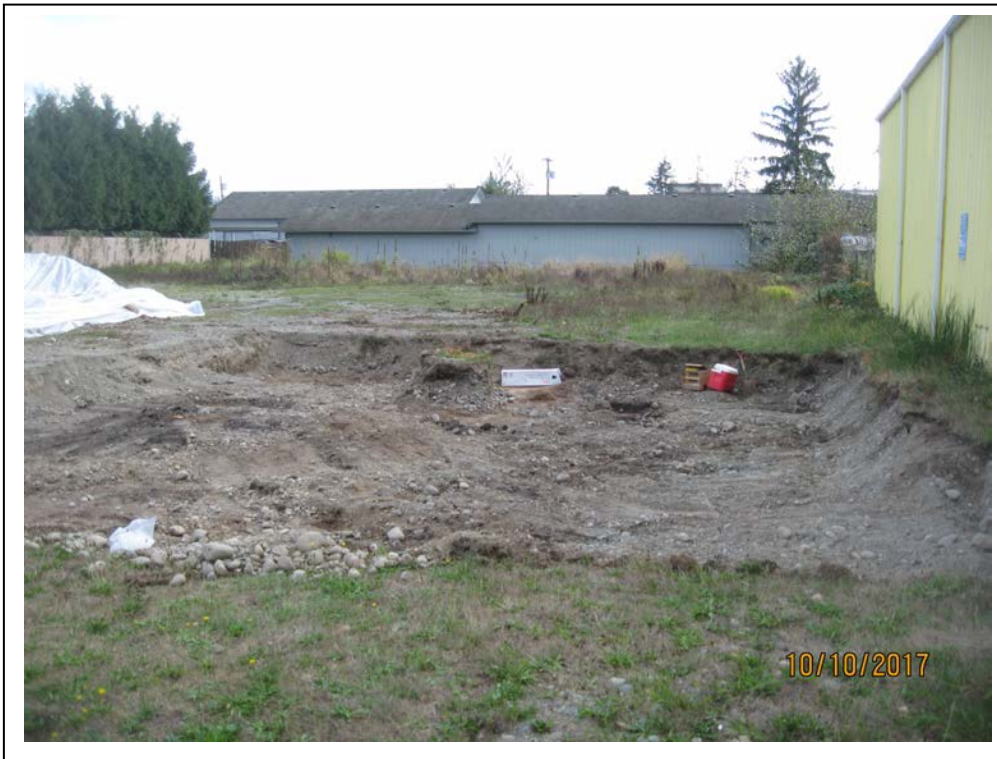
<b>Project No.</b> <b>37018</b>	<b>Description</b>	Photo of sample preparation of remedial excavation, facing S	<b>Photo 5</b>
	<b>Site Name</b>	Former National Auto Parts, 16008 60 <sup>th</sup> St E, Sumner, WA	<b>Photo Date</b>
	<b>Client</b>	Sunset Chevrolet/Mitchell Development	October 5, 2017

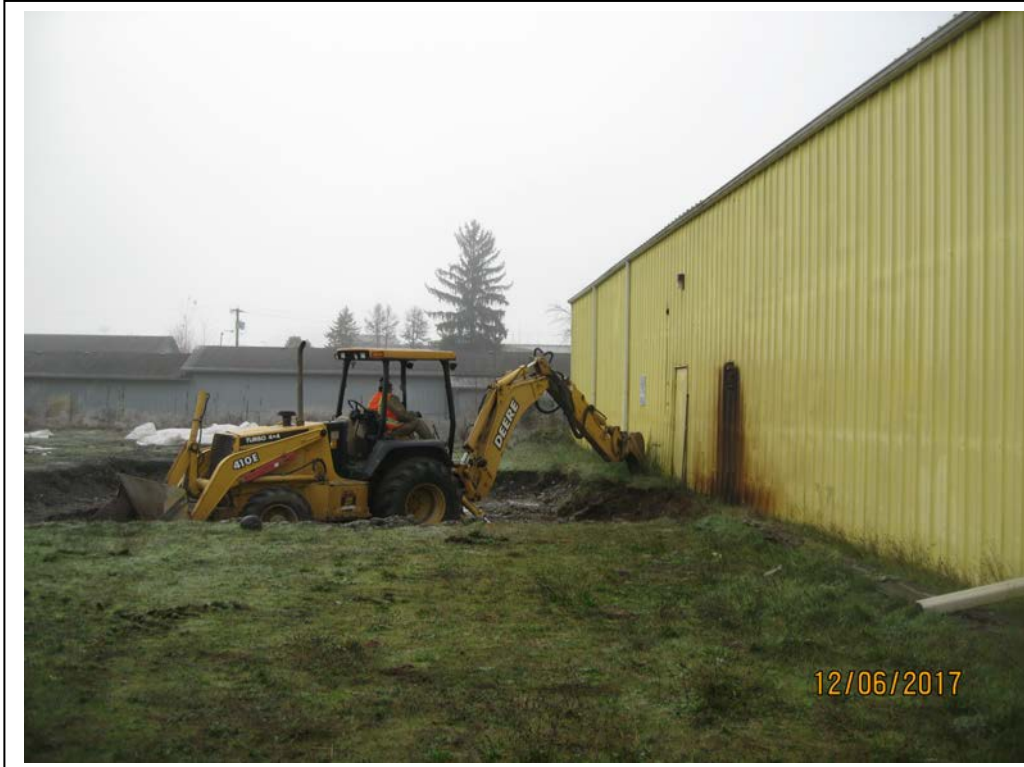
<b>Project No.</b> <b>37018</b>	<b>Description</b>	Photo of continued remedial excavation, facing S	<b>Photo 6</b>
	<b>Site Name</b>	Former National Auto Parts, 16008 60 <sup>th</sup> St E, Sumner, WA	<b>Photo Date</b>
	<b>Client</b>	Sunset Chevrolet/Mitchell Development	December 6, 2017

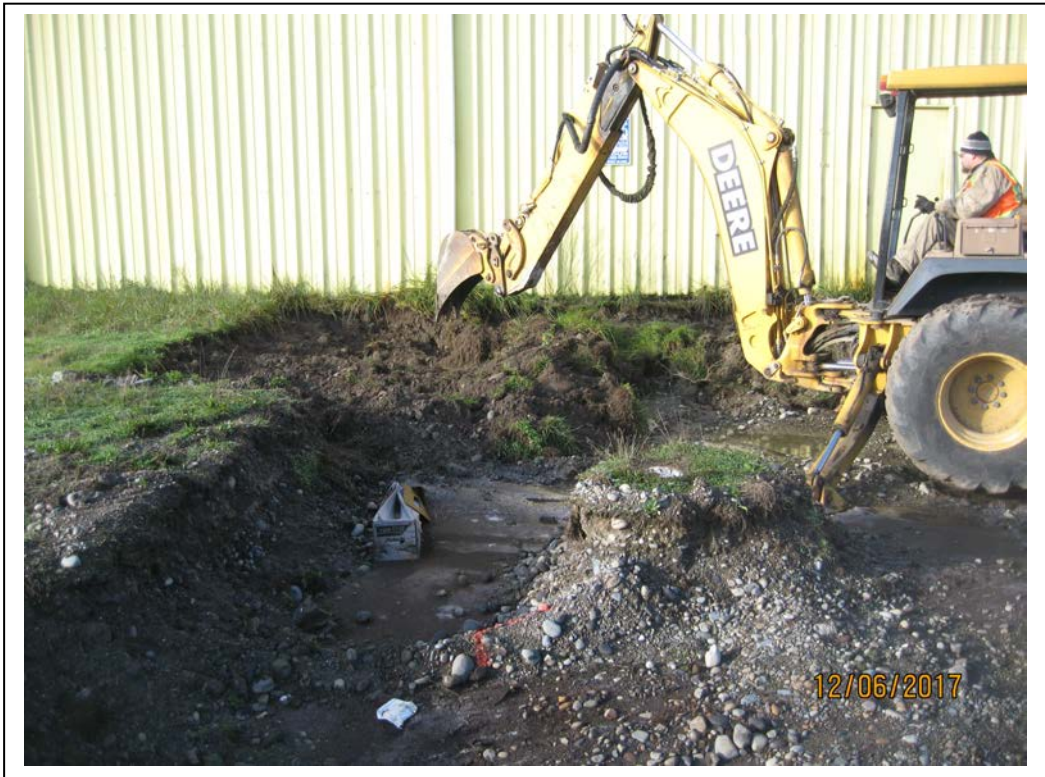
<b>Project No. 37018</b>	<b>Description</b>	Photo of continued remedial excavation, facing W	<b>Photo 7</b>
	<b>Site Name</b>	Former National Auto Parts, 16008 60 <sup>th</sup> St E, Sumner, WA	<b>Photo Date</b> December 6, 2017
	<b>Client</b>	Sunset Chevrolet/Mitchell Development

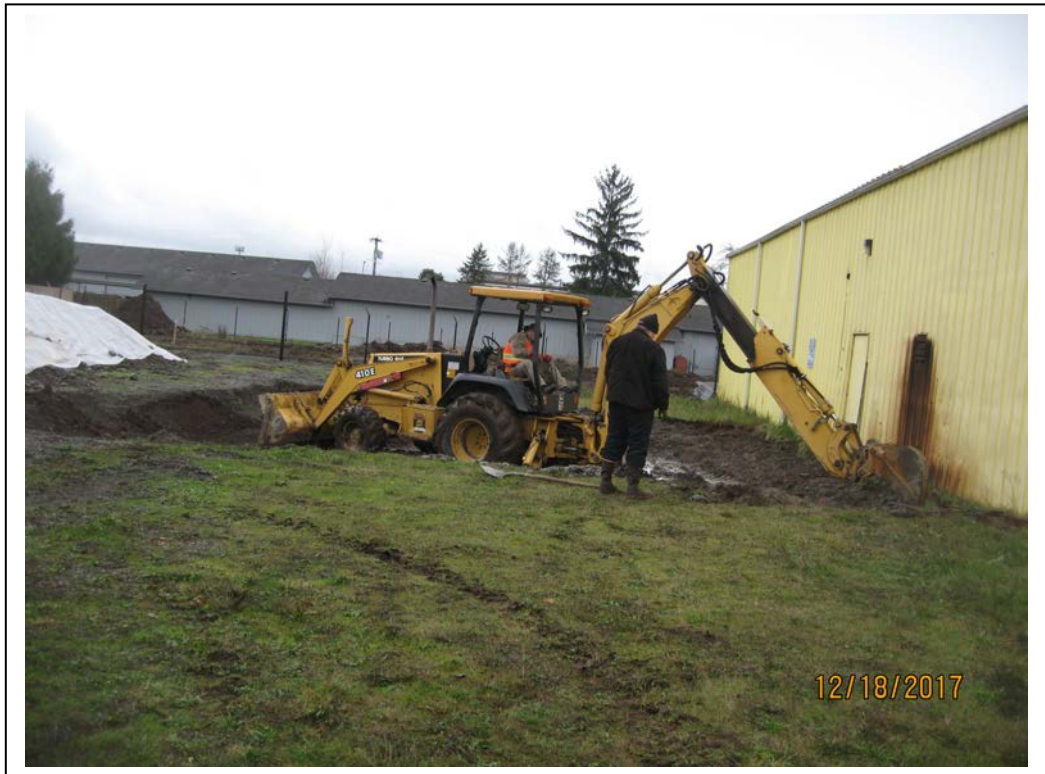
<b>Project No. 37018</b>	<b>Description</b>	Photo of continued remedial excavation, facing S	<b>Photo 8</b>
	<b>Site Name</b>	Former National Auto Parts, 16008 60 <sup>th</sup> St E, Sumner, WA	<b>Photo Date</b> December 18, 2017
	<b>Client</b>	Sunset Chevrolet/Mitchell Development

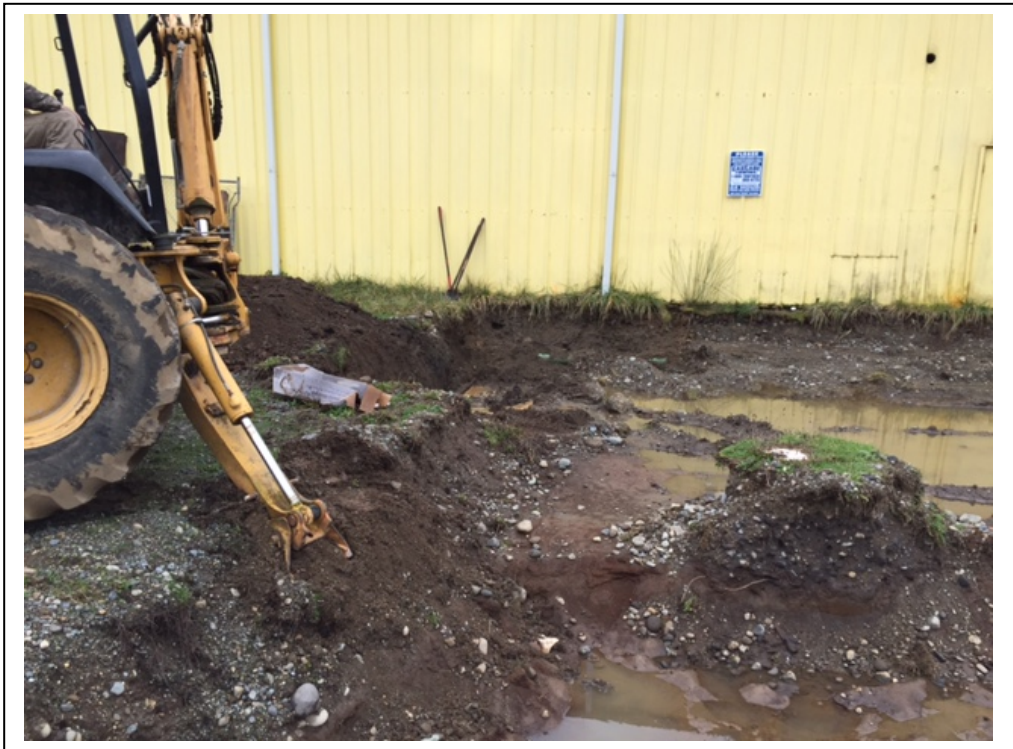
<b>Project No. 37018</b>	<b>Description</b>	Photo of continued remedial excavation, facing W	<b>Photo 9</b>
	<b>Site Name</b>	Former National Auto Parts, 16008 60 <sup>th</sup> St E, Sumner, WA	
	<b>Client</b>	Sunset Chevrolet/Mitchell Development	<b>Photo Date</b> January 17, 2018

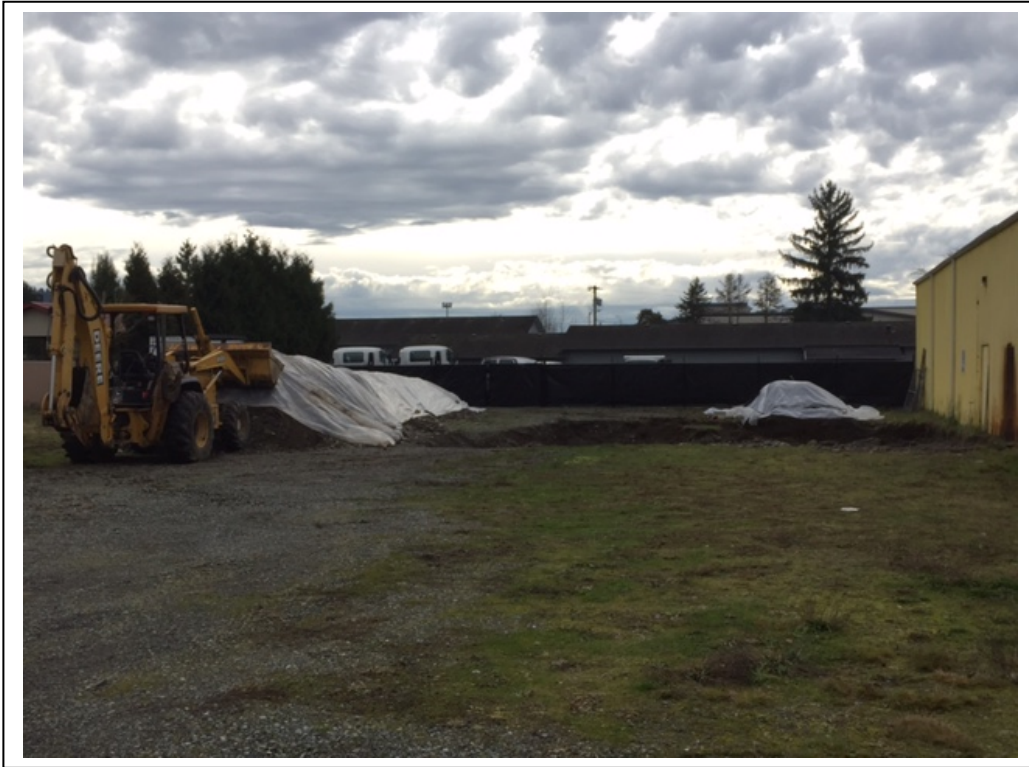
<b>Project No. 37018</b>	<b>Description</b>	Photo of continued remedial excavation, facing S	<b>Photo 10</b>
	<b>Site Name</b>	Former National Auto Parts, 16008 60 <sup>th</sup> St E, Sumner, WA	
	<b>Client</b>	Sunset Chevrolet/Mitchell Development	<b>Photo Date</b> January 17, 2018

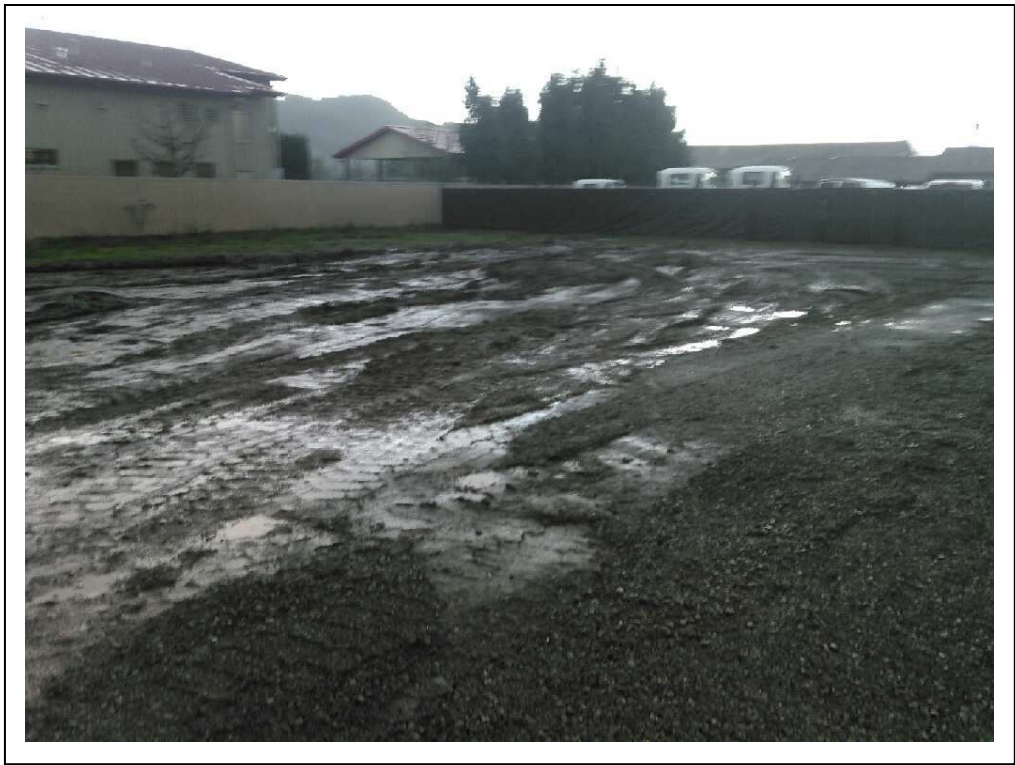
<b>Project No. 37018</b>	<b>Description</b>	Photo of post-remedial excavation backfilling, facing SE	<b>Photo 11</b>
	<b>Site Name</b>	Former National Auto Parts, 16008 60 <sup>th</sup> St E, Sumner, WA	
	<b>Client</b>	Sunset Chevrolet/Mitchell Development	<b>Photo Date</b> January 31, 2018

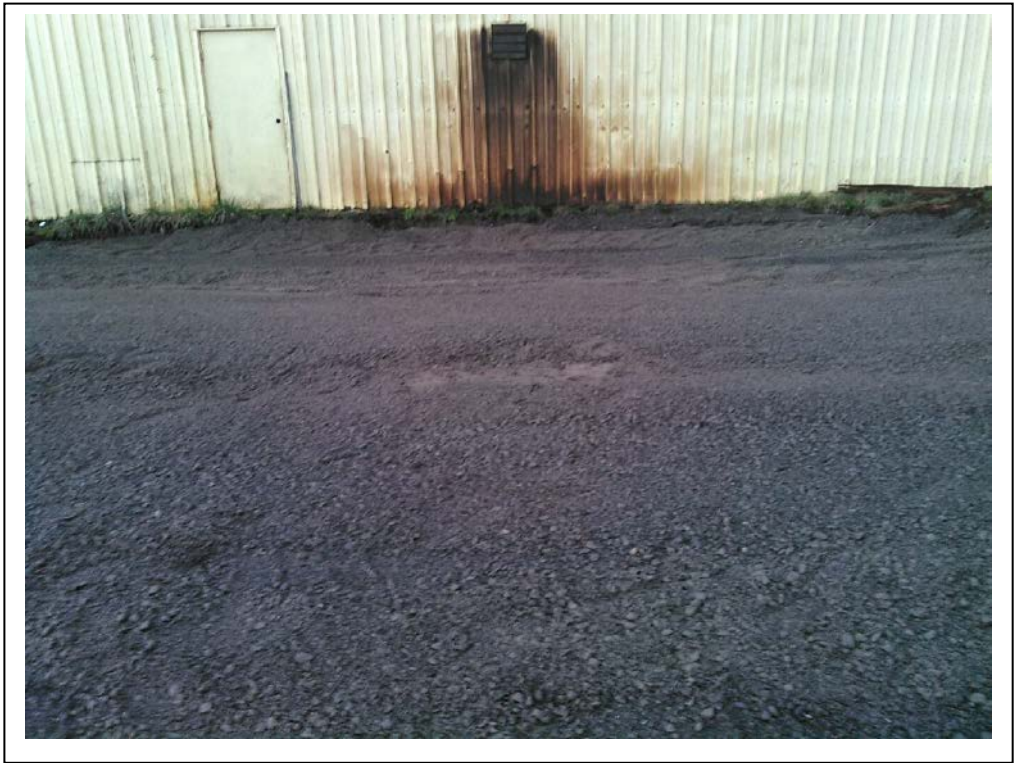
<b>Project No. 37018</b>	<b>Description</b>	Photo of post-remedial excavation backfilling, facing W	<b>Photo 12</b>
	<b>Site Name</b>	Former National Auto Parts, 16008 60 <sup>th</sup> St E, Sumner, WA	
	<b>Client</b>	Sunset Chevrolet/Mitchell Development	<b>Photo Date</b> January 31, 2018

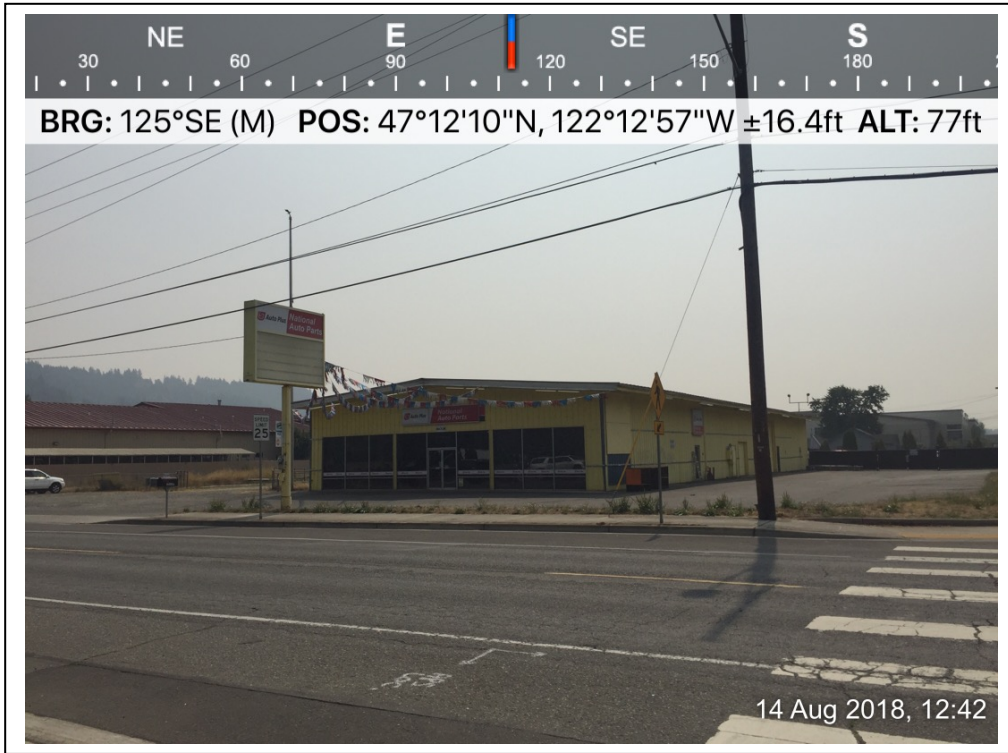
<b>Project No. 37018</b>	<b>Description</b>	Photo of the site, facing E/SE	<b>Photo 13</b>
	<b>Site Name</b>	Former National Auto Parts, 16008 60 <sup>th</sup> St E, Sumner, WA	<b>Photo Date</b>
	<b>Client</b>	Sunset Chevrolet/Mitchell Development	August 14, 2018
