# **INDEPENDENT REMEDIAL** **ACTION REPORT**

**NATIONAL AUTO PARTS PROPERTY  
SUMNER, WASHINGTON  
ECOLOGY VCP PROJECT #SW1547**

September 3, 2020

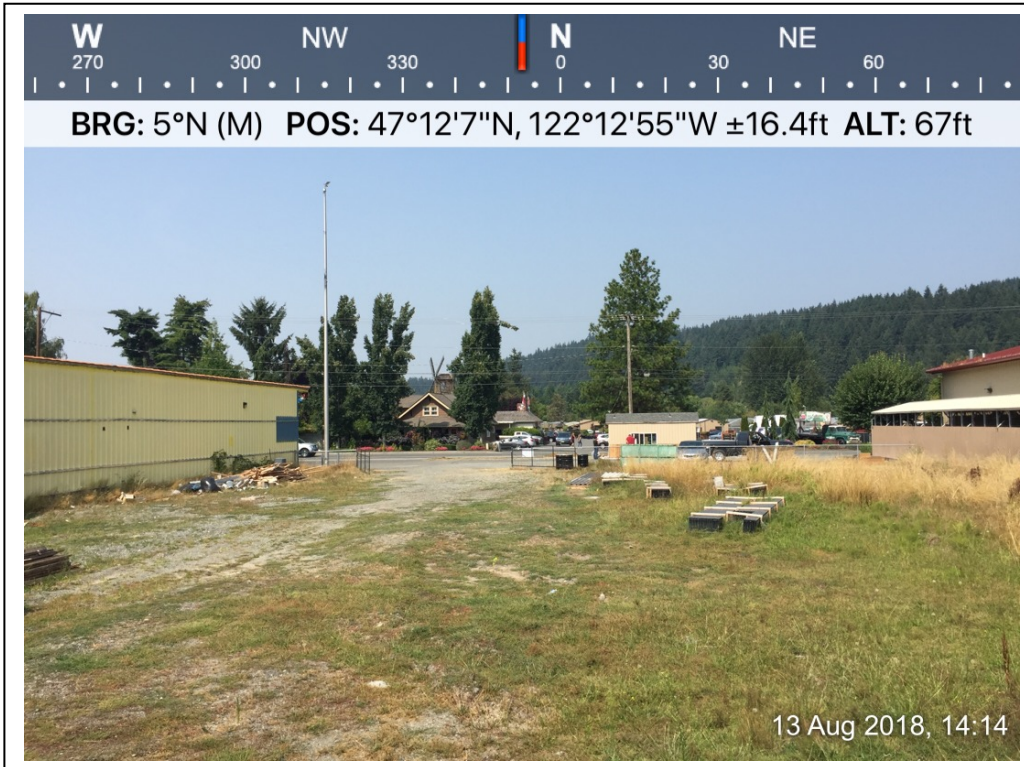
<b>Project No. 37018</b>	<b>Description</b>	Photo of the eastern portion site, facing N	<b>Photo 14</b>
	<b>Site Name</b>	Former National Auto Parts, 16008 60 <sup>th</sup> St E, Sumner, WA	<b>Photo Date</b>
	<b>Client</b>	Sunset Chevrolet/Mitchell Development	August 13, 2018

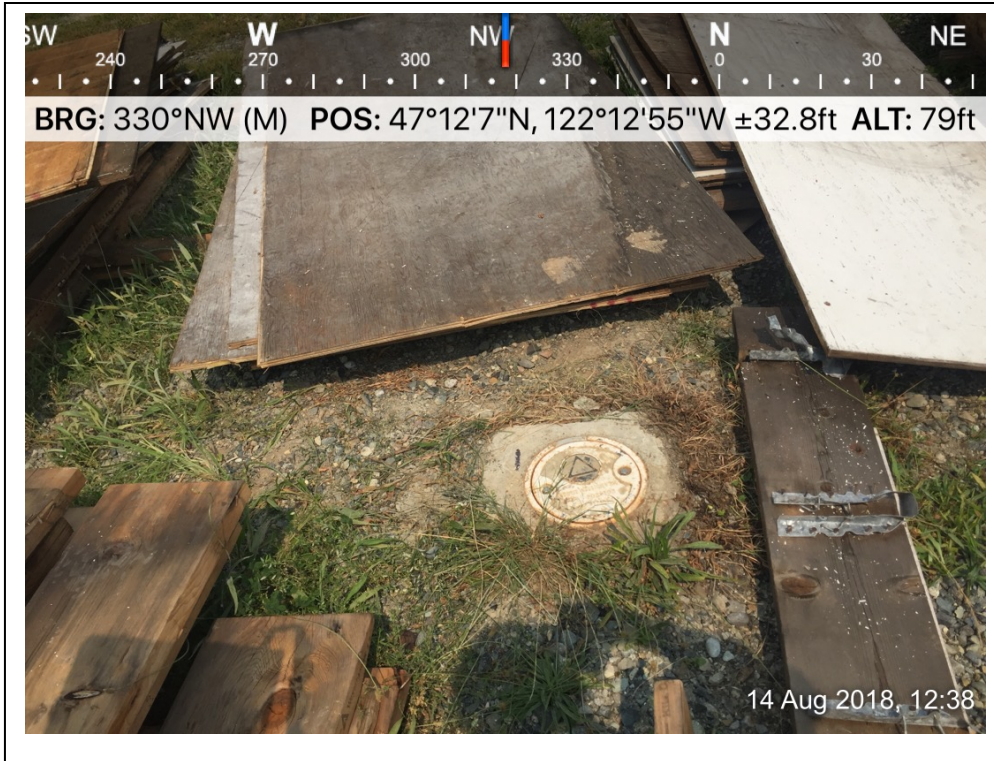
<b>Project No. 37018</b>	<b>Description</b>	Photo of the existing groundwater well MW-1	<b>Photo 15</b>
	<b>Site Name</b>	Former National Auto Parts, 16008 60 <sup>th</sup> St E, Sumner, WA	<b>Photo Date</b>
	<b>Client</b>	Sunset Chevrolet/Mitchell Development	August 14, 2018

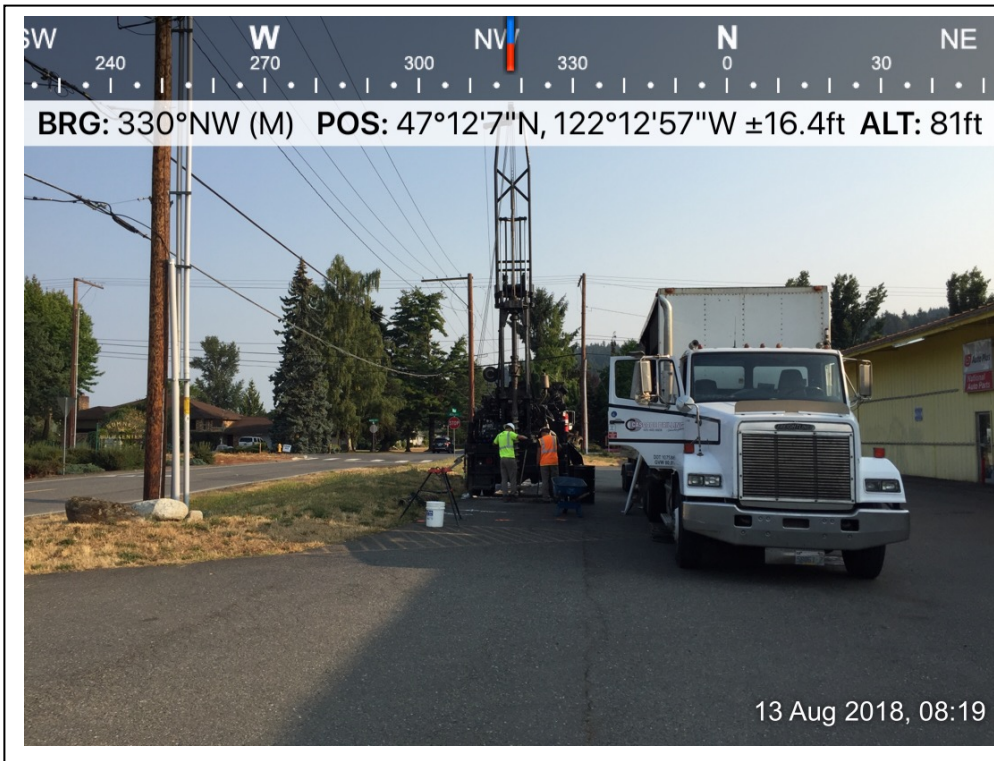
<b>Project No. 37018</b>	<b>Description</b>	Photo of the drilling to install groundwater well MW-2	<b>Photo 16</b>
	<b>Site Name</b>	Former National Auto Parts, 16008 60 <sup>th</sup> St E, Sumner, WA	<b>Photo Date</b>
	<b>Client</b>	Sunset Chevrolet/Mitchell Development	August 13, 2018

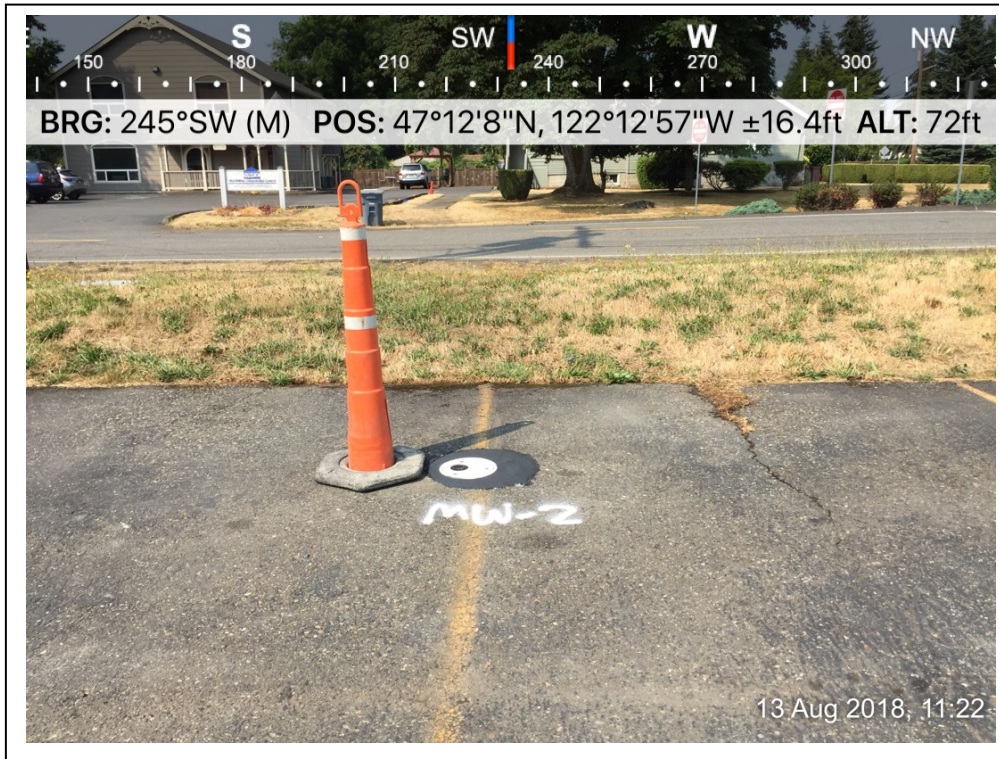
<b>Project No. 37018</b>	<b>Description</b>	Photo of finished completion of groundwater well MW-2	<b>Photo 17</b>
	<b>Site Name</b>	Former National Auto Parts, 16008 60 <sup>th</sup> St E, Sumner, WA	<b>Photo Date</b>
	<b>Client</b>	Sunset Chevrolet/Mitchell Development	August 13, 2018

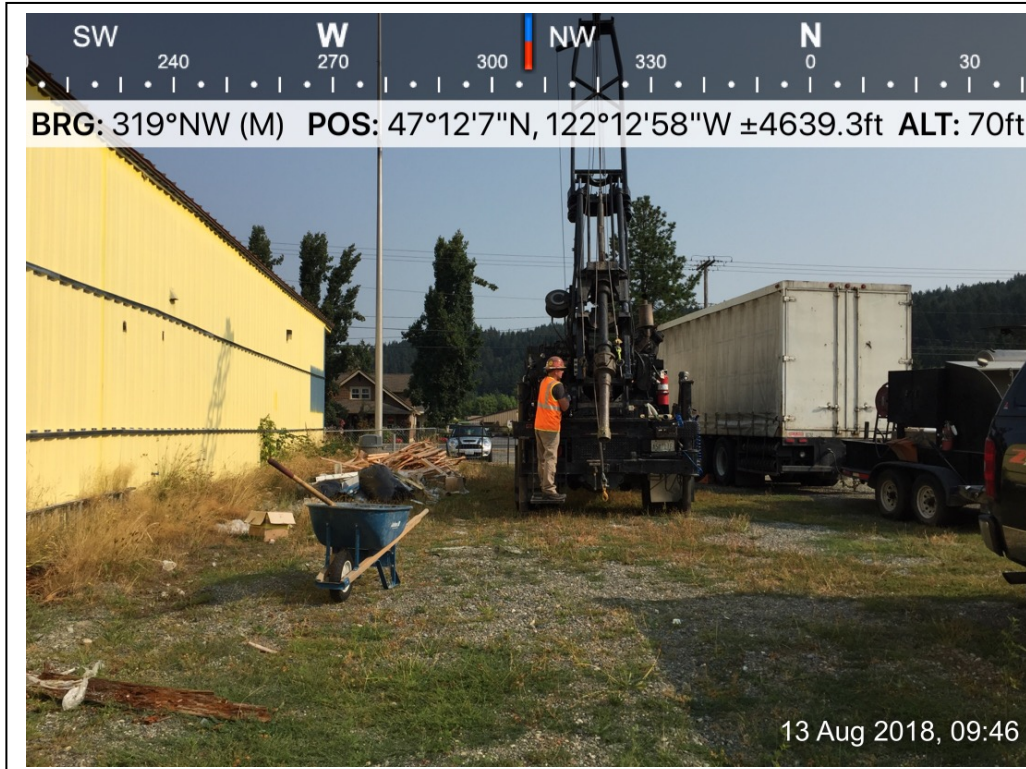
<b>Project No. 37018</b>	<b>Description</b>	Photo of the drilling to install groundwater well MW-3	<b>Photo 18</b>
	<b>Site Name</b>	Former National Auto Parts, 16008 60 <sup>th</sup> St E, Sumner, WA	<b>Photo Date</b>
	<b>Client</b>	Sunset Chevrolet/Mitchell Development	August 13, 2018

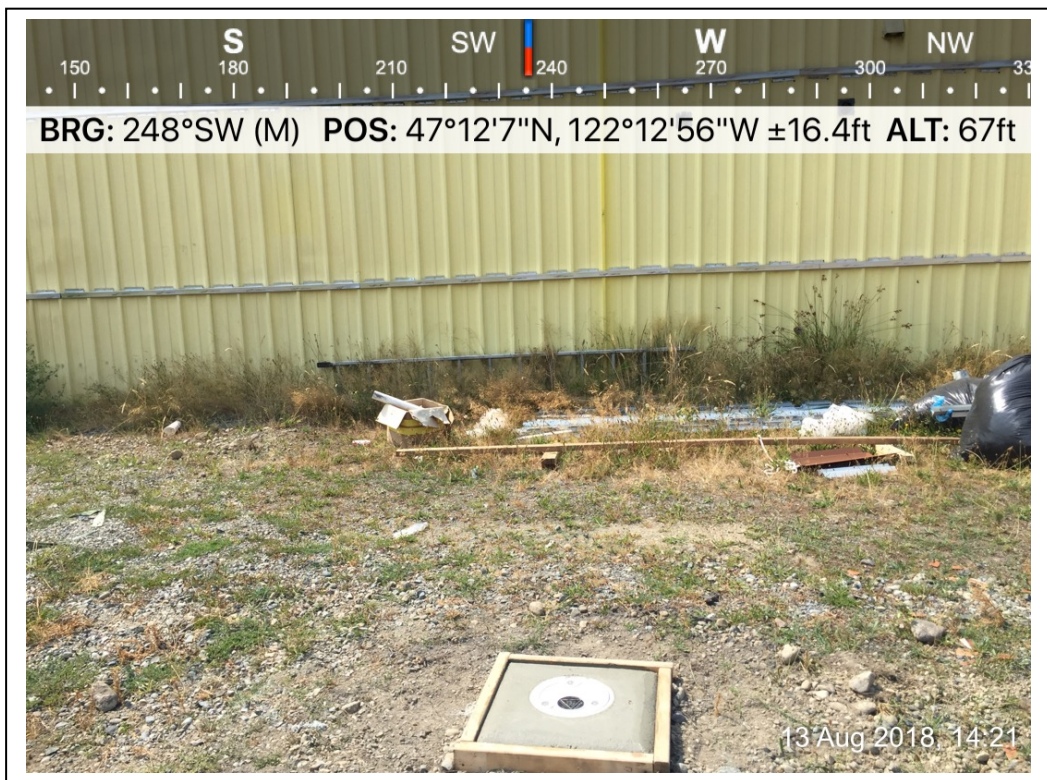
<b>Project No. 37018</b>	<b>Description</b>	Photo of finished completion of groundwater well MW-3	<b>Photo 19</b>
	<b>Site Name</b>	Former National Auto Parts, 16008 60 <sup>th</sup> St E, Sumner, WA	<b>Photo Date</b>
	<b>Client</b>	Sunset Chevrolet/Mitchell Development	August 13, 2018

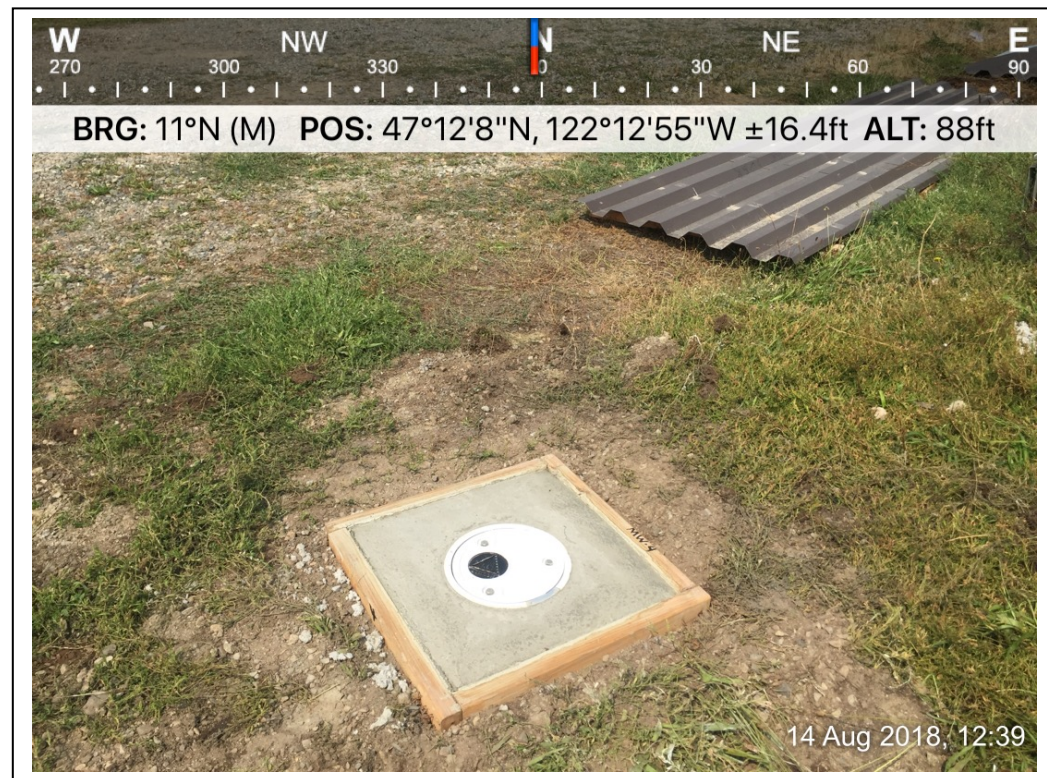
<b>Project No. 37018</b>	<b>Description</b>	Photo of finished completion of groundwater well MW-4	<b>Photo 20</b>
	<b>Site Name</b>	Former National Auto Parts, 16008 60 <sup>th</sup> St E, Sumner, WA	<b>Photo Date</b>
	<b>Client</b>	Sunset Chevrolet/Mitchell Development	August 14, 2018
