**Re: Opinion pursuant to WAC 173-340-515(5) on Proposed Remedial Action for the following Hazardous Waste Site:**

- **Name:** Phillips 66 070644
- **Address:** 2800 Martin Luther King Way S., Seattle
- **Facility/Site No.:** 42746846
- **VCP No.:** NW2321

## Enclosure A

### Description and Diagrams of the Site

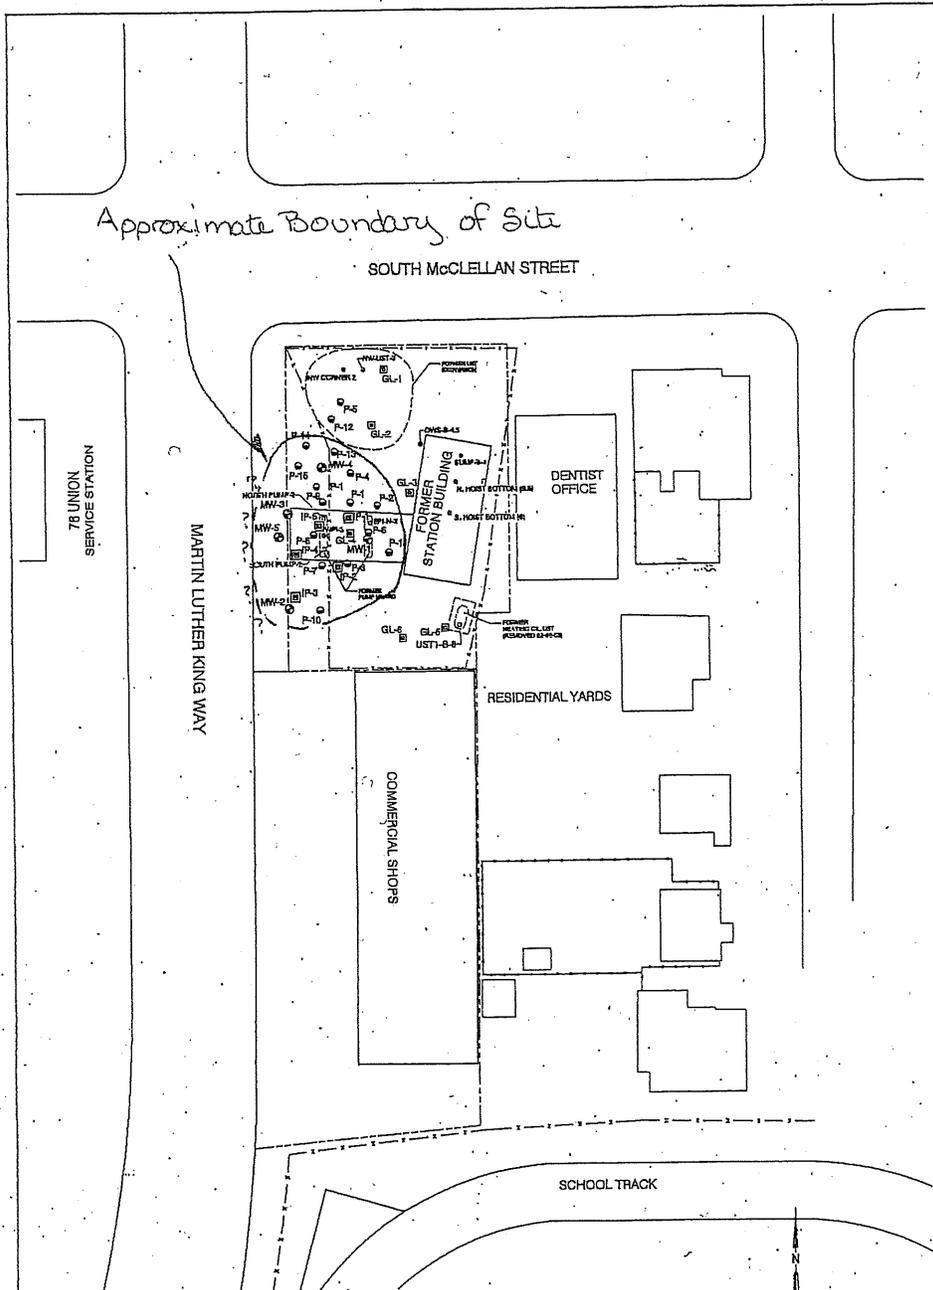
<b>Stantec</b>	FOR: FORMER TIDWATER SERVICE STATION 2800 MARTIN LUTHER KING WAY SEATTLE, WASHINGTON	<b>EXTENDED SITE PLAN</b>		FIGURE: <b>2</b>
	JOB NUMBER: 21140038.000.020	DRAWN BY: MDR	CHECKED BY: TG	APPROVED BY: DS

Soil and ground water sampling indicated that soil and ground water near the dispenser islands had levels of THGg and BTEX above MTCA Method A cleanup levels. The vertical and lateral extent of soil and ground water contamination was not fully characterized along the south and western edges of the property.

November 2009, ground water samples were collected from the monitoring wells to evaluate current conditions at the Site. The ground water results indicated that the levels of chemicals of concern were lower than before remediation. Ground water at MW-5 was still above MTCA Method A cleanup levels for TPHg.

- A confirmation soil boring be located between historical boring P-13 and P-14 to confirm that releases from the tank nest (which was removed in 1989) have been remediated.

- A soil boring be located west of MW-5 to characterize the lateral and vertical extent of soil contamination. Based on conditions encountered, additional boring locations may be needed to bound soil contamination.

- Soil samples should be collected every 5 feet, from 5 feet below grade to 5 feet below encountered ground water.
