STATE OF WASHINGTON  
DEPARTMENT OF ECOLOGY

**Re: No Further Action at the following Site:**

- **Site Name:** Mutual Materials Newcastle Lot 4 Cr Site
- **Site Address:** 6620 Coal Creek Parkway SE, Newcastle, WA 98056
- **Facility/Site ID No.:** 50608
- **Cleanup Site ID No.:** 15081
- **VCP Project No.:** NW3248

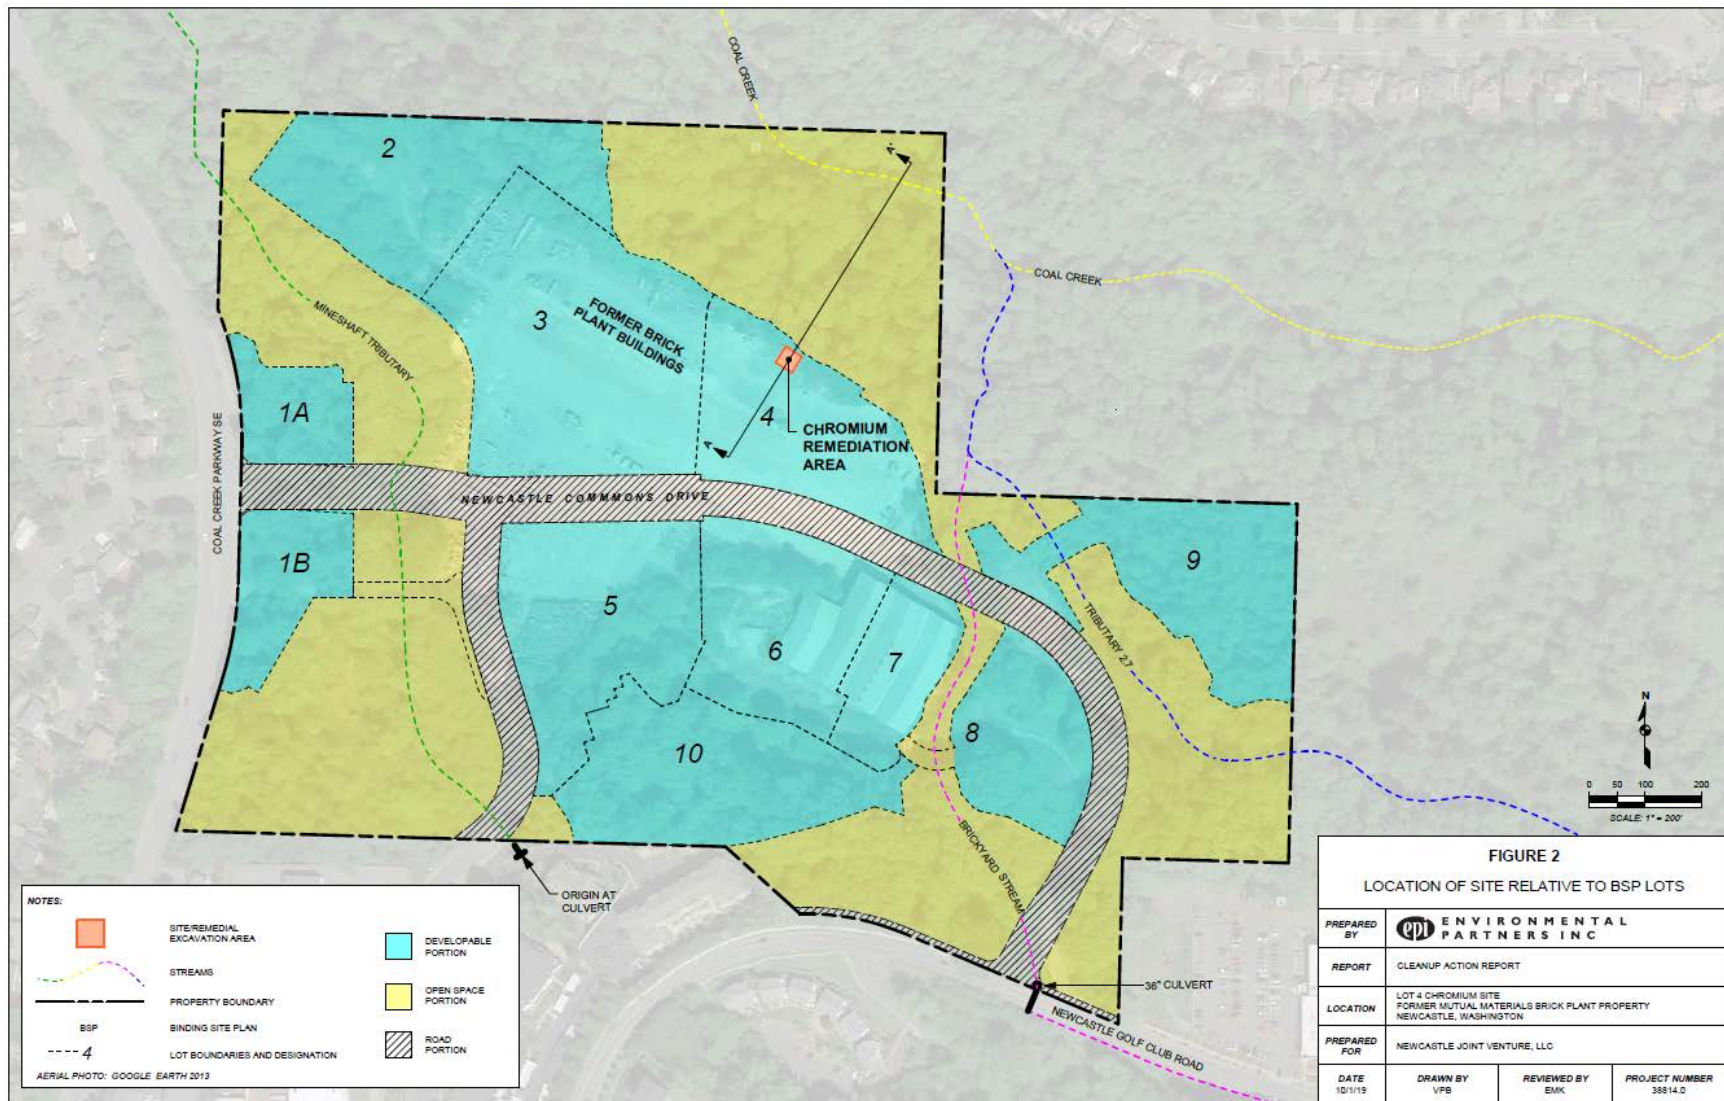
**Figure 2 Site Plan and Soil Excavation Area (EPI, 2020)**

Groundwater was not encountered during the Site assessments and subsequent soil excavation performed at the Site. Groundwater is expected to be present on the Site at a depth of approximately 30 feet bgs. This estimate was based on the depth to the water table at the neighboring areas and the Site hydrogeologic conditions. There are two wells located next to the Property in which groundwater was encountered at a depth of 30 feet, one in Lot 3 and one about 180 feet southeast of the Site (**Enclosure A, Figure 2**).

The elevation of Lot 4 is approximately 390 feet average mean sea level (AMSL). The water table was encountered on the adjacent Lot 3 (**Enclosure A, Figure 2**) to the west at an elevation of about 360 feet AMSL, or 30 feet bgs. Therefore groundwater at the Site is anticipated to be at a similar depth of 30 feet bgs.

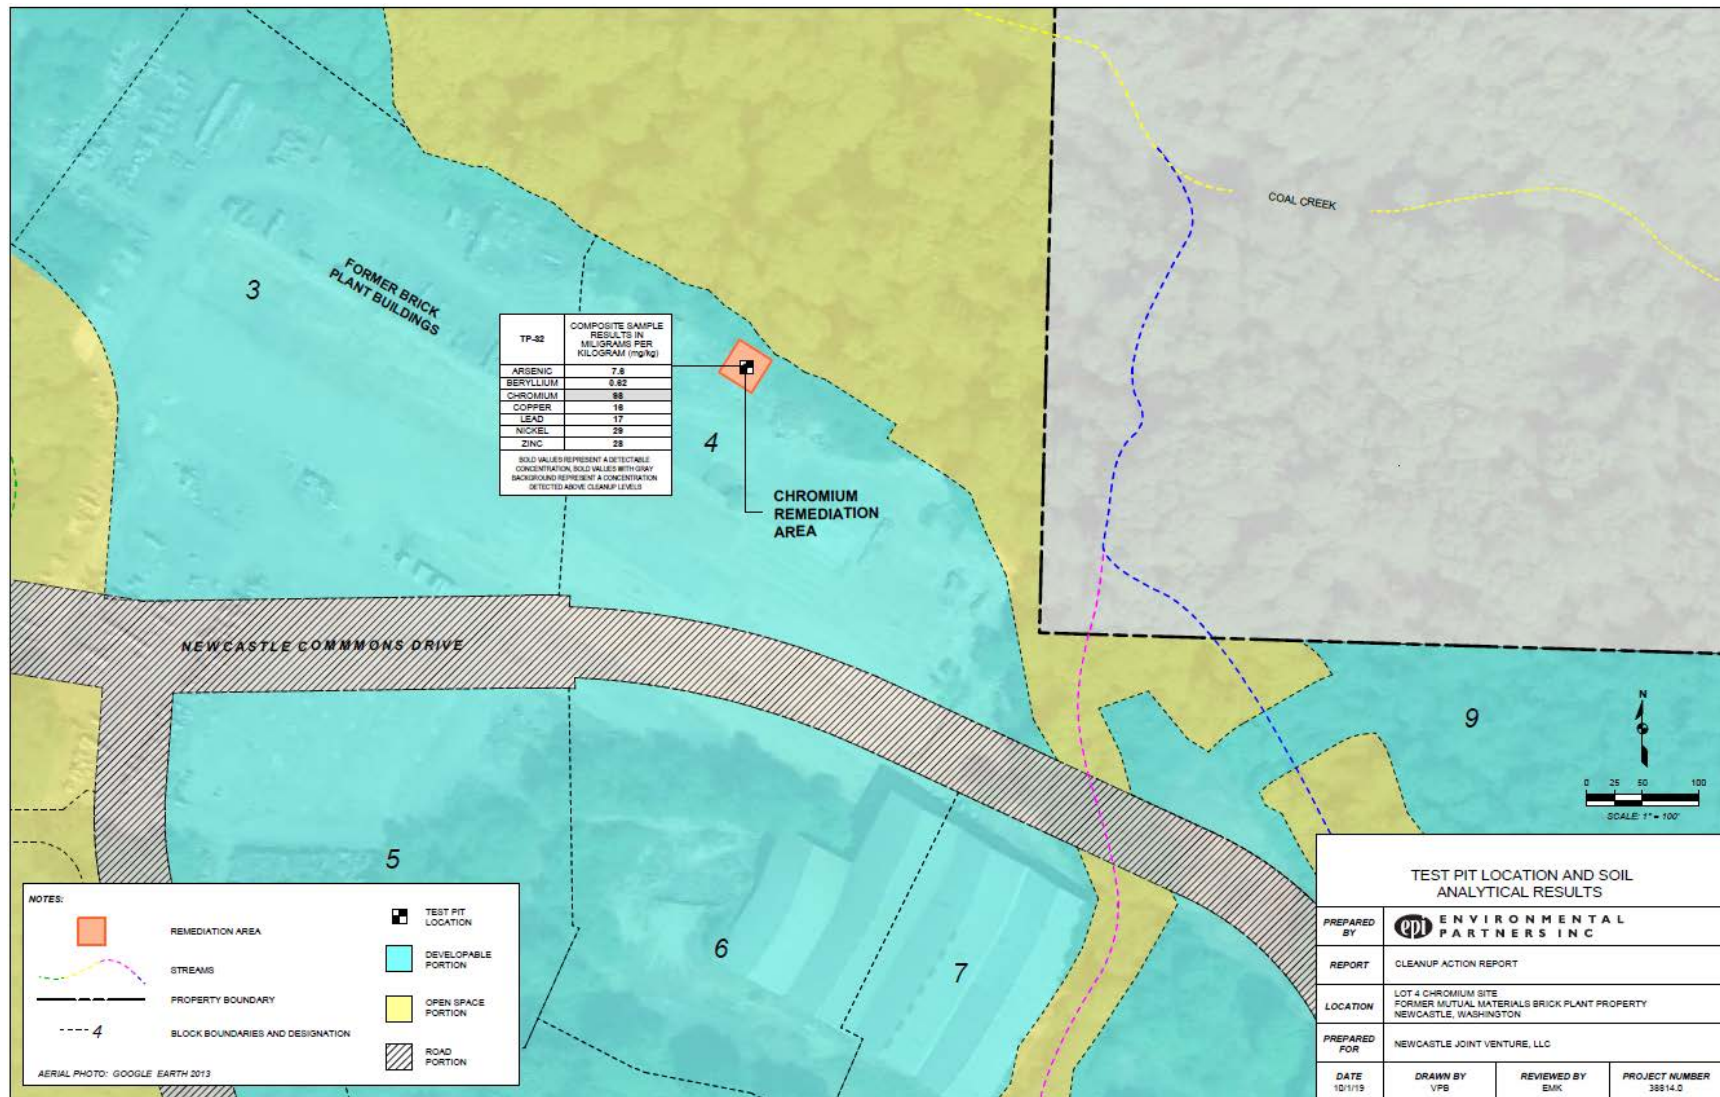
**Figure 3 Soil Contaminated by Chromium at the Site (EPI, 2020)**

Based on the Revised Cleanup Action Report (RCAR, August 12, 2020), the soil impacted by chromium was defined and limited to an area of approximately 361 square feet within the Property at depths ranging from 3 to 6 feet below ground surface (bgs)(**Enclosure A, Figures 3 and 4**).

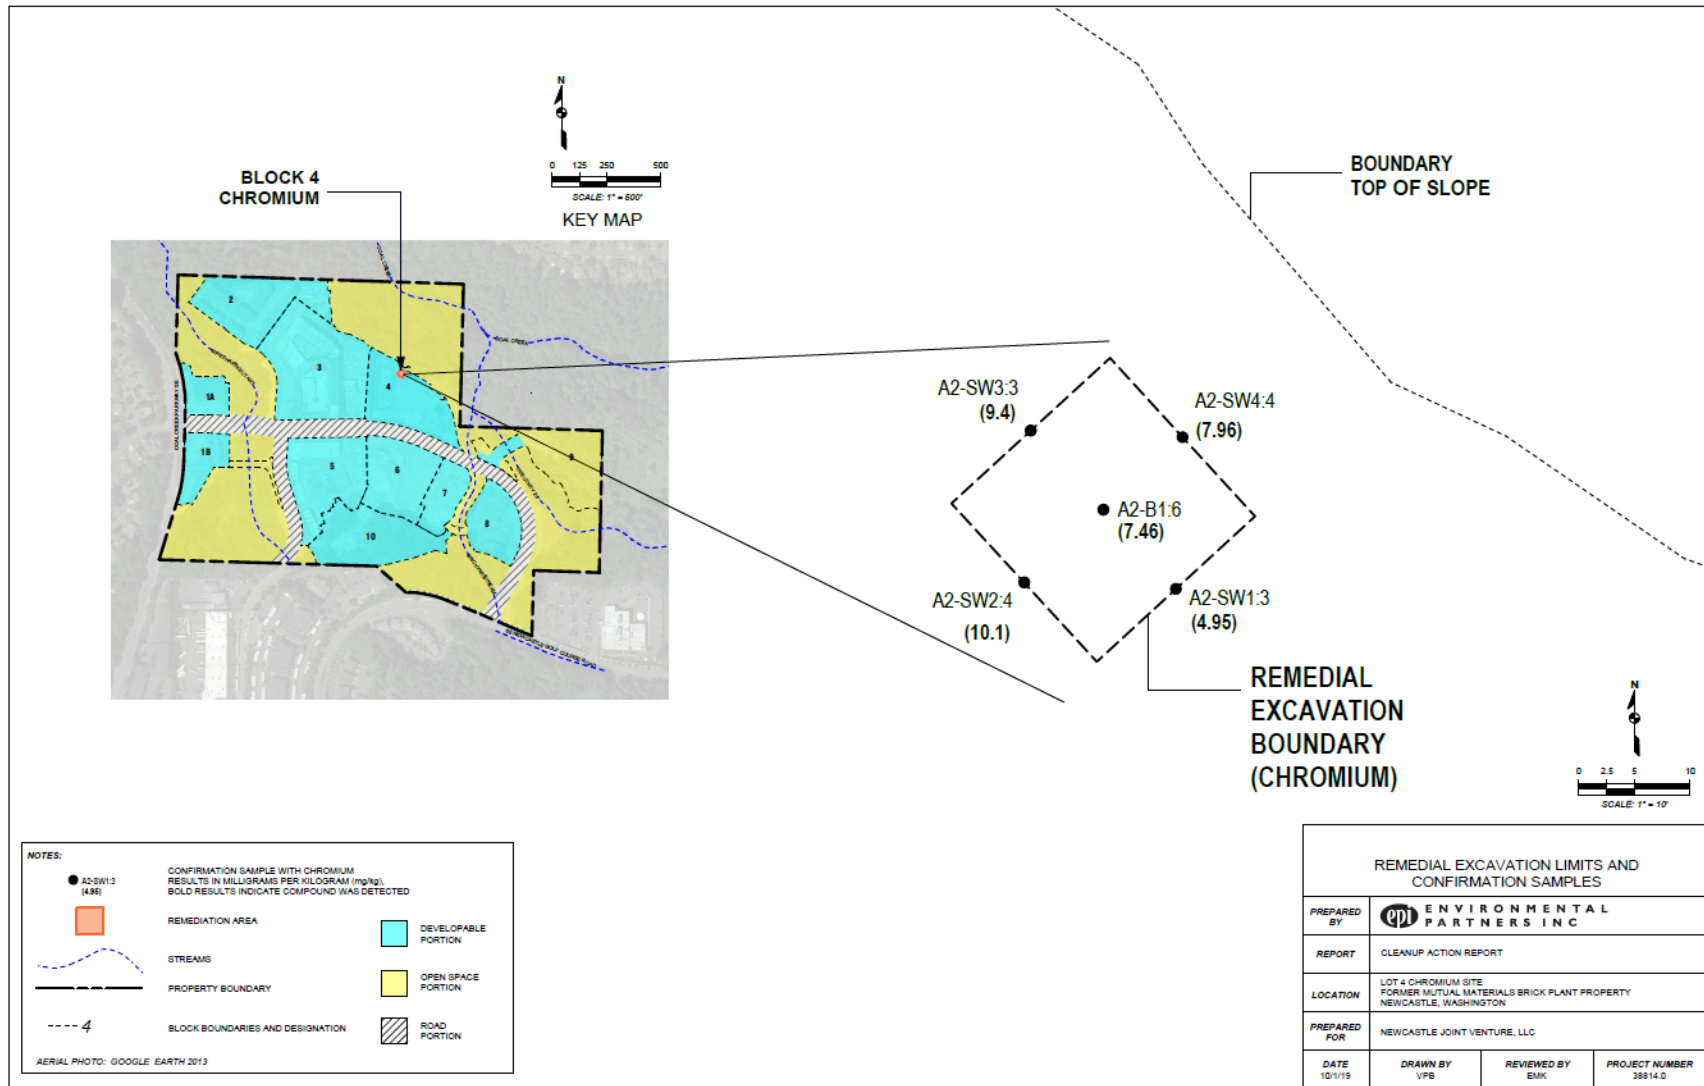
**Figure 4 Soil Excavation Boundary and Confirmation Sampling Locations at the Site (EPI, 2020)**

- Five confirmation soil samples collected at the sidewalls and bottom of the excavation demonstrated that chromium concentrations remaining in soil range from 4.95 to 10.10 mg/kg, which are below the Site cleanup level (2,000 mg/kg) (Enclosure A, Figure 4).

Cleanup efforts consisted of excavation of the contaminated soil in April 2015 at a contaminated area (**Enclosure A, Figure 4**), off-Site disposal of the excavated soil, and research of the local groundwater occurrence. Soil confirmation sampling was also conducted to verify the completion of the remediation.

- The remedial excavation area was approximately 19 feet square and 3 to 6 feet deep (**Enclosure A, Figures 4 and 5**). In April 2015, a total of approximately 142 tons of impacted soil was removed and disposed of at a regulated off-Site facility.

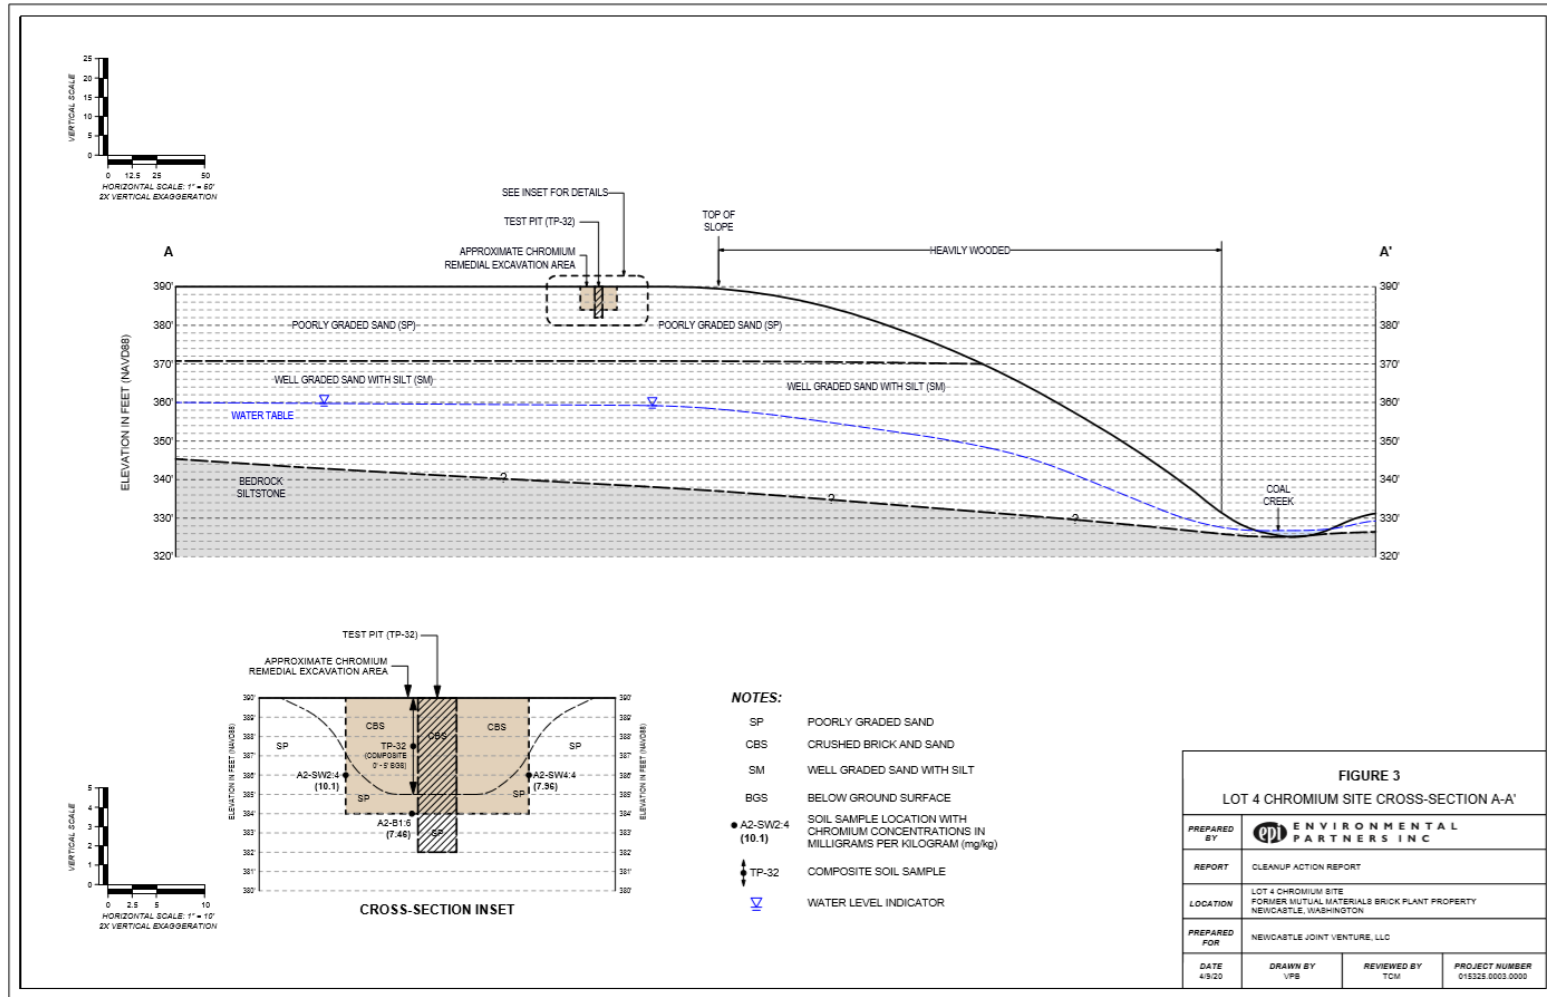
**Figure 5 Geological Cross- Section at the Mutual Materials Newcastle Lot 4 Cr Site (EPI, 2020)**

Groundwater migration in a water table aquifer, if present, is anticipated to be northerly to northeasterly, consistent with local topography and surface water flows (**Enclosure A, Figures 2 and 5**).
