PHASE I ENVIRONMENTAL ASSESSMENT

Industrial Park
18250 - 18430 - 68th Avenue South
Kent, Washington 98032

August 8, 2003

JN 23217

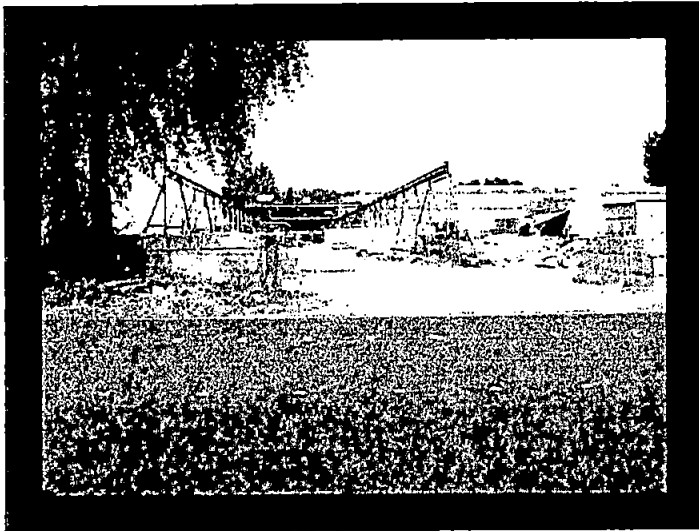
A view of the subject property looking west from across 72nd Avenue South.

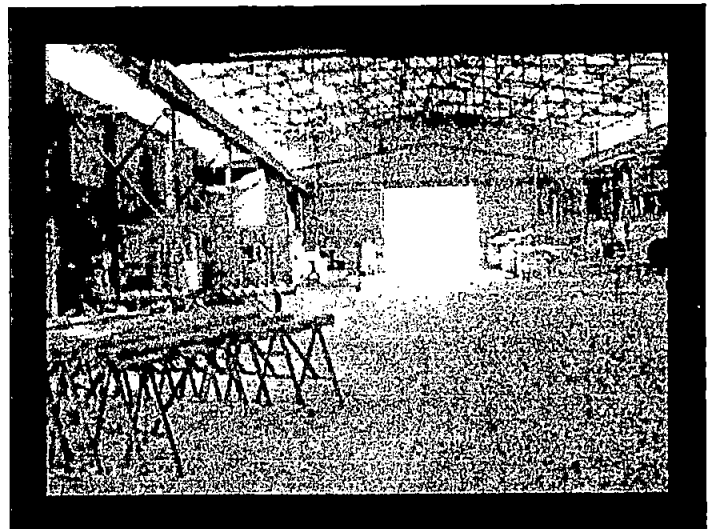
An interior view looking north within Bldg. 2.

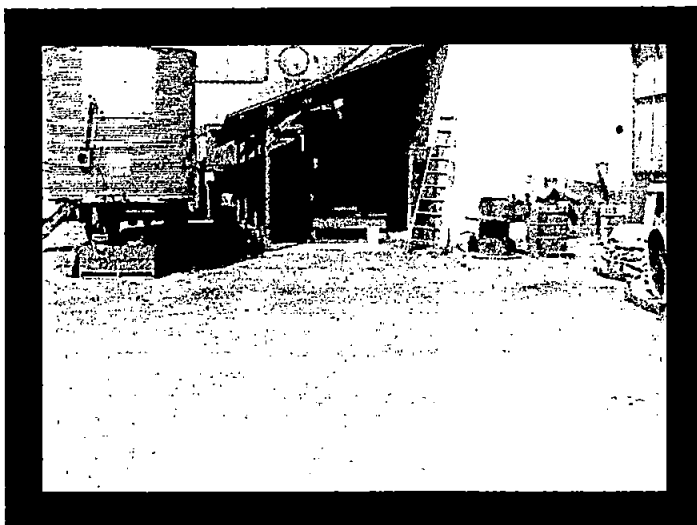
The second area of reported soil excavation was in the vicinity of the stained soil which HLA had tested in 1990 and found to contain elevated levels of chromium and lead within the upper 6 inches of soil proximal to the "blast room" (see Plate 2, Site Plan) (HLA, 1991). In February and March of 1991, HLA reportedly observed the excavation of approximately 38 cubic yards of metal-impacted soil, to depths of up to approximately 1 foot bgs proximal to the southeastern portion of the "blast room" (see Plate 2, Site Plan, and HLA's Figure 3 in Appendix C). HLA reported that a "black grit material" was encountered in an approximately 1-inch thick layer in the excavated soil near the "blast room" at a depth of approximately 6 to 12-inches bgs. A soil sample from this "black grit material" was reportedly collected and laboratory tested and found to contain concentrations of lead and cadmium (2,820 ppm and 27.3 ppm, respectively) which were above MTCA cleanup levels for industrial sites at that time. HLA reportedly observed the excavation of this "black grit layer", from the collected location of that laboratory-tested sample, "...and [excavation] proceeded in all directions until no further signs of the black grit were observed or until obstructions were

encountered. In general, soil excavation was able to proceed without interruption to the north, east, and south allowing for complete removal of this material. However, soil excavation to the west was terminated due to obstruction by the blast room building foundation and the concrete apron. Soil excavation was conducted right up [to] the building foundation and the edge of the concrete pad" (HLA, 1991). HLA reported that a "thin layer [less than approximately 1-inch thick] of black grit was still present in the soil at a depth of 12-15 inches below the ground surface at some locations along the concrete apron and building foundation. This material appeared to extend below the building foundation and the concrete apron, but further excavation was not possible below these structures" (HLA, 1991). Soil excavation work was reportedly terminated at the edge of the "blast room" foundation and concrete apron (currently the site of an addition to the blast room), and a single soil sample was collected from the sidewall of the excavation proximal to the "concrete apron" (see HLA-3 on Plate 2, Site Plan), and submitted for laboratory analysis. Results of laboratory testing of that sidewall sample revealed that concentrations of cadmium and lead (10.8 ppm and 1,790 ppm, respectively) were above their applicable MTCA cleanup levels for industrial properties. Laboratory testing of a confirmation soil sample collected from the base of the excavation (see sample 10 B of HLA's Figure 3 in Appendix C) revealed concentrations of cadmium, chromium, and lead well below their applicable MTCA Method A cleanup levels for industrial properties. HLA concluded that "removal of the black grit material from these areas [beneath the "blast room" and "concrete apron"] is not technically feasible without demolition of the structures" and "the extent of the metals contamination appears to be limited to a very thin layer of material (< 1-inch thick)". HLA advised on page 5 of their July 1991-dated report that "the grit material should be excavated and properly disposed of or treated if the blast room and concrete apron are eventually demolished (either by CAB Systems, CAM Properties or by subsequent property owners)" (HLA, 1991).

A view looking west-northwest toward the "blast room" and area of metal-impacted soil excavation reportedly conducted by others (HLA, 1991). Inaccessible metal-impacted soil reportedly remained beneath the structures seen on the right side of the photograph.
