INITIAL INVESTIGATION FIELD REPORT

ERTS Number 600251

SITE NAME 2202 Broadway

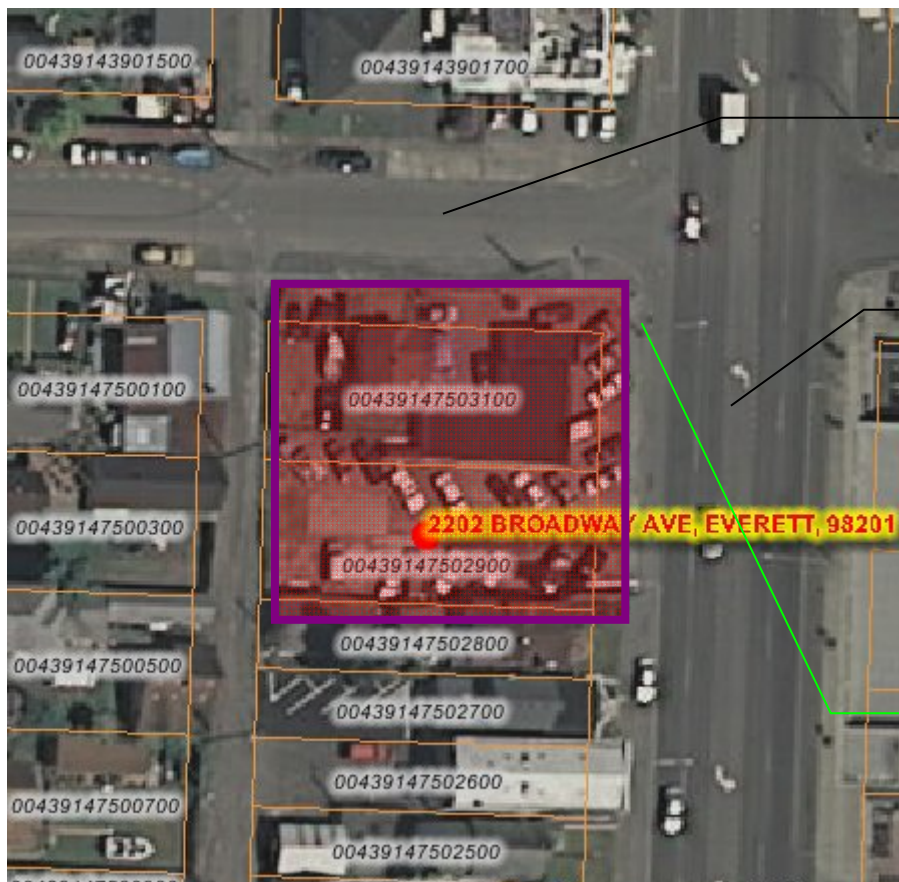
SITE MAP/DIAGRAM

Approximate location of remaining contamination
