# 2020 ANNUAL CAP INSPECTION REPORT

**BNSF Northport Site**

December 16, 2020

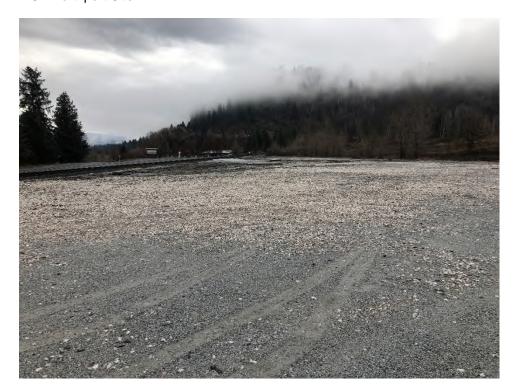
Photograph: 1

Gravel cap, looking

east

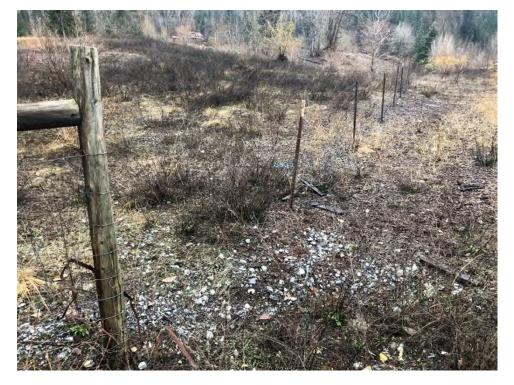
Photograph: 2

Access point in fence on west side of cap, looking southeast

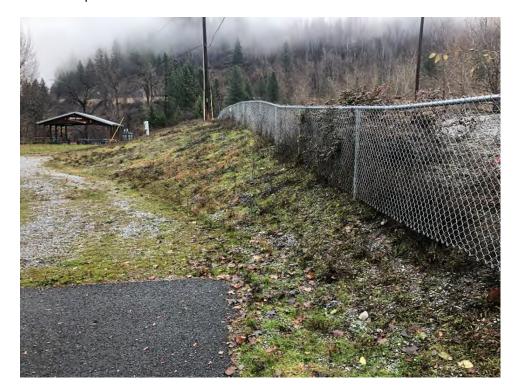
Photograph: 3

Fence between park and tracks, looking east

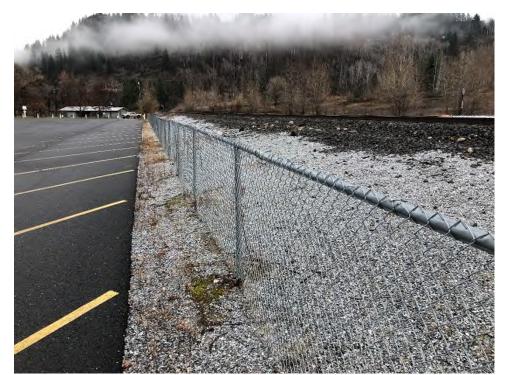
Photograph: 4

Fence between parking lot of park and tracks, looking east

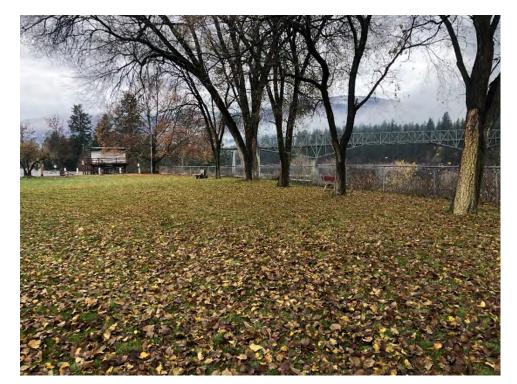
Photograph: 5

Park grass and trees, looking west

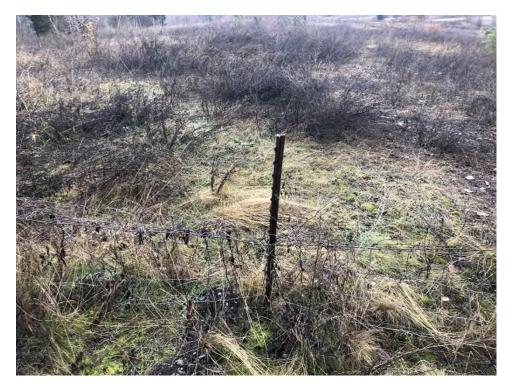
Photograph: 6

Identified low spot on east side of cap

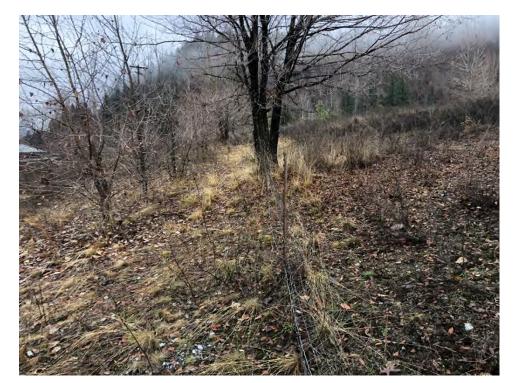
Photograph: 7

Identified low spot in the middle of fence line

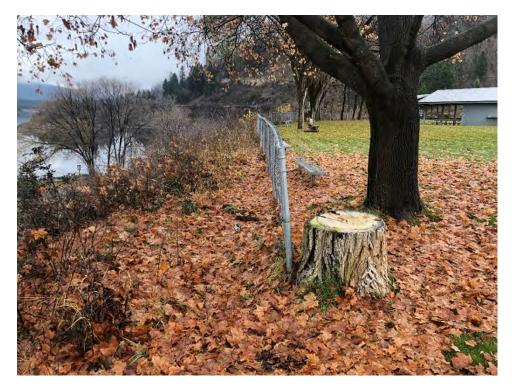
Photograph: 8

Fence between park and boat launch, looking east

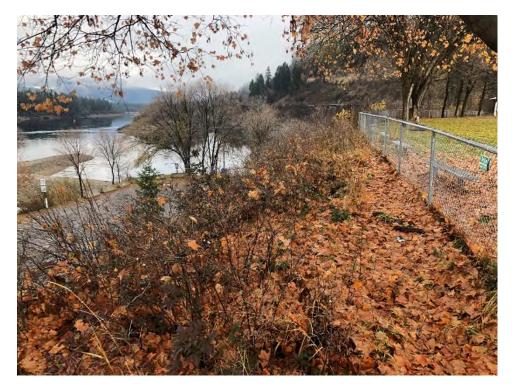
Photograph: 9

Area between park and boat launch, looking east

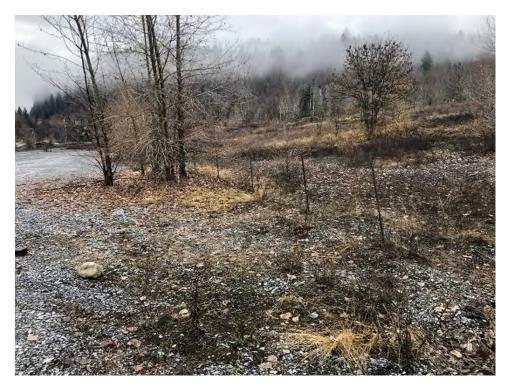
Photograph: 10

South fenceline of gravel cap area, looking south east

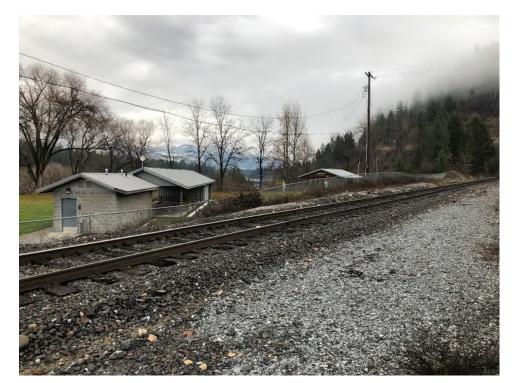
Photograph: 11

Tracks south of park, looking northeast

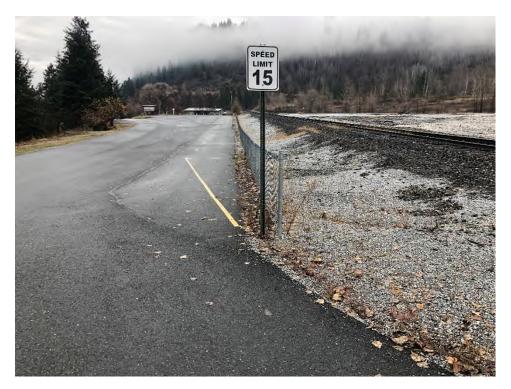
Photograph: 12

Entrance to parking lot, looking east

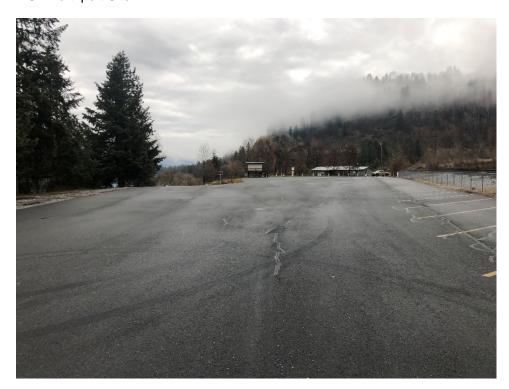
Photograph: 13

Parking lot, looking east
