STATE OF WASHINGTON
DEPARTMENT OF ECOLOGY

Re: Opinion on Proposed Cleanup of the following Site:

- **Site Name:** Streibels Deli Mart
- **Site Address:** 26605 State Road 104 NE, Kingston, WA
- **Facility/Site No.:** 681 981 52
- **VCP Project No.:** NW 2232

Description and Diagram of the Site

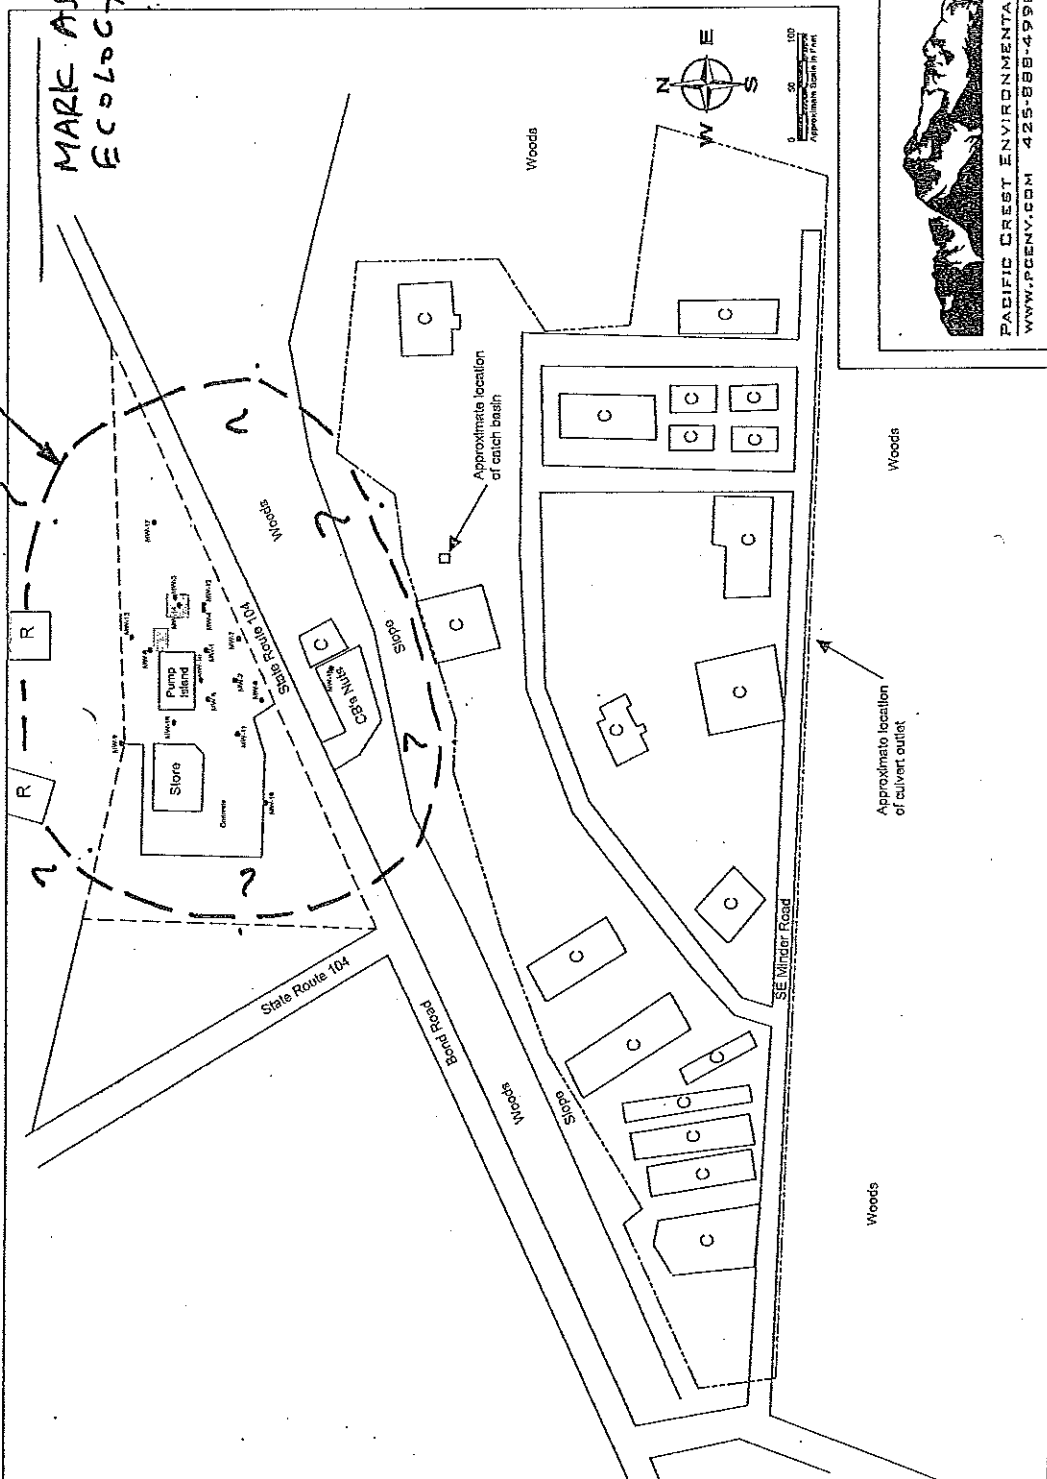
SITE MAP

Site: The Site comprises petroleum hydrocarbon releases, primarily gasoline, at the property located at 26605 State Road 104 NE near Kingston in Kitsap County (the Property). An operating convenience store, with retail fuel sales, currently occupies the Property. The Property and the Site are shown on the attached Site Map.

APPROXIMATE EXTENT OF
MICA SITE
