**RE: Everett Landfill – 2020 Landfill Gas Annual Report**

December 11, 2020  
HWA Project No. 98165-670

**Subject: Gas Monitoring Annual Report, 2020  
Everett Landfill/Tire Fire Site  
Everett, Washington**

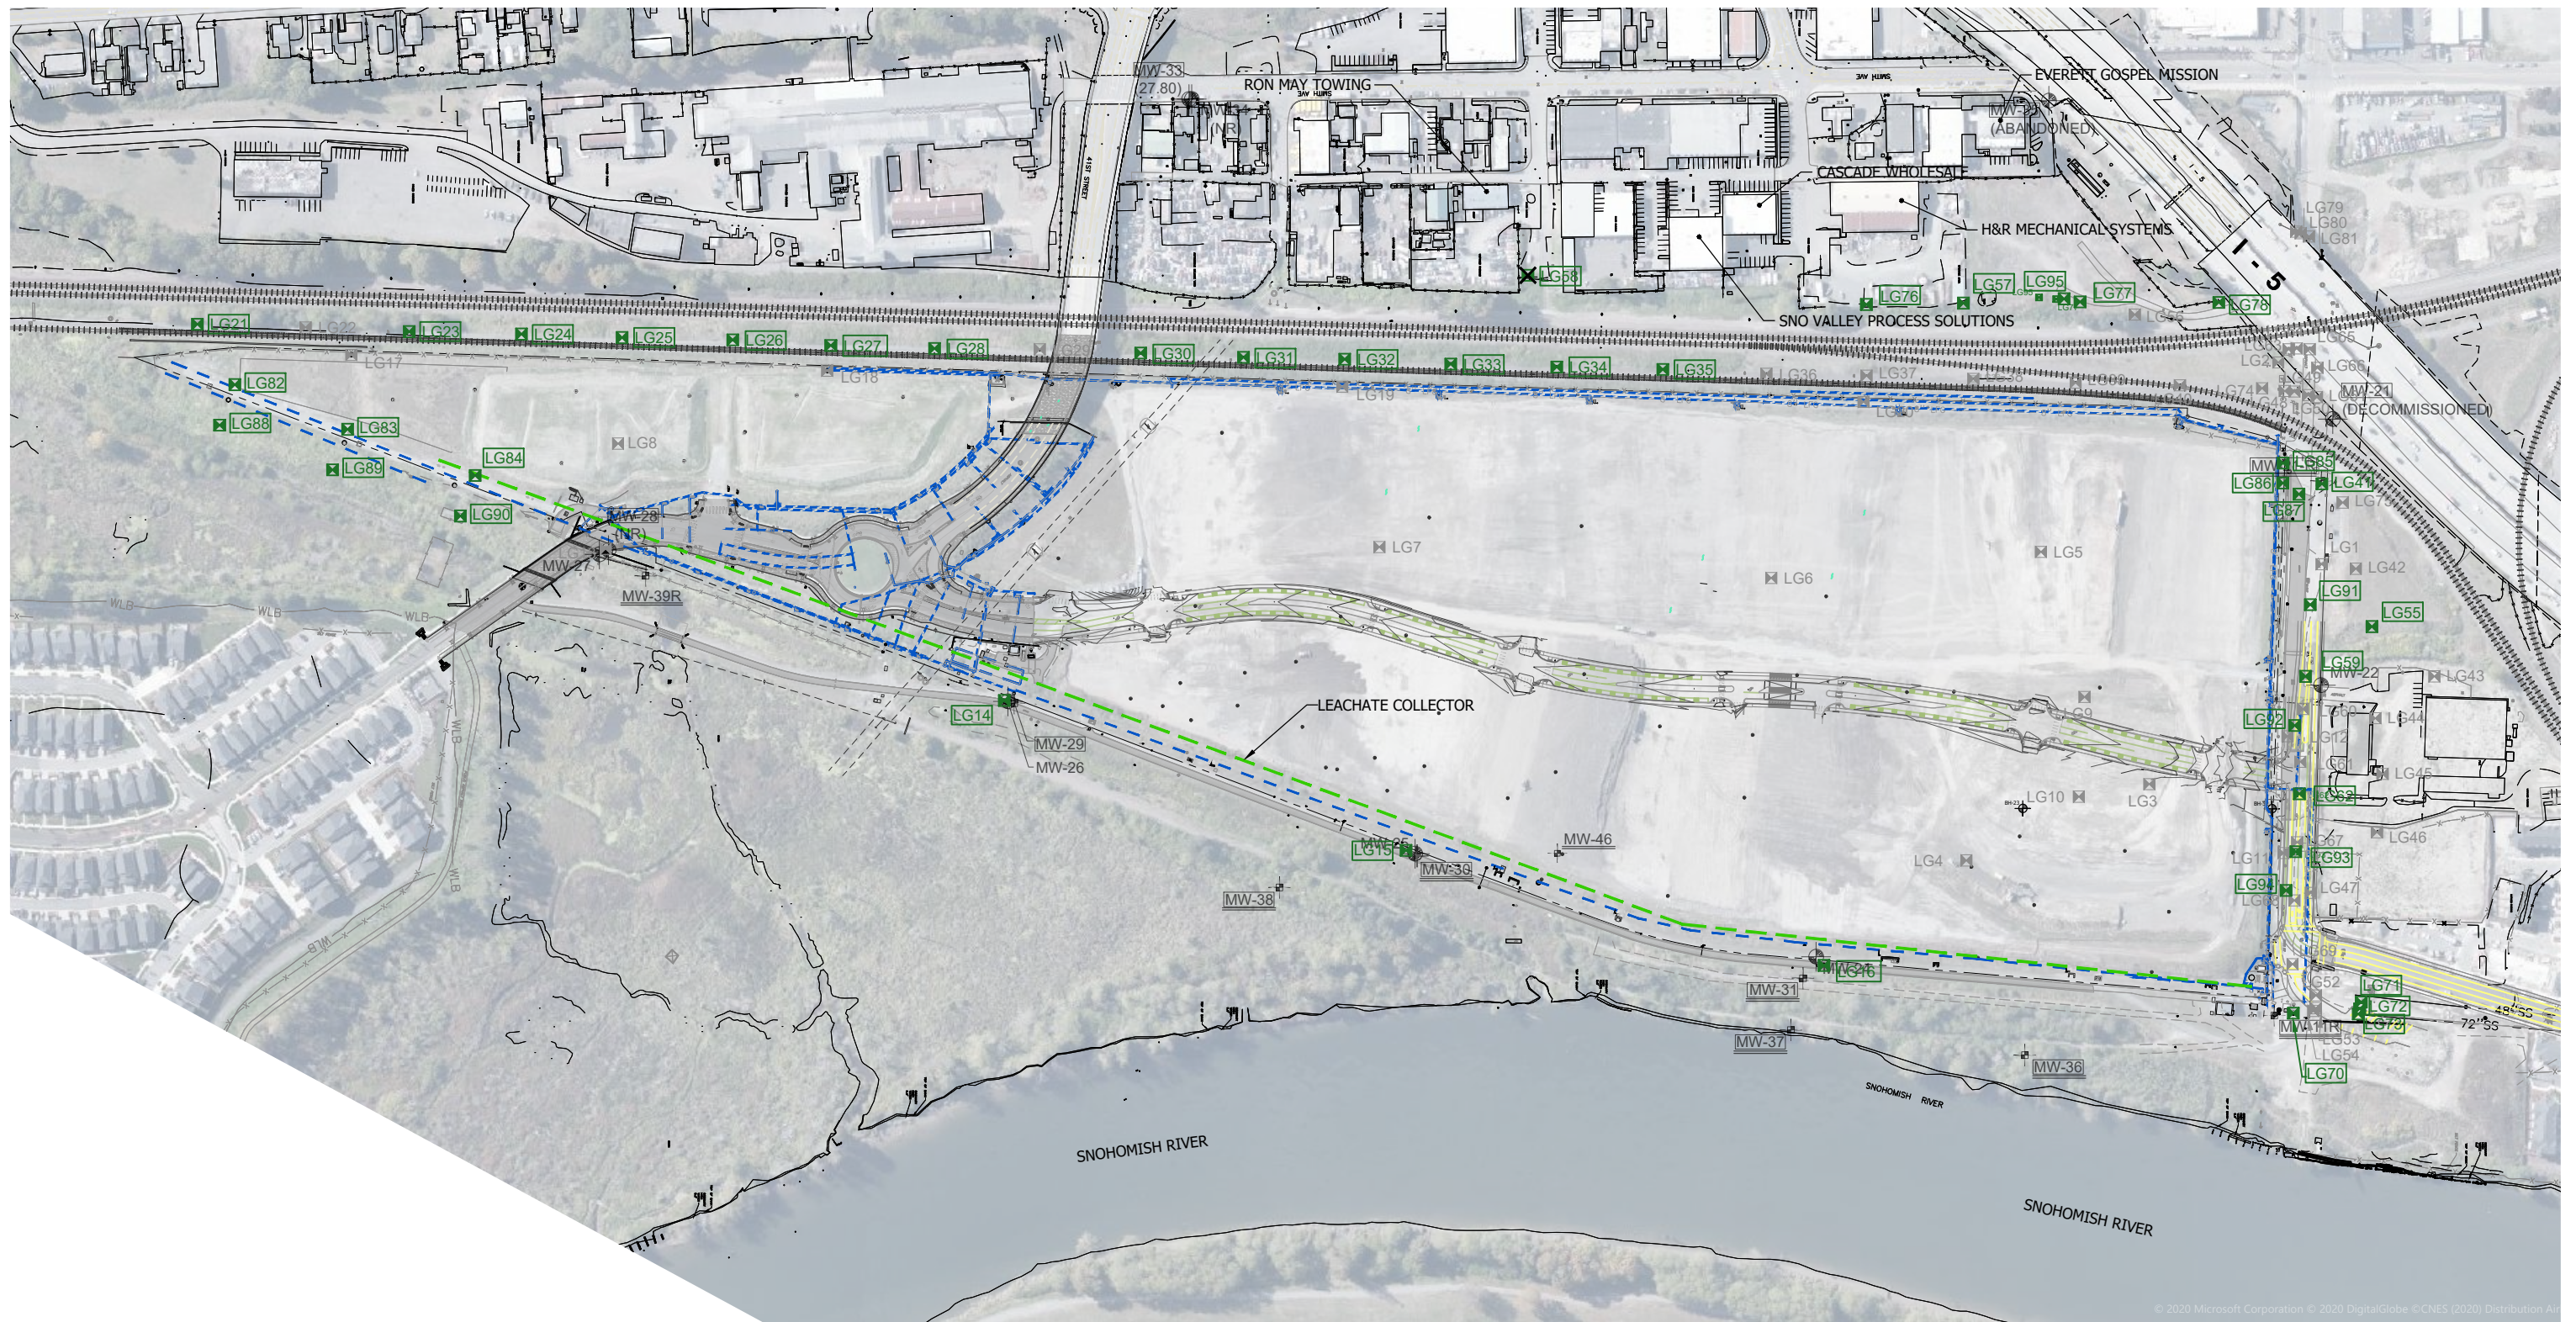
LANDFILL GAS PROBE  
LOCATION MAP

the eastern landfill boundary, utilizing the existing leachate collector trench in 2013. A new segment of gas interceptor was completed in 2018 along the southeastern landfill boundary, as an extension of the existing gas collector along the eastern boundary, also utilizing the existing leachate collector trench. A second, separate gas extraction trench was constructed in 2019 and 2020 from the southern tip of the landfill some 480 feet northward, east of the combined leachate collector/gas extraction trench. At present, almost the entire landfill perimeter is surrounded by active gas interception trenches (see Figure1).

Three new gas probes (LG-88, LG-89, and LG-90) were installed in October 2019 (see Figure 1) west of the wetlands to monitor the potential for gas migration east of the landfill boundary. Results from the 2020 gas monitoring showed minimal to no detections of methane, with a single detection of methane of 0.5% in probe LG-89 in March 2020. Results indicate that the active gas collection system is working and that the wetlands likely function as a passive gas barrier. These three new gas probes have been installed to replace Probes LG 82, 83, and 84, which were installed within the gas collection trench, and are not representative of gas migration from the Landfill. These older probes should only be monitored as needed for operation of the active gas collection and are recommended to be excluded from site perimeter monitoring and future annual reports, with LG-88, LG-89 and LG-90 providing perimeter compliance monitoring for this segment of the landfill boundary.

Other than as described above, none of the remaining probes that are sampled quarterly for this project were identified as having been damaged or buried during construction activities at and around the Landfill during the 2020 sampling year. Figure 1 shows all active, decommissioned, and damaged probes.

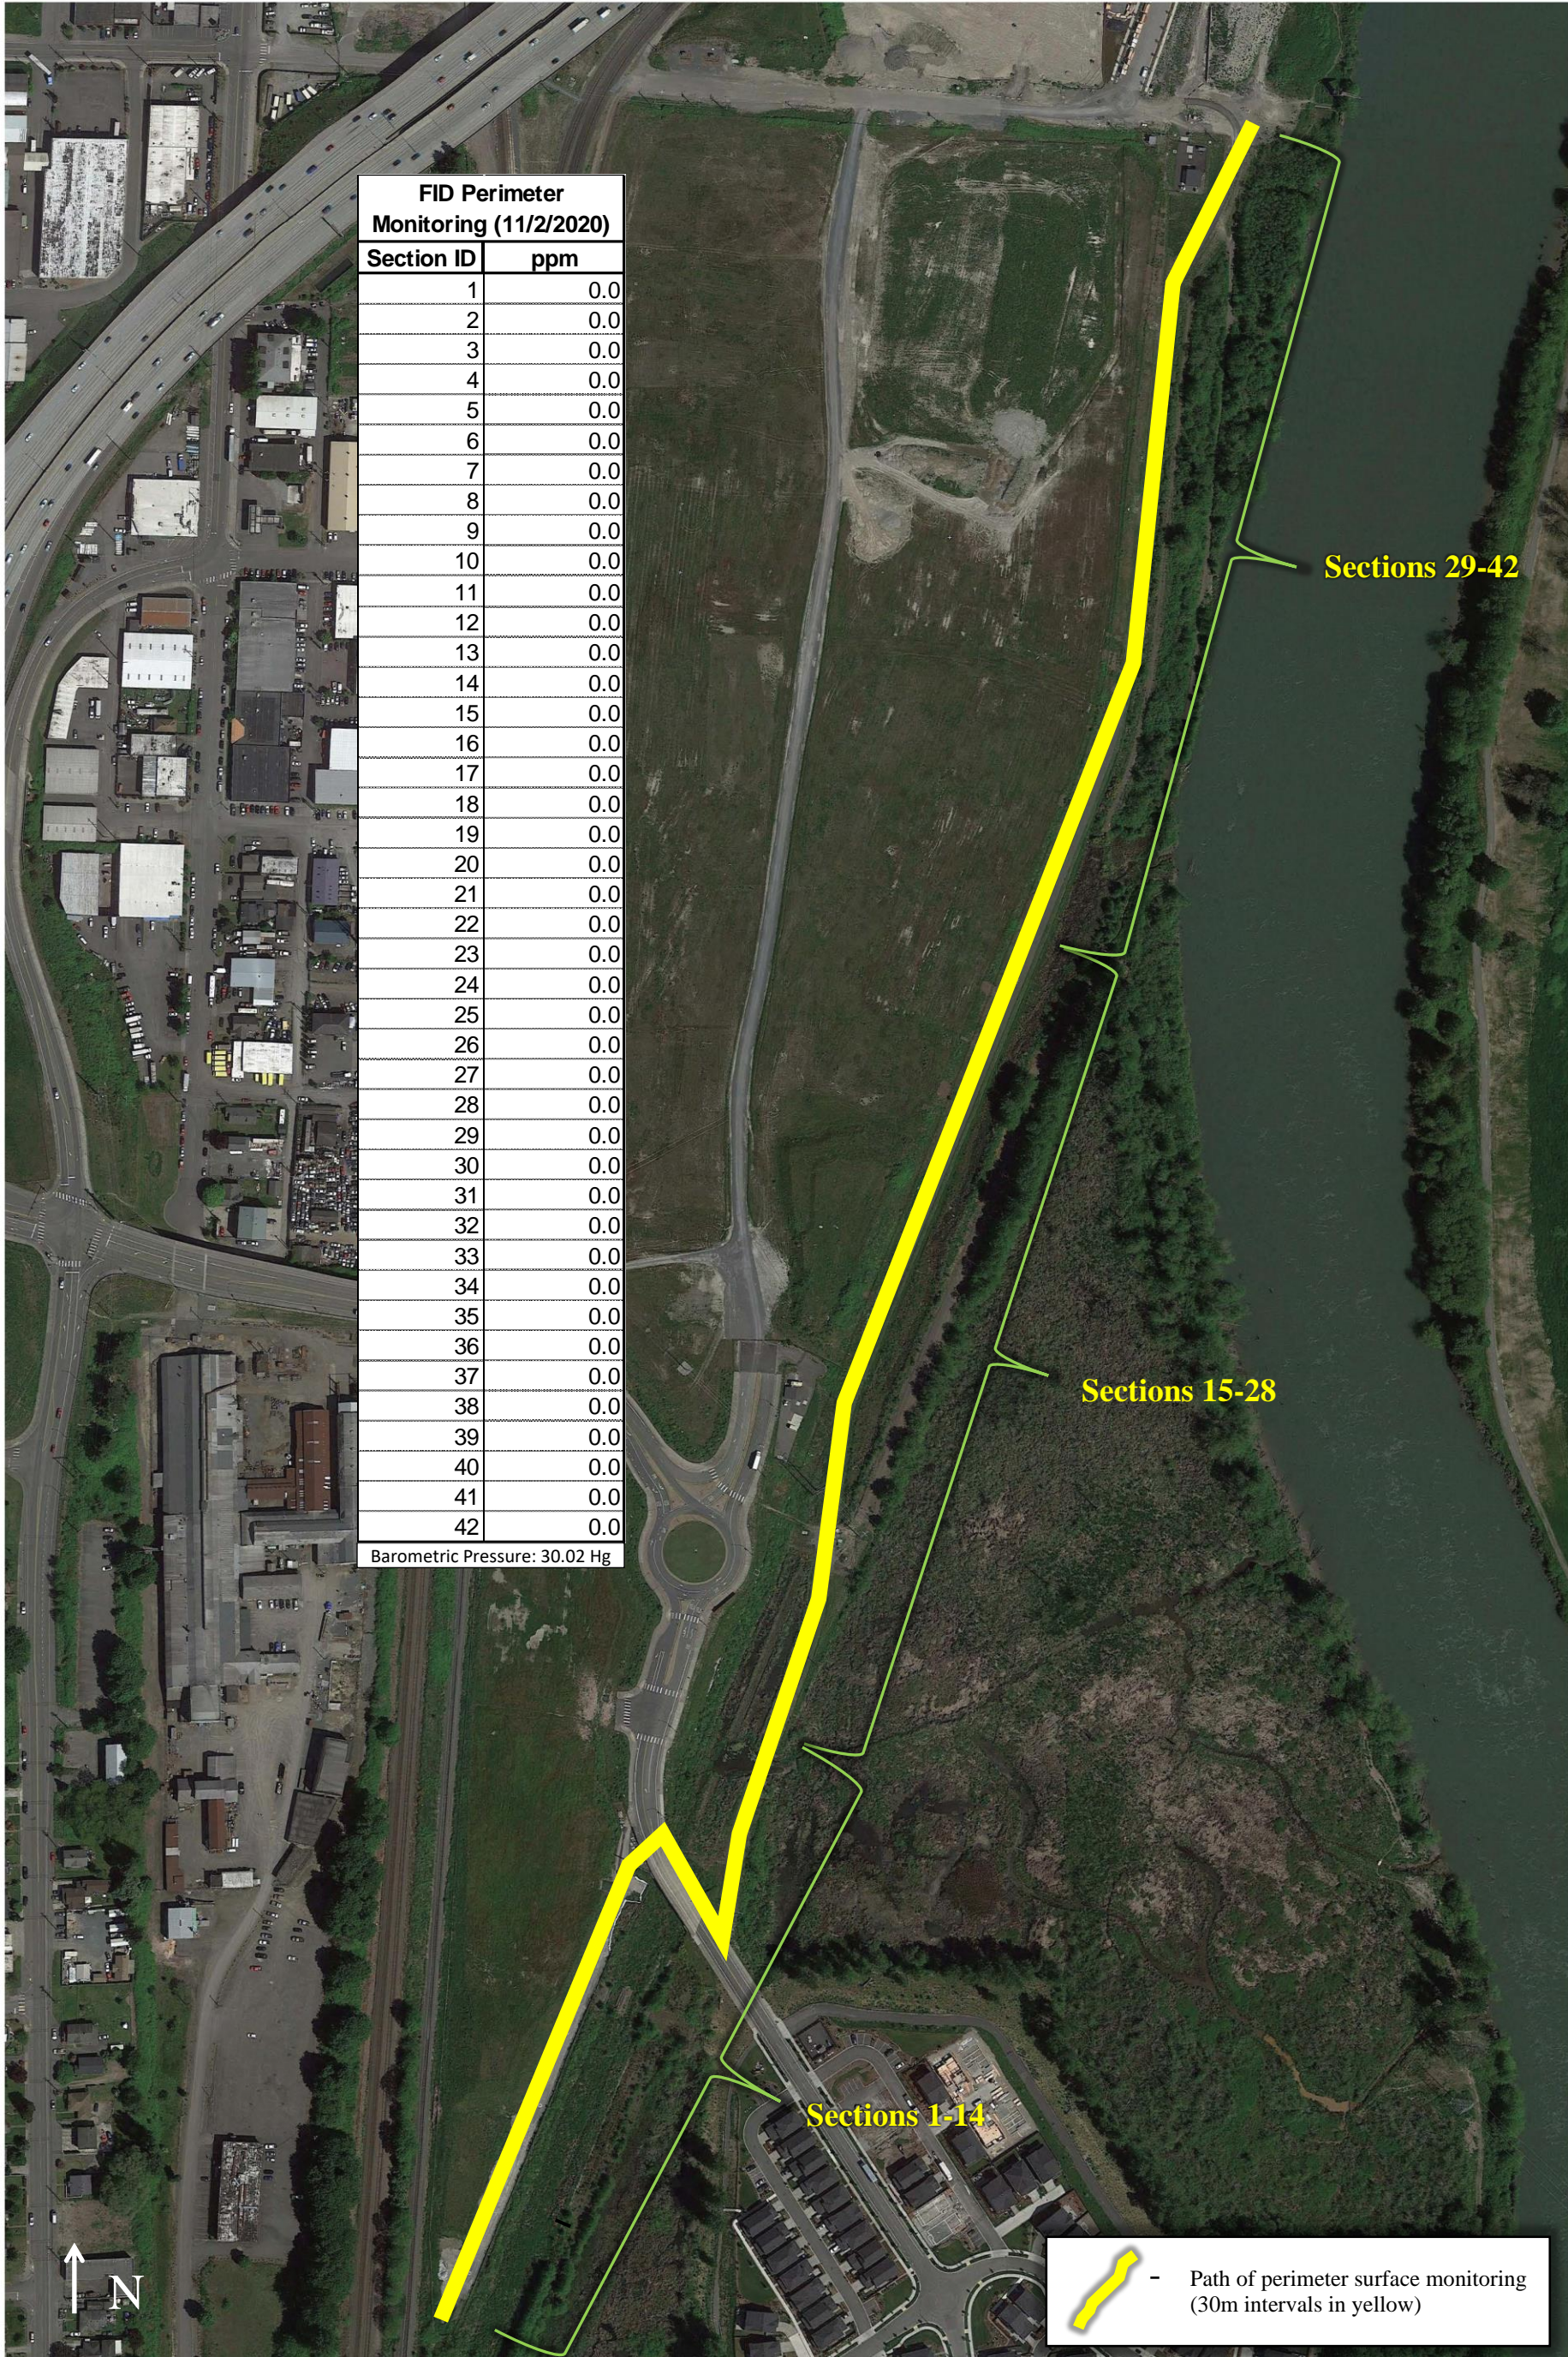
PERIMETER SURFACE GAS MONITORING 11/2/2020

Surface emissions monitoring per 40 CFR 60.753(d) was conducted along the east landfill boundary and trail as part of 2020 gas monitoring activities performed at the landfill. The monitoring was performed utilizing a flame ionization detector (FID), traversing the eastern landfill boundary in a serpentine pattern and measuring gas at 30-meter intervals, and based on visual observations, e.g., distressed vegetation, cracks, or seeps in the ground. The probe of the FID was held between 5 to 10 centimeters above the ground surface during the survey. Background concentrations were measured prior to conducting the gas survey upwind of the landfill and found to have detections of around 0.3 ppm, while the highest concentration detected during the survey was 0.6 ppm. Gas concentrations detected during this survey were well below the 500 ppm (0.05%) action level. All surface gas monitoring procedures were conducted following the Environmental Protection Agency (EPA) Code of Federal Regulations (CFR) Part 60 Subpart WWW *Standards of Performance for Municipal Solid Waste Landfills*. The survey locations and results of the initial survey are displayed on Figure 3. The City will continue surface emissions testing along the eastern perimeter and trail as part of the quarterly gas monitoring events.
