STATE OF WASHINGTON  
DEPARTMENT OF ECOLOGY

**Re: Opinion pursuant to WAC 173-340-515(5) on Remedial Investigation for the following Hazardous Waste Site:**

- Name: North Lot Development
- Property Address: 201 South King Street, Seattle, WA 98104
- Facility/Site No.: 5378137
- VCP Project No.: NW1986

## Enclosure A

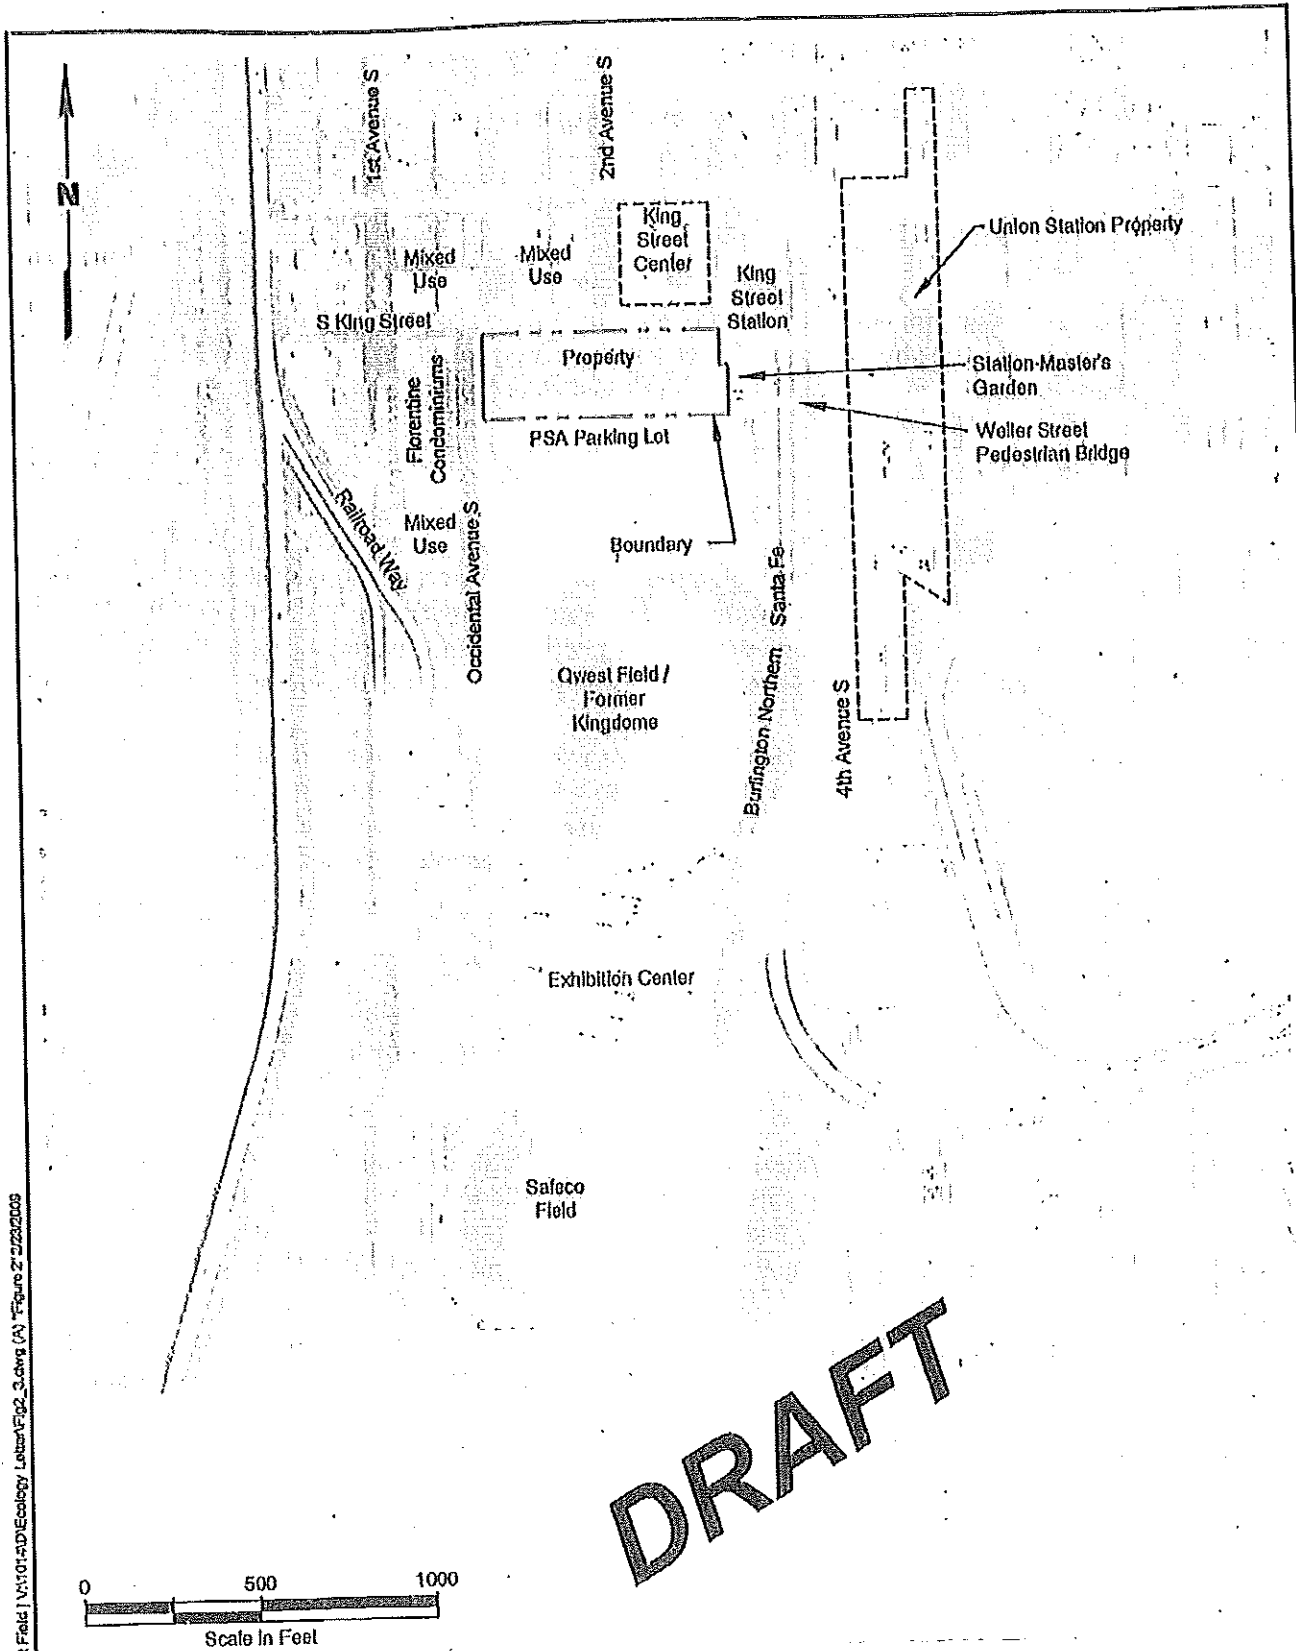
North Lot Development Site Diagram

Copied from Figure 2, Ecology Review Draft Report, Remedial Investigation/Feasibility Study, North Lot Development, Seattle, Washington, prepared by Landau Associates dated February 24, 2009.
