STATE OF WASHINGTON
DEPARTMENT OF ECOLOGY

Re: Further Action at the following Site:

- **Site Name:** Seattle Steam Co. Western Ave.
- **Site Address:** 1319 Western Avenue, Seattle
- **Facility/Site No.:** 2243
- **VCP Project No.:** NW 2196

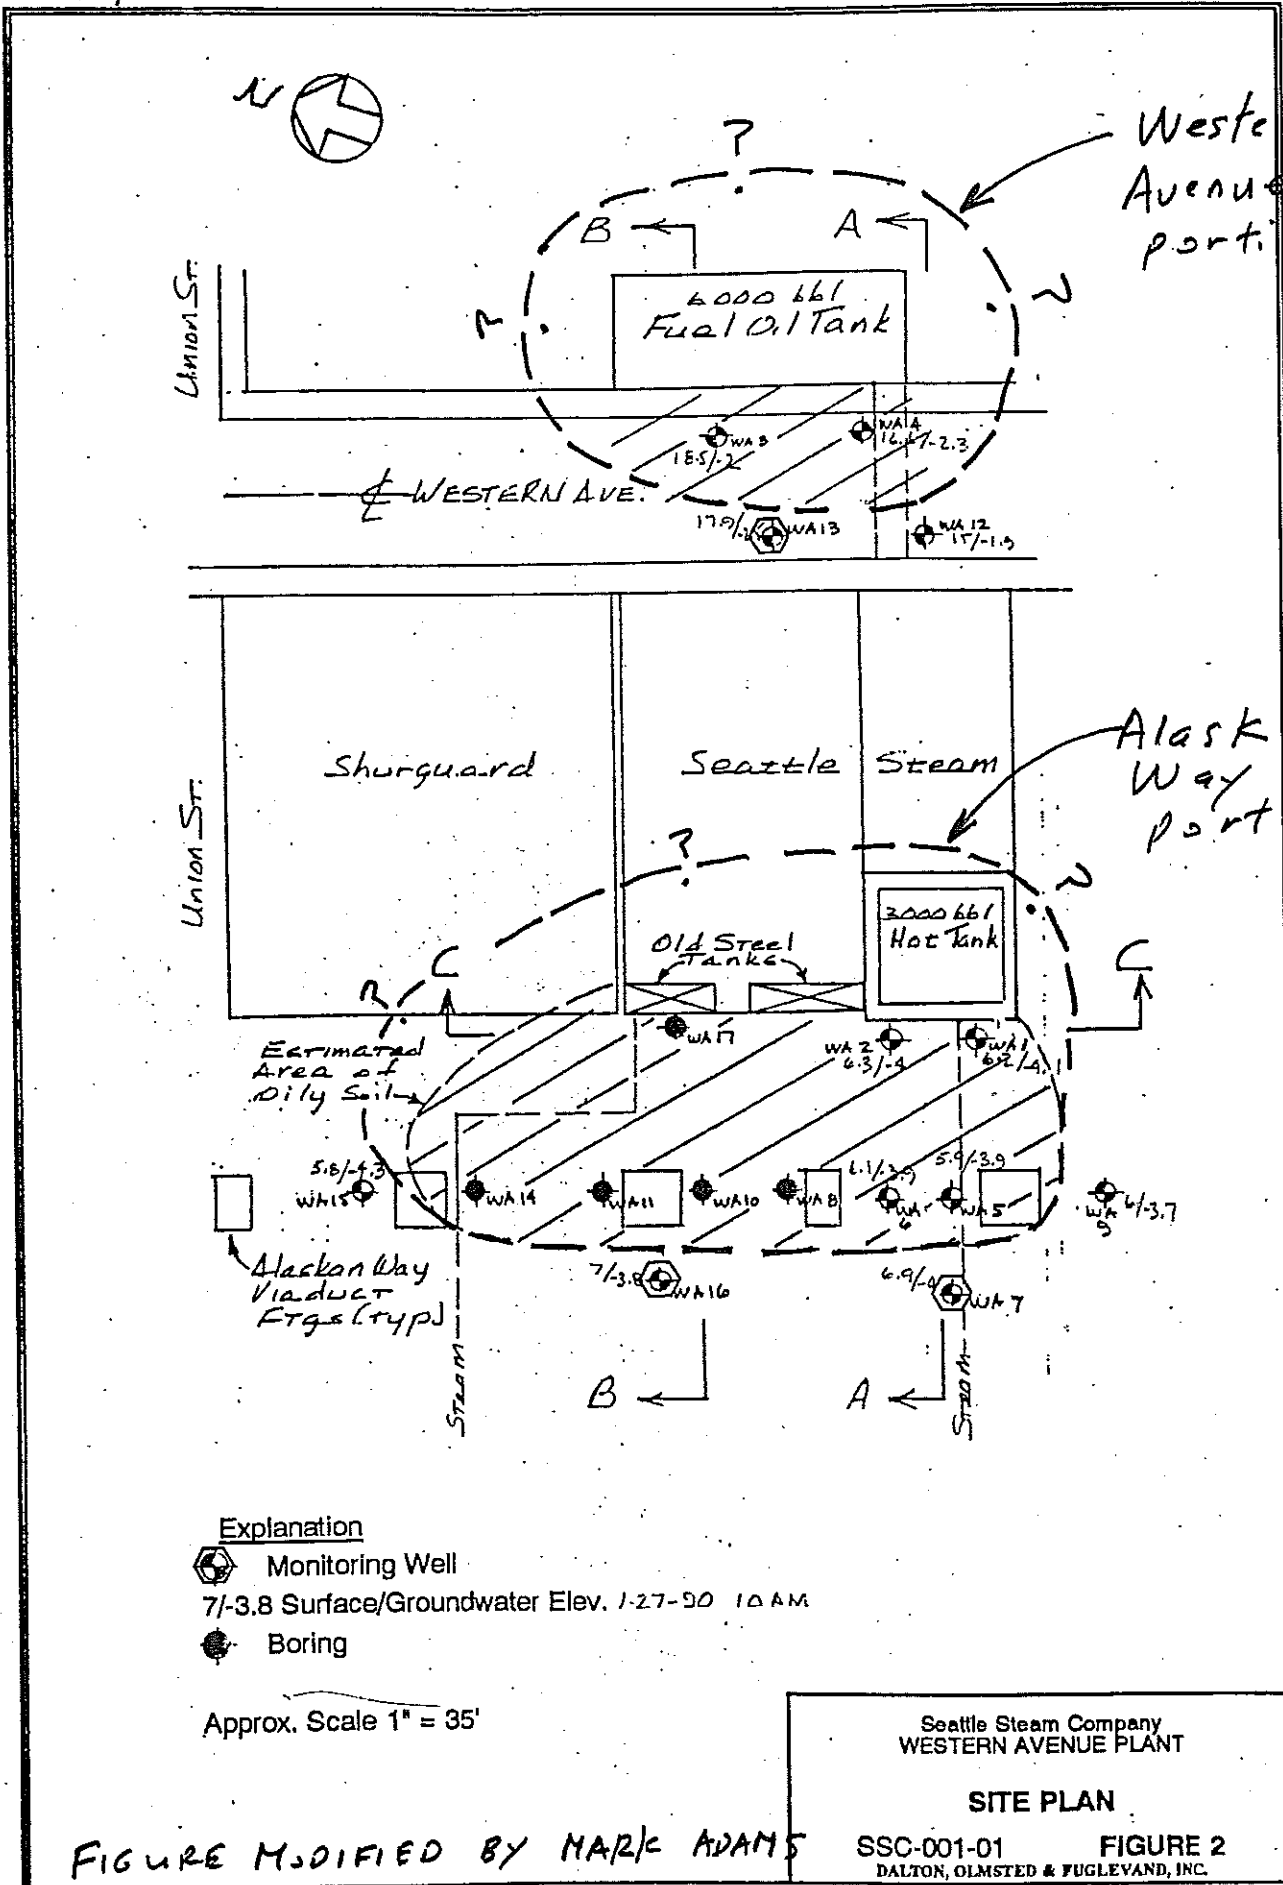
Seattle Steam Company
WESTERN AVENUE PLANT
SITE PLAN
SSC-001-01 FIGURE 2
DALTON, OLMSTED & FUGLEVAND, INC.

Site: Seattle Steam at this location has two facilities separated by Western Avenue (together the Property). One is located between Western Avenue and Alaskan Way (1319 Western Avenue), and the other is across Western Avenue to the east. The Site also includes two separate contaminated areas associated with the Seattle Steam facility. One is located within and east of the Western Avenue right-of-way. The other is located within and east of the Alaskan Way right-of-way. Petroleum hydrocarbons and polycyclic aromatic hydrocarbons (PAHs) were released to soil and ground water in these areas, and comprise the Site, as shown on the attached Site Diagram.

APPROXIMATE BOUNDARY OF MTEA SITE
