STATE OF WASHINGTON  
DEPARTMENT OF ECOLOGY

**Re: Opinion on Proposed Cleanup of the following Site:**

- **Site Name:** Harbour Pointe Cleaners Lynnwood
- **Site Address:** 13619 Mukilteo Speedway, Lynnwood, WA 98037
- **Facility/Site No.:** 41352598
- **Cleanup Site ID No.:** 12413
- **VCP Project No.:** NW2902

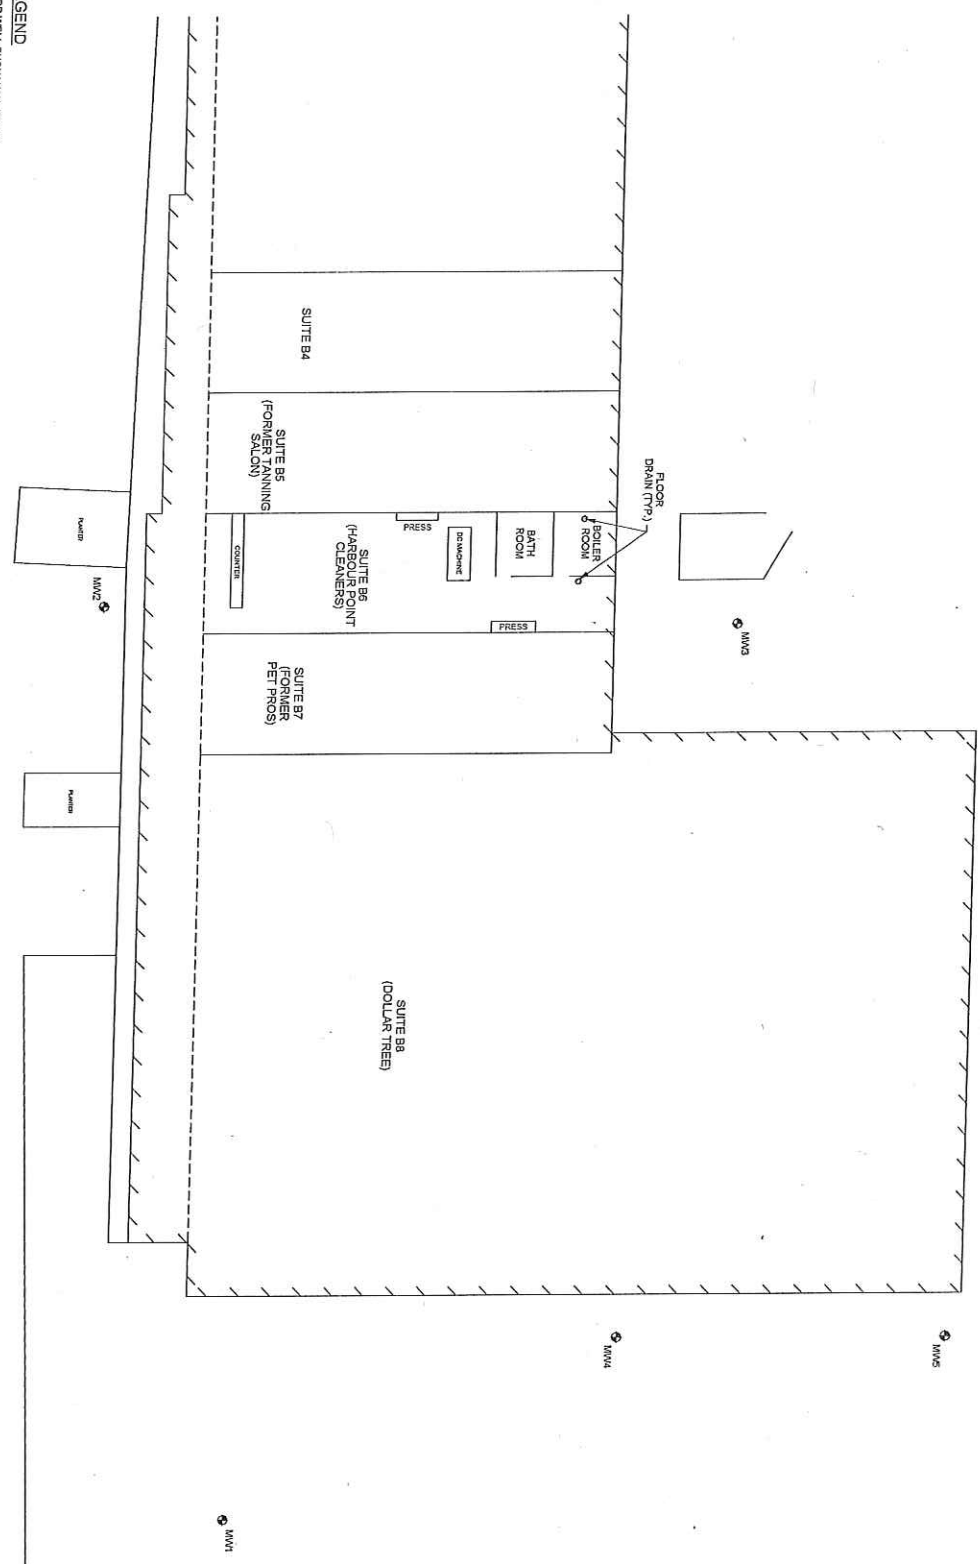
**GROUNDWATER MONITORING WELL LOCATIONS**

**Release and Extent of Contamination – Ground Water:** Between June and August 2006, a total of five ground water monitoring wells were installed between 15 and 25 feet bgs, designated as MW-1 through MW-5 (see **Figure 5**). Laboratory results from ground water samples collected from the five monitoring wells identified the presence of TCE and 1,1-dichloroethane at concentrations below MTCA Method A cleanup levels. No other PCE degradation compounds have been detected in the ground water.

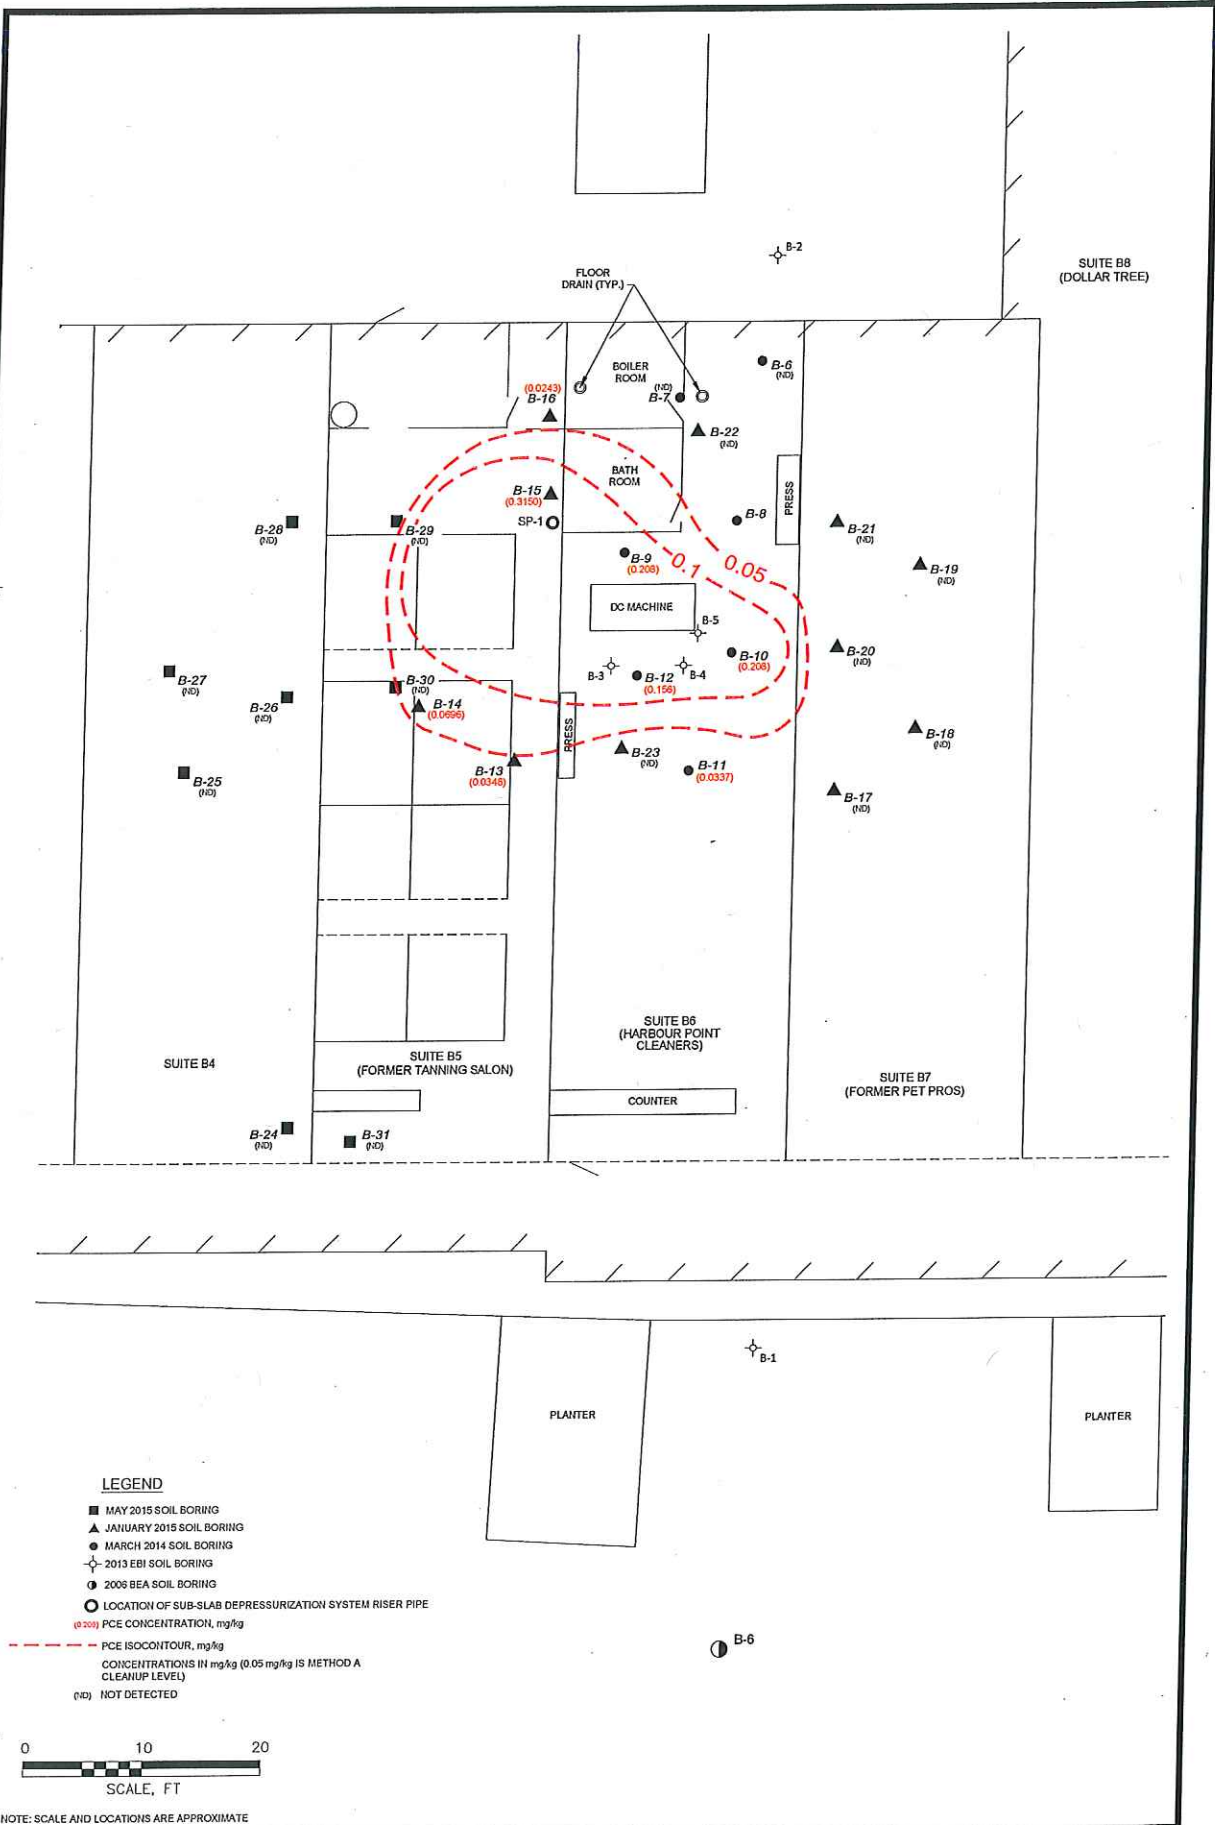
**PRE-REMEDIATION PCE CONCENTRATIONS IN SOIL AT 1 FOOT BELOW GROUND LEVEL ISOCONTOURS**  
 FORMER HARBOUR POINT CLEANERS  
 13619 MUKILTEO SPEEDWAY  
 LYNNWOOD, WA

**Release and Extent of Contamination – Soil:** PCE and TCE are the known contaminants present in soil at the Site. There is evidence of a release of PCE to soil above the MTCA Method A cleanup level of 0.05 mg/kg in the western and eastern portions of the Site at a depth of the approximately 1 foot bgs. TCE was detected at concentrations below cleanup levels. The maximum vertical extent of PCE-impacted soil is approximately 3 feet below ground surface (bgs) based on the results of the subsurface investigation conducted in 2014 (**Figure 2 and 4**).

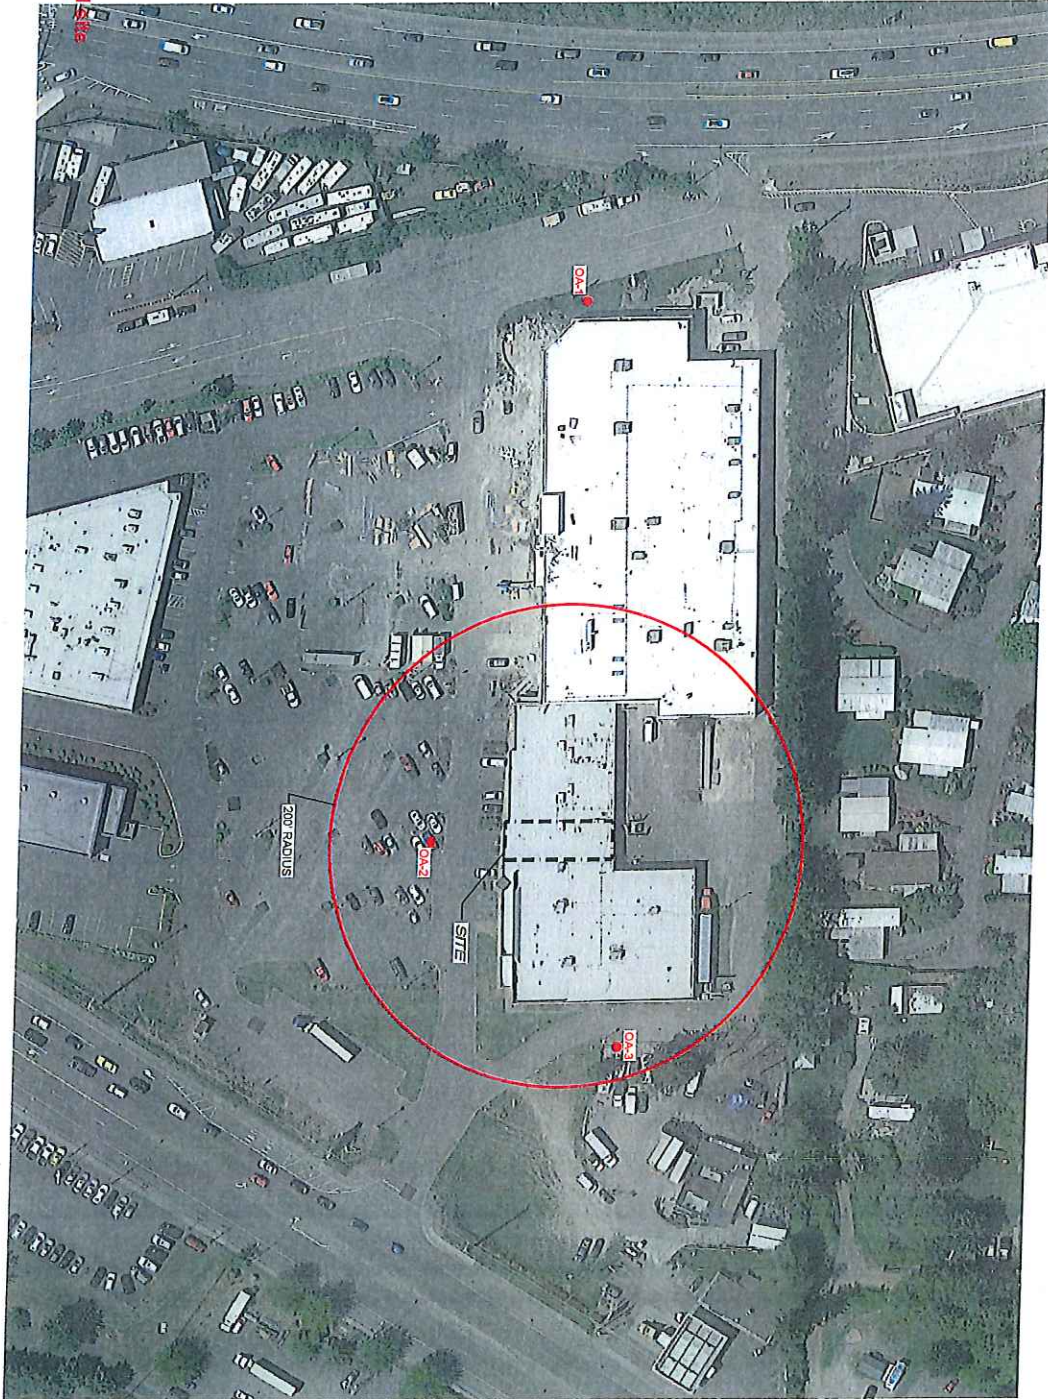
**OUTDOOR AIR SAMPLE LOCATIONS**

- Please document that TCE exceeded its air CUL at OA-3 near the service station. The exceedance suggests an outside source of TCE unrelated to Site VI.
- MTCA Method B and C values for indoor and outdoor air are cleanup levels. They are not screening levels. Please correct Table 1.
- Ensure that all tables report detection limits rather than the symbol “ND” for non-detected results.
- The updated CAR will include the information presented in the October 15, 2018 report, the March 19, 2019 submittal, and the additional data and technical rational which were not presented in the reports, along with the above specifics which were discussed at the April 10, 2019 meeting.

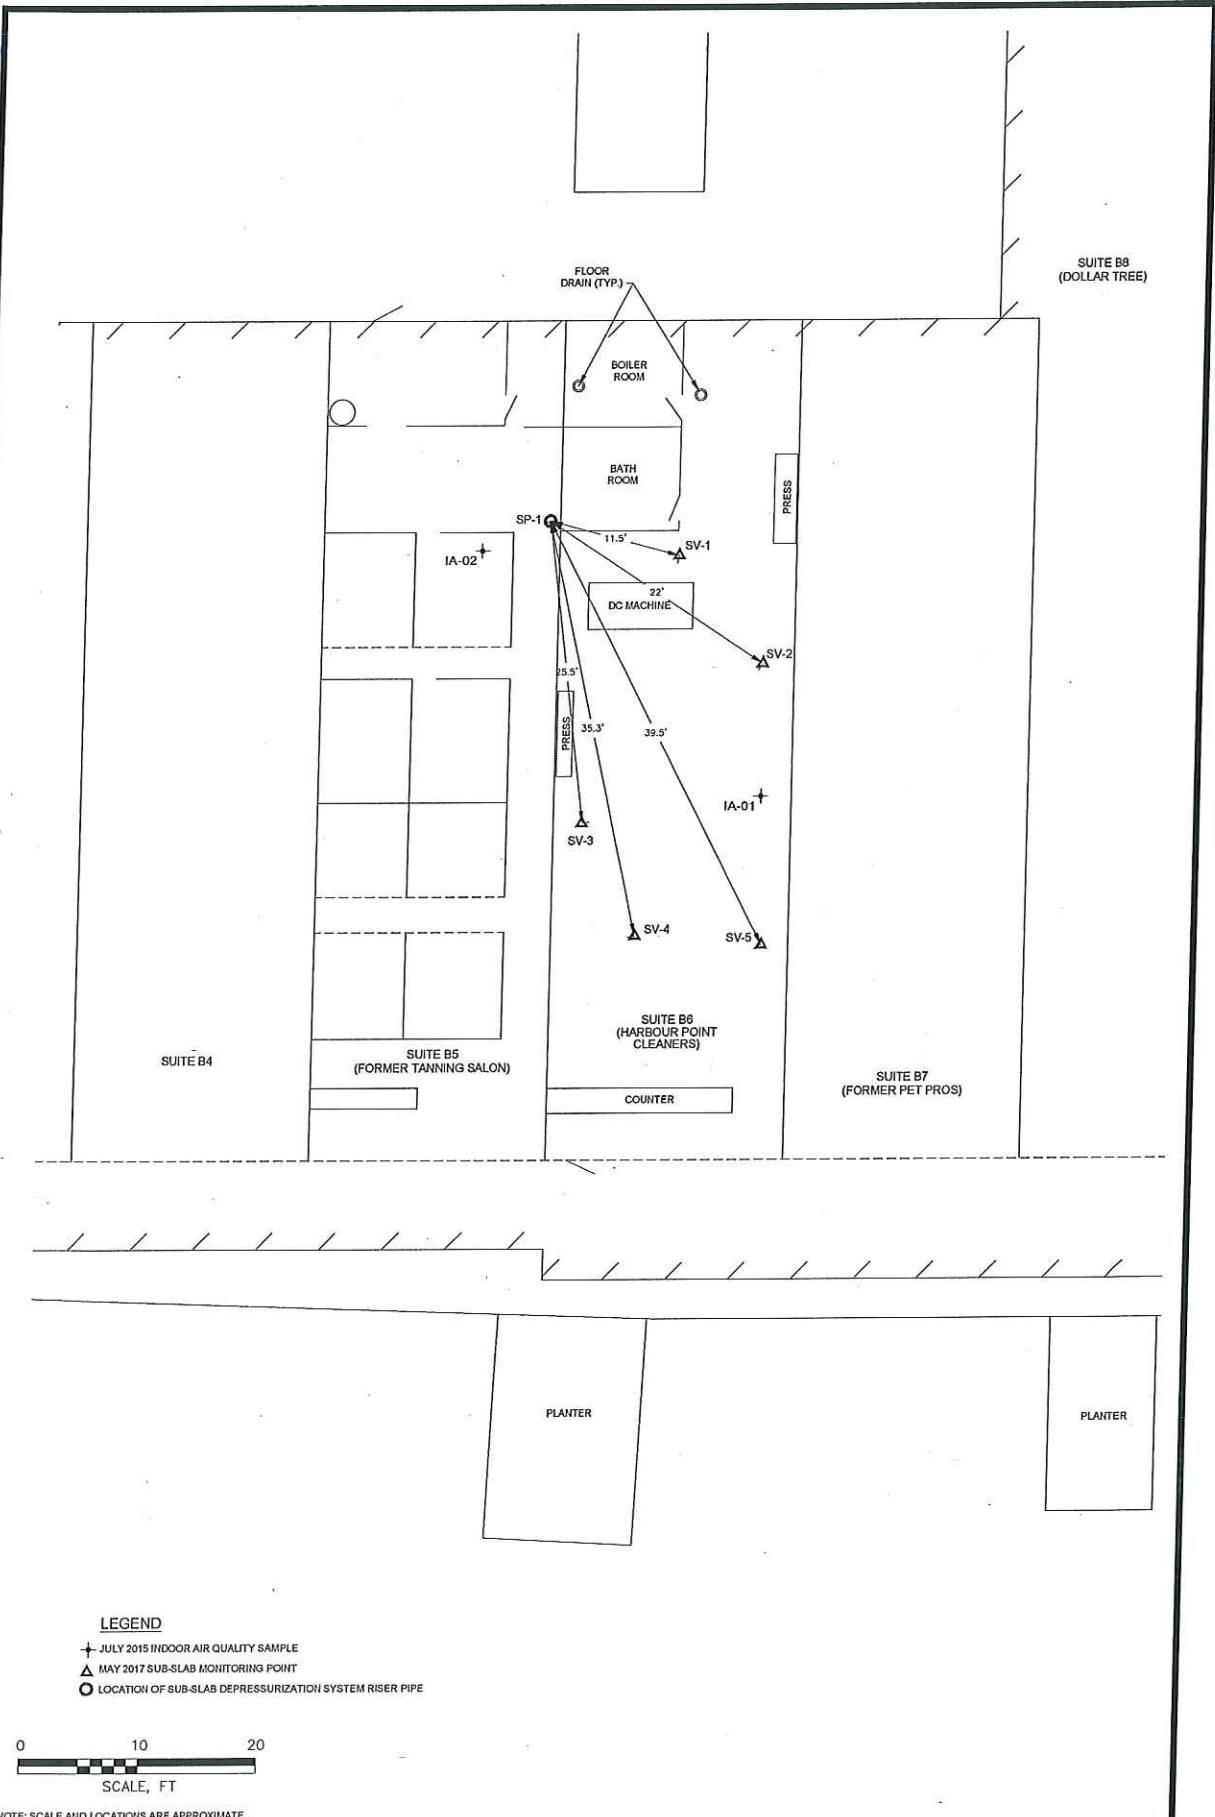
**Release and Extent of Contamination – Soil Gas:** PCE and TCE are the known contaminants present in soil gas at the Site. These COCs were detected in temporary sub-slab vapor samples VE-1, VE-2, and V-3 at concentrations above the MTCA Method B sub-slab soil gas screening levels (**Figure 7**).
