**RE: Further Action at the following Site:**

- **Site Name:** Richland Uptown Shopping Center Parcel 10
- **Site Address:** 1364 Jadwin Avenue, Richland
- **Facility Site ID No.:** 10144
- **Cleanup Site ID No.:** 11645
- **VCP Project No.:** CE0518

**Issue Presented and Opinion**

**YES. Ecology has determined that further remedial action is necessary to clean up contamination at the Site.**

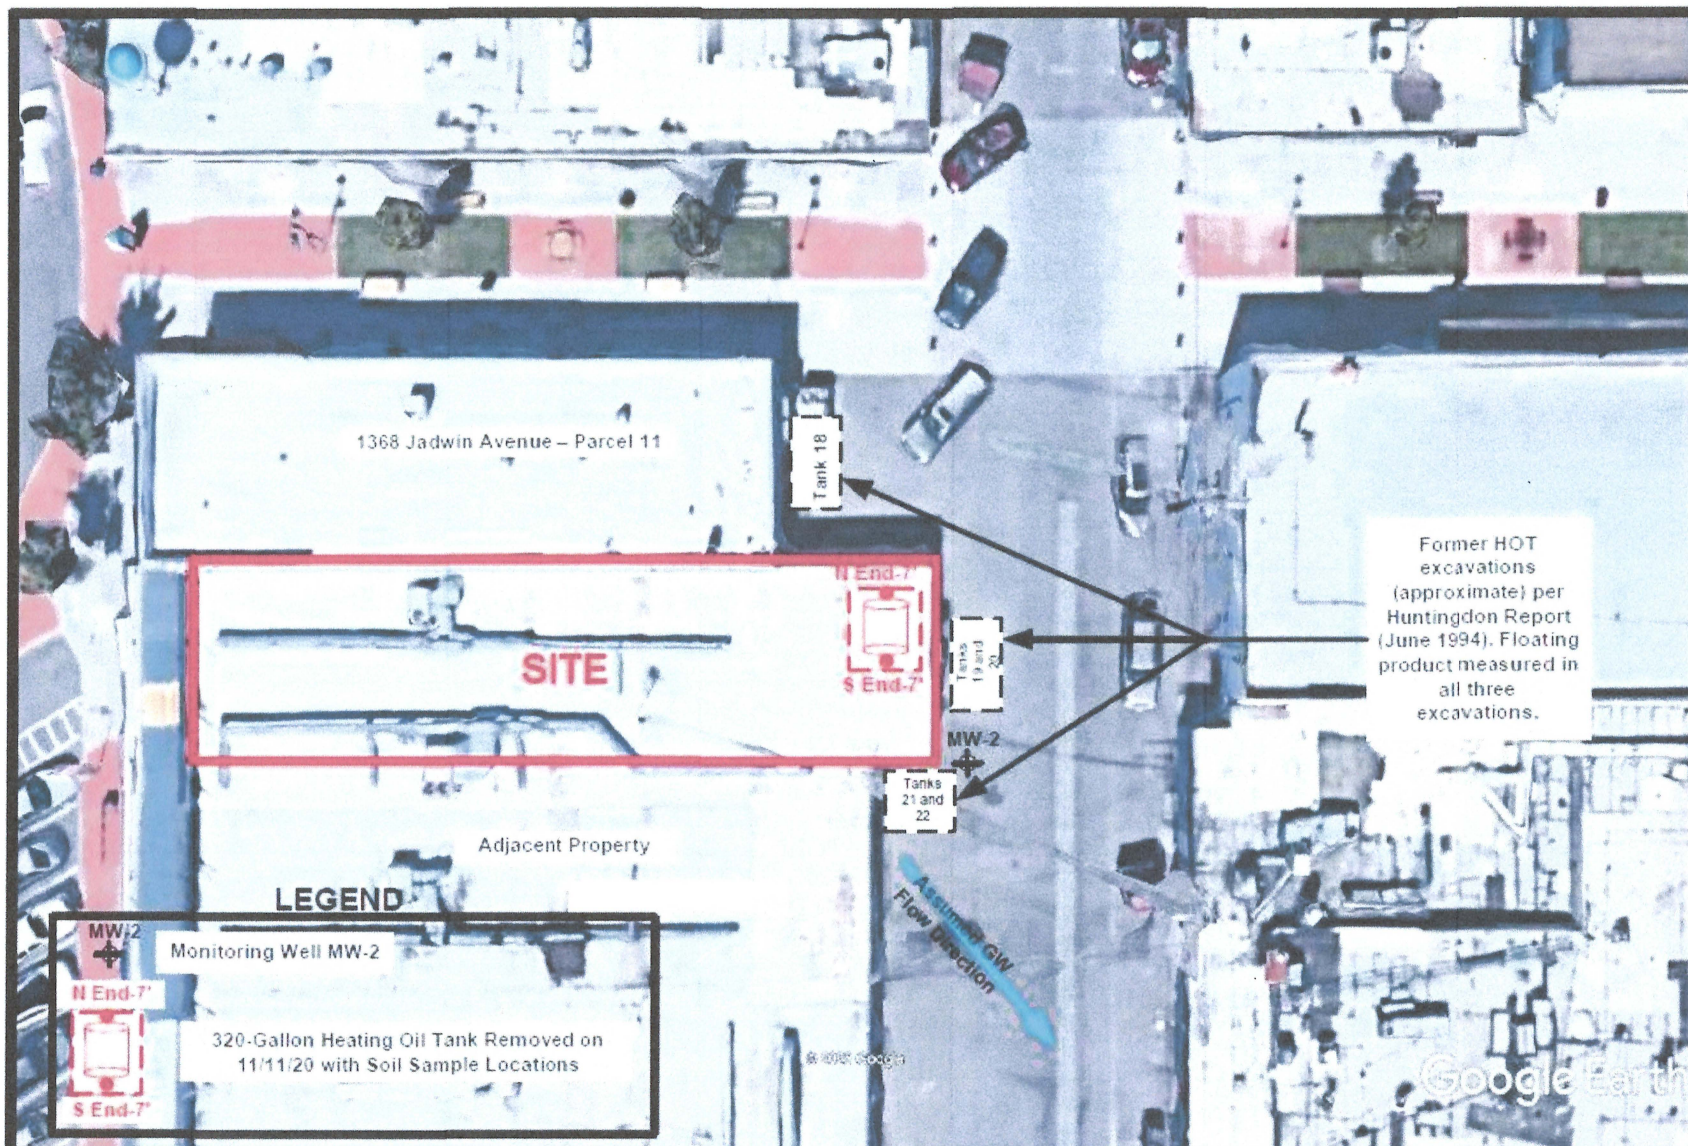
**FIGURE 2 – HEATING OIL TANK  
EXCAVATION LOCATIONS  
IN 1994 AND 2020**

Previously in 1994, a total of four USTs in two tank pits were identified at the Site. Two of these USTs were reportedly removed (#21 and #22) and two left in place (#19 and #20). It appears that tanks #19 and #20 may actually be the one HOT that was removed in 2020; the current report appears to suggest that location and number of remaining tanks was in error within the 1994 report. The 1994 report indicated that the status of USTs #19 and #20 were unknown and within the building.

USTs #21 and #22 located outside of the structure also appeared to have petroleum releases. During the 1994 removal of these tanks, petroleum was detected in soil at a depth of 5 ft bgs at 18,000 mg/kg. The USTs that were removed were corroded and pitted. Soil contamination at this location may remain and needs to be addressed.

Although cleanup of contaminated soil within the building footprint may not be feasible at this time, Ecology anticipates that cleanup of contaminated groundwater, including removal of all free product, should be achievable. In addition, remaining soil contamination associated with USTs #21 and #22 may also be accessible for cleanup.
