STATE OF WASHINGTON
DEPARTMENT OF ECOLOGY

Re: Opinion pursuant to WAC 173-340-515(5) on Remedial Action for the following Property associated with a Site:

- **Property Name:** TD Auto Body & Repair
- **Property Address:** 1209 East Fir Street, Seattle, WA 98122
- **Facility/Site No.:** 2501
- **Cleanup Site ID No.:** 2666
- **VCP Project No.:** NW3194

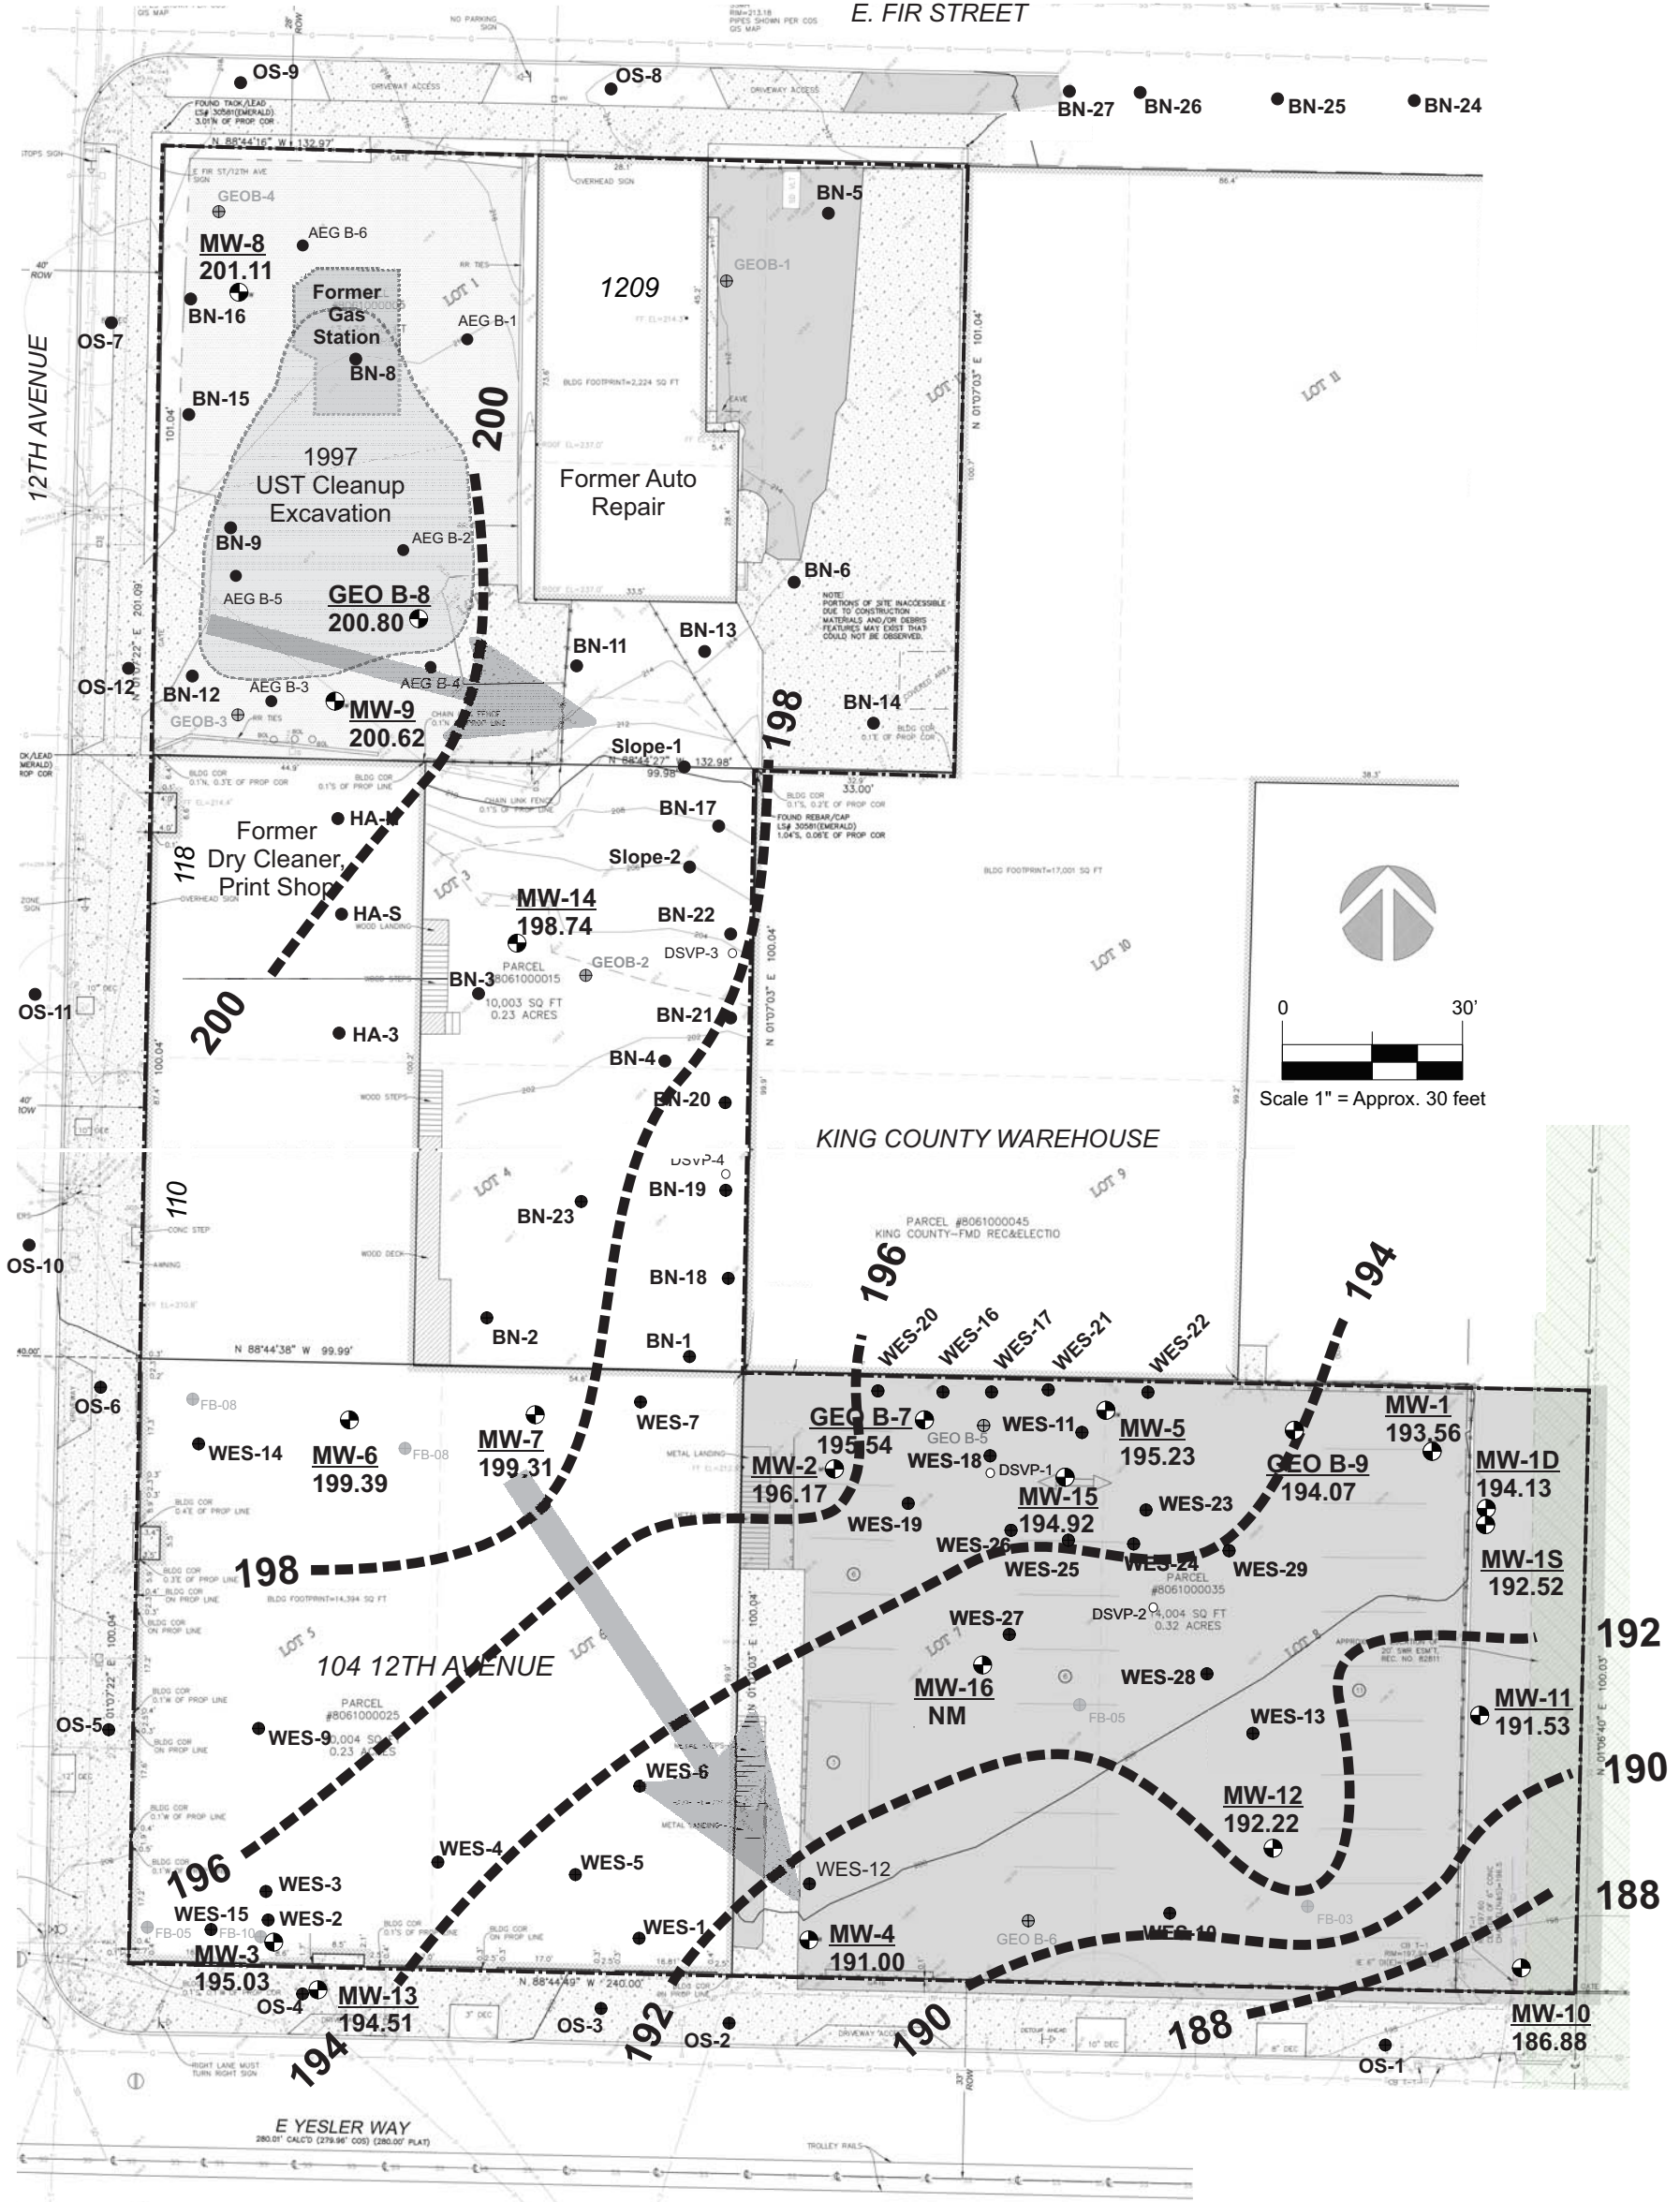
Figure 2 - Monitoring Well Location Plan and Interpolated Groundwater Contours - 9/28/2020

Groundwater: Groundwater has been encountered in borings and monitoring wells at depths of 0.25 to 15.76 feet bgs. The water levels in individual monitoring wells vary seasonally by as much as 3 feet over the period of record (since 2017). Based on groundwater elevation measurements, the groundwater flow direction is consistently towards the southeast (**Figure 2**).

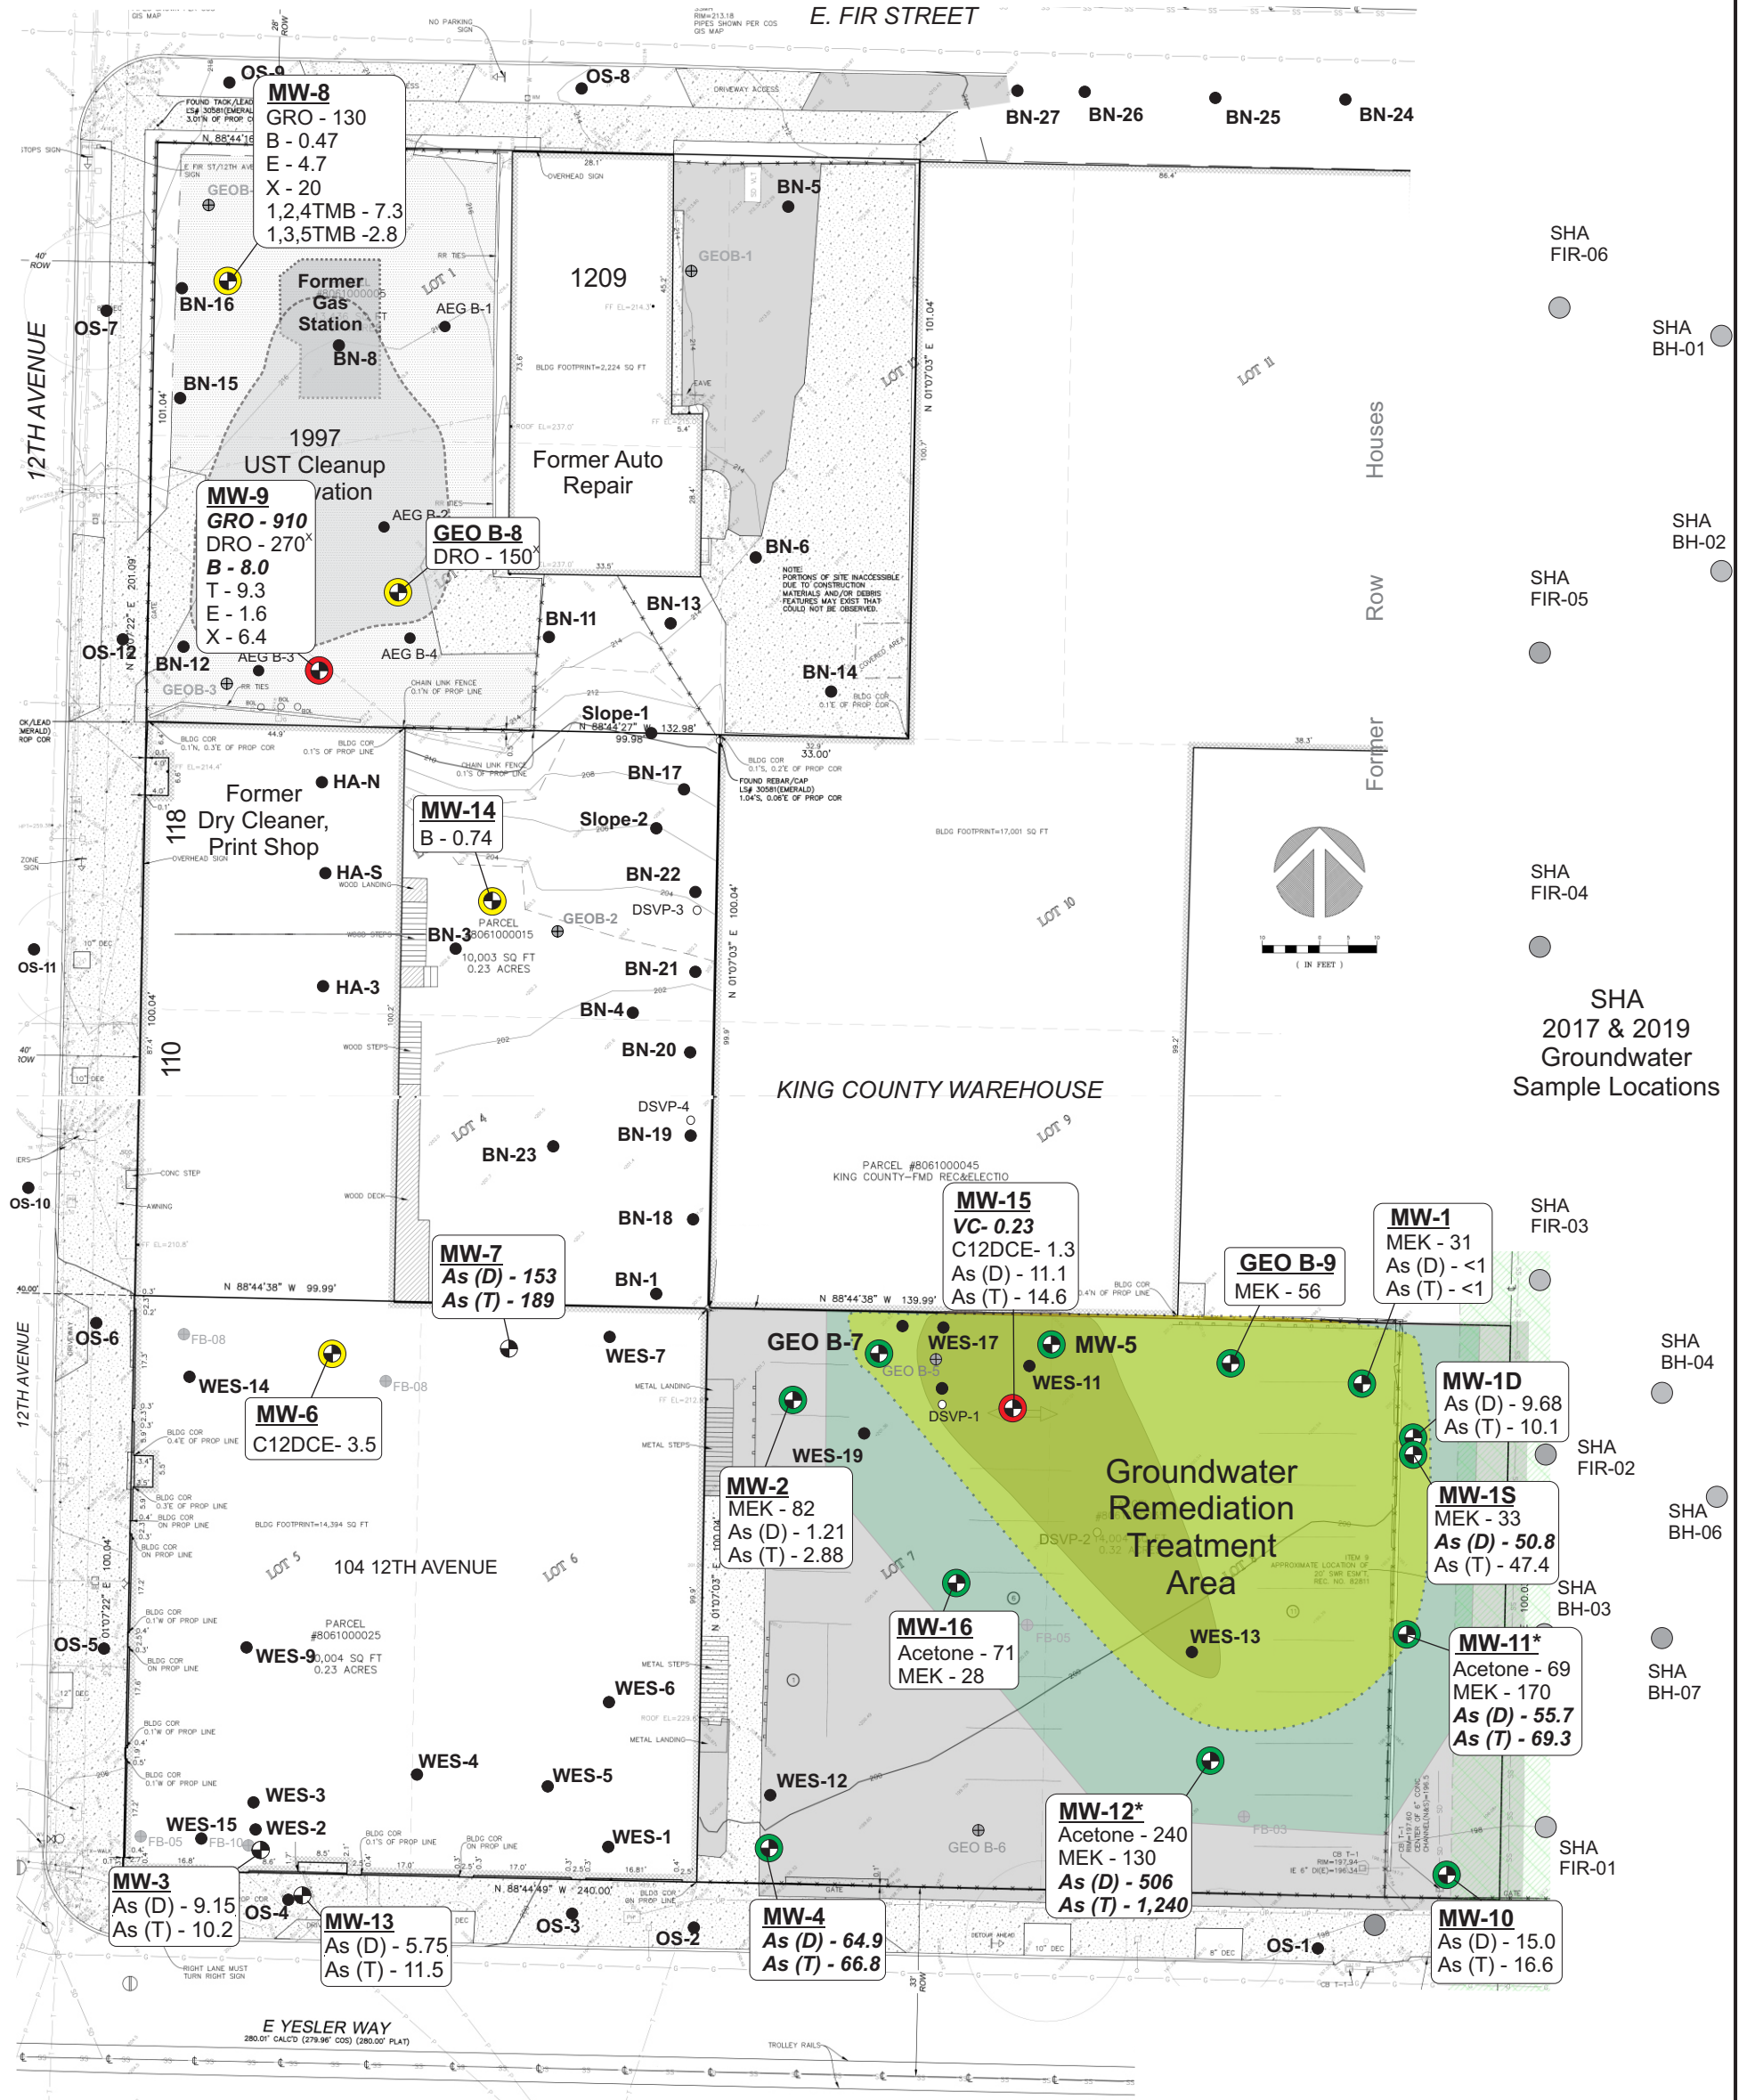
Figure 3 - 3rd Quarter 2020 Groundwater Sampling Analytical Results

Sources of Contamination: The hazardous substances released at the Site include petroleum hydrocarbons, chlorinated solvents, and metals (**Figure 3**). The media affected include soil, groundwater, and air (potentially via soil vapor migration). Multiple potential sources have been identified, including the following former activities: service station (including underground tanks), two auto repair shops, dry cleaner, and potential dumping or contaminated fill on the vegetated slope in the central area of the Property, and an unknown potential source beneath the KCRESB facility.
