# Final Closure Report

## Juanita Village Kirkland, Washington Prospective Purchaser Consent Decree 00-2-16556-1SEA

**May 21, 2012**

**Project Number: 01007**

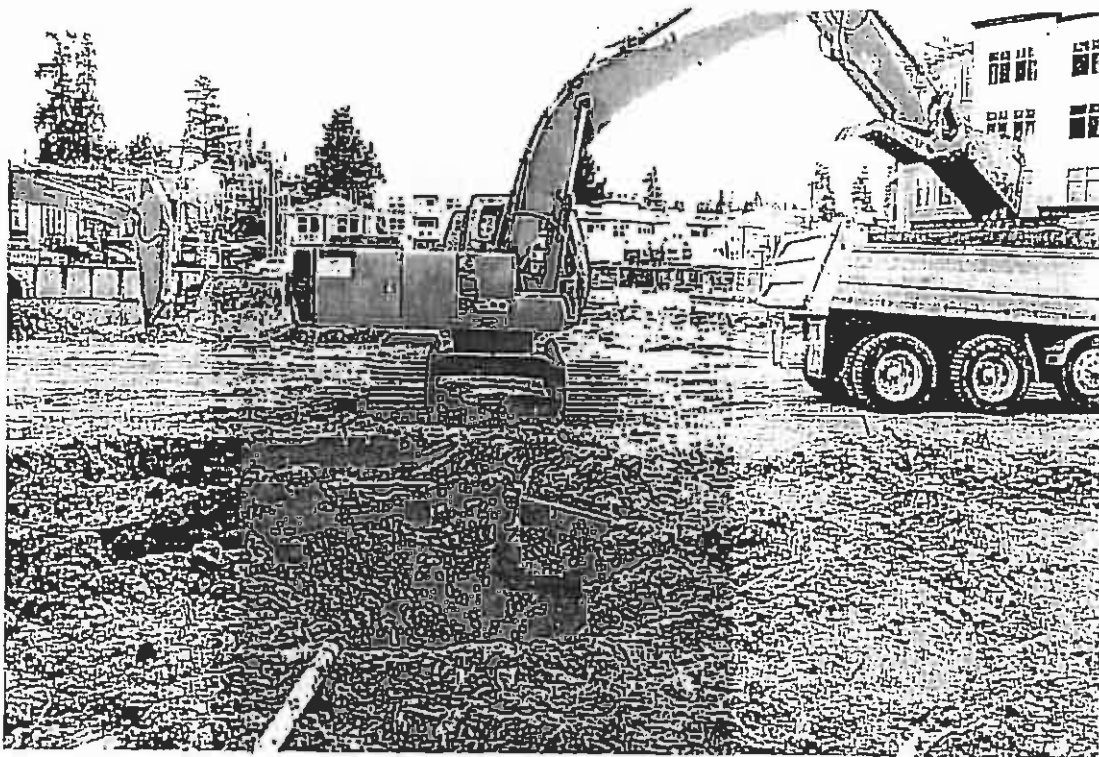
Photograph 1. View of the excavation in progress in the area of the former dry cleaners.

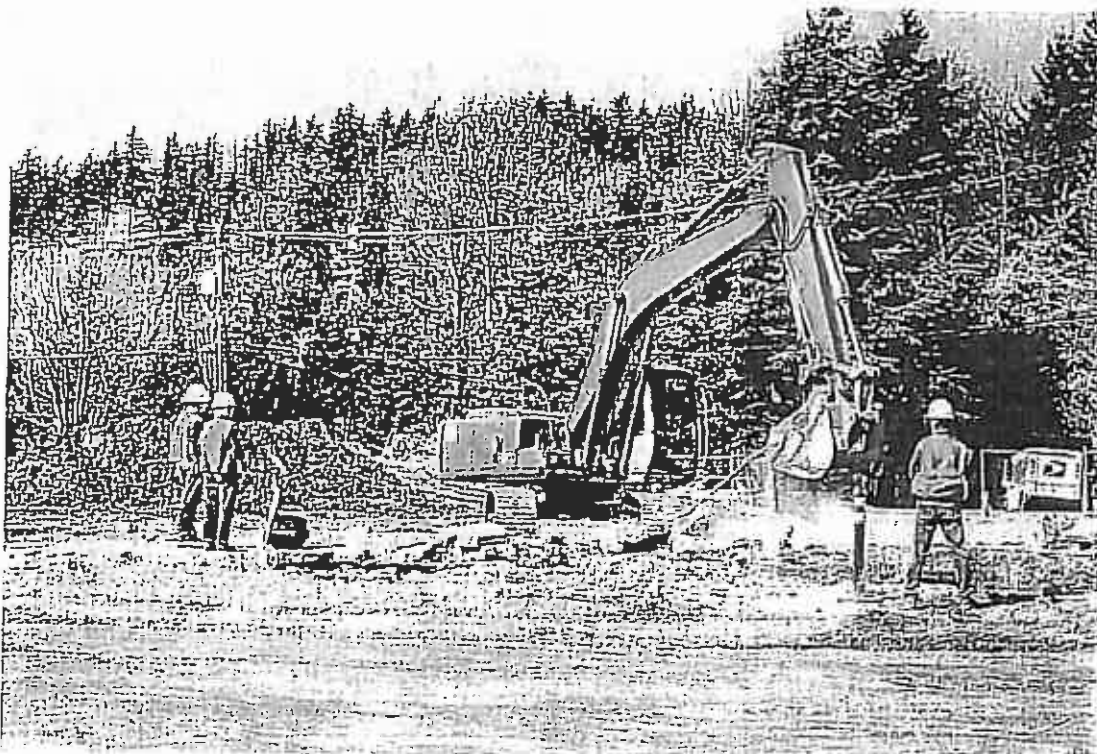
Photograph 2. Additional view of the excavation in the area of the former dry cleaners.

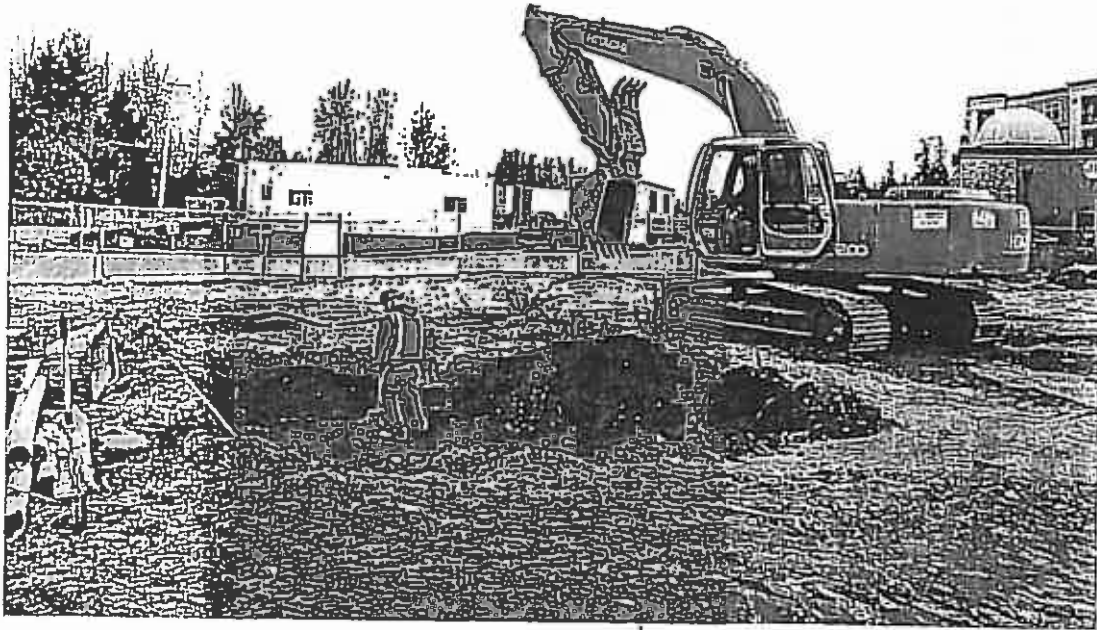
**Photograph 3. View of excavation in progress in the area of the previously stockpiled-PCS.**

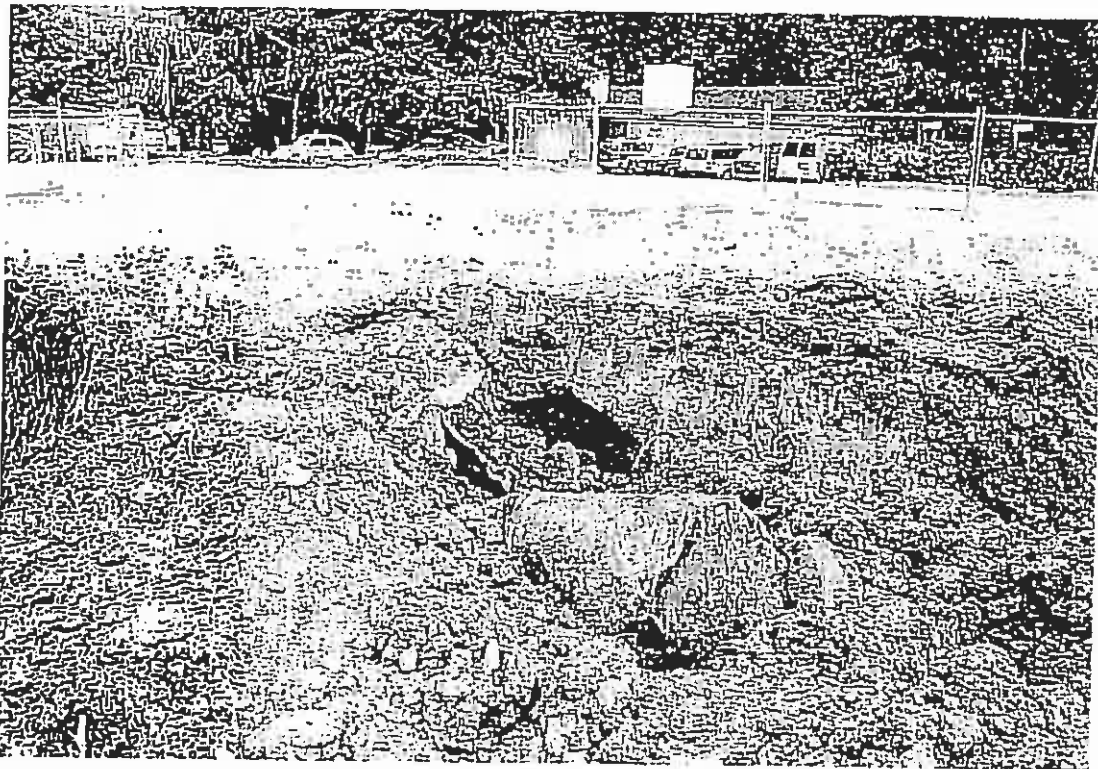
**Photograph 4. View of the abandoned 300-gallon UST discovered on April 27, 2004.**

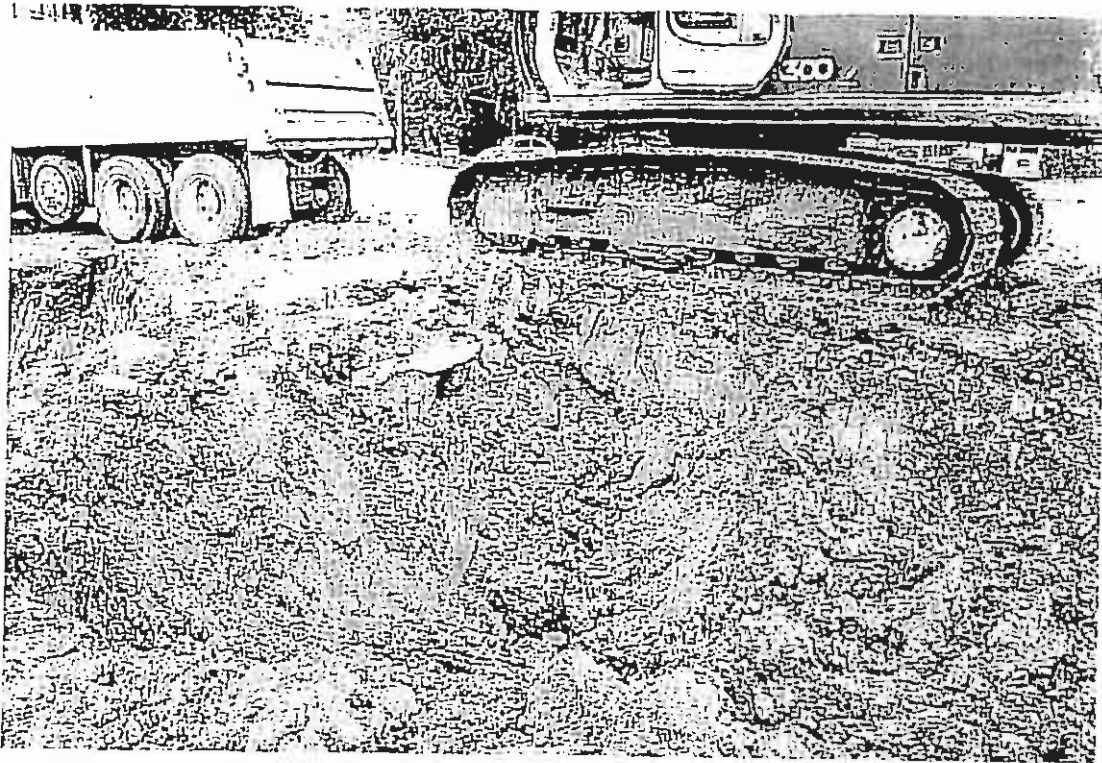
Photograph 5. View of the excavation after removal of the UST. Note area of gray-colored PCS.

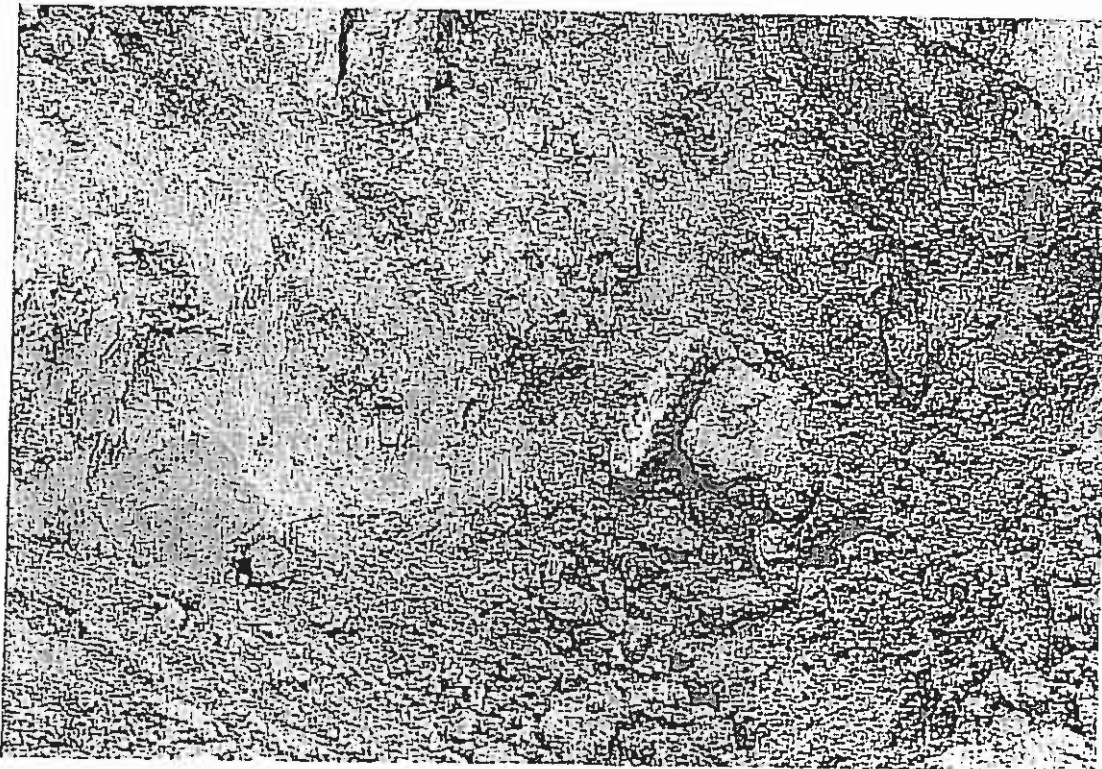
Photograph 6. View of the final dimensions of the UST excavation.

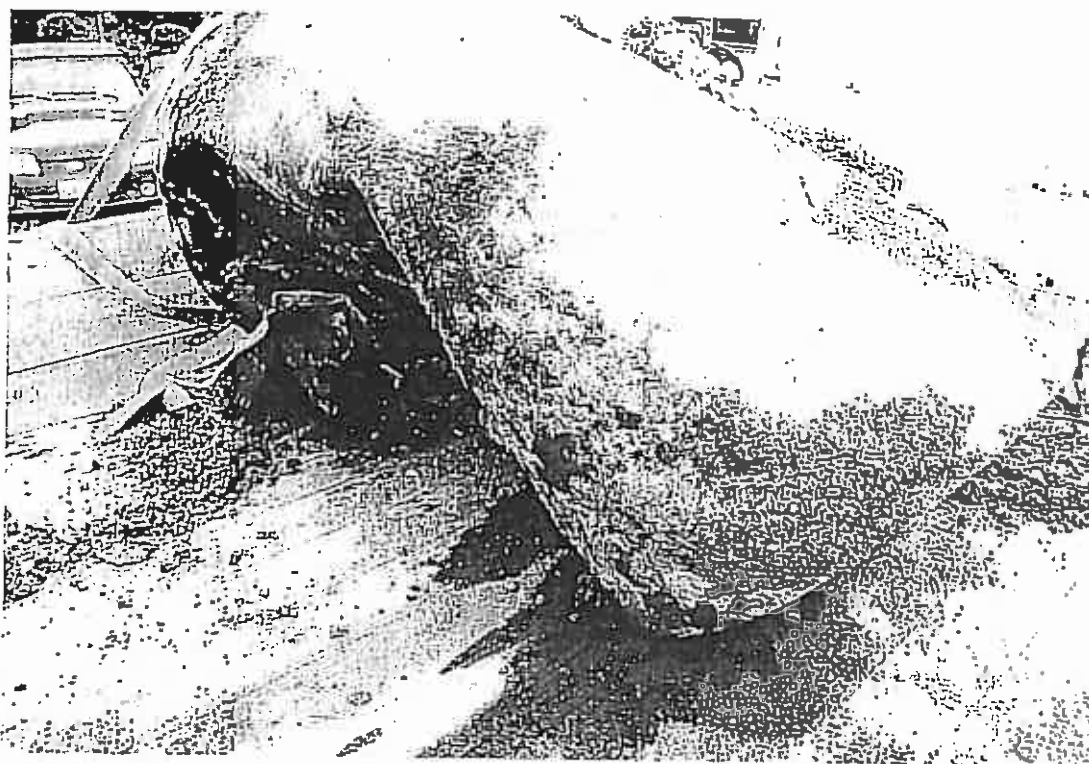
Photograph 7. View of the UST prior to disposal.

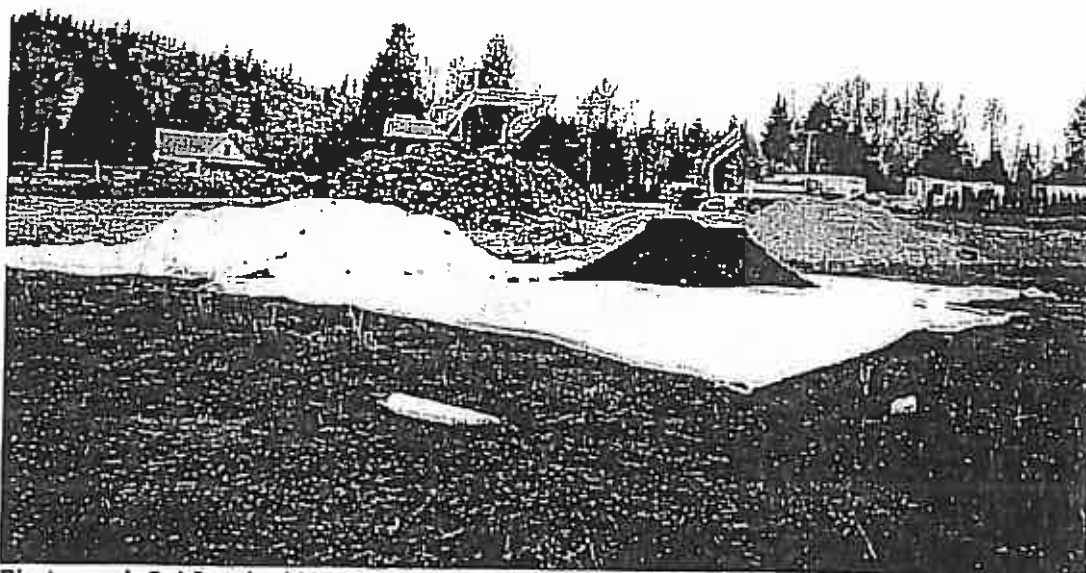
Photograph 8. View looking over the area of stockpiled soil. The petroleum-impacted soil is in the foreground; soil excavated from the area of the former dry cleaner area is in the background. Soil from the UST excavation was later placed to the west of the visible stockpiles.

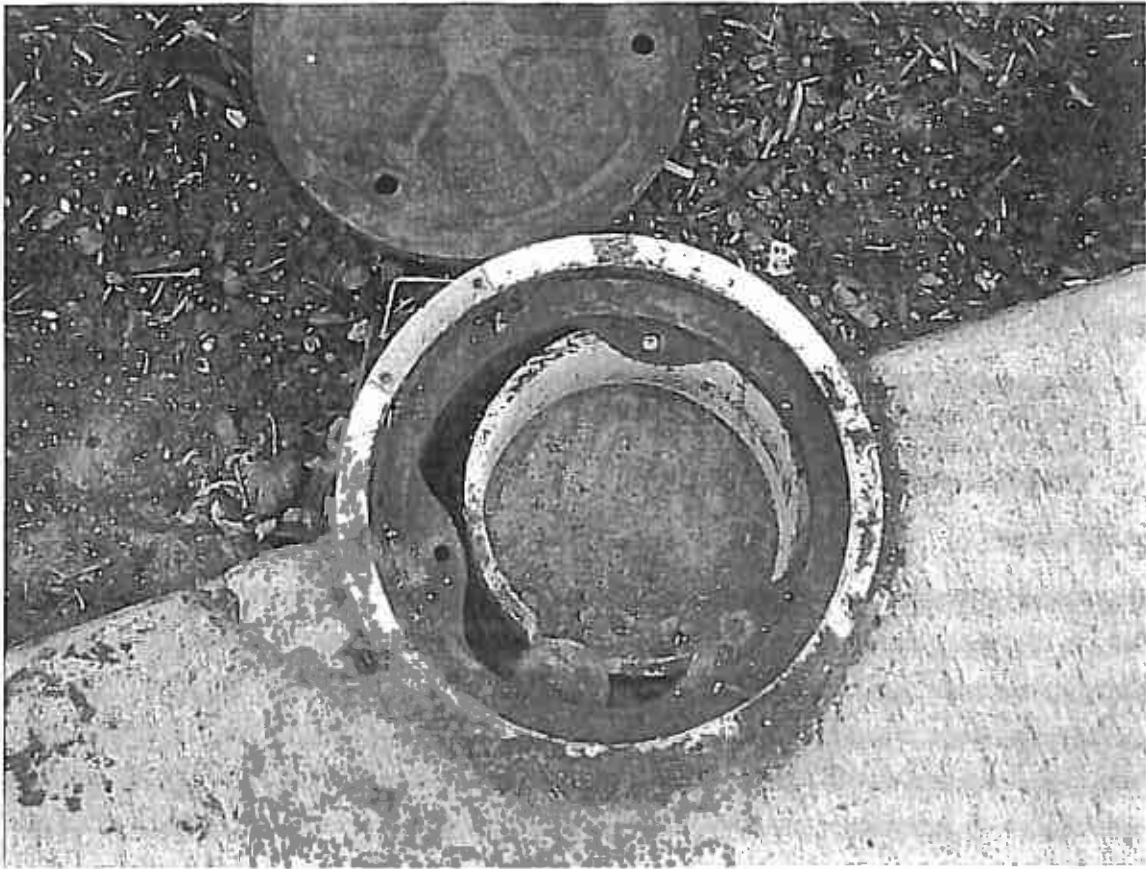
**Attachment B**  
**TW-12 Photograph April 17, 2008**

Treatment well MW-12 closed with concrete April 17, 2008
