September 28, 2020

Project No. 9231000006.5000

LANDSBURG MINE SITE REMEDIATION CONSTRUCTION ACTIVITIES SUMMARY REPORT SEPTEMBER 2020

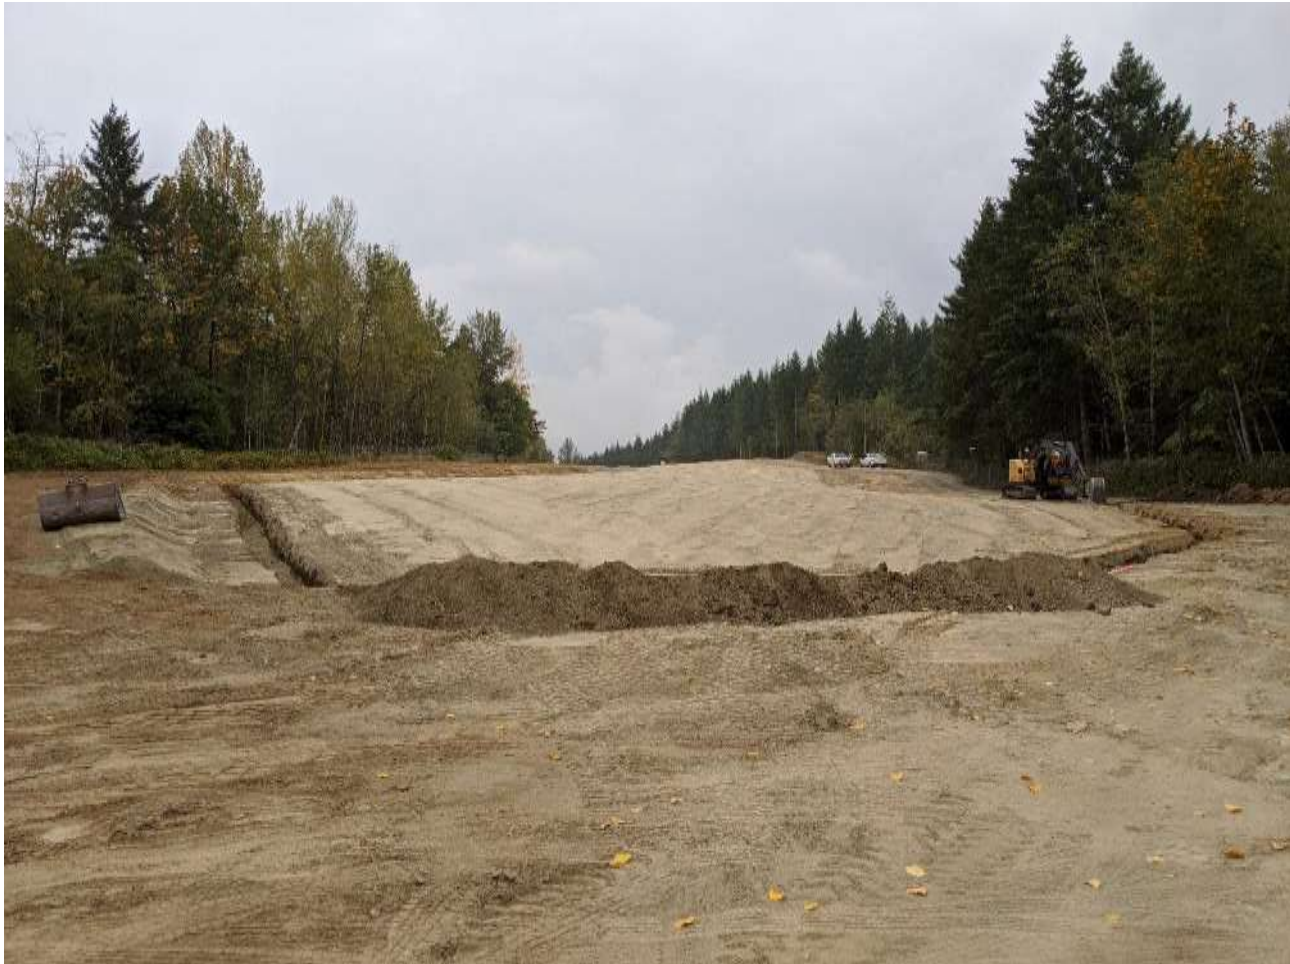
Photograph 1: Anchor trenches dug and Area 8 subgrade rolled in preparation for liner installation.

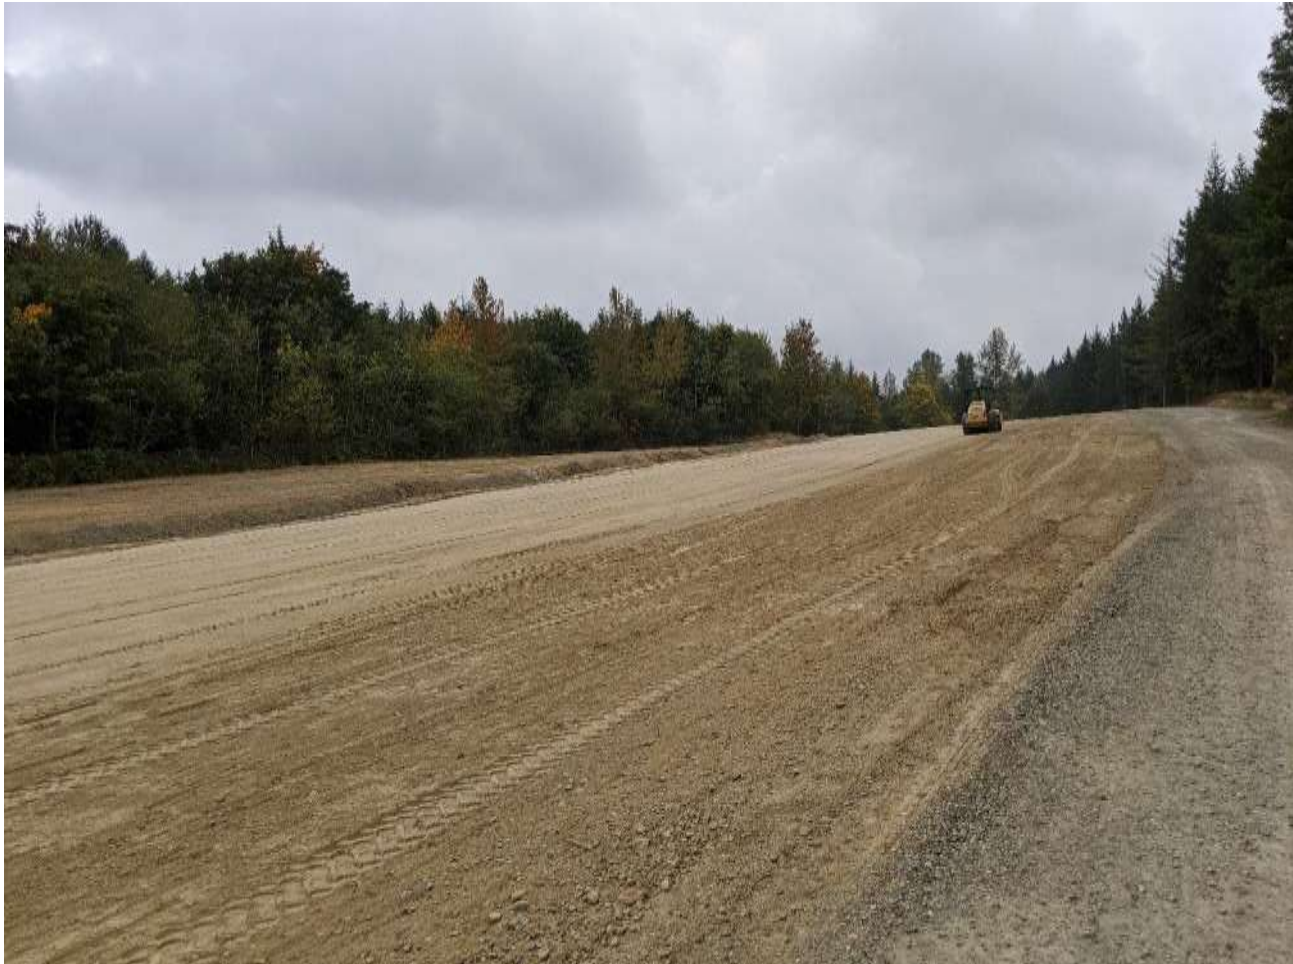
Photograph 2: Areas 7 and 8 regraded and being rolled in preparation for liner installation.

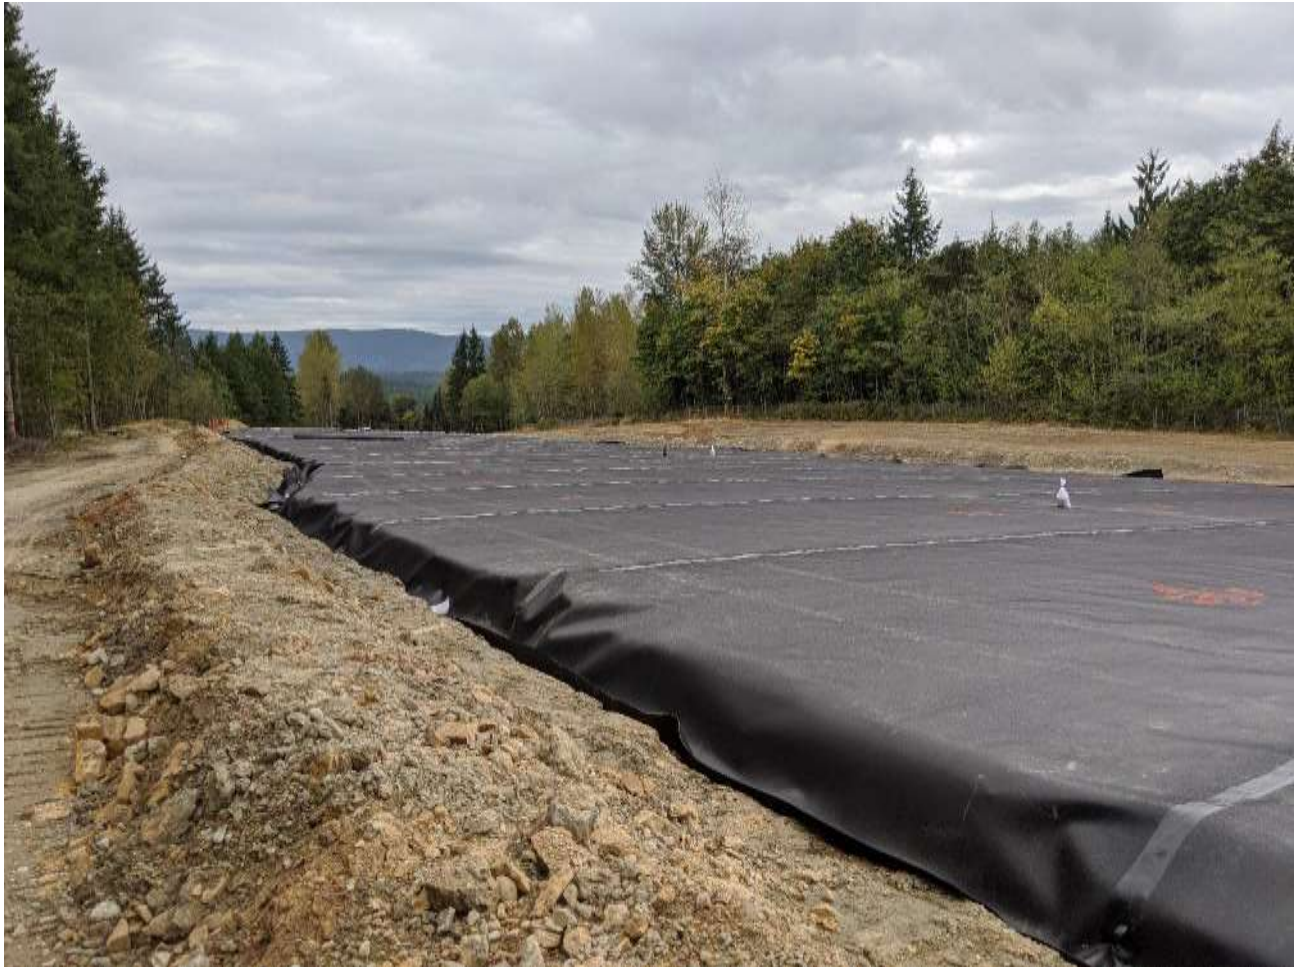
Photograph 3: Geomembrane liner deployed over Area 7.

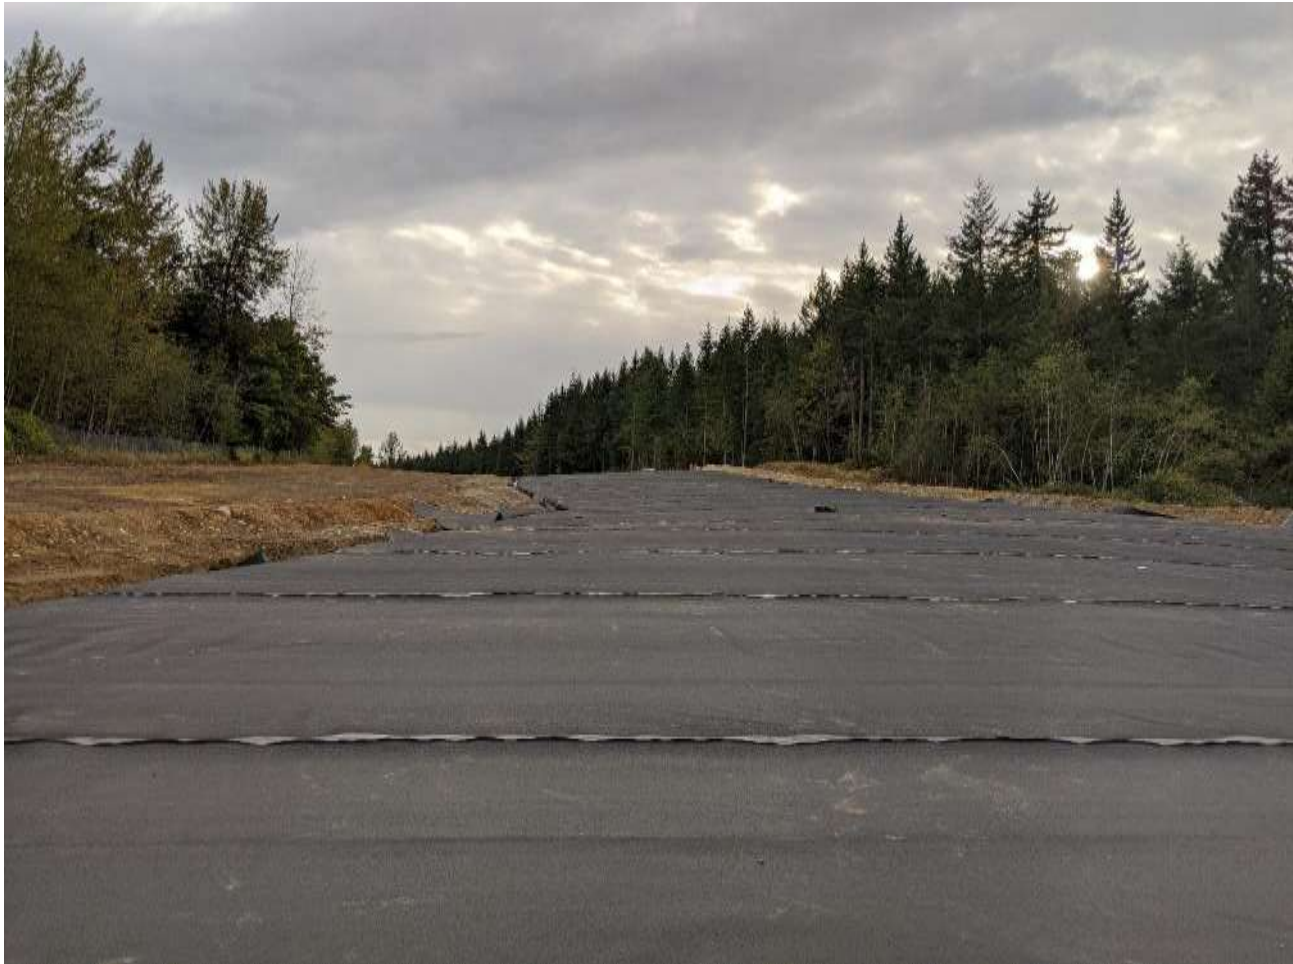
Photograph 4: Geomembrane liner deployed over Area 8.
