August 30, 2019

Project No. 9231000005.5000

LANDSBURG MINE SITE REMEDIATION CONSTRUCTION ACTIVITIES SUMMARY REPORT AUGUST 2019

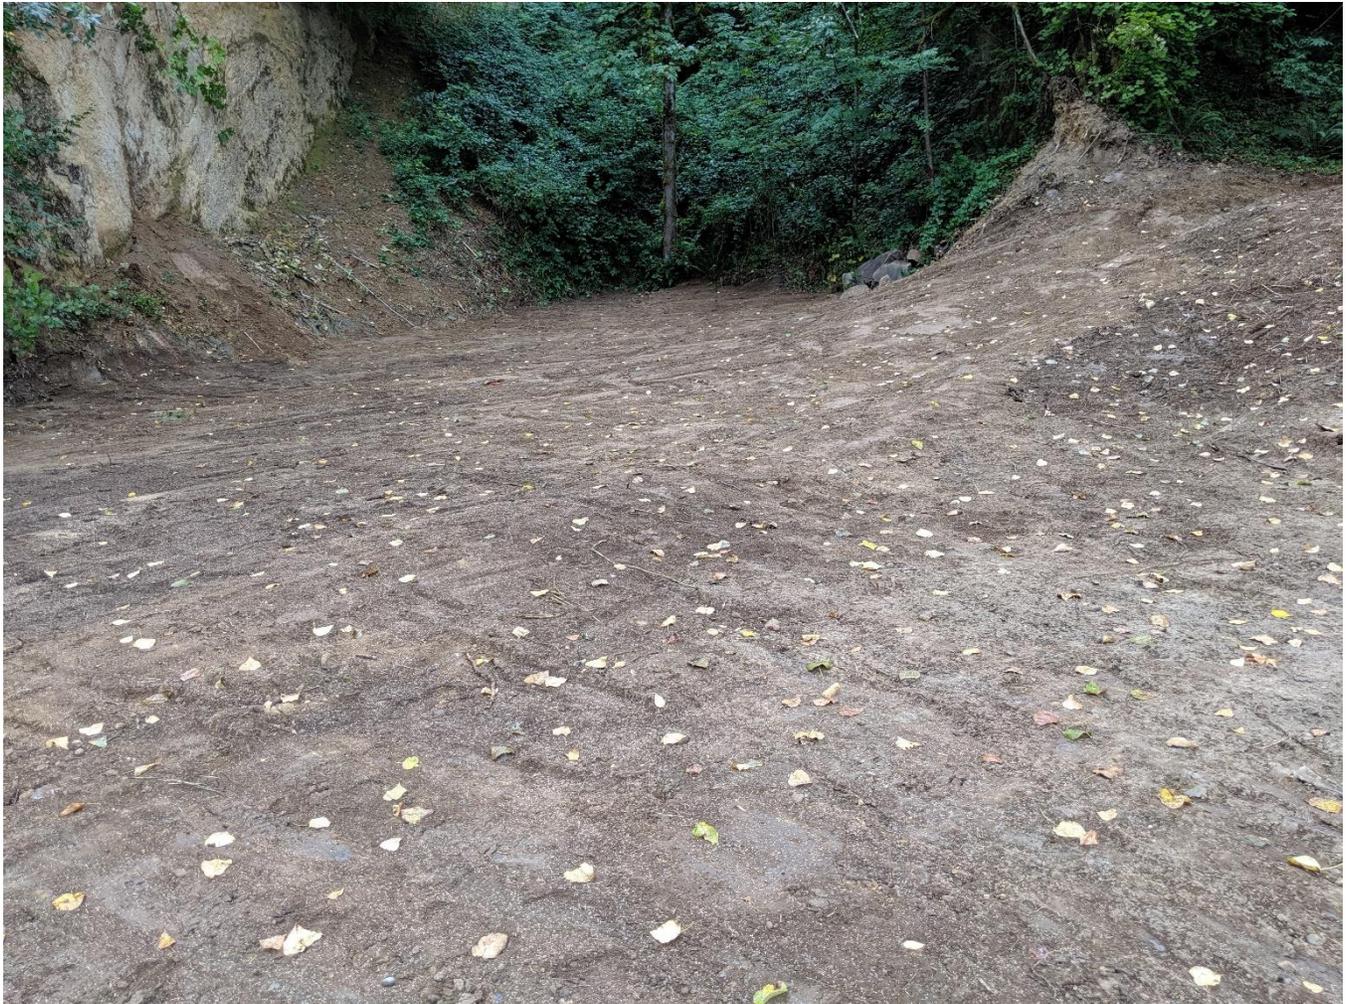
- Backfilling of Portal #2 was completed the week of August 19. Approximately 1,000 cy of fill material was placed at Portal #2. The same fill material that was used to backfill the trenches was used to backfill the Portal # 2 depression.

Photo 1 – Portal #2 backfilled, August 29, 2019 (looking south from northern tip)

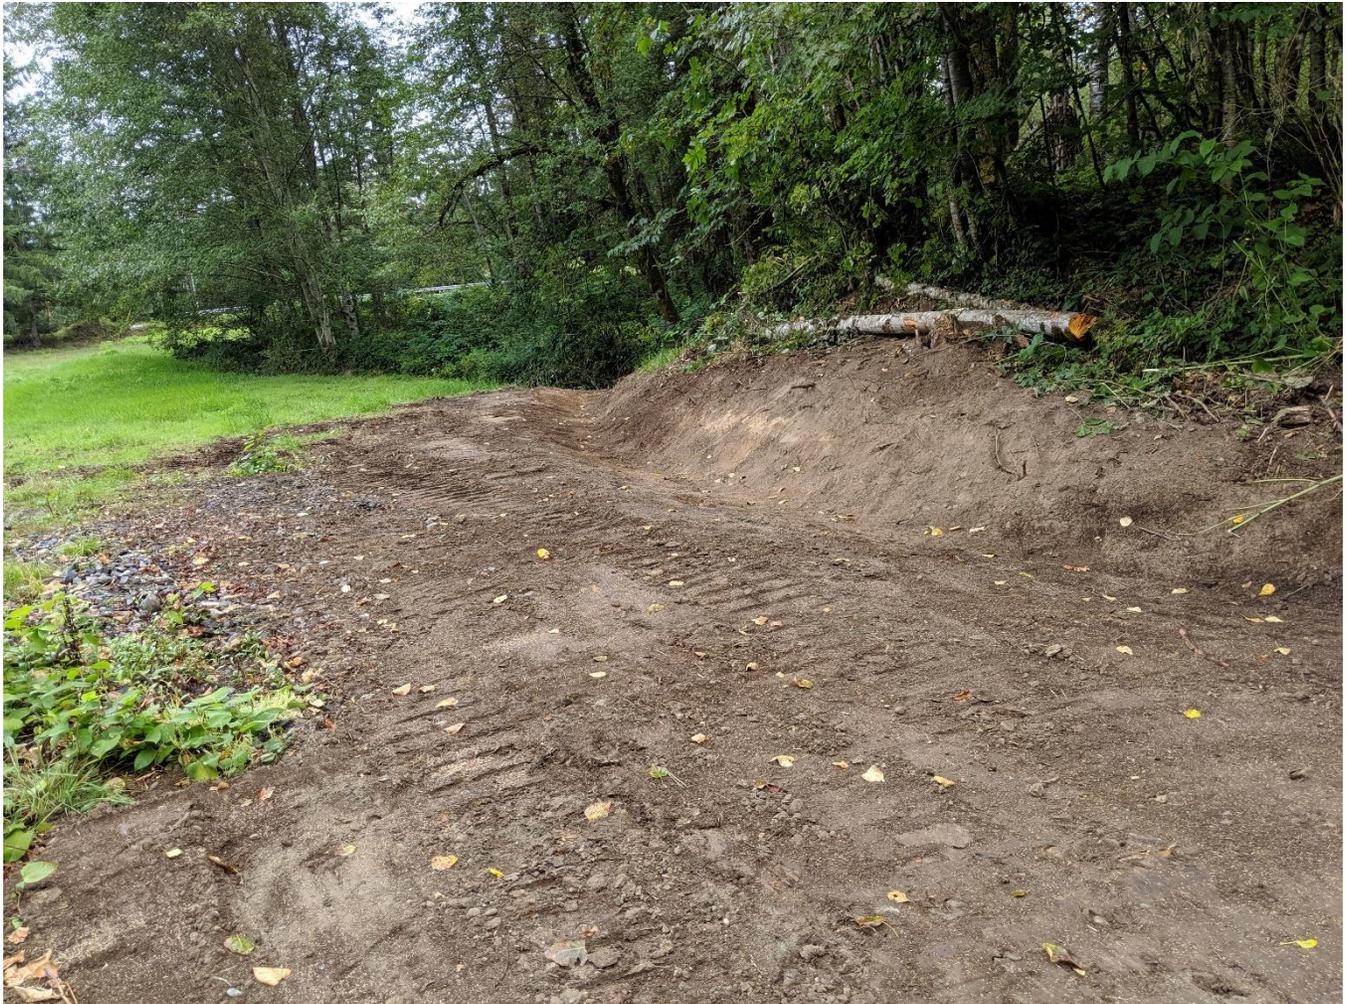
Photo 2 – Portal #2 backfilled, August 29, 2019 (looking northeast from northern tip)
